APPENDIX G

ROCK CORE PHOTOGRAPHS

CCG REF: CCG-C-18-10350
SITE: CO2, WEST WATERLOO
DOCK, LIVERPOOL
CLIENT: ROMAL CAPITAL
BH1 6.70-9.70mbgl

LABORATORY REPORT

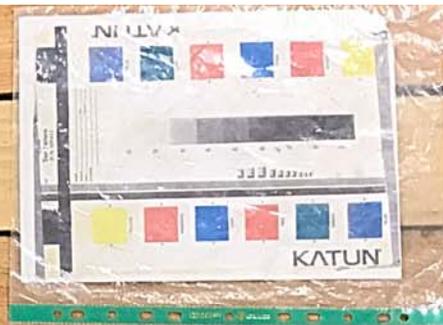
CCG REF: CCG-C-18-10350
SITE: CO2, WEST WATERLOO
DOCK, LIVERPOOL
CLIENT: ROMAL CAPITAL
BH1 9.70-12.70mbgl

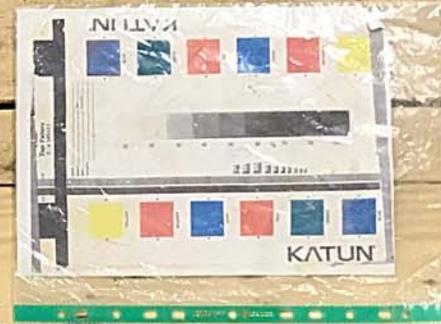
CCG REF: CCG-C-18-10350
SITE: CO2, WEST WATERLOO
DOCK, LIVERPOOL
CLIENT: ROMAL CAPITAL
BH2 7.20-10.20mbgl

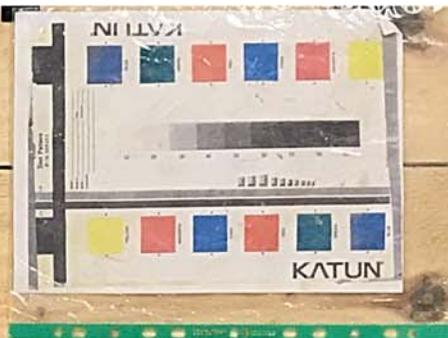
CCG REF: CCG-C-18-10350
SITE: CO2, WEST WATERLOO
DOCK, LIVERPOOL
CLIENT: ROMAL CAPITAL
BH2 10.20-13.20mbgl

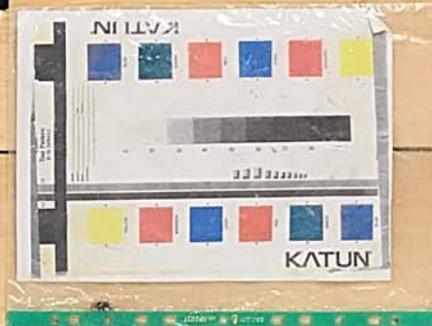
CCG REF: CCG-C-18-10350
SITE: CO2, WEST WATERLOO
DOCK, LIVERPOOL
CLIENT: ROMAL CAPITAL
BH3 7.50-10.50mbgl

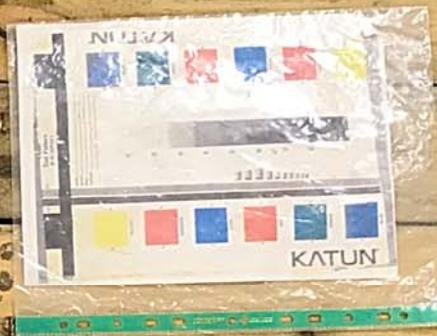
CCG REF: CCG-C-18-10350
SITE: CO2, WEST WATERLOO
DOCK, LIVERPOOL
CLIENT: ROMAL CAPITAL
BH3 10.50-13.50mbgl

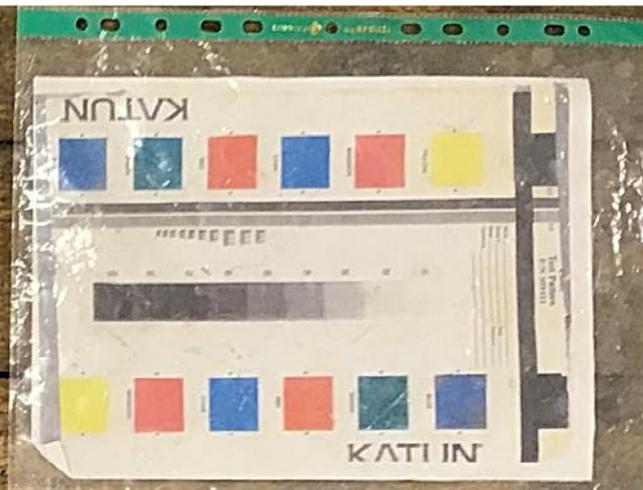
CCG REF: CCG-C-18-10350
SITE: CO2, WEST WATERLOO
DOCK, LIVERPOOL
CLIENT: ROMAL CAPITAL
BH4 9.80-10.80mbgl

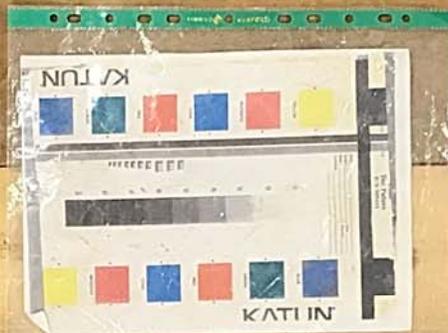
CCG REF: CCG-C-18-10350
SITE: CO2, WEST WATERLOO
DOCK, LIVERPOOL
CLIENT: ROMAL CAPITAL
BH4 10.80-13.80mbgl

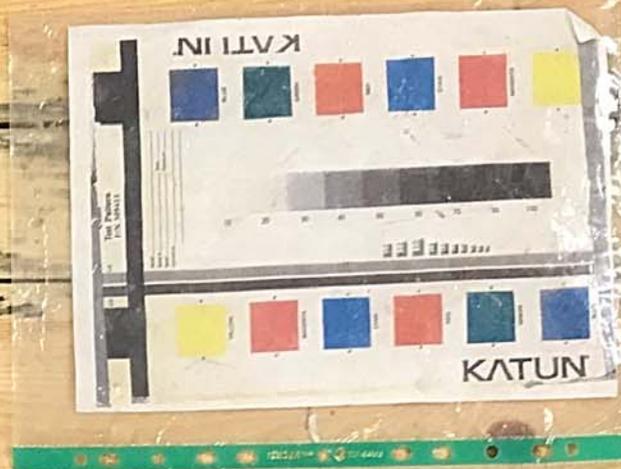
CCG REF: CCG-C-18-10350
SITE: CO2, WEST WATERLOO
DOCK, LIVERPOOL
CLIENT: ROMAL CAPITAL
BH5 18.30-21.30mbgl

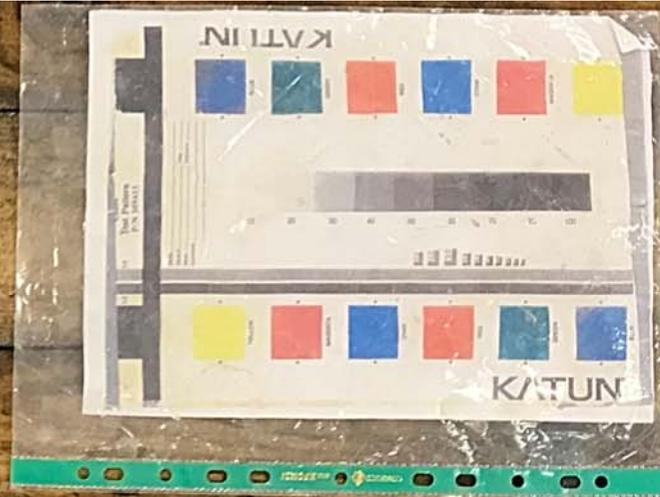
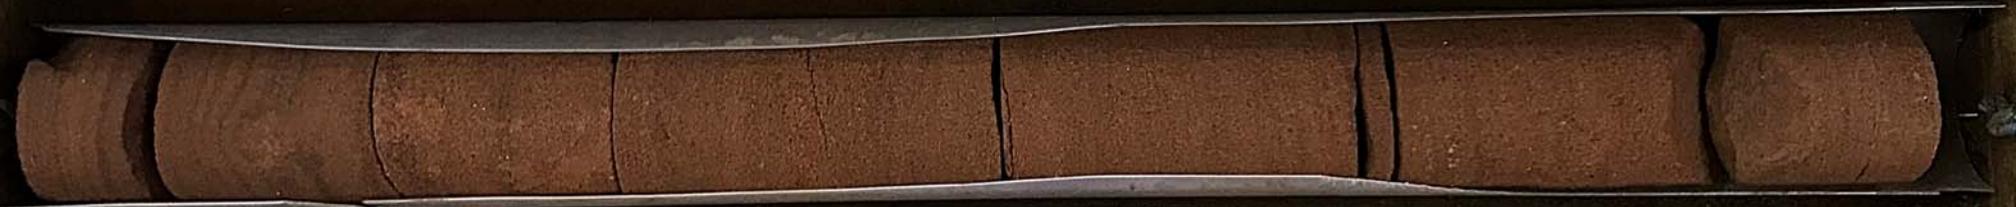
CCG REF: CCG-C-18-10350
SITE: CO2, WEST WATERLOO
DOCK, LIVERPOOL
CLIENT: ROMAL CAPITAL
BH5 21.30-23.30mbgl

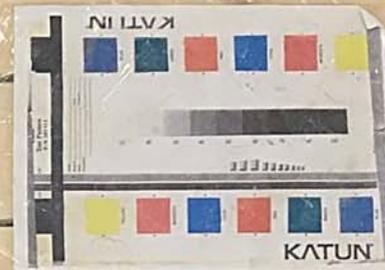
CCG REF: CCG-C-18-10350
SITE: CO2, WEST WATERLOO
DOCK, LIVERPOOL
CLIENT: ROMAL CAPITAL
BH5 23.30-26.30mbgl

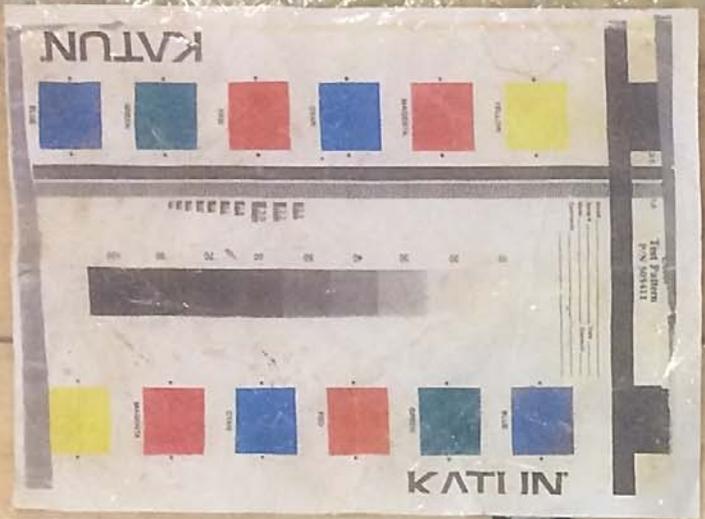
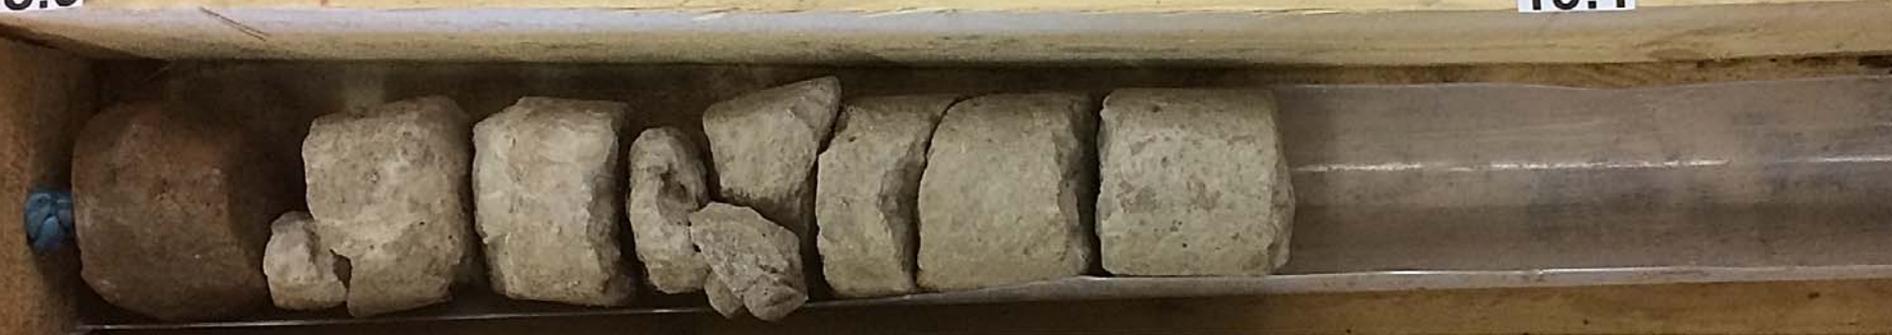
CCG REF: CCG-C-18-10350
SITE: CO2, WEST WATERLOO
DOCK, LIVERPOOL
CLIENT: ROMAL CAPITAL
BH6 18.50-19.10mbgl

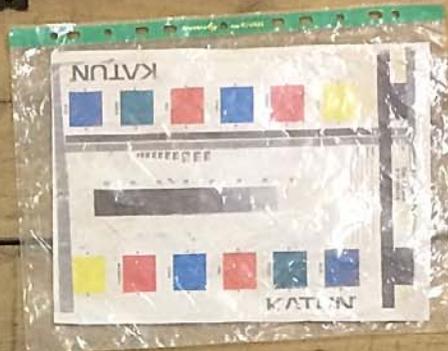
CCG REF: CCG-C-18-10350
SITE: CO2, WEST WATERLOO
DOCK, LIVERPOOL
CLIENT: ROMAL CAPITAL
BH6 20.60-23.60mbgl

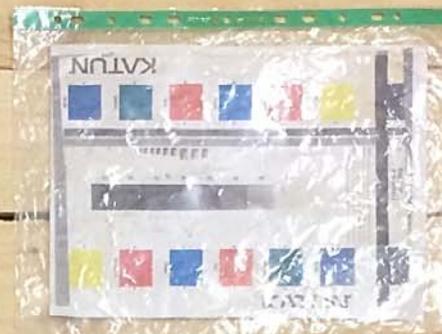
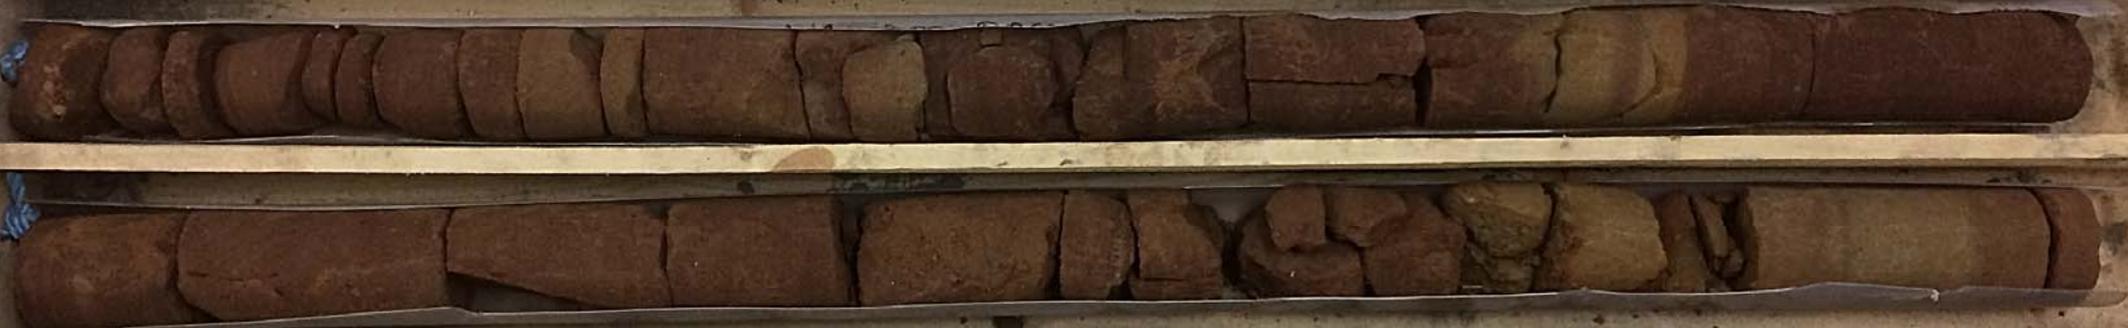
CCG REF: CCG-C-18-10350
SITE: CO2, WEST WATERLOO
DOCK, LIVERPOOL
CLIENT: ROMAL CAPITAL
BH6 23.60-26.60mbgl

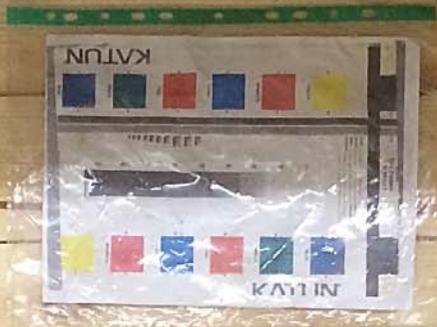
CCG REF: CCG-C-18-10350
SITE: CO2, WEST WATERLOO
DOCK, LIVERPOOL
CLIENT: ROMAL CAPITAL
BH7 15.60-18.60mbgl

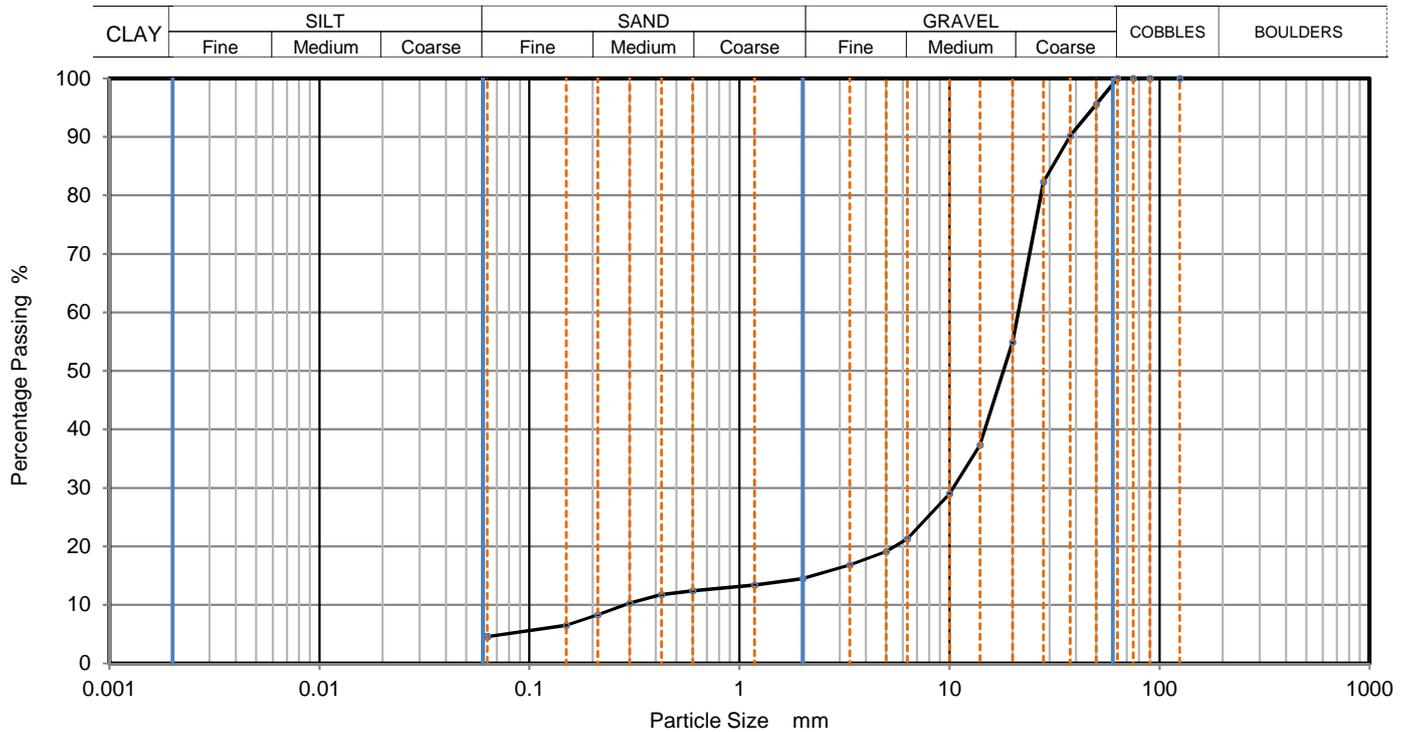
WET SIEVE

Sieving		Sedimentation	
Particle Size mm	% Passing	Particle Size mm	% Passing
125	100		
90	100		
75	100		
63	100		
50	96		
37.5	90		
28	82		
20	55		
14	37		
10	29		
6.3	21		
5	19		
3.35	17		
2	14		
1.18	13		
0.6	12		
0.425	12		
0.3	10		
0.212	8		
0.15	7		
0.063	5

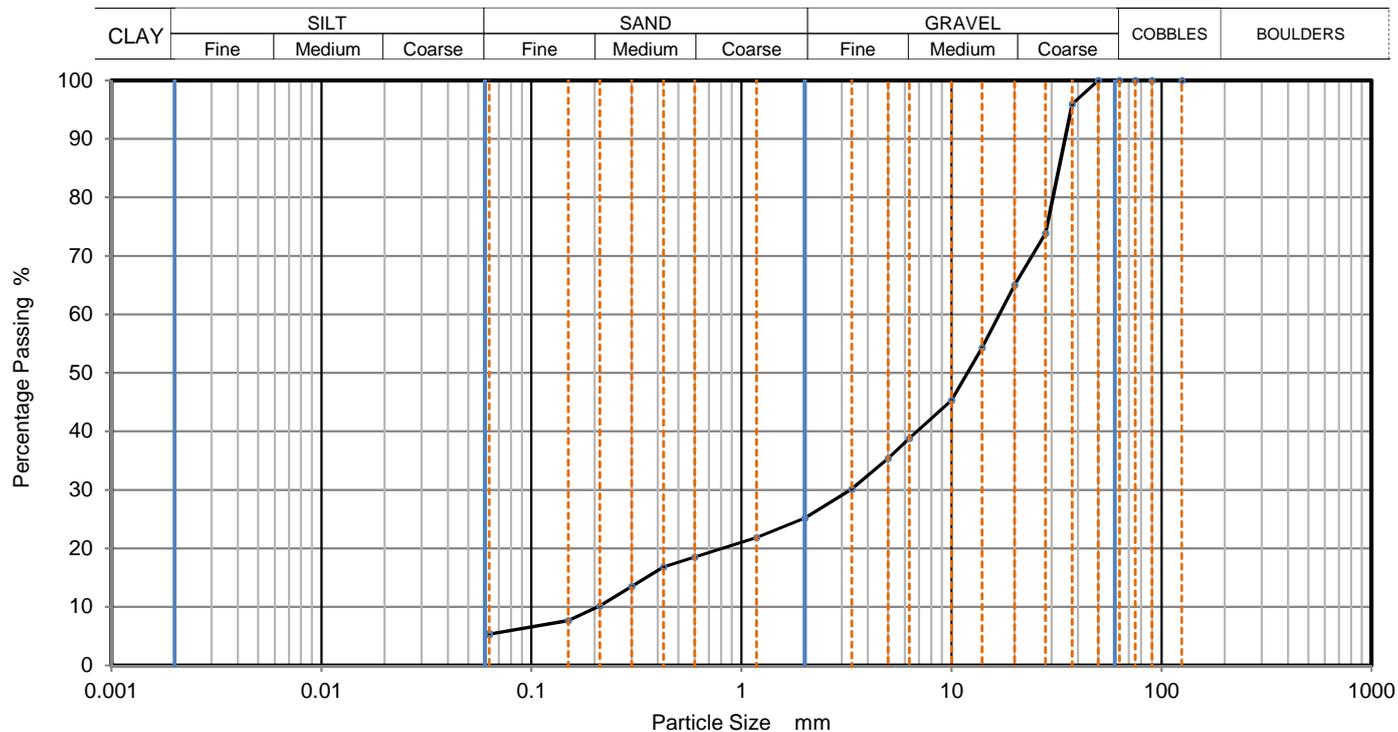
WET SIEVE

Sieving		Sedimentation	
Particle Size mm	% Passing	Particle Size mm	% Passing
125	100		
90	100		
75	100		
63	100		
50	100		
37.5	96		
28	74		
20	65		
14	54		
10	45		
6.3	39		
5	35		
3.35	30		
2	25		
1.18	22		
0.6	19		
0.425	17		
0.3	14		
0.212	10		
0.15	8		
0.063	5

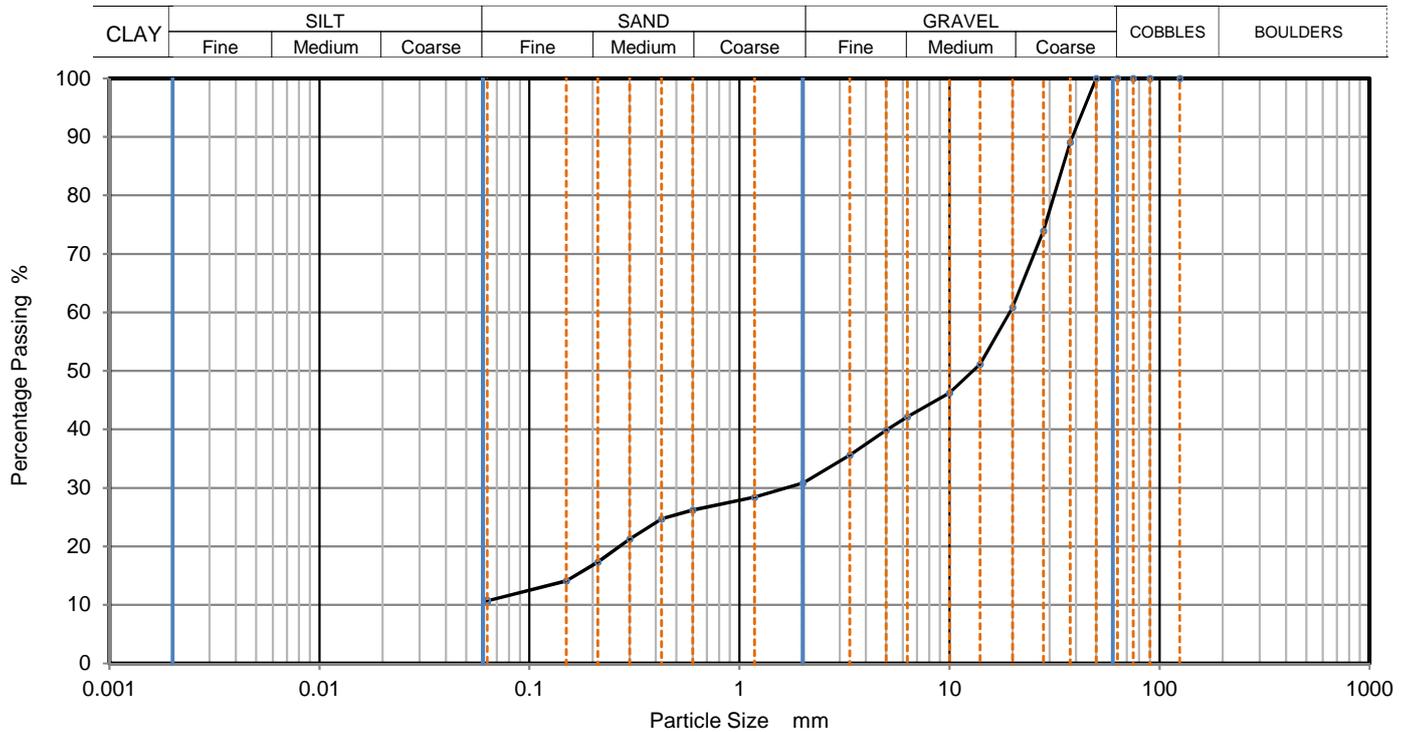
WET SIEVE

Sieving		Sedimentation	
Particle Size mm	% Passing	Particle Size mm	% Passing
125	100		
90	100		
75	100		
63	100		
50	100		
37.5	89		
28	74		
20	61		
14	51		
10	46		
6.3	42		
5	40		
3.35	36		
2	31		
1.18	28		
0.6	26		
0.425	25		
0.3	21		
0.212	17		
0.15	14		
0.063	11

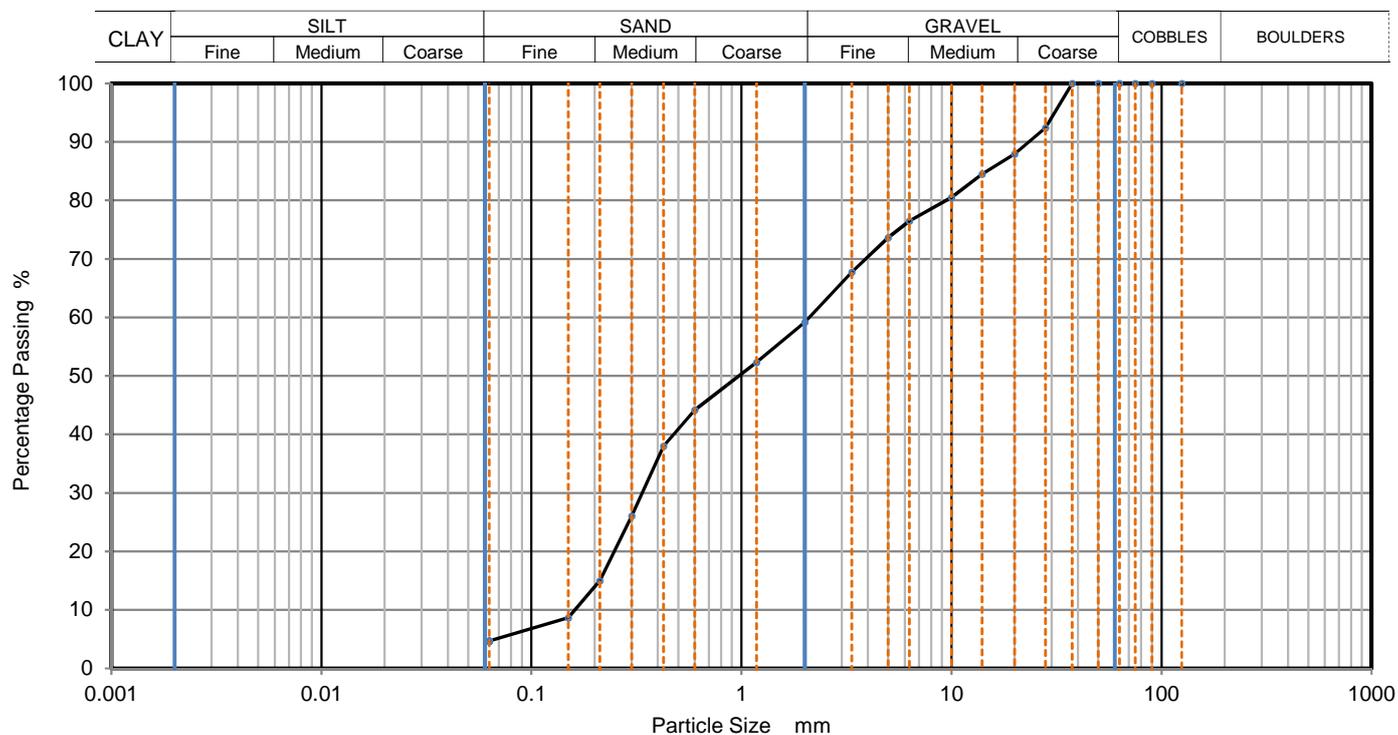
WET SIEVE

Sieving		Sedimentation	
Particle Size mm	% Passing	Particle Size mm	% Passing
125	100		
90	100		
75	100		
63	100		
50	100		
37.5	100		
28	92		
20	88		
14	85		
10	81		
6.3	76		
5	74		
3.35	68		
2	59		
1.18	52		
0.6	44		
0.425	38		
0.3	26		
0.212	15		
0.15	9		
0.063	5

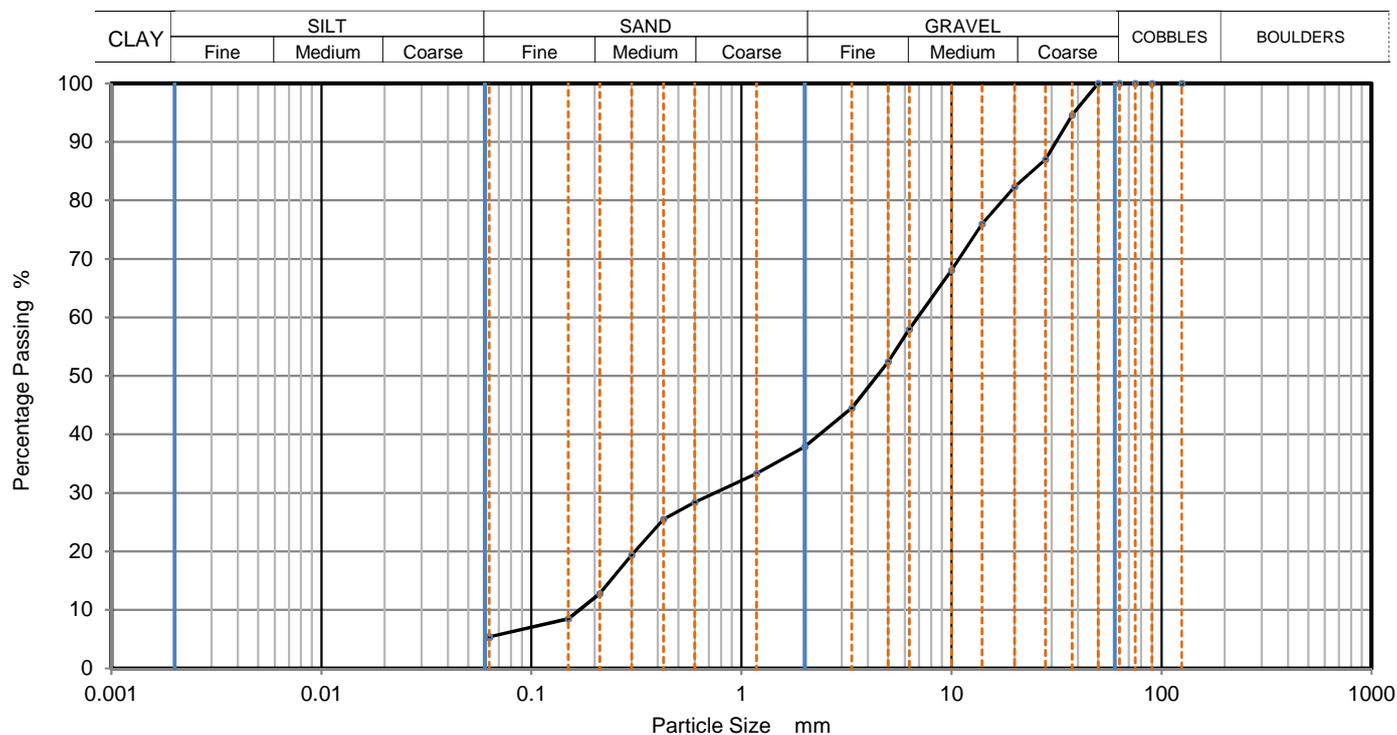
WET SIEVE

Sieving		Sedimentation	
Particle Size mm	% Passing	Particle Size mm	% Passing
125	100		
90	100		
75	100		
63	100		
50	100		
37.5	95		
28	87		
20	82		
14	76		
10	68		
6.3	58		
5	52		
3.35	45		
2	38		
1.18	33		
0.6	28		
0.425	26		
0.3	19		
0.212	13		
0.15	9		
0.063	5

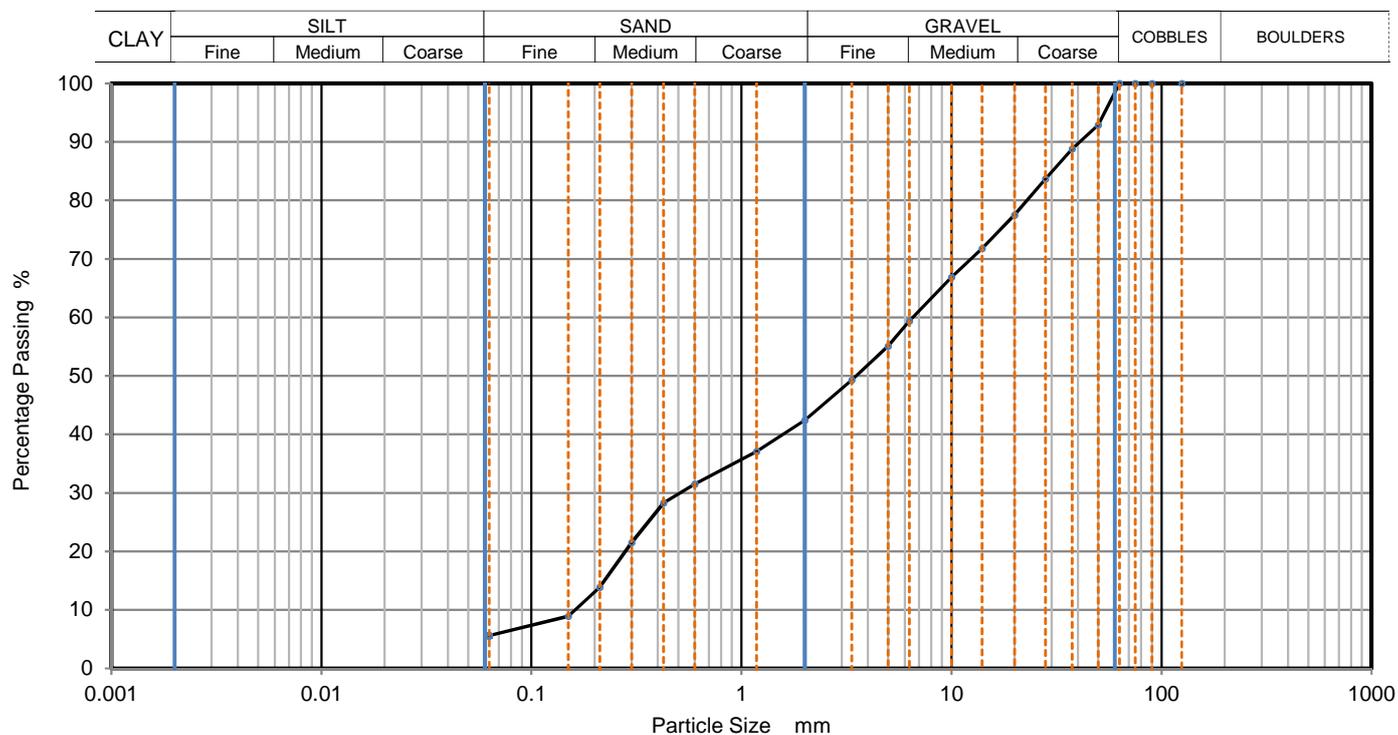
WET SIEVE

Sieving		Sedimentation	
Particle Size mm	% Passing	Particle Size mm	% Passing
125	100		
90	100		
75	100		
63	100		
50	93		
37.5	89		
28	84		
20	78		
14	72		
10	67		
6.3	59		
5	55		
3.35	49		
2	42		
1.18	37		
0.6	32		
0.425	28		
0.3	22		
0.212	14		
0.15	9		
0.063	6

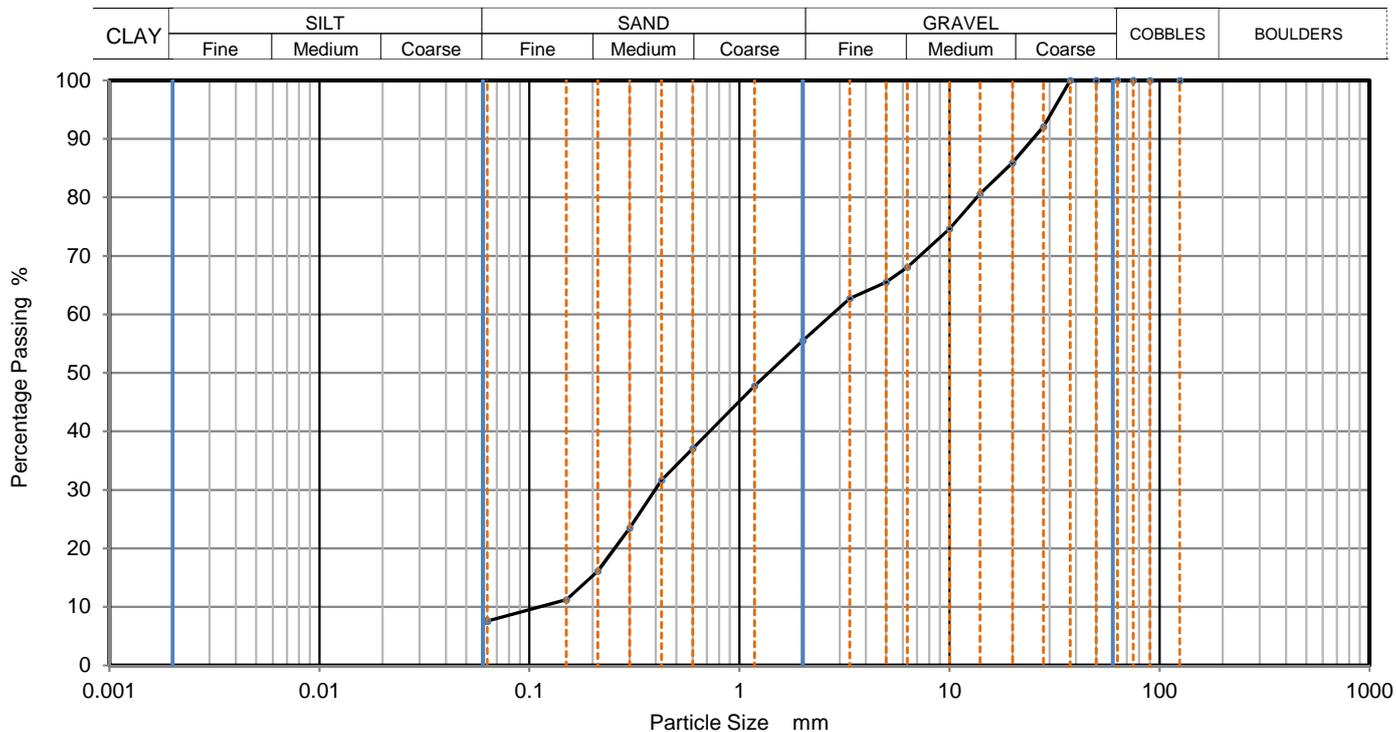
WET SIEVE

Sieving		Sedimentation	
Particle Size mm	% Passing	Particle Size mm	% Passing
125	100		
90	100		
75	100		
63	100		
50	100		
37.5	100		
28	92		
20	86		
14	81		
10	75		
6.3	68		
5	66		
3.35	63		
2	56		
1.18	48		
0.6	37		
0.425	32		
0.3	24		
0.212	16		
0.15	11		
0.063	8

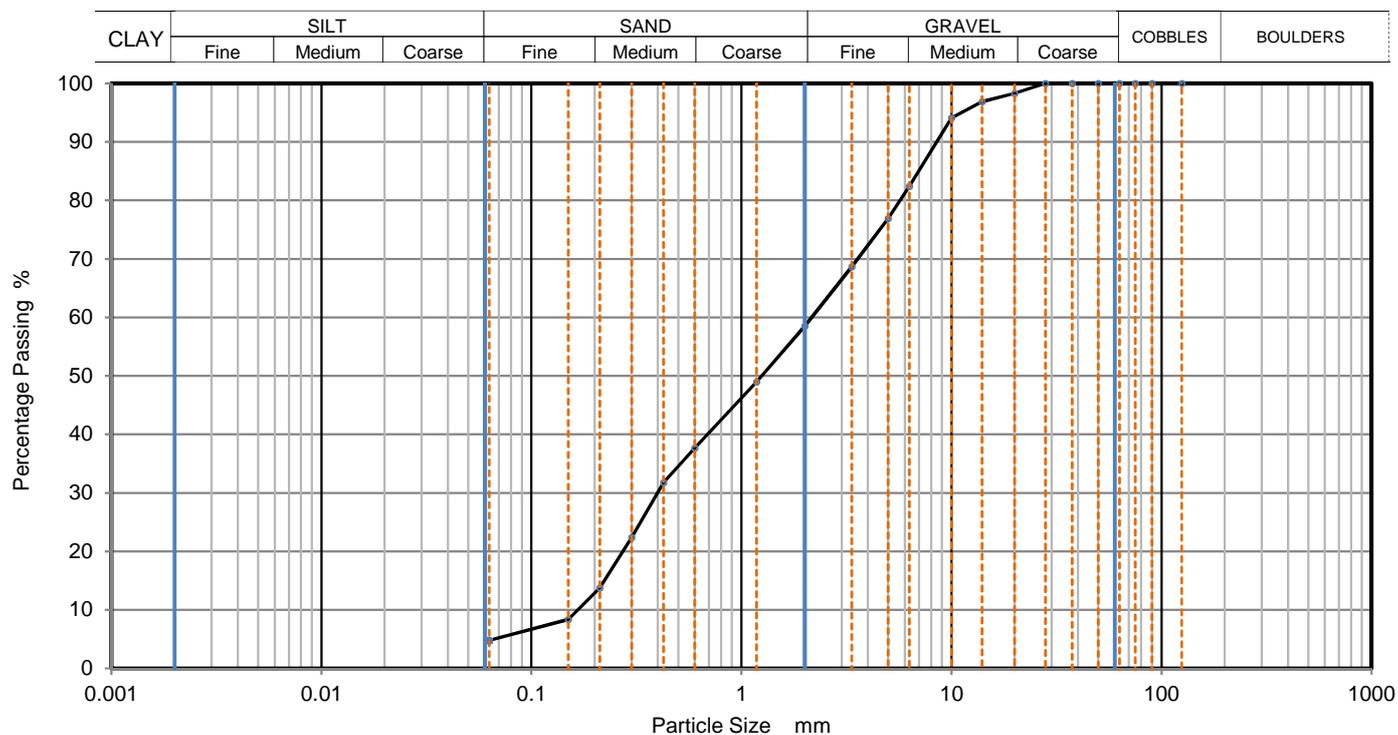
WET SIEVE

Sieving		Sedimentation	
Particle Size mm	% Passing	Particle Size mm	% Passing
125	100		
90	100		
75	100		
63	100		
50	100		
37.5	100		
28	100		
20	98		
14	97		
10	94		
6.3	82		
5	77		
3.35	69		
2	59		
1.18	49		
0.6	38		
0.425	32		
0.3	22		
0.212	14		
0.15	8		
0.063	5

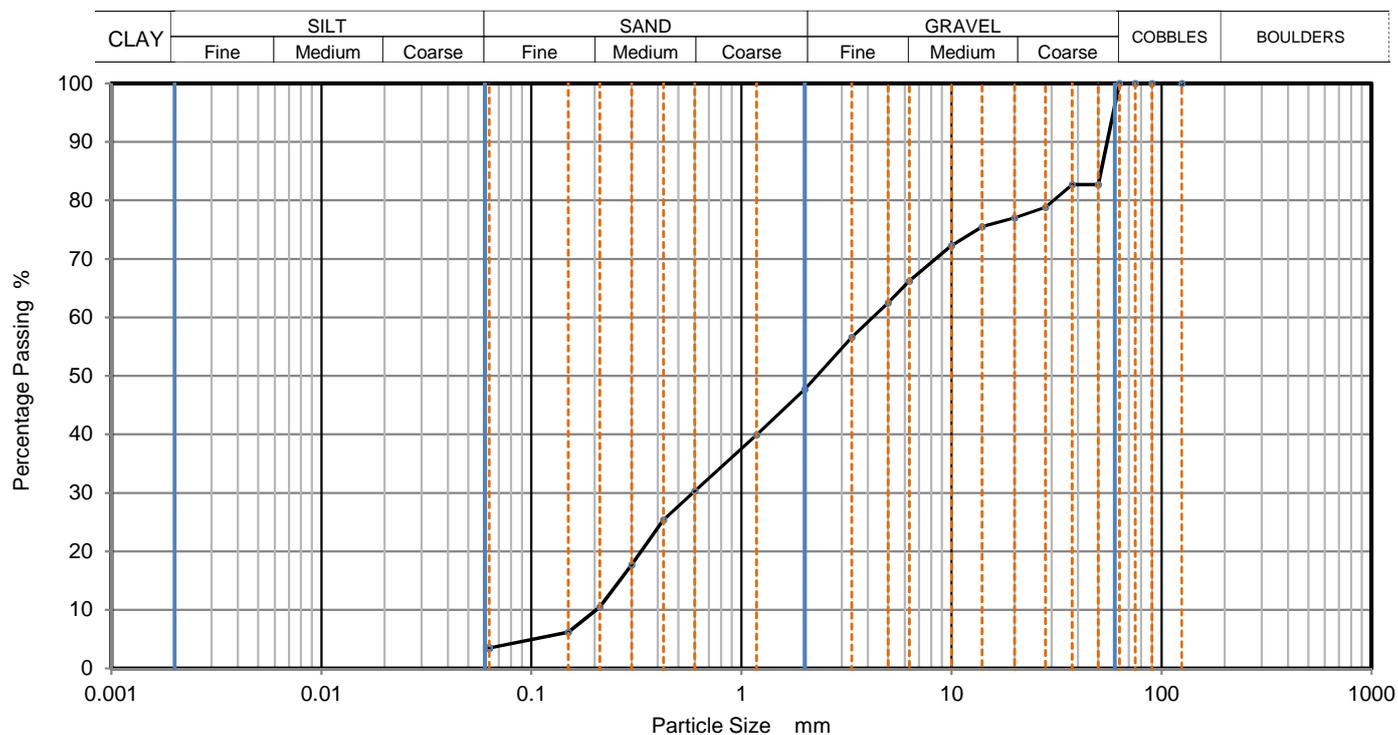
WET SIEVE

Sieving		Sedimentation	
Particle Size mm	% Passing	Particle Size mm	% Passing
125	100		
90	100		
75	100		
63	100		
50	83		
37.5	83		
28	79		
20	77		
14	76		
10	72		
6.3	66		
5	63		
3.35	57		
2	48		
1.18	40		
0.6	30		
0.425	25		
0.3	18		
0.212	11		
0.15	6		
0.063	4

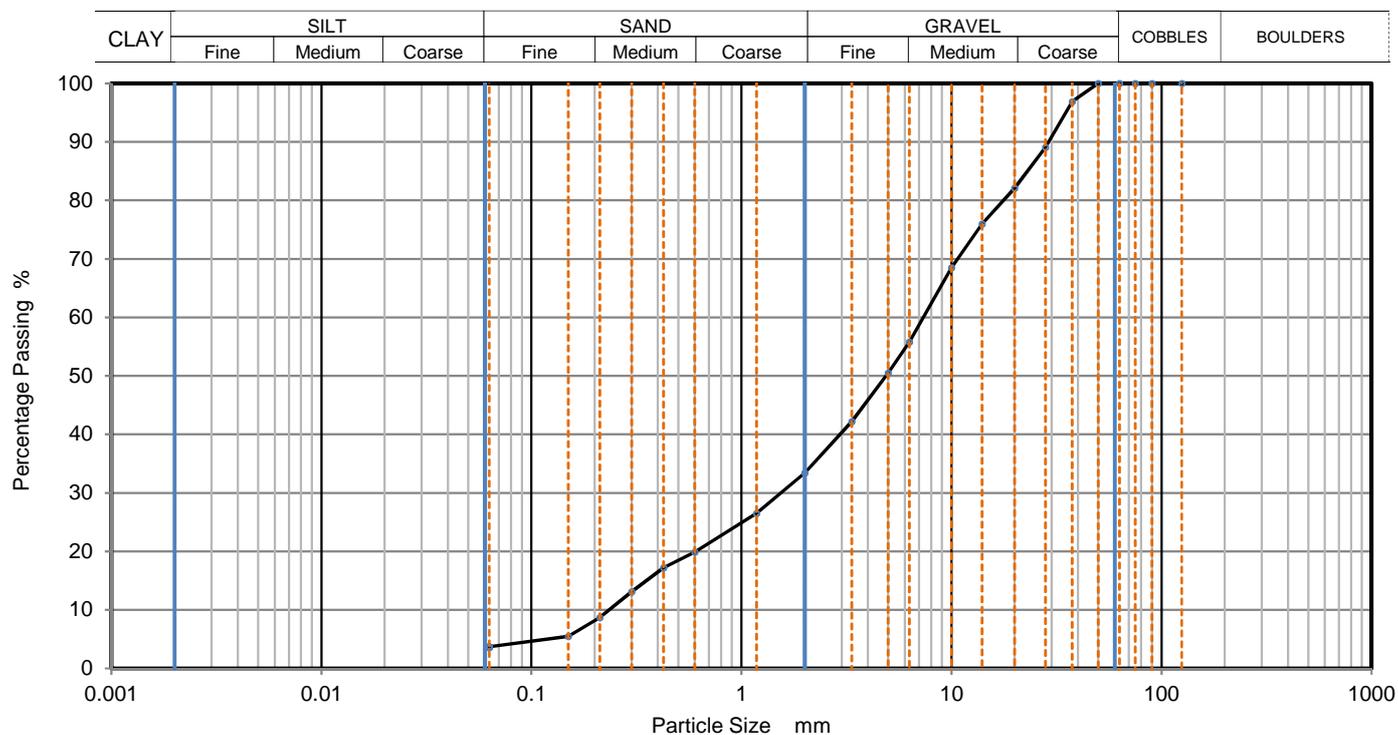
WET SIEVE

Sieving		Sedimentation	
Particle Size mm	% Passing	Particle Size mm	% Passing
125	100		
90	100		
75	100		
63	100		
50	100		
37.5	97		
28	89		
20	82		
14	76		
10	69		
6.3	56		
5	51		
3.35	42		
2	33		
1.18	27		
0.6	20		
0.425	17		
0.3	13		
0.212	9		
0.15	6		
0.063	4

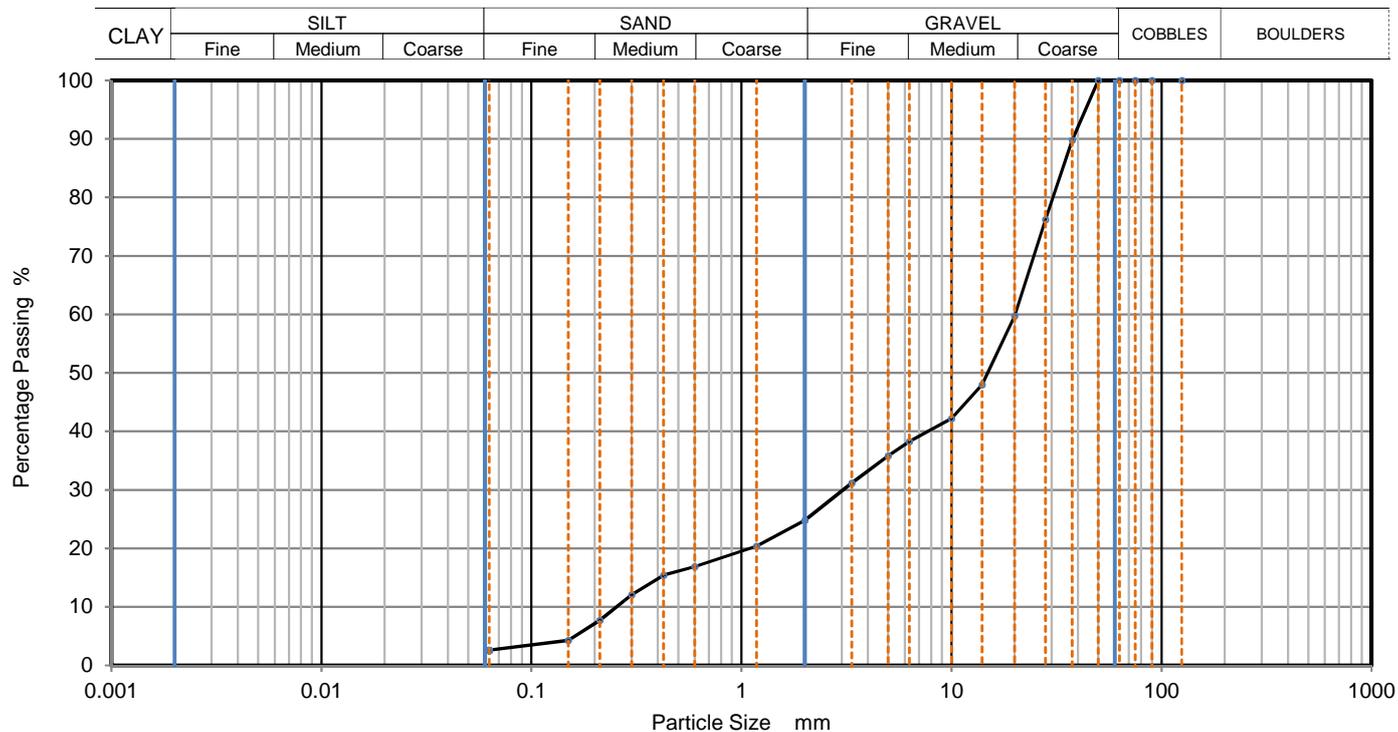
WET SIEVE

Sieving		Sedimentation	
Particle Size mm	% Passing	Particle Size mm	% Passing
125	100		
90	100		
75	100		
63	100		
50	100		
37.5	90		
28	76		
20	60		
14	48		
10	42		
6.3	38		
5	36		
3.35	31		
2	25		
1.18	20		
0.6	17		
0.425	15		
0.3	12		
0.212	8		
0.15	4		
0.063	3

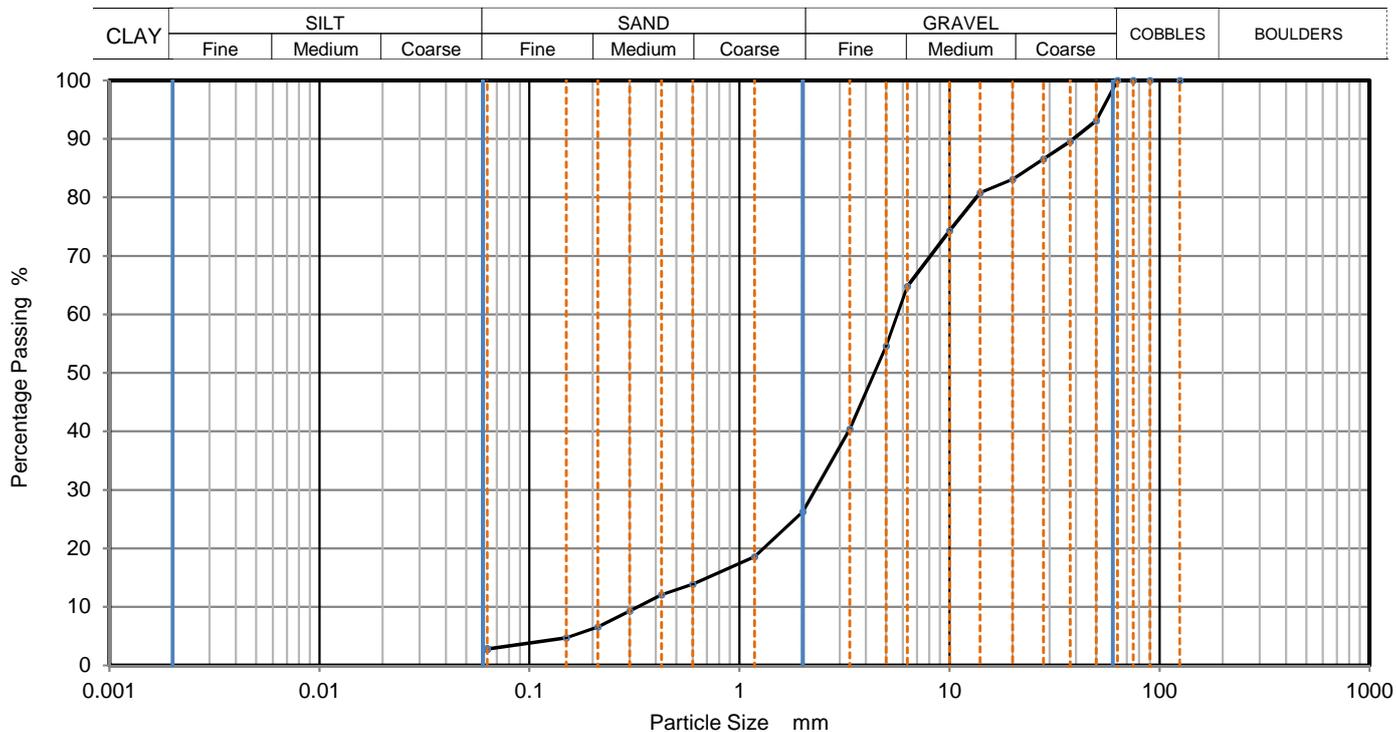
WET SIEVE

Sieving		Sedimentation	
Particle Size mm	% Passing	Particle Size mm	% Passing
125	100		
90	100		
75	100		
63	100		
50	93		
37.5	90		
28	87		
20	83		
14	81		
10	74		
6.3	65		
5	55		
3.35	40		
2	26		
1.18	19		
0.6	14		
0.425	12		
0.3	9		
0.212	7		
0.15	5		
0.063	3

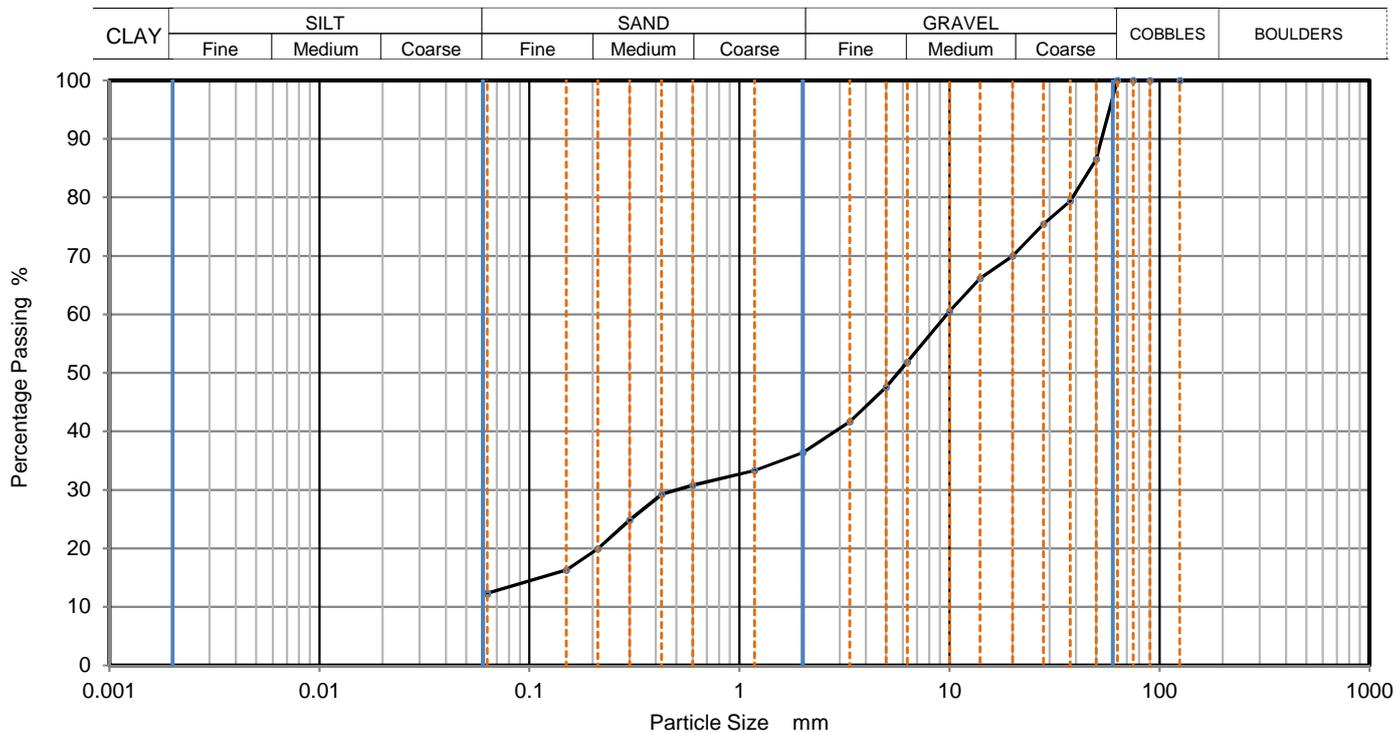
WET SIEVE

Sieving		Sedimentation	
Particle Size mm	% Passing	Particle Size mm	% Passing
125	100		
90	100		
75	100		
63	100		
50	87		
37.5	79		
28	75		
20	70		
14	66		
10	61		
6.3	52		
5	48		
3.35	42		
2	36		
1.18	33		
0.6	31		
0.425	29		
0.3	25		
0.212	20		
0.15	16		
0.063	12

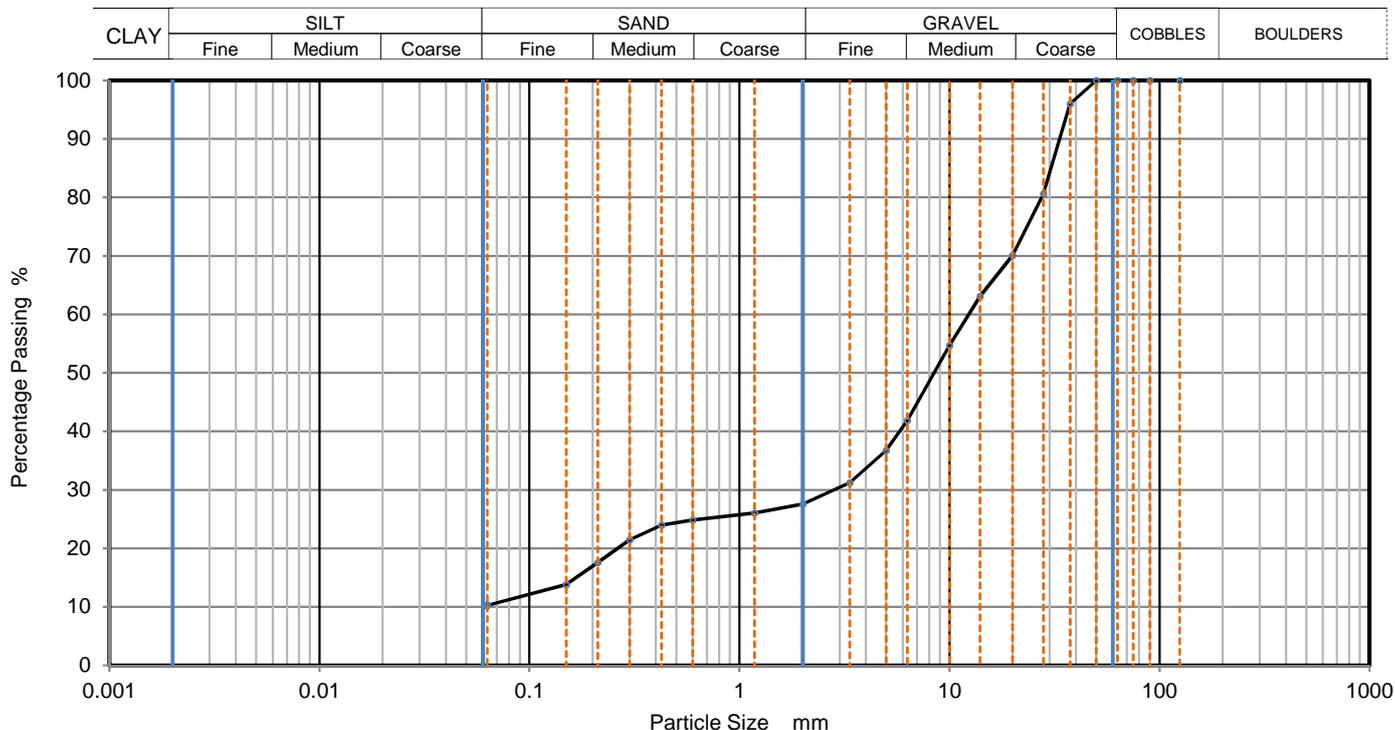
WET SIEVE

Sieving		Sedimentation	
Particle Size mm	% Passing	Particle Size mm	% Passing
125	100		
90	100		
75	100		
63	100		
50	100		
37.5	96		
28	81		
20	70		
14	63		
10	55		
6.3	42		
5	37		
3.35	31		
2	28		
1.18	26		
0.6	25		
0.425	24		
0.3	21		
0.212	18		
0.15	14		
0.063	10

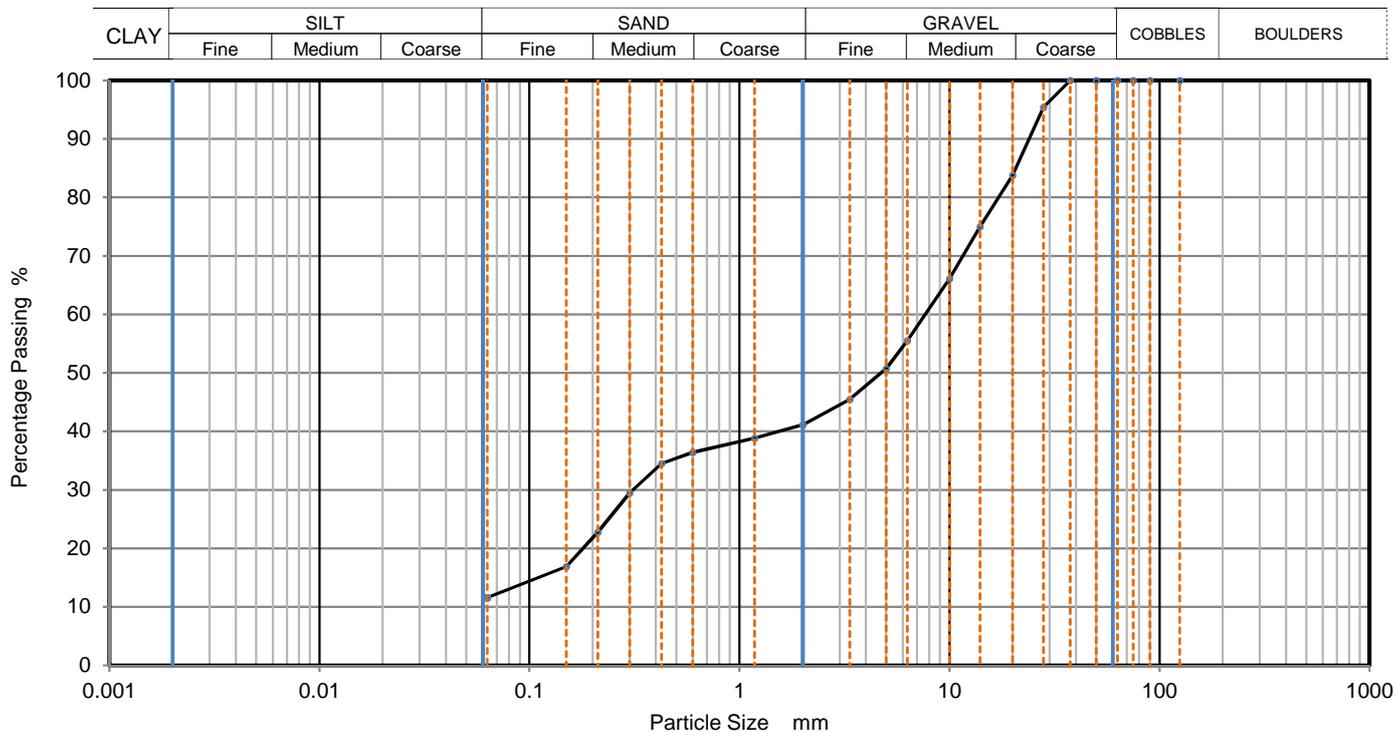
WET SIEVE

Sieving		Sedimentation	
Particle Size mm	% Passing	Particle Size mm	% Passing
125	100		
90	100		
75	100		
63	100		
50	100		
37.5	100		
28	95		
20	84		
14	75		
10	66		
6.3	56		
5	51		
3.35	46		
2	41		
1.18	39		
0.6	36		
0.425	35		
0.3	30		
0.212	23		
0.15	17		
0.063	12

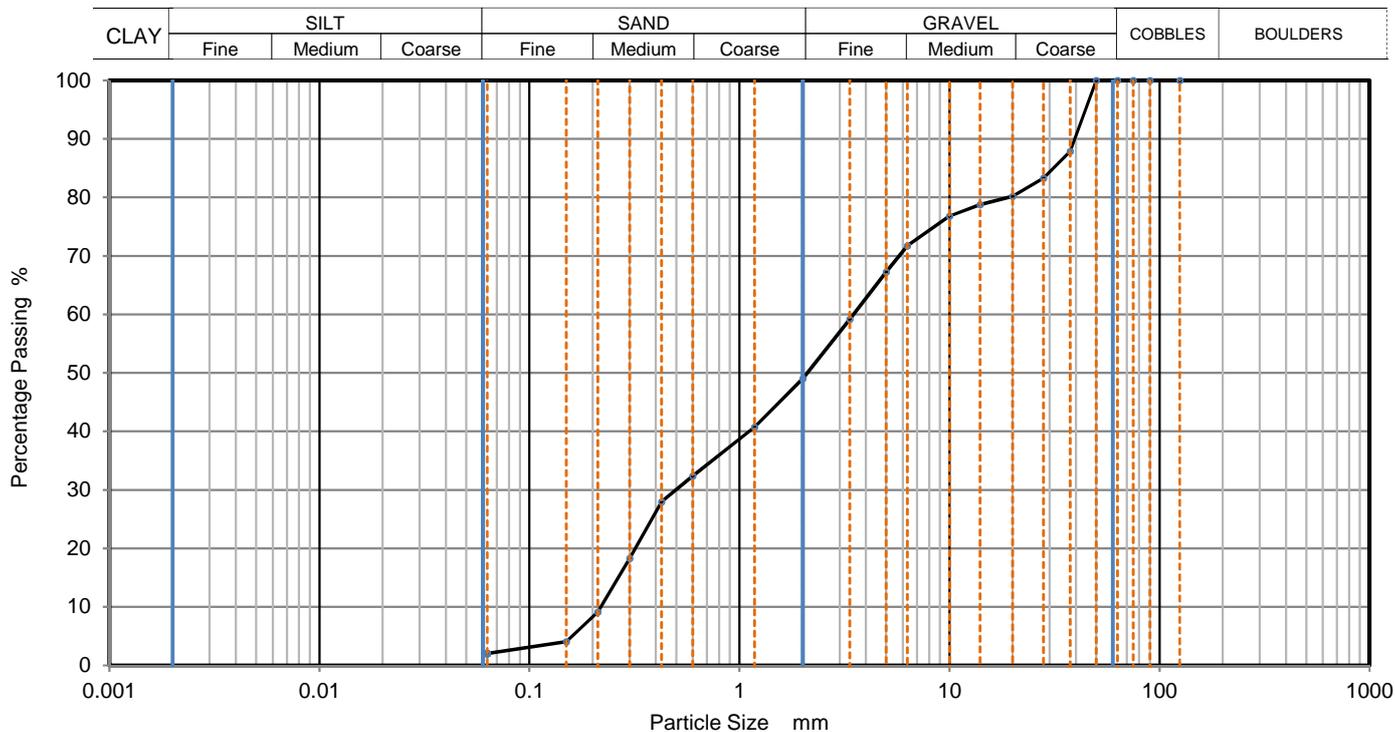
WET SIEVE

Sieving		Sedimentation	
Particle Size mm	% Passing	Particle Size mm	% Passing
125	100		
90	100		
75	100		
63	100		
50	100		
37.5	88		
28	83		
20	80		
14	79		
10	77		
6.3	72		
5	67		
3.35	59		
2	49		
1.18	41		
0.6	32		
0.425	28		
0.3	18		
0.212	9		
0.15	4		
0.063	2
