APPENDIX G

ROCK CORE PHOTOGRAPHS

CCG REF: CCG-C-18-10350
SITE: CO2, WEST WATERLOO
DOCK, LIVERPOOL
CLIENT: ROMAL CAPITAL
BH1 6.70-9.70mbgl

LABORATORY REPORT

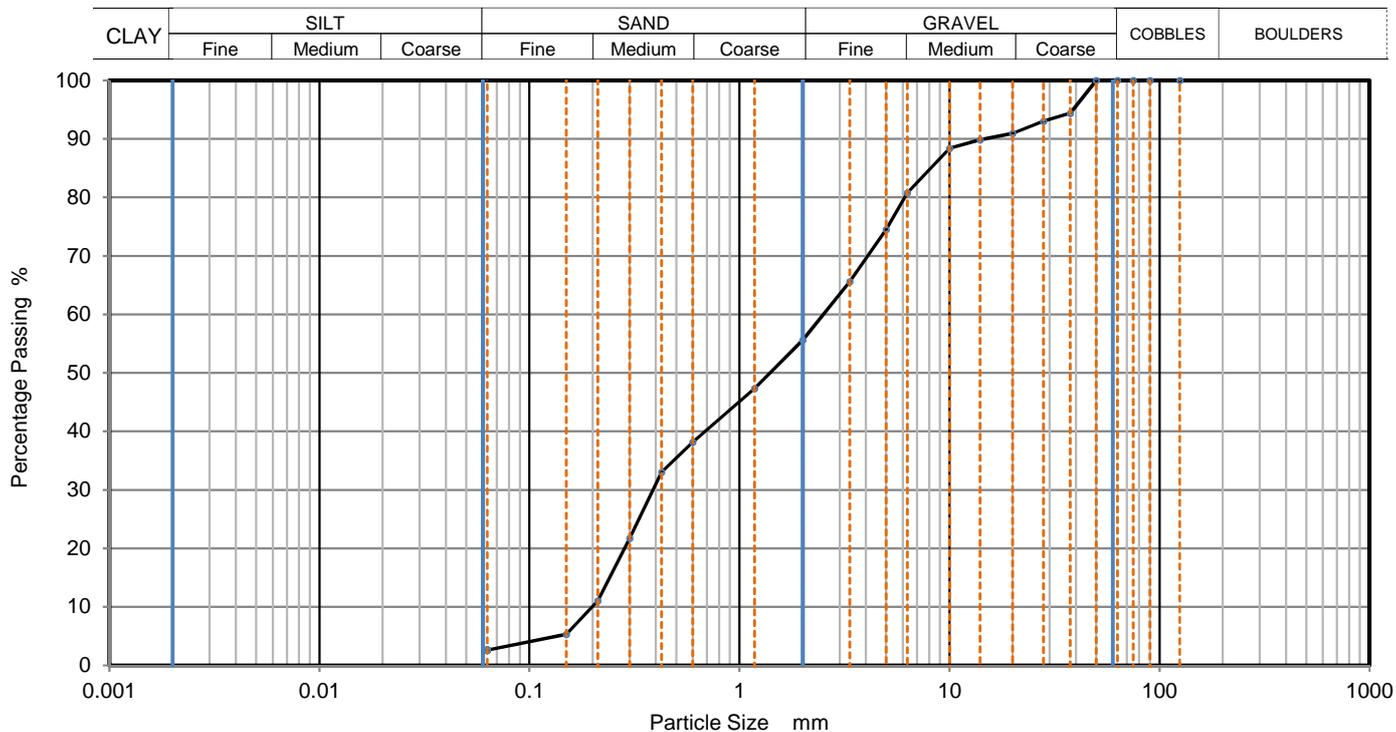
WET SIEVE

Sieving		Sedimentation	
Particle Size mm	% Passing	Particle Size mm	% Passing
125	100		
90	100		
75	100		
63	100		
50	100		
37.5	94		
28	93		
20	91		
14	90		
10	88		
6.3	81		
5	74		
3.35	66		
2	56		
1.18	47		
0.6	38		
0.425	33		
0.3	22		
0.212	11		
0.15	5		
0.063	3

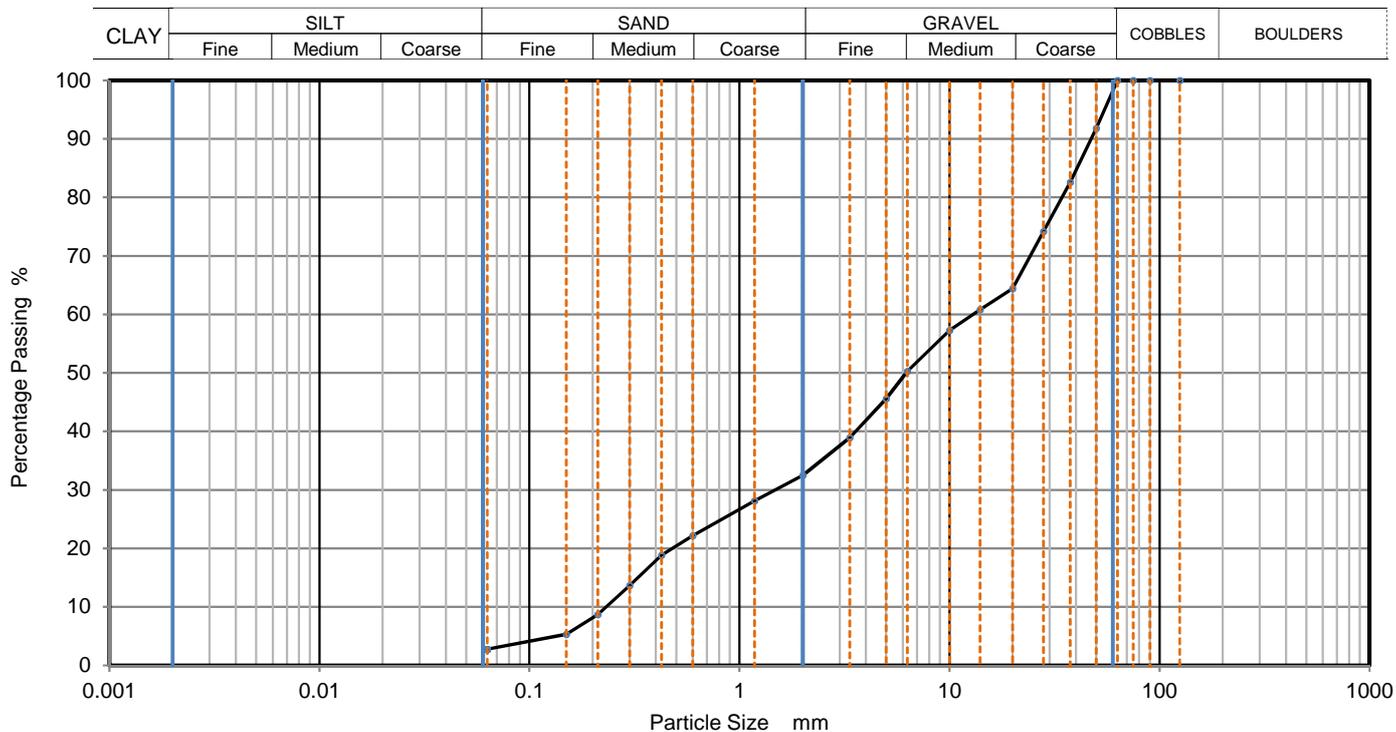
WET SIEVE

Sieving		Sedimentation	
Particle Size mm	% Passing	Particle Size mm	% Passing
125	100		
90	100		
75	100		
63	100		
50	92		
37.5	83		
28	74		
20	64		
14	61		
10	57		
6.3	50		
5	46		
3.35	39		
2	32		
1.18	28		
0.6	22		
0.425	19		
0.3	14		
0.212	9		
0.15	5		
0.063	3

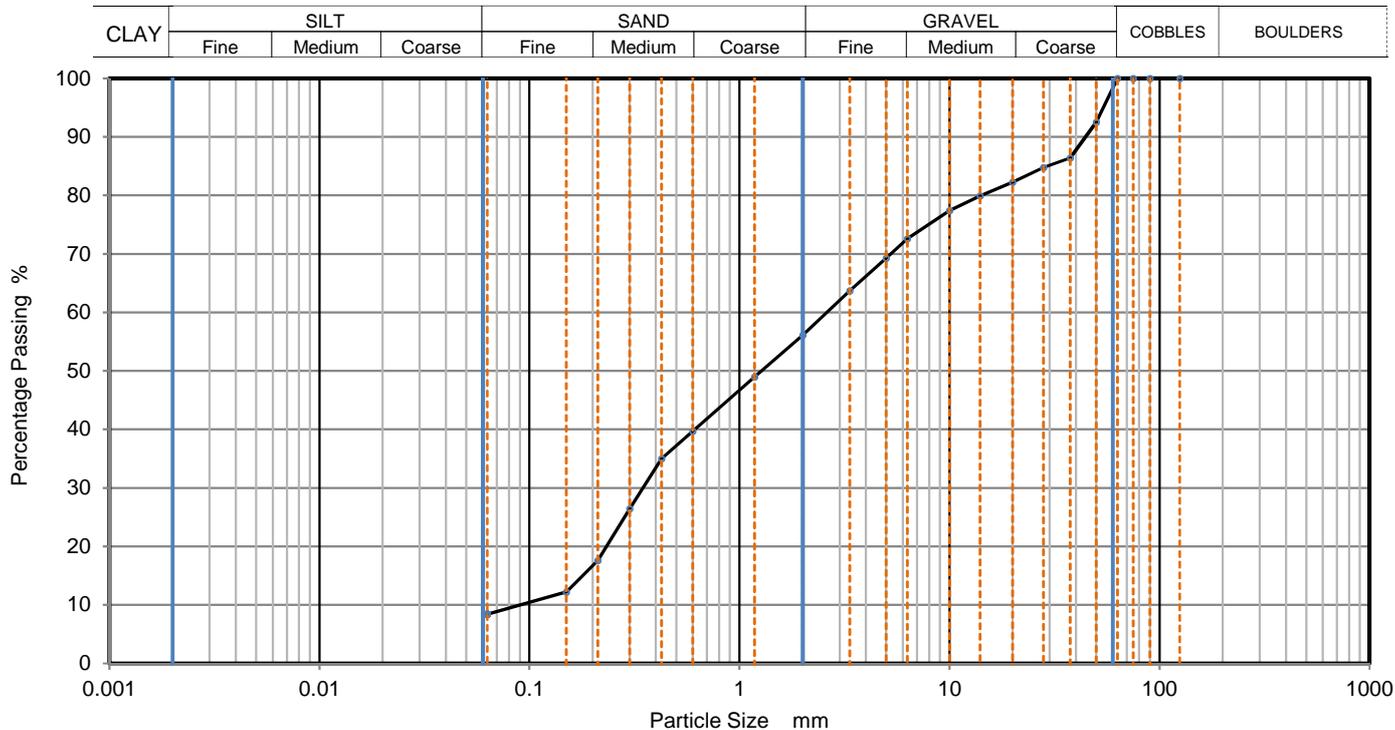
WET SIEVE

Sieving		Sedimentation	
Particle Size mm	% Passing	Particle Size mm	% Passing
125	100		
90	100		
75	100		
63	100		
50	93		
37.5	86		
28	85		
20	82		
14	80		
10	77		
6.3	73		
5	69		
3.35	64		
2	56		
1.18	49		
0.6	40		
0.425	35		
0.3	26		
0.212	18		
0.15	12		
0.063	8

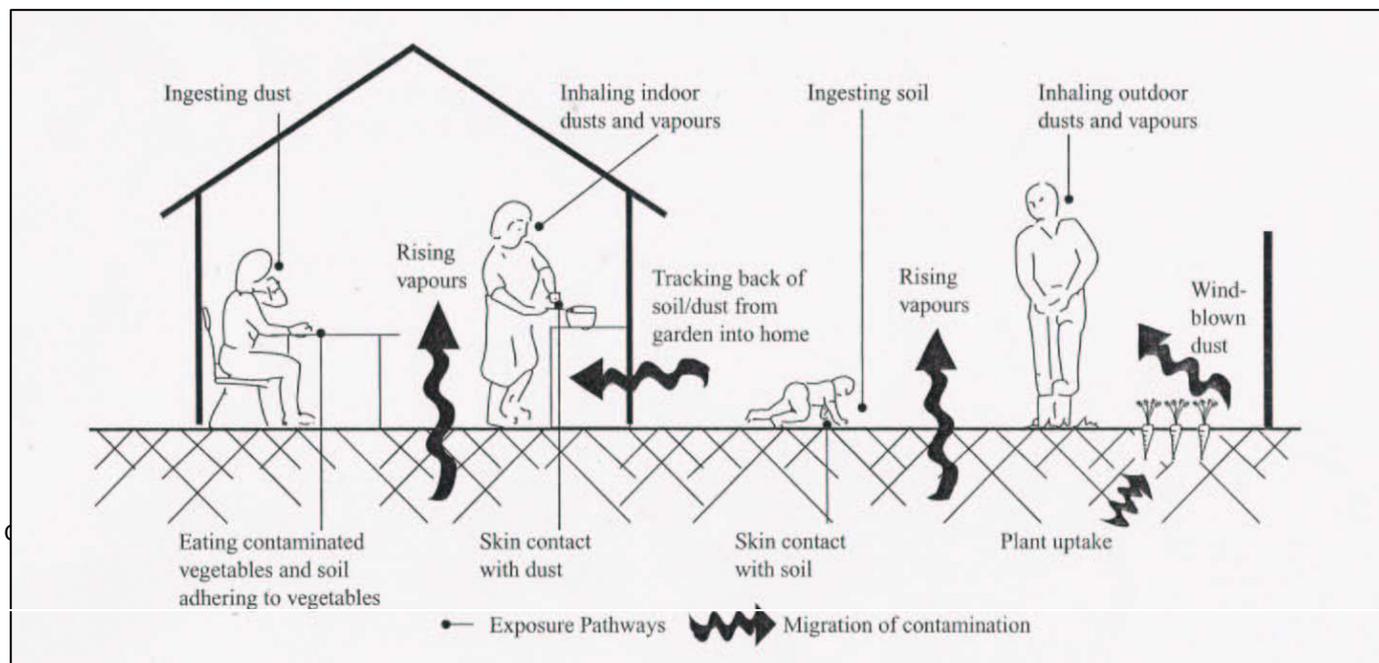
The CLEA model has been developed to calculate an estimated tolerable daily soil intake (TDSI) for site users given a set 'default' exposure pathways. Ten human exposure pathways are covered in the CLEA model as presented below:

- ingestion of outdoor soil
- ingestion of indoor dust
- ingestion of home grown produce
- ingestion of soil attached to home grown produce

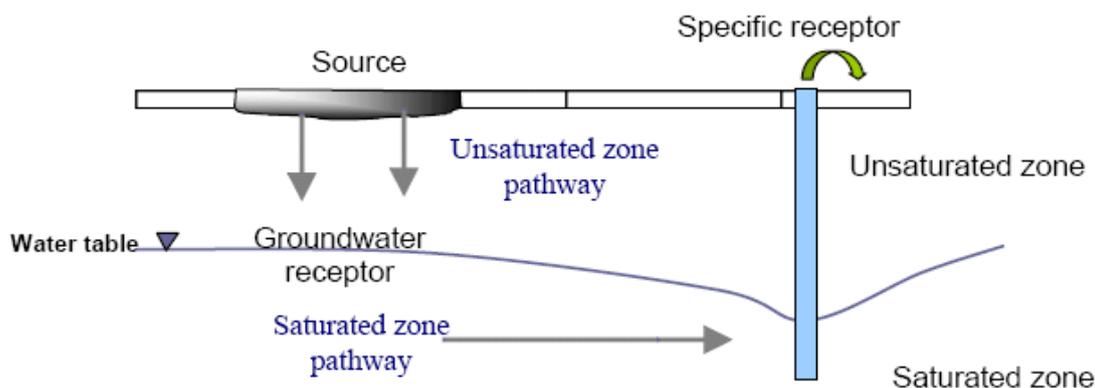
- 1. Risk Screening (Tier 1 Preliminary Risk Assessment):** The understanding of the Conceptual Site Model (CSM) is the key to assessing any site. Using a robust CSM, potential pathways or receptors may be screened out from any further assessment at an early stage. For example if the pathway through the unsaturated zone is blocked by the presence of a significant thickness of low permeability clay. A greater understanding of the CSM is achieved with each tier of risk assessment. An example of a basic CSM is given below (taken from the Environment Agency GP3 draft consultation document, 2006):

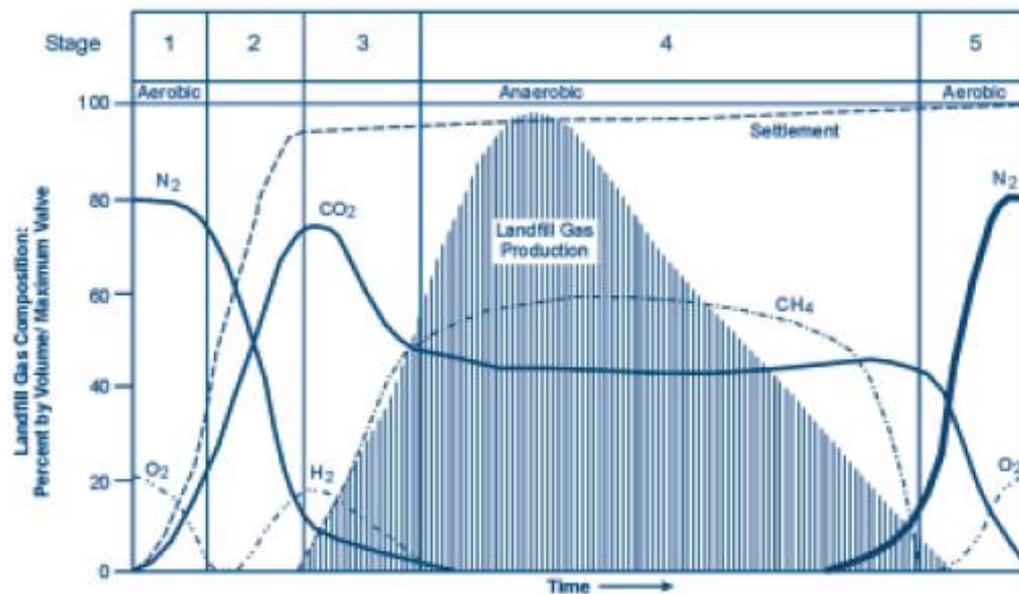
The figure below is taken from EA guidance document LFTGN 03 illustrates typical ground gas generation curves from biodegradable materials:

The production of methane and carbon dioxide at a landfill site may be expected to be considerable and ongoing. Concentrations of methane will eventually decrease, followed by concentrations of carbon dioxide, but the duration and rate of gas production can vary markedly between sites. Five distinct phases of gas production occur during the process which are, in order of event as marked above, as follows:

1. An aerobic phase involving oxygen depletion and temperature increase through aerobic respiration;
2. The establishment of anaerobic conditions and the evolution of carbon dioxide and hydrogen through acidogenic activity;
3. Commencement of methanogenic activity; the establishment of populations of methanogenic bacteria;
4. A phase of stable methanogenic activity, which may go on for many tens of years;
5. A phase of decreasing methanogenic activity, representing depletion of the organic material and a return to aerobic conditions.
