Appendix 9.3: Potential Roost Assessment (PRA) for trees and structures - Technical Note (2020)

Project:	Liverpool Football Club (LFC) Anfield Road Stand Expansion		
Reference:	405016-MMD-XX-XX-FN-EN-0001		
Prepared by:	Sam Smith	Date:	05/02/2020
Approved by:	Lorna Meek	Checked by:	Rebecca Purslow
Subject:	Potential Roost Assessment (PRA) for trees and structures

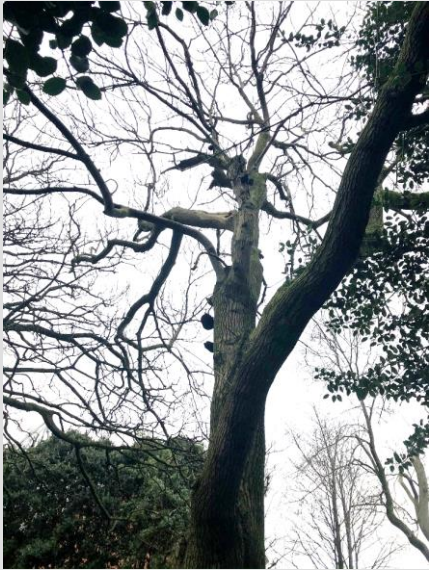
Description	Photograph
T1 – A general view of the ash <i>Fraxinus excelsior</i> .

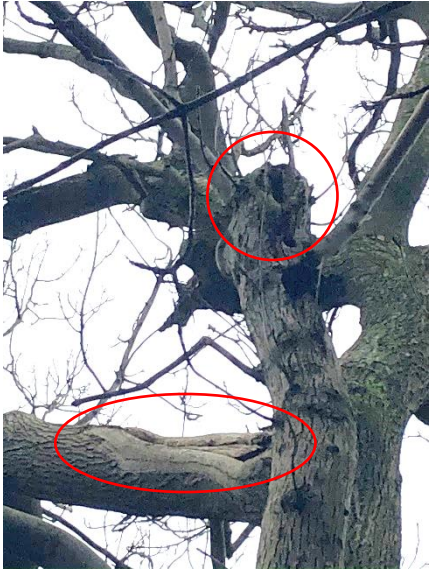
T1 – A view of the callus rolls noted on the north aspect of the tree.

- If trees are to be felled, individual trees assessed with low bat roosting potential do not require further nocturnal surveys (T1-T5). However, it is recommended that 'soft felling' measures are undertaken, whereby, the trees should be felled in a sectional manner, with brash from the canopy being removed first. Brash should be laid on the ground around the trunk to form a cushion when lowering further branches and trunk sections with suitable roosting features. Suitable roosting features should be lowered, and positioned face up, then inspected by a suitably qualified licensed bat ecologist. Should roosting bats be found or suspected at any time, then works must stop immediately.

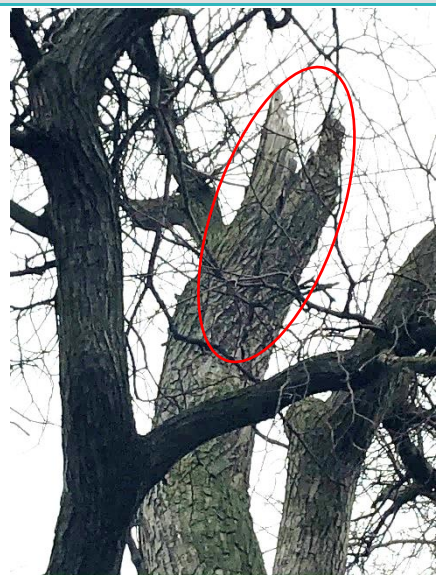
T2 – A view of the crack noted within the trunk of the tree on the north east aspect.

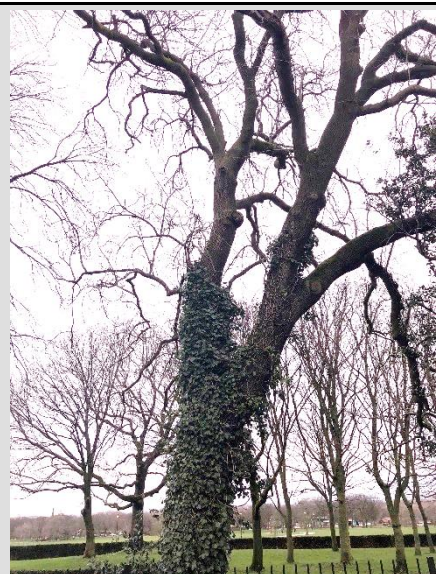
T3 – A general view of the ash tree.

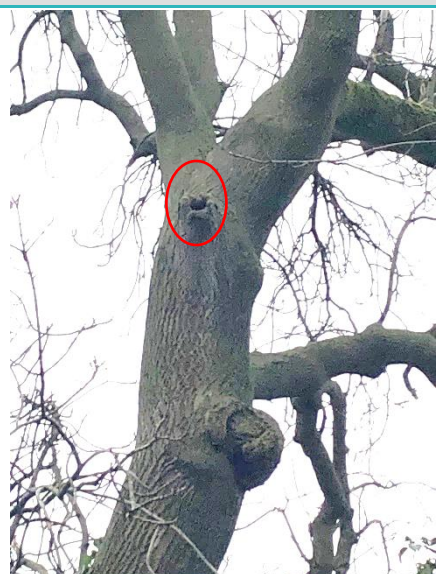
T3 – A view of the callus roll noted on the south west aspect of the tree.

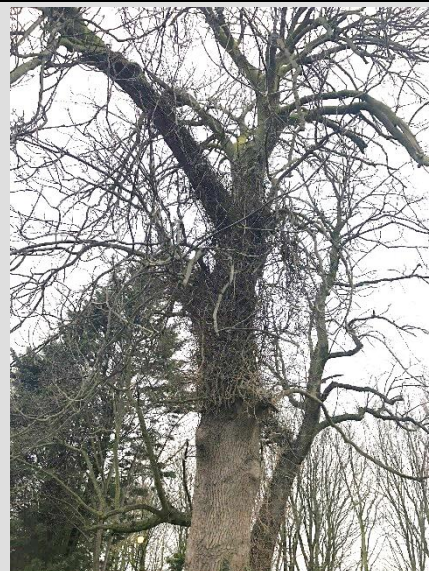
T4 – A general view of the ash tree.

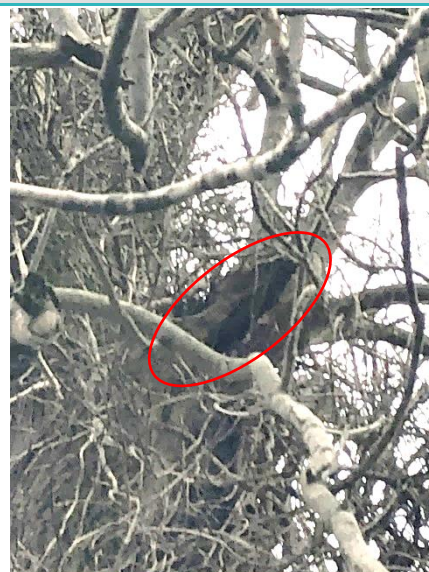
T4 – A view of the large callus roll on the south aspect of the tree.

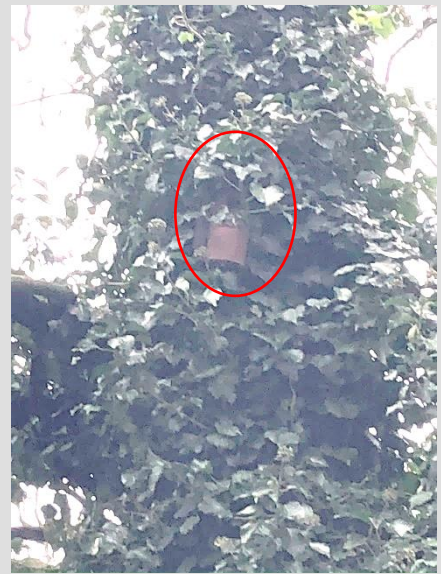
T5 – View of the sycamore *Acer pseudoplatanus* with a bird box positioned on the north east aspect.

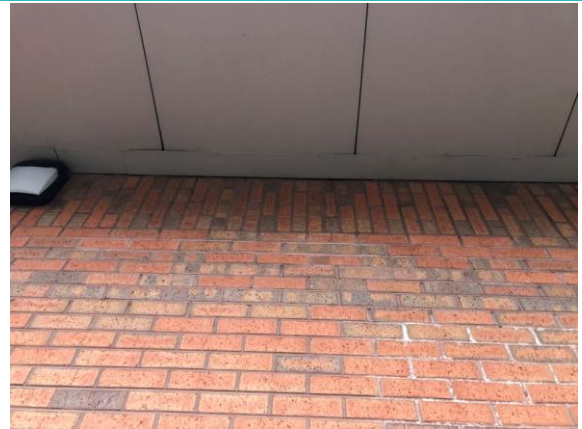
A.3 – View of the north east aspect of Anfield Road stand, with a gap between the metal panels and brick wall.

- Two nocturnal surveys are required consisting one dusk and one separate dawn survey to be undertaken between May and September with at least one being undertaken between May and August. These surveys will be carried out in-line with *Bat Surveys for Professional Ecologists: Good Practice Guidelines* (Collins J, 2016). Should these surveys identify a roost, a European Protected Species Licence (EPSL) would be required to legally destroy, damage, obstruct or disturb the bat roosting features identified within the Anfield Road stand.

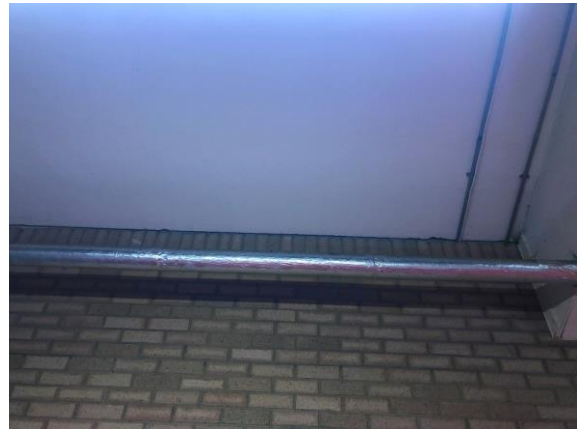
A.3 – View of the gaps where the concrete roof meets the brick walls noted along the south western aspect of the level one welfare area of the Anfield Road stand.

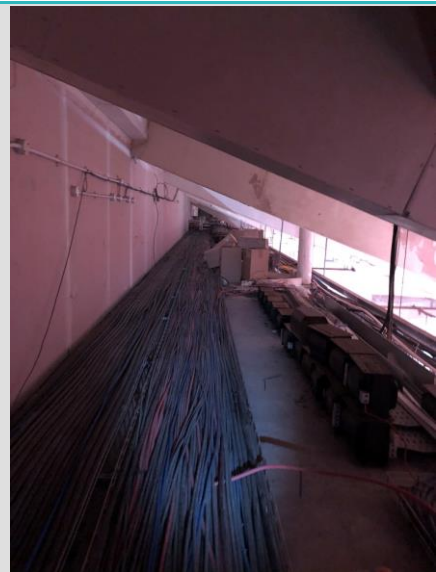
A.3 – View of the open void that runs along the north east aspect of the level one welfare area of the Anfield Road stand.

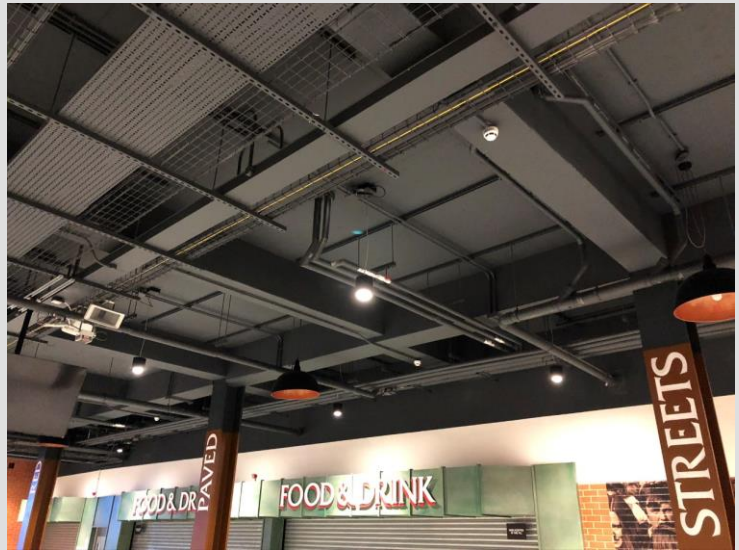
A.4 – View of the concrete roof and lighting in the welfare areas in the Main stand.

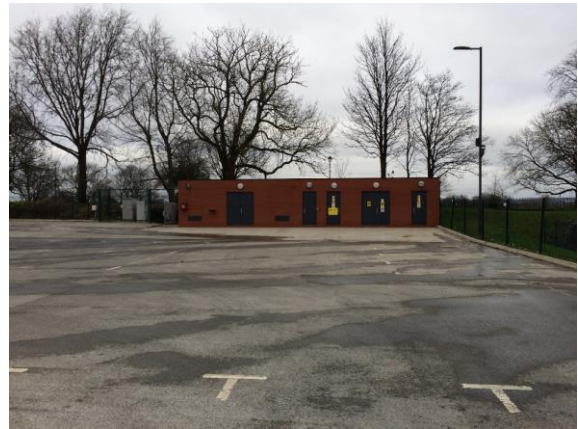
B – View of the south west aspect of the substation outbuilding that is located north east of Anfield Stadium.

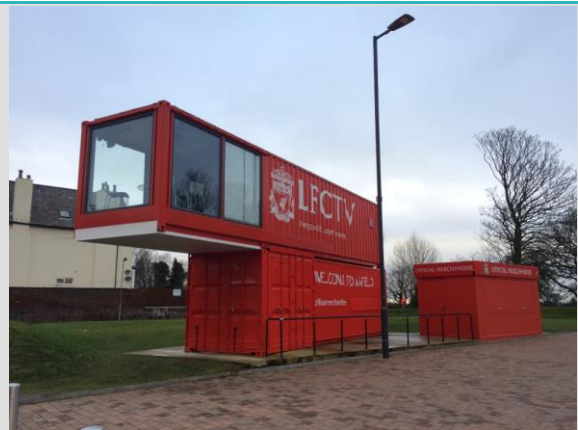
C – View of the west aspect of the metal containers used for LFCTV and selling merchandise.

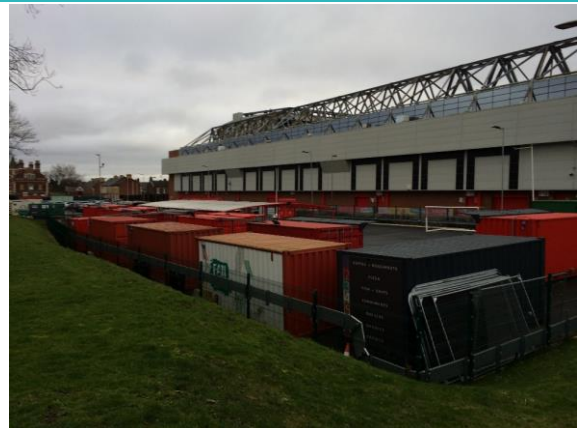
D – View of a group of metal containers on hardstanding used as food vendors.

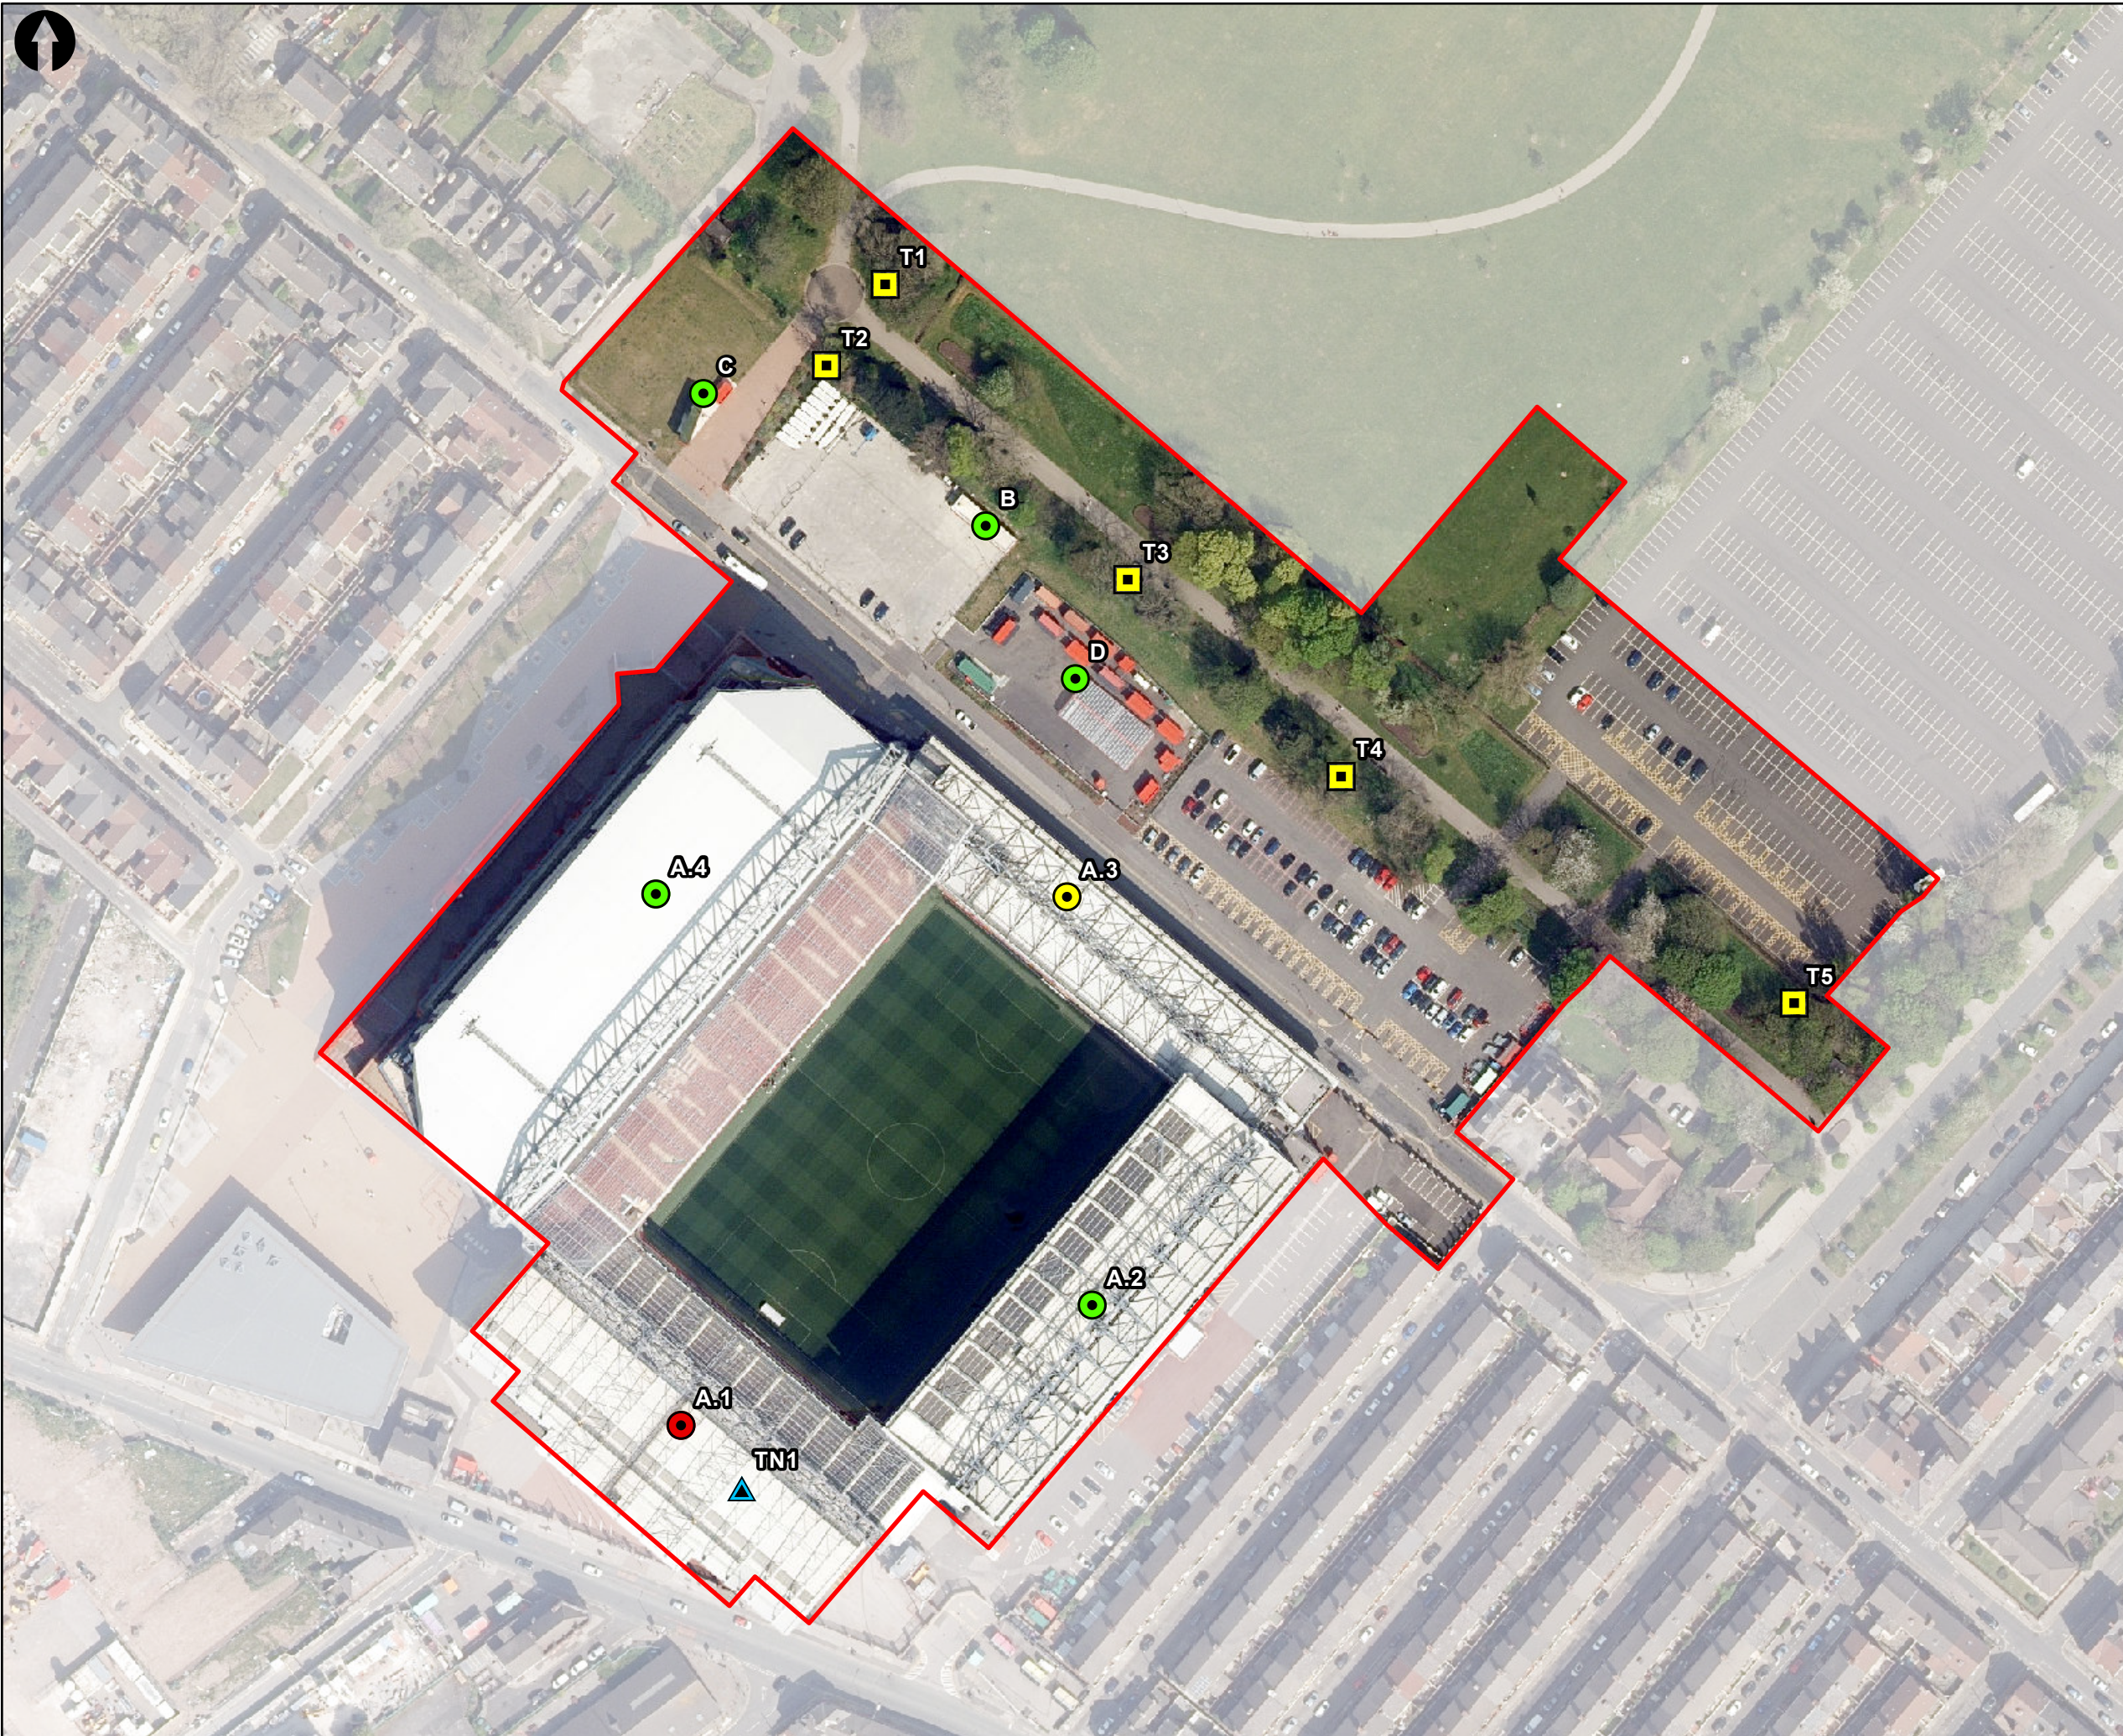
LFC Anfield Road Stand Expansion
Potential Roost Assessment
Results Plan
