Appendix 9.4: Updated Bat Assessment ‘LFC Bat Technical Note: Bat survey results – Anfield Stadium’

Project:	Liverpool Football Club Event Management		
Our reference:	396087	Your reference:	SH-MMD-XX-RP-J-001
Prepared by:	C. Maghanga	Date:	01/06/2018
Approved by:	M. Freckleton	Checked by:	P Renshaw
Subject:	Bat survey results – Anfield Stadium

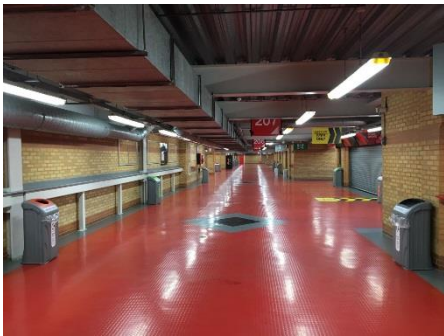
Description and Grid Reference.	Ecological constraint (if applicable)	Photo reference(s)
<ul style="list-style-type: none"> Photograph to illustrate the 2nd floor corridor at the back of the Kop stand. Note the height of the handrail on left side.

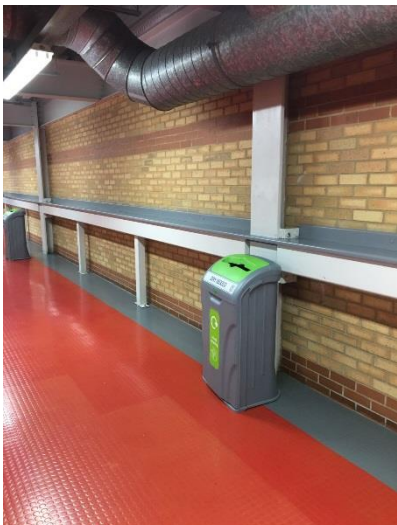
<p>Photo 1.</p>
<ul style="list-style-type: none"> Hand rail along back wall of corridor

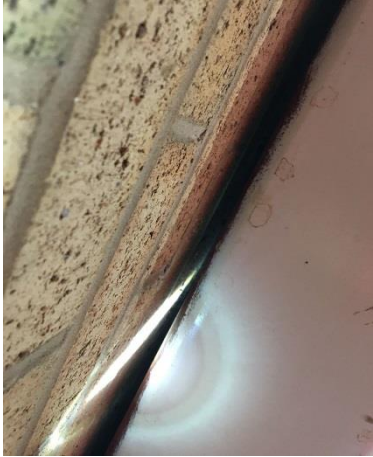
Using an endoscope, the crevice between the handrail and the wall was carefully examined all the way along the structure to check for the presence of any bats. None were observed.

Photo 2.
<ul style="list-style-type: none">• Crevice between wall and handrail (searched with endoscope along length of wall/handrail).

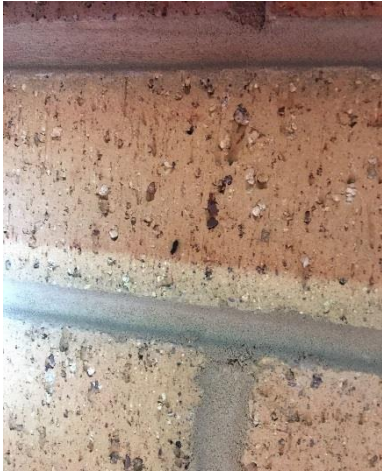
A sample of these droppings were collected and analysed. The results confirm they are from a common pipistrelle bat *Pipistrellus pipistrellus*.

<p>Photo 3.</p>
<ul style="list-style-type: none">• Bat droppings stuck to wall underneath handrail.

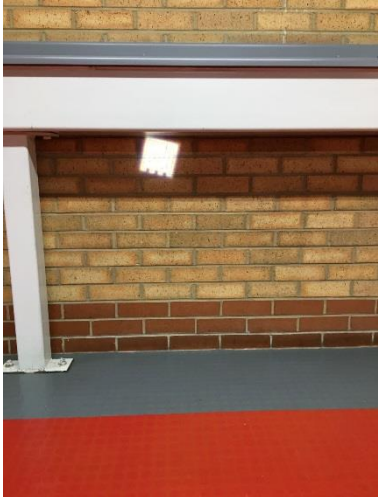
Photo 5.

<p>Photo 4.</p>
<ul style="list-style-type: none">• Photograph to show the wall in relation to the handrail.
