Detailed Unexploded Ordnance (UXO) Risk Assessment

Project Name	The Strand, Liverpool		
Client	Curtins		
Site Address	Strand House, 21 Strand St, Liverpool, L1 8LT		
Report Reference	DA3469-00	Revision	00
Date	18 th May 2016		
Originator	AT

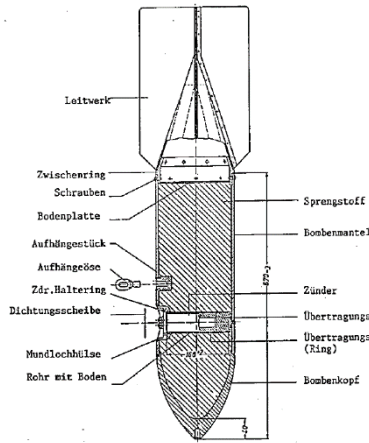
SC 50kg

Bomb Weight	40-54kg (110-119lb)
Explosive Weight	c25kg (55lb)
Fuze Type	Impact fuze/electro-mechanical time delay fuze
Bomb Dimensions	1,090 x 280mm (42.9 x 11.0in)
Body Diameter	200mm (7.87in)
Use	Against lightly damageable materials, hangars, railway rolling stock, ammunition depots, light bridges and buildings up to three stories.
Remarks	The smallest and most common conventional German bomb. Nearly 70% of bombs dropped on the UK were 50kg.

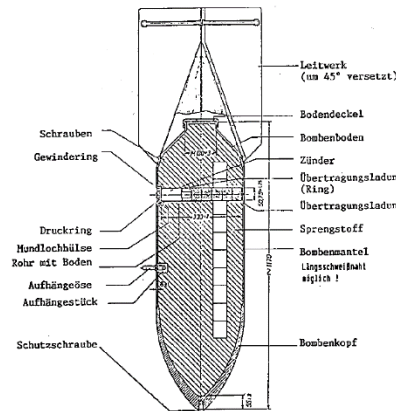
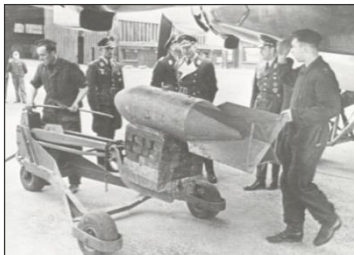
SC 250kg

Bomb Weight	245-256kg (540-564lb)
Explosive Weight	125-130kg (276-287lb)
Fuze Type	Electrical impact/mechanical time delay fuze.
Bomb Dimensions	1640 x 512mm (64.57 x 20.16in)
Body Diameter	368mm (14.5in)
Use	Against railway installations, embankments, flyovers, underpasses, large buildings and below-ground installations.
Remarks	It could be carried by almost all German bomber aircraft, and was used to notable effect by the Junkers Ju-87 Stuka (Sturzkampfflugzeug or dive-bomber).

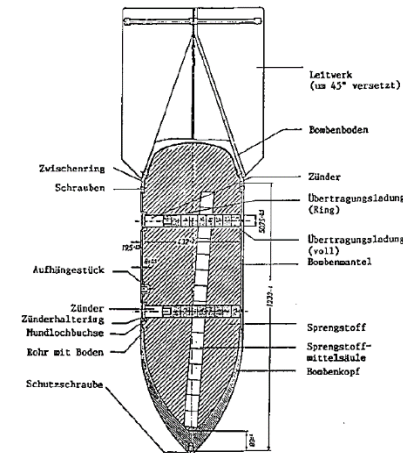
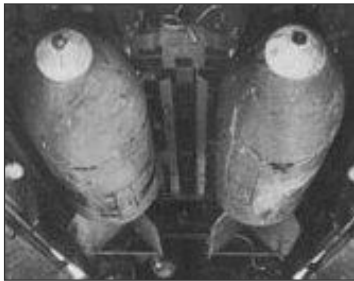
SC 500kg

Bomb Weight	480-520kg (1,058-1,146lb)
Explosive Weight	250-260kg (551-573lb)
Fuze Type	Electrical impact/mechanical time delay fuze.
Bomb Dimensions	1957 x 640mm (77 x 25.2in)
Body Diameter	470mm (18.5in)
Use	Against fixed airfield installations, hangars, assembly halls, flyovers, underpasses, high-rise buildings and below-ground installations.
Remarks	40/60 or 50/50 Amatol TNT, trialene. Bombs recovered with Trialene filling have cylindrical paper wrapped pellets 1-15/16 in. in length and diameter forming

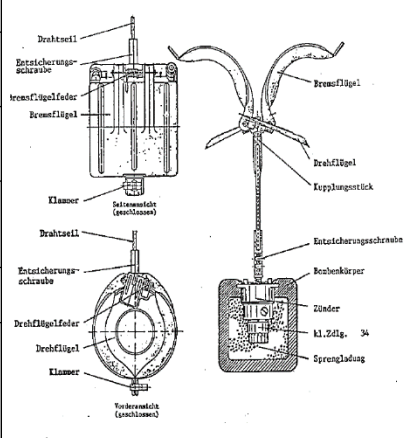
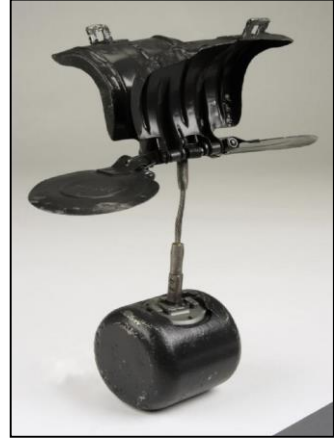
SD2 Butterfly Bomb

Bomb Weight	2kg (4.41lb)

Explosive Weight	7.5oz (225 grams) of TNT surrounded by a layer of bituminous composition.			
Fuze Type	41 fuze (time) , 67 fuze (clockwork time delay) or 70 fuze (anti-handling device)			
Bomb Dimensions	Length 240 mm Width 140 mm Height 310 mm			
Body Diameter	3in (7.62 cm) diameter, 3.1in (7.874) long			
Use	It was designed as an anti-personnel/fragmentation weapon. They were delivered by air, being dropped in containers that opened at a predetermined height, thus scattering the bombs.			
Remarks	The smallest and most common conventional German bomb. Nearly 70% of bombs dropped on the UK were 50kg.

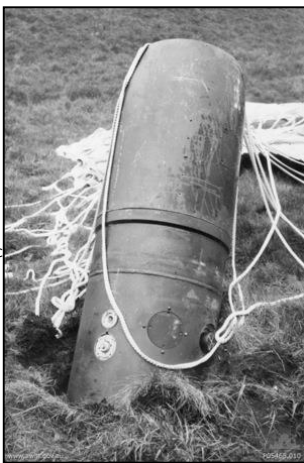
Parachute Mine (Luftmine B / LMB)

Bomb Weight	987.017kg (2176lb)

Explosive Weight	125-130kg (276-287lb)		
Fuze Type	Impact/ Time delay / hydrostatic pressure fuze		
Bomb Dimensions	1640 x 512mm (64.57 x 20.16in)		
Body Diameter	368mm (14.5in)		
Use	Against civilian, military and industrial targets. Designed to detonate above ground level to maximise damage to a wider area.		
Remarks	Parachute Mines were normally carried by HE 115 (Naval operations), HE 111 and JU 88 aircraft types. Deployed a parachute when dropped in order to control its descent.

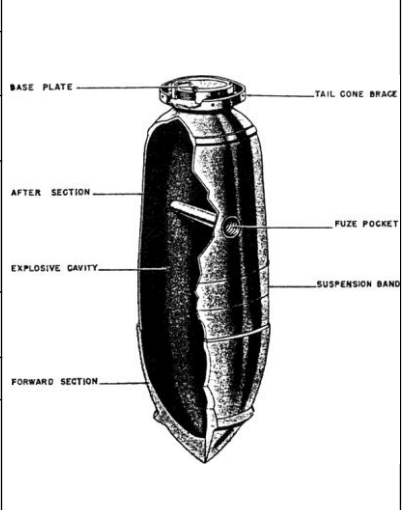
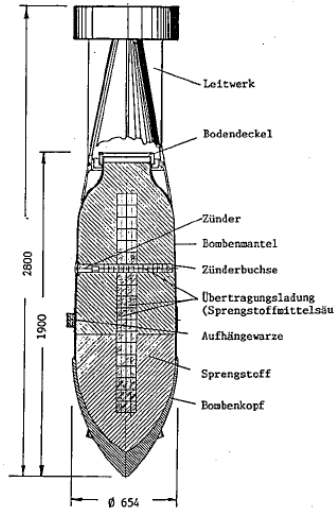
SC 1000kg

Bomb Weight	996-1061kg (1,058-1,146lb)

Explosive Weight	530-620kg (551-573lb)			
Fuze Type	Electrical impact/mechanical time delay fuze.			
Filling	Mixture of 40% amatol and 60% TNT, but when used as an anti-shipping bomb it was filled with Trialen 105, a mixture of 15% RDX, 70% TNT and 15% aluminium powder.			
Bomb Dimensions	2800 x 654mm (77 x 25.2in)			
Body Diameter	654mm (18.5in)			
Use	SC type bombs are General Purpose Bombs used primarily for general demolition work. Constructed of parallel walls with comparatively heavy noses. They are usually of three piece welded construction

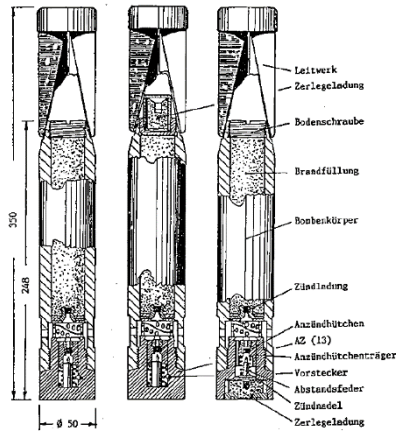
1kg Incendiary Bomb

Bomb Weight	1.0 and 1.3kg (2.2 and 2.87lb)
Explosive Weight	680gm (1.3lb) Thermite
Fuze Type	Impact fuze
Bomb Dimensions	350 x 50mm (13.8 x 1.97in)
Body Diameter	50mm (1.97in)
Use	As incendiary – dropped in clusters against towns and industrial complexes
Remarks	Magnesium alloy case. Sometimes fitted with high explosive charge. The body is a cylindrical alloy casting threaded internally at the nose to receive the fuze holder and fuze.

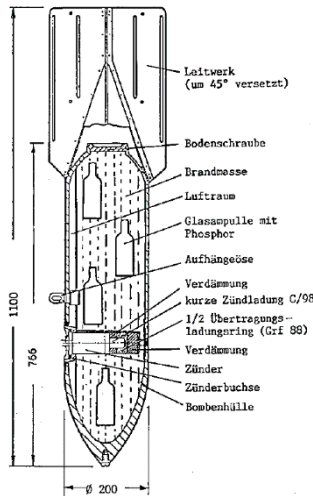
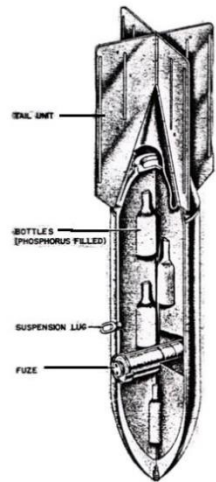
C50 A Incendiary Bomb

Bomb Weight	c41kg (90.4lb)
Explosive Weight	0.03kg (0.066lb)
Incendiary Filling	12kg (25.5lb) liquid filling with phosphor igniters in glass phials. Benzine 85%; Phosphorus 4%; Pure Rubber 10%
Fuze Type	Electrical impact fuze
Bomb Dimensions	1,100 x 280mm (43.2 x 8in)
Use	Against all targets where an incendiary effect is to be expected
Remarks	Early fill was a phosphorous/carbon disulphide incendiary mixture

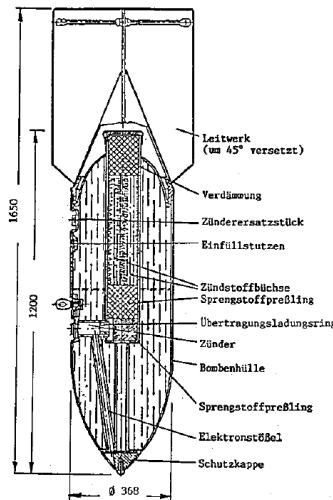
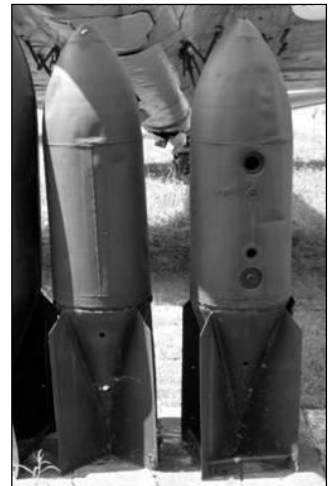
Flam C-250 Oil Bomb

Bomb Weight	125kg (276lb)
Explosive Weight	1kg (2.2lb)
Fuze Type	Super-fast electrical impact fuze
Filling	Mixture of 30% petrol and 70% crude oil
Bomb Dimensions	1,650 x 512.2mm (65 x 20.2in)
Body Diameter	368mm (14.5in)
Use	Often used for surprise attacks on living targets, against troop barracks and industrial installations. Thin casing – not designed for ground penetration

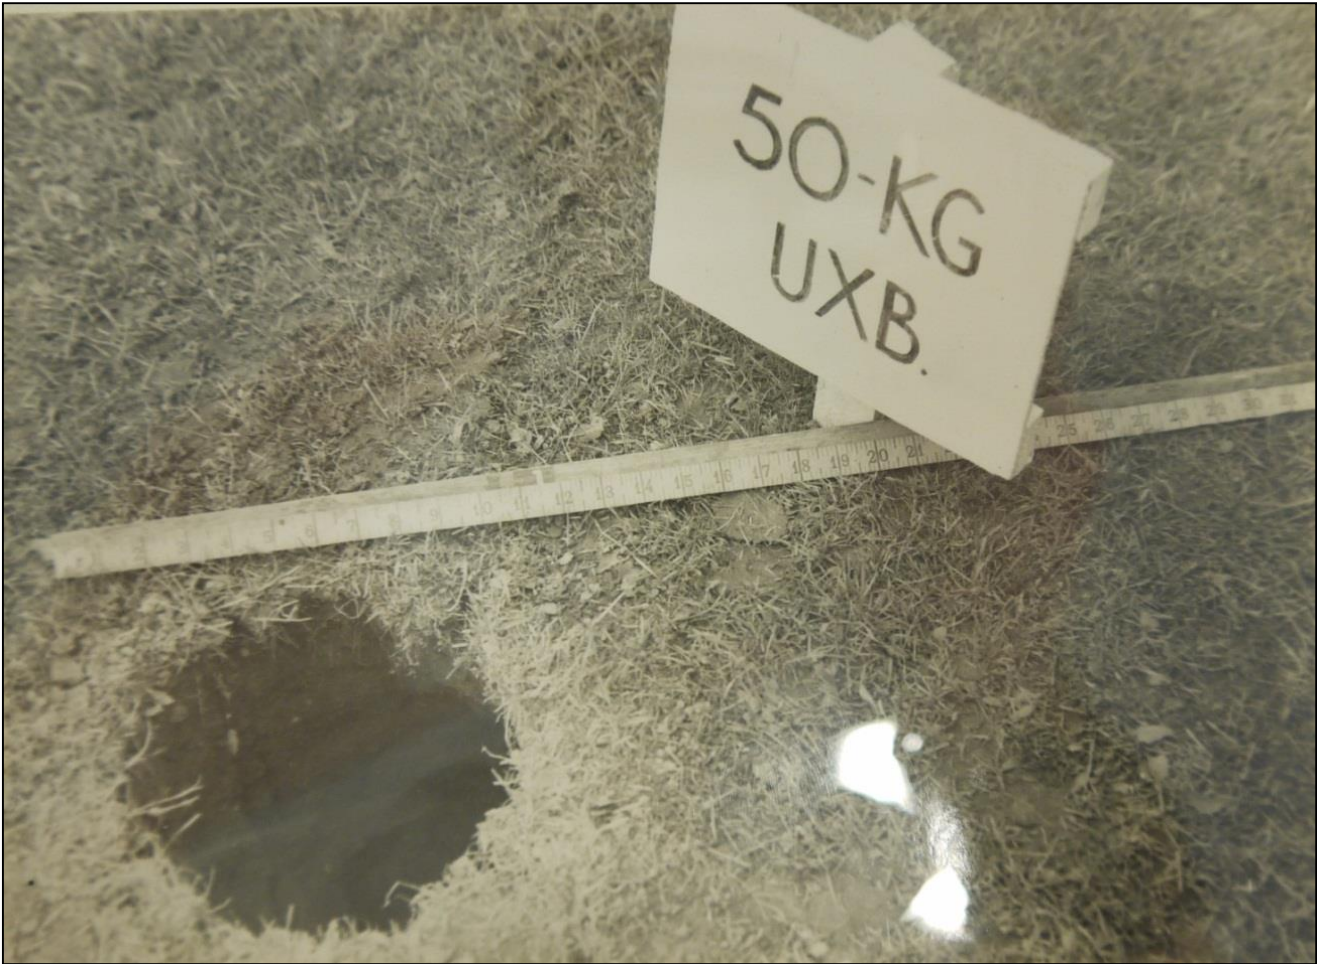
German 50kg HE Bomb Entry Hole

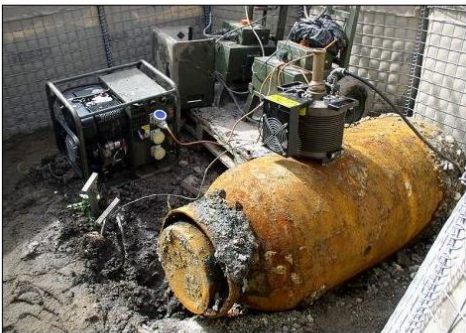
Army experts worked to disarm the 2,000lb UXB faced delays after discovering metal used to make the Second World War device was thicker than expected.

This morning, however, military engineers managed to cut through the casing of the bomb, which measures 5ft by 2ft, enabling them to begin 'steaming' the explosive inside to make it safe.

Effort: Army experts' machines and the unexploded bomb in East London

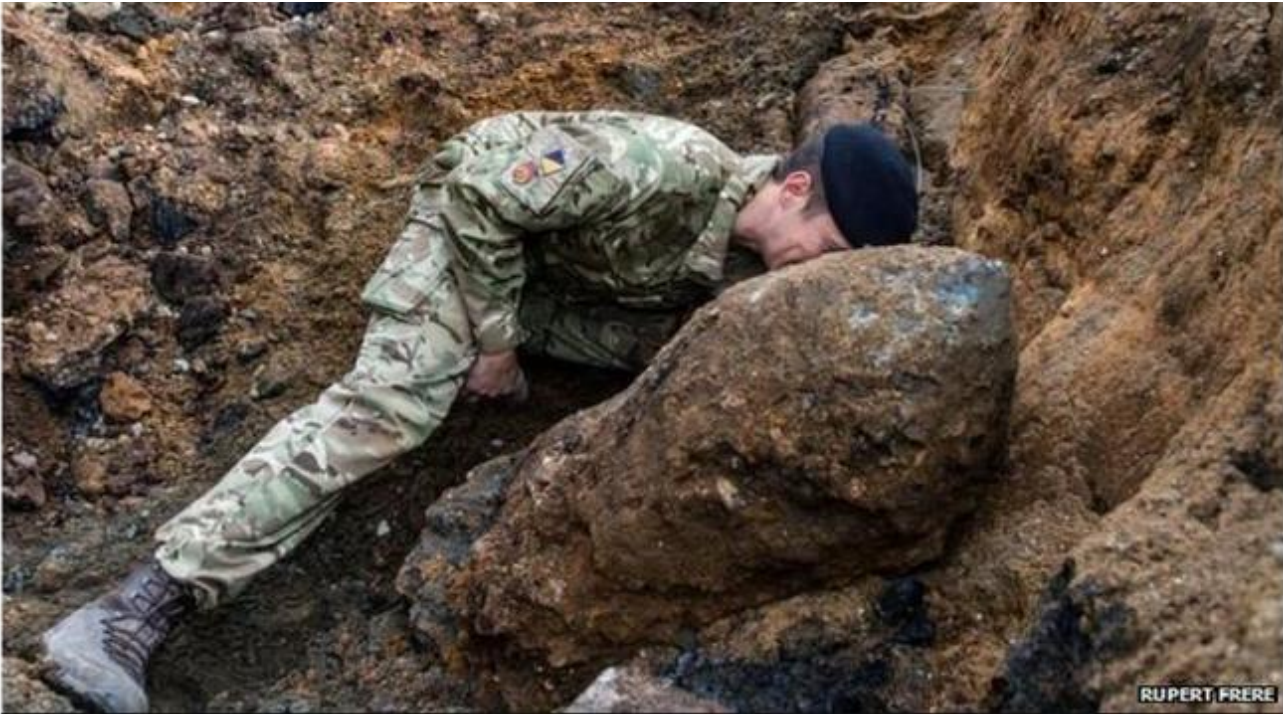
An unexploded World War Two bomb found in south London has been driven away safely under police and Army escort. The 500lb (250kg) device was found on a building site in Grange Walk, Bermondsey on Monday. Two primary schools were closed and hundreds of homes were evacuated as a precaution.

The Metropolitan Police force said the device was a “SA” 250kg WWII German air-dropped bomb, known to the Army’s Royal Logistic Corps bomb disposal experts.

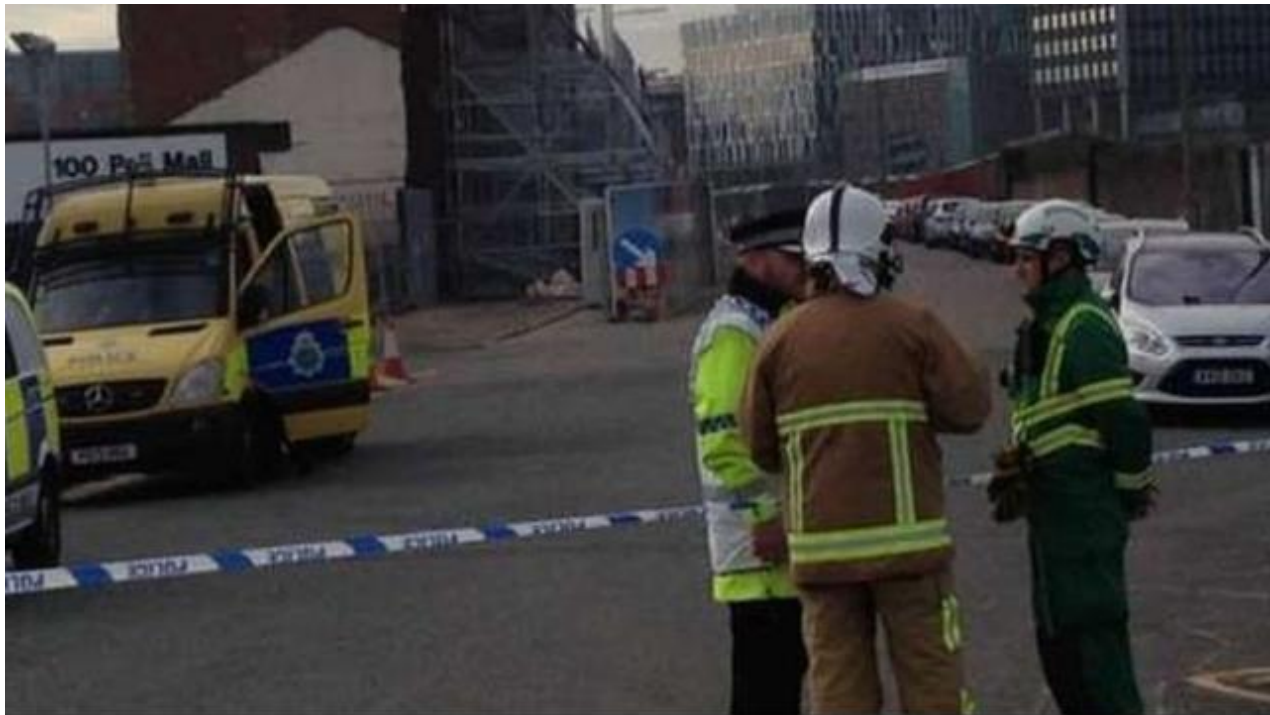
Seven shells have been found over 24 hours in the Pall Mall area

Seven suspected unexploded World War Two shells were discovered in the same area of Liverpool in the space of 24 hours.

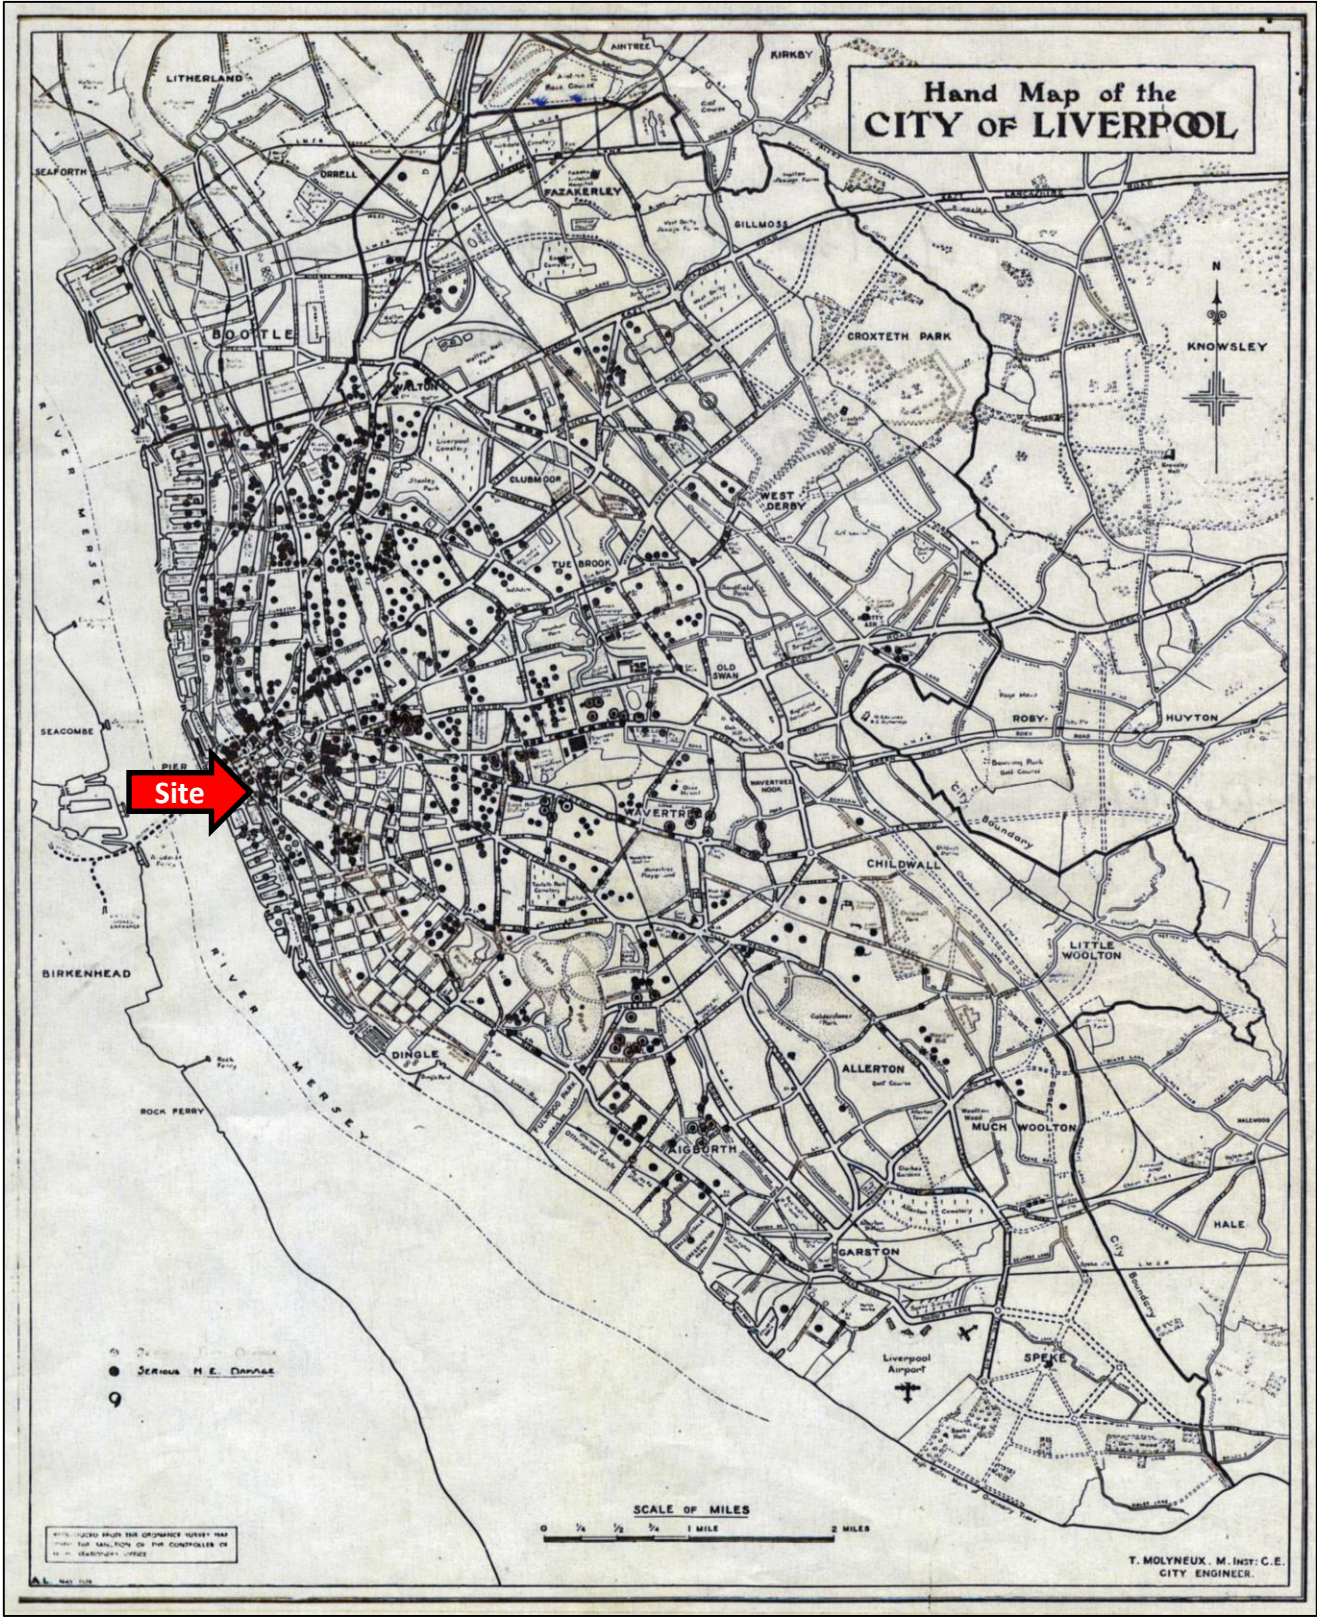
Serious H.E. Damage

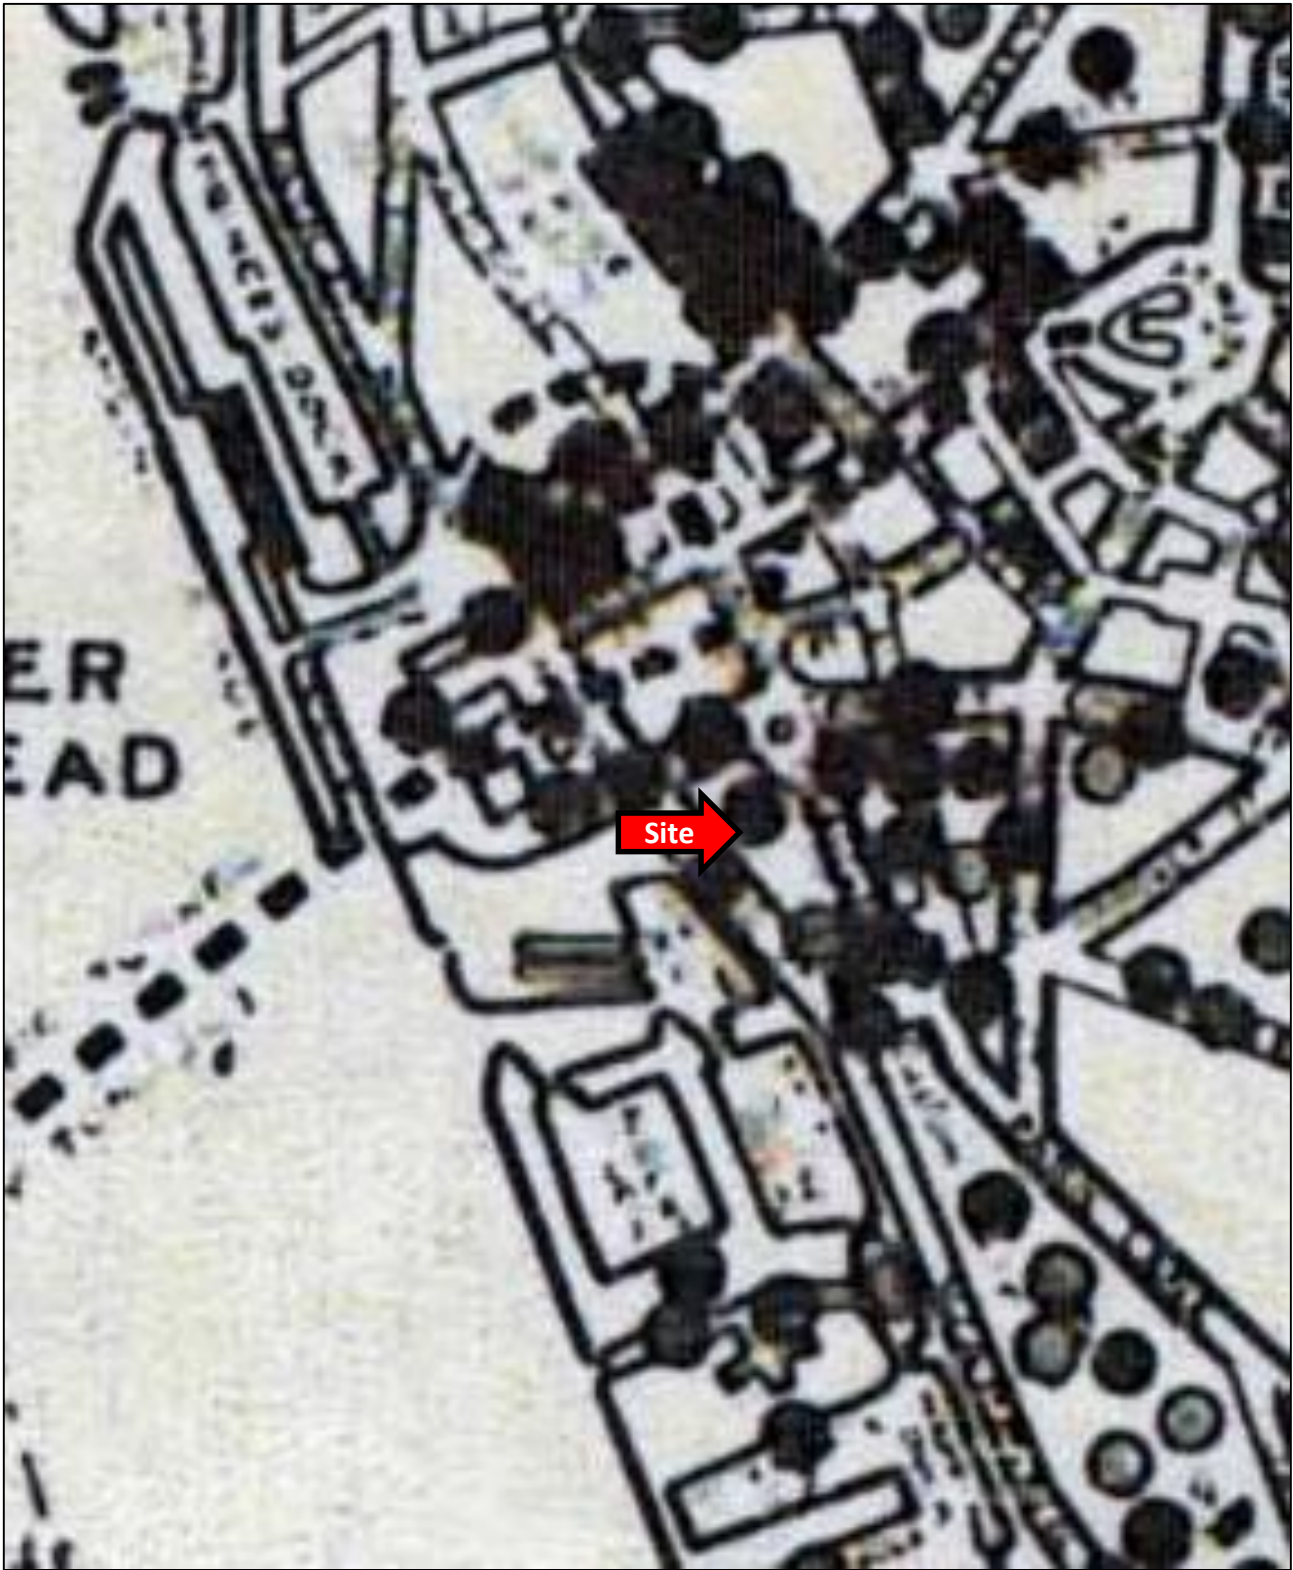
Serious H.E. Damage

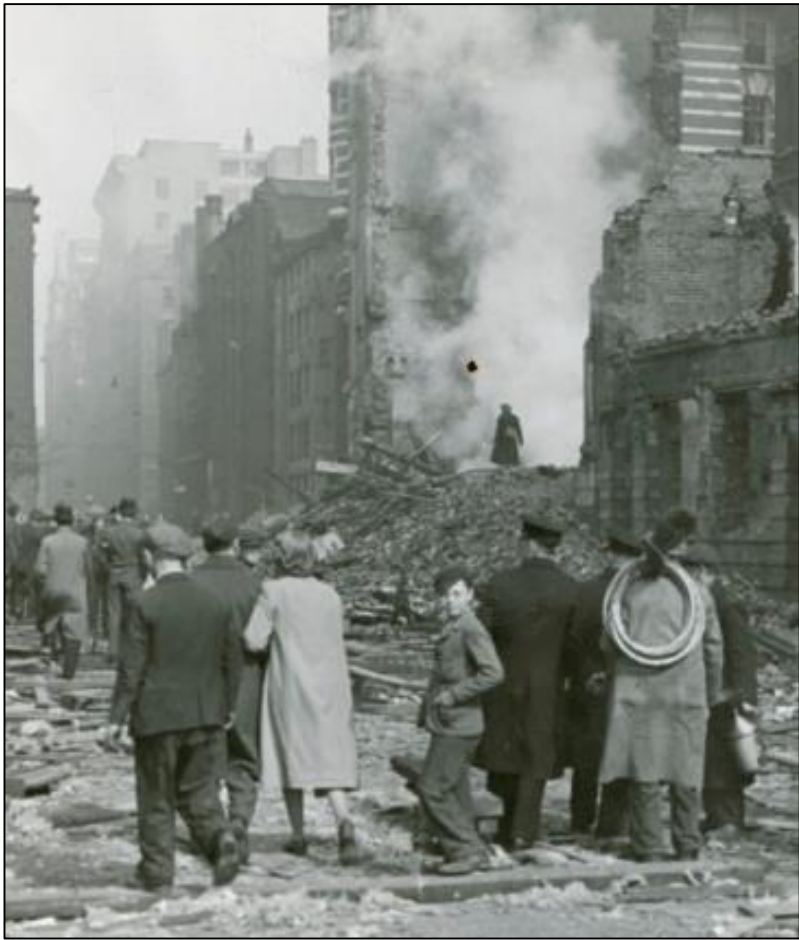
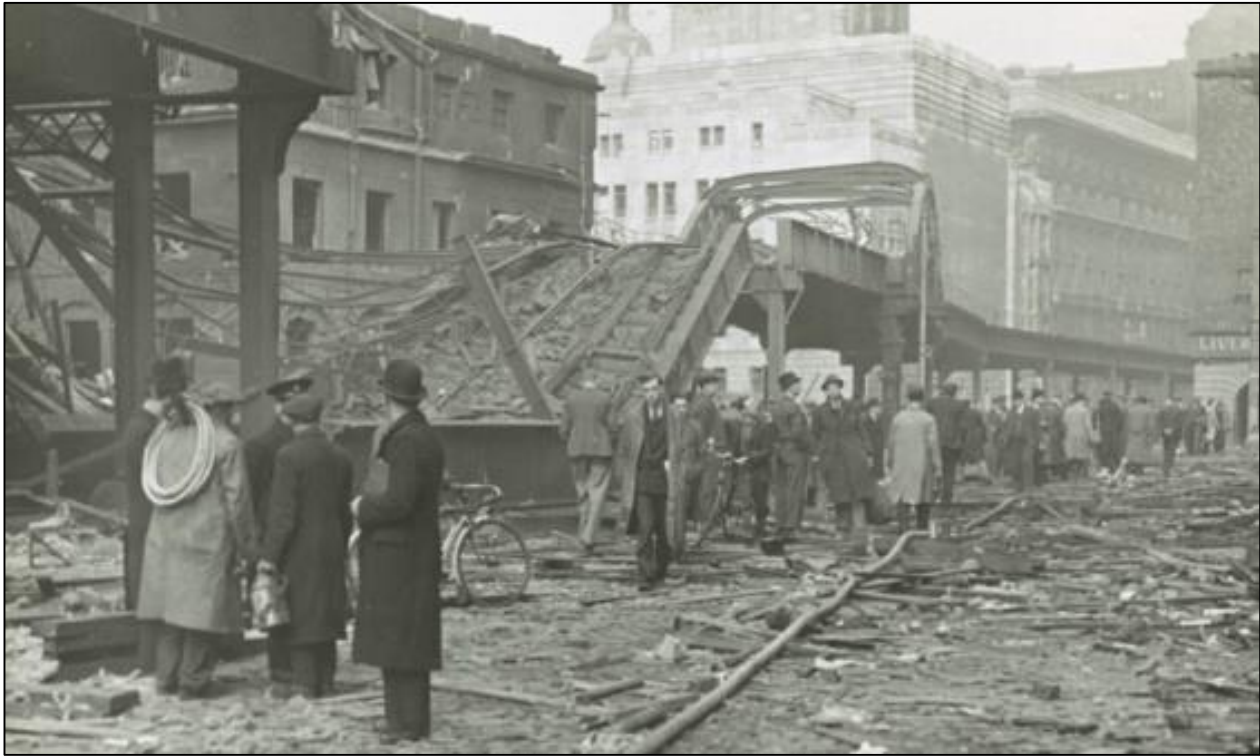
Left Image: This image shows heavy damage on the corner of Strand Street and James Street which was bombed on 3 and 4 May 1941. In the centre of the picture an ARP warden can be seen inspecting a fire in a destroyed building while people look on.

Below Image: This image shows damage to a section of the Overhead Railway on Stand Street, near James Street in the city centre. The railway was severely damaged by a high explosive bomb on 3 May 1941 and would be hit twice again later in the month. The railway was extensively repaired and remained in operation until 1956.

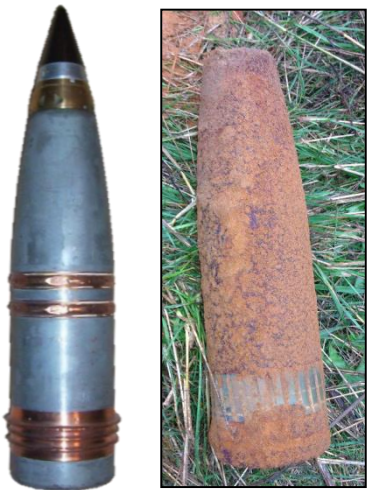
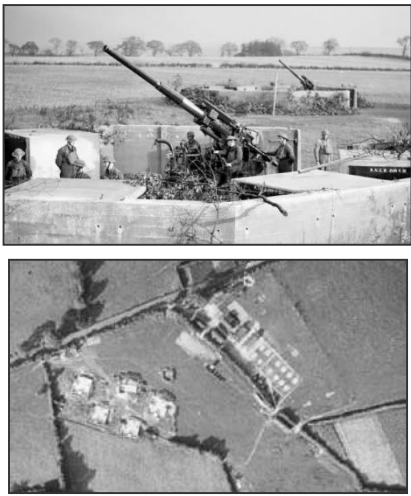
Projectile Weight	28lb (12.6 kg)
Explosive Weight	2.52lbs
Fuze Type	Mechanical Time Fuze
Dimensions	3.7in x 14.7in (94mm x 360mm)
Rate of Fire	10 to 20 rounds per minute
Use	High Explosive Anti-Aircraft projectile. 4.5in projectiles were also used in this role.
Ceiling	30,000ft to 59,000ft

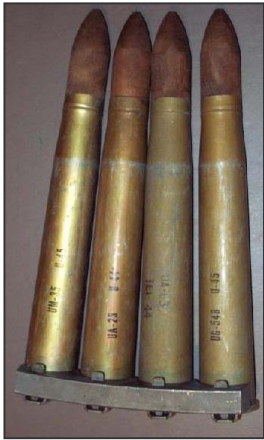
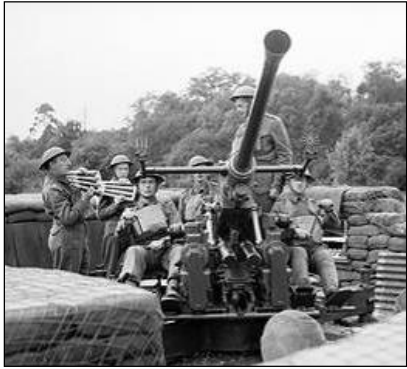
40mm Bofors Projectile

Projectile Weight	1.96lb (0.86kg)
Explosive Weight	300g (0.6lb)
Fuze Type	Proximity and Mechanical Time Fuze
Rate of Fire	120 rounds per minute
Projectile Dimensions	40mm x 310mm (1.6in x 12.2in)
Ceiling	23,000ft (7000m)

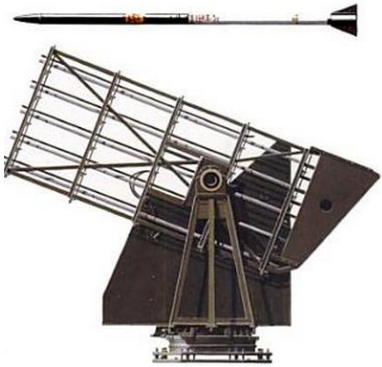
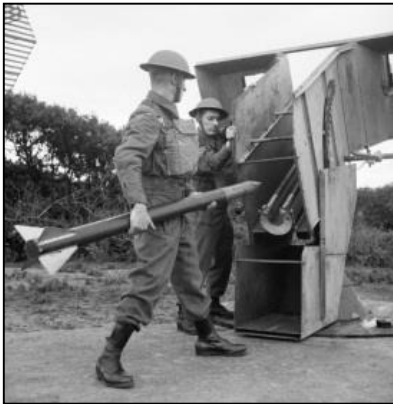
Unrotated Projectile (UP) – Z Battery

Projectile Weight	84lb (24.5kg)
Warhead Weight	4.28lb (1.94kg)
Warhead	Aerial Mine with a No. 700 / 720 fuze
Filling	High Explosive
Dimensions	1930mm x 82.6mm (76 x 3.25in)
Use	As a short range rocket-firing anti-aircraft weapon developed for the Royal Navy. It was used extensively by British ships during the early days of World War II. The UP was also used in ground-based single and 128-round launchers known as Z Batteries.
