Tree Survey and Constraints Report

Dyson Hall

Prepared for: Willmott Dixon

Detail:
TREE CONSTRAINTS PLAN - Overview

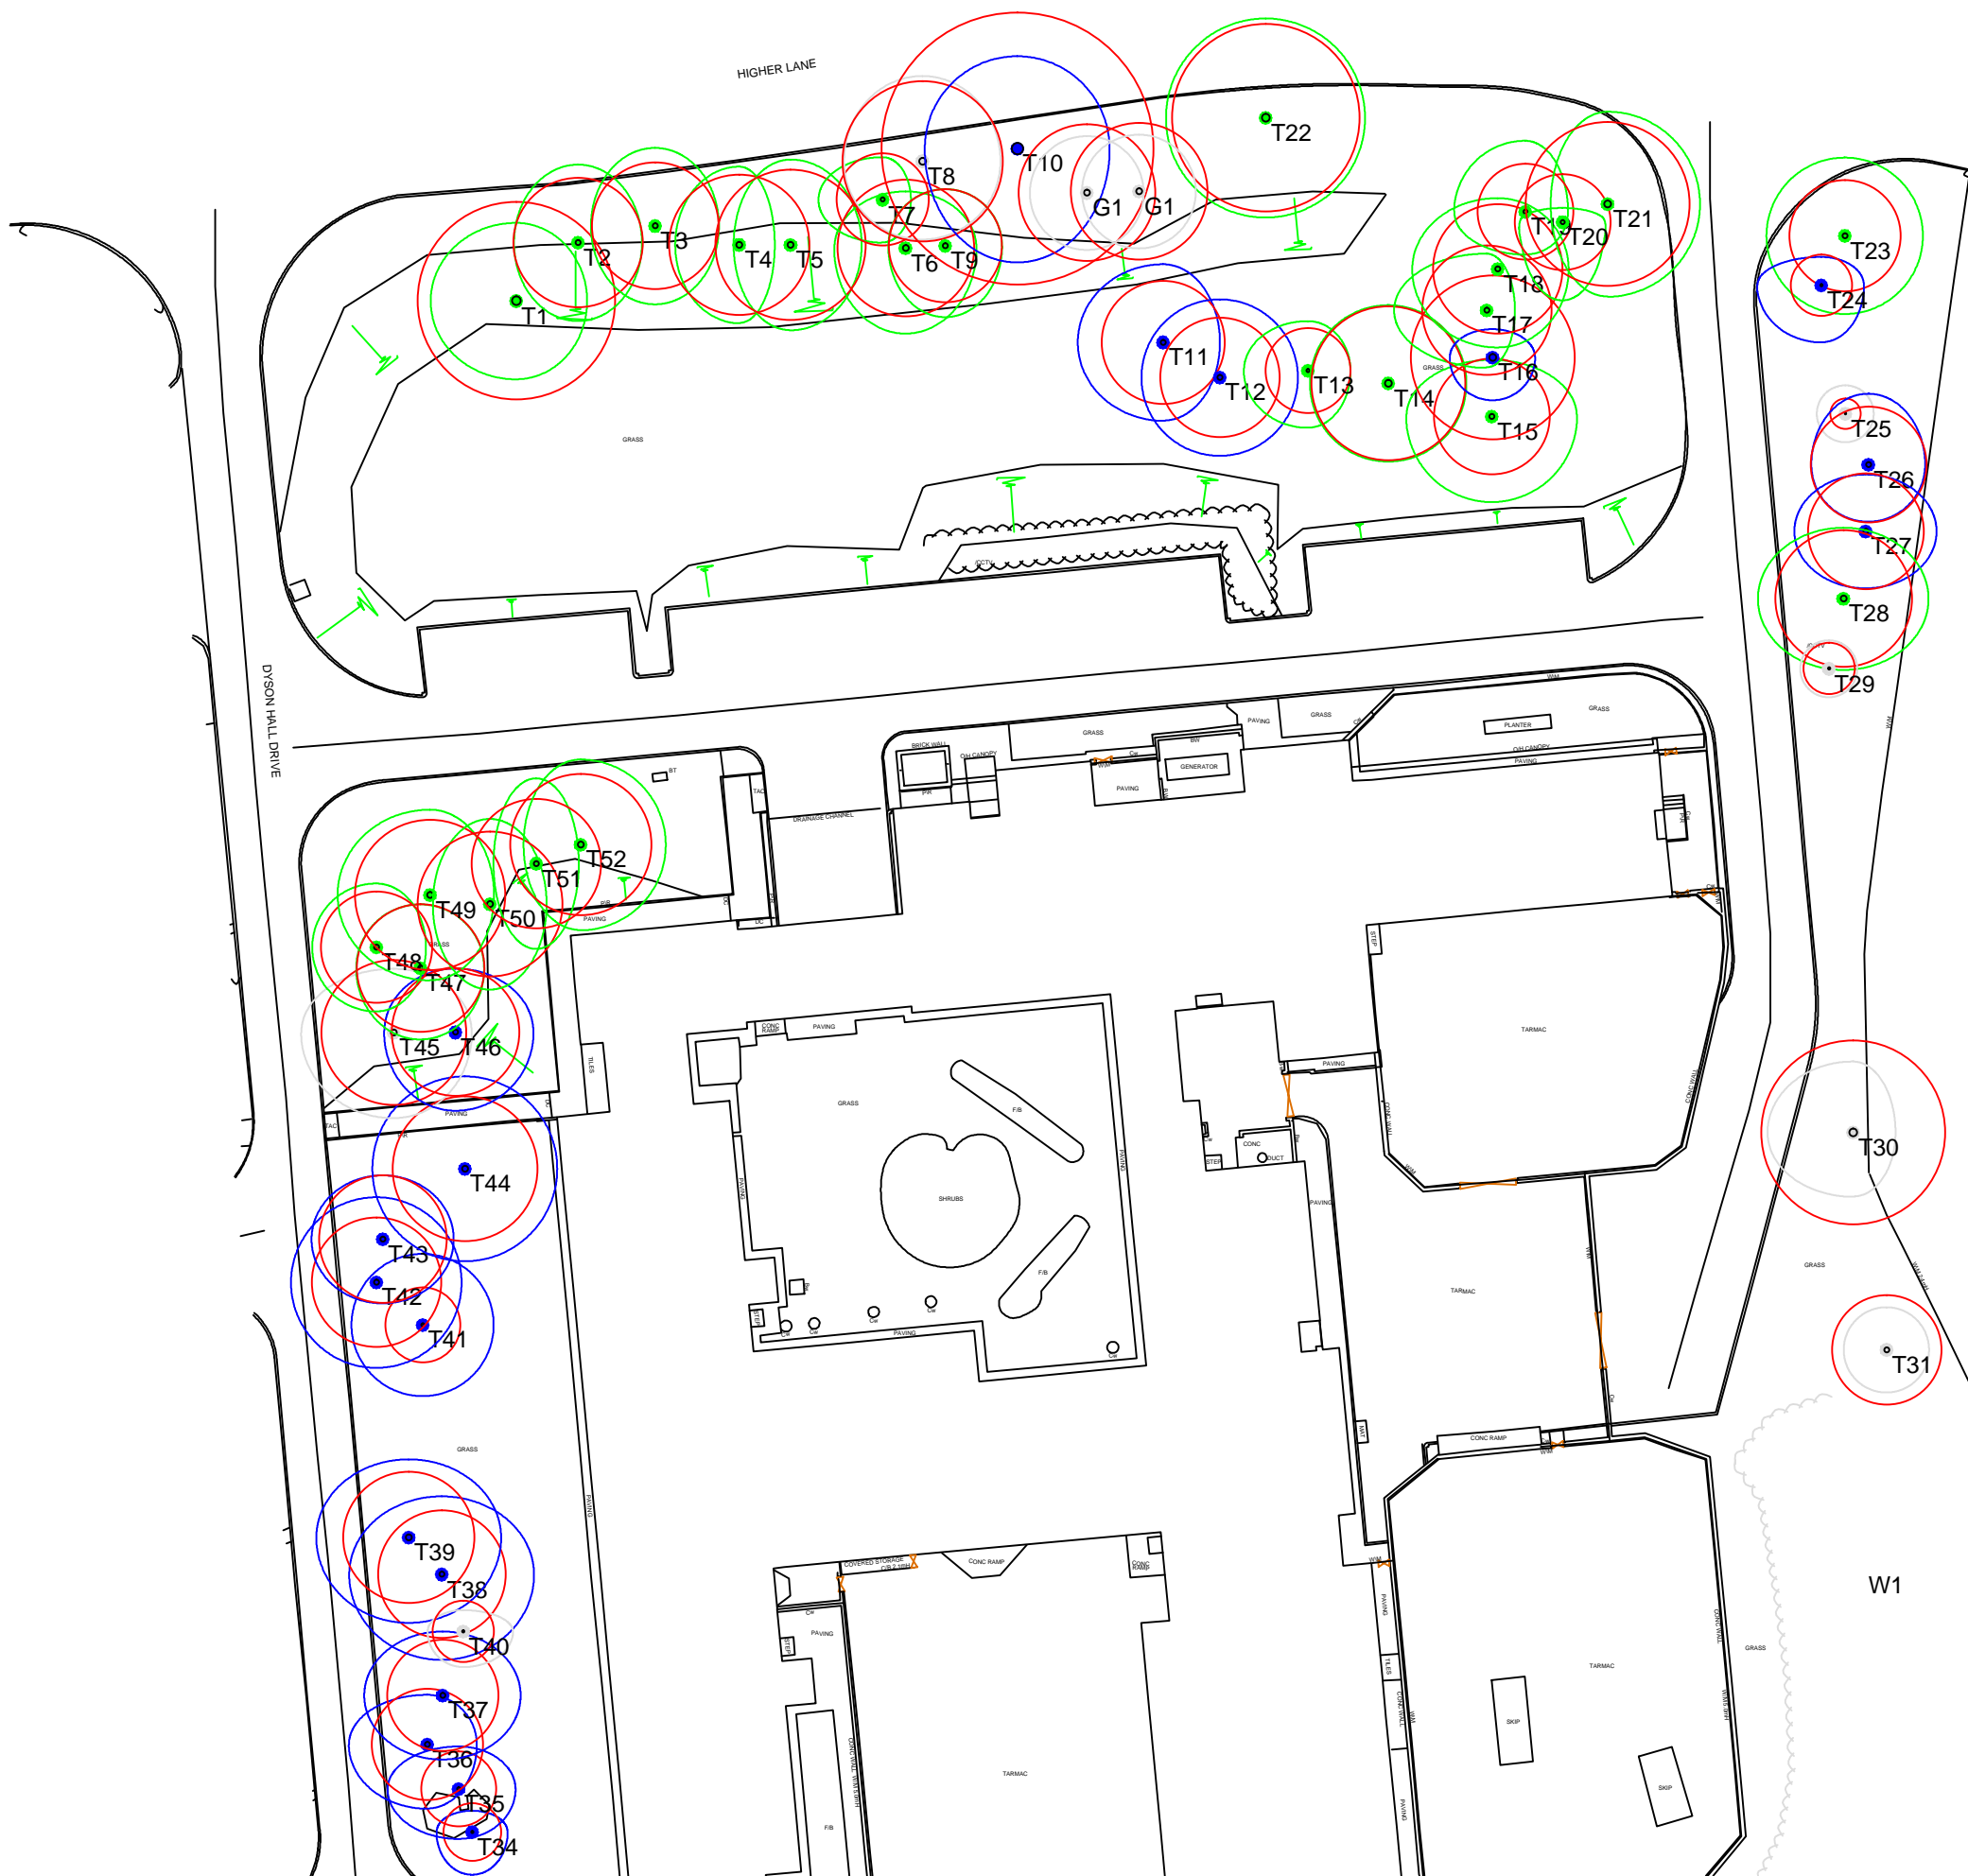
TREE CONSTRAINTS PLAN

Root Protection Areas (RPA's) have been identified and are based on BS5837:2012. RPA's have been shown as a red polyline.
