LIPA 6th Form

Phase 2 Intrusive Investigation

Curtins Ref: EB1738/GL/4833

Issue Date: 13 August 2015

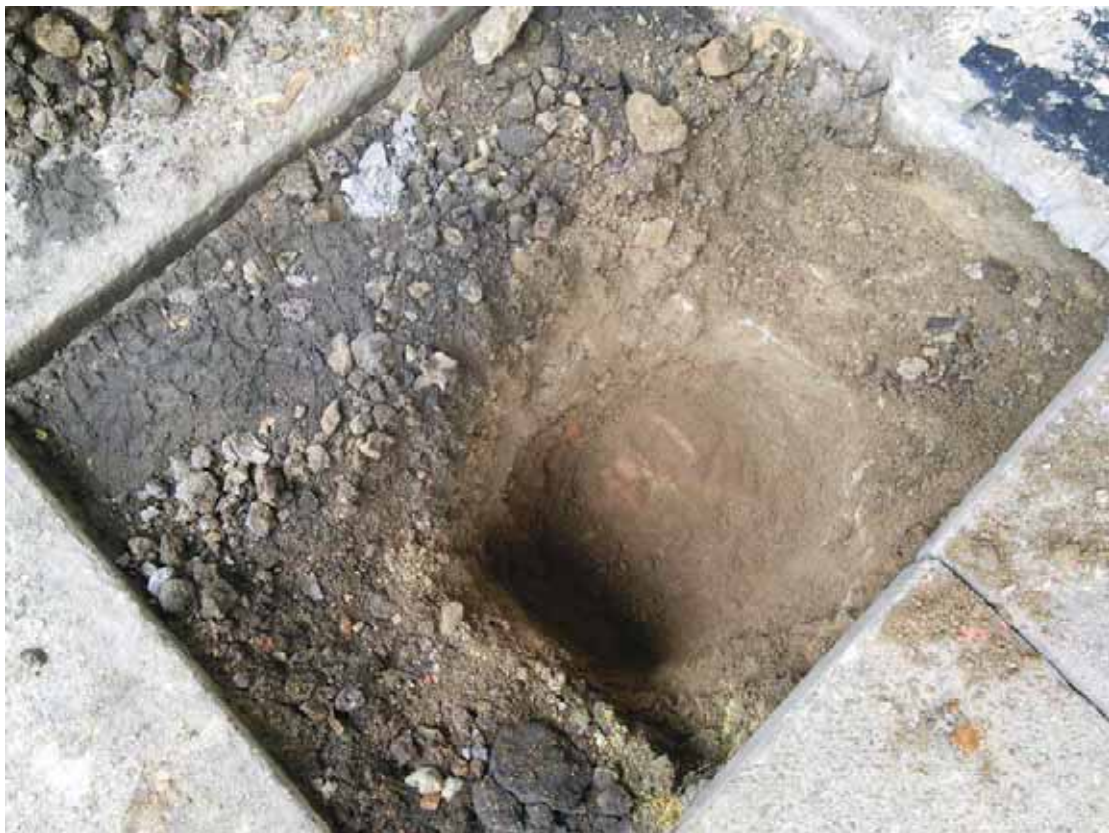
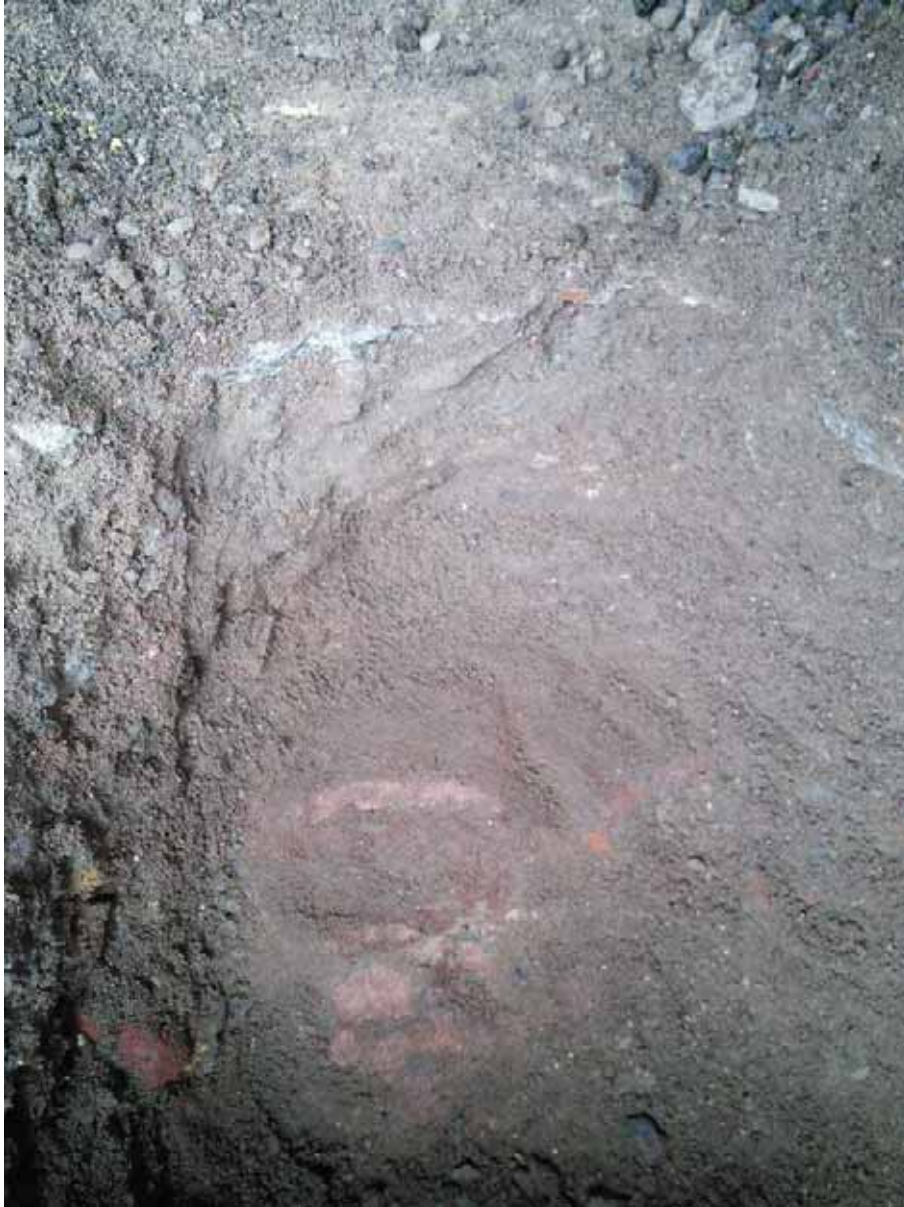
Hand Pit Drawings & Photographs HP01

Existing building foundations were encountered in HP01, HP02 and HP03. 6.1.2 The foundation encountered within HP01 comprised concrete post structure founded on concrete foundations at depth of 0.20m. The thickness of the concrete foundation was 0.15m. The foundation step-out was 0.20m.

The base of the foundation was encountered in HP01 at depth of 0.35m and was founded upon sandstone. The base of the foundation was not encountered within HP02 and HP03, these two locations were terminated at 1.10m and 0.73m.

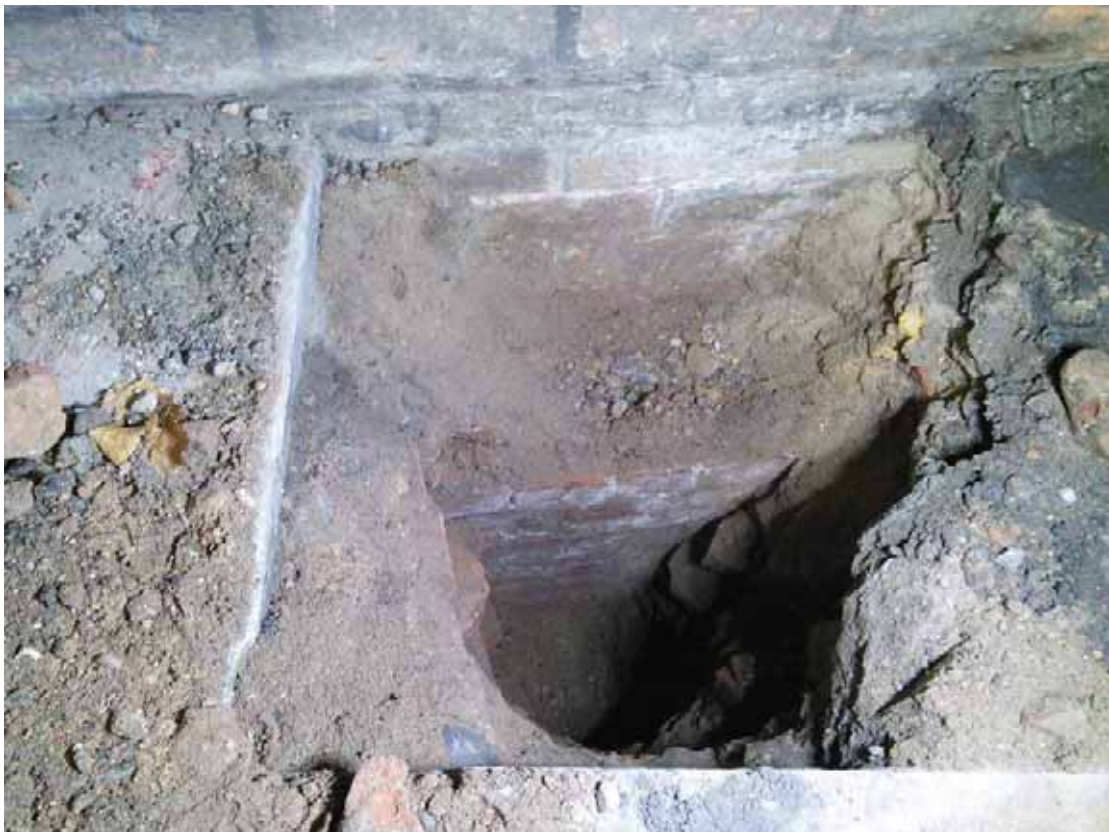
Hand Pit Drawing and Photograph HP02

In HP02 a brick structure founded upon a brick foundation at depth of 0.40m was found with the base of the foundation not encountered within 1.10m depth of excavation.

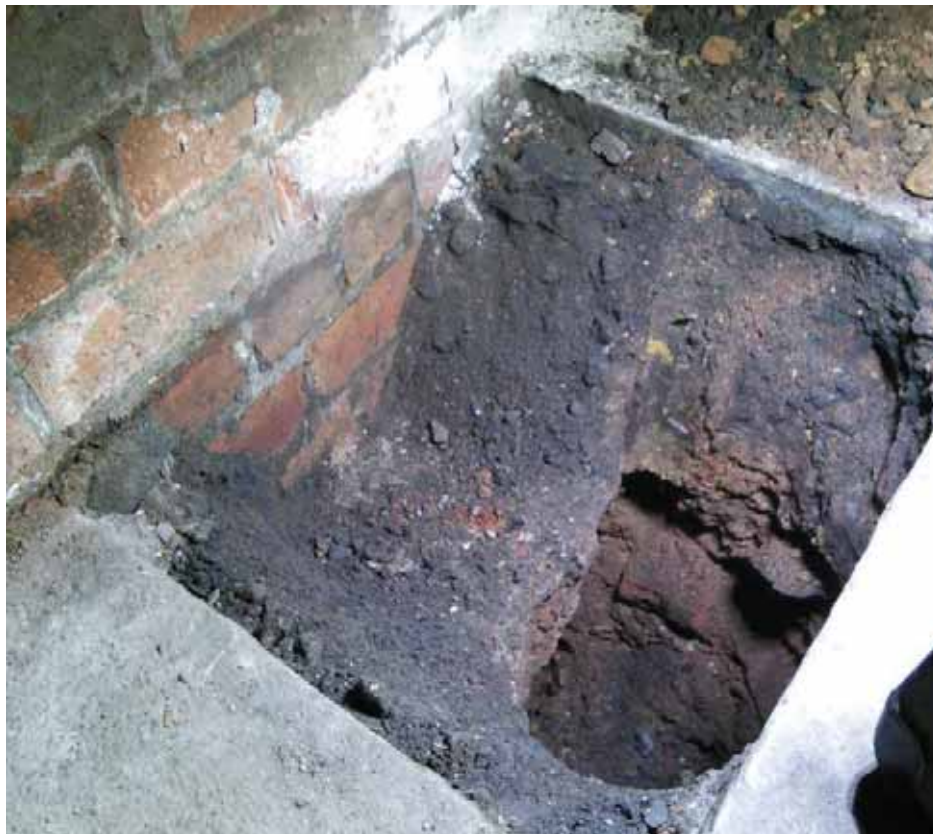
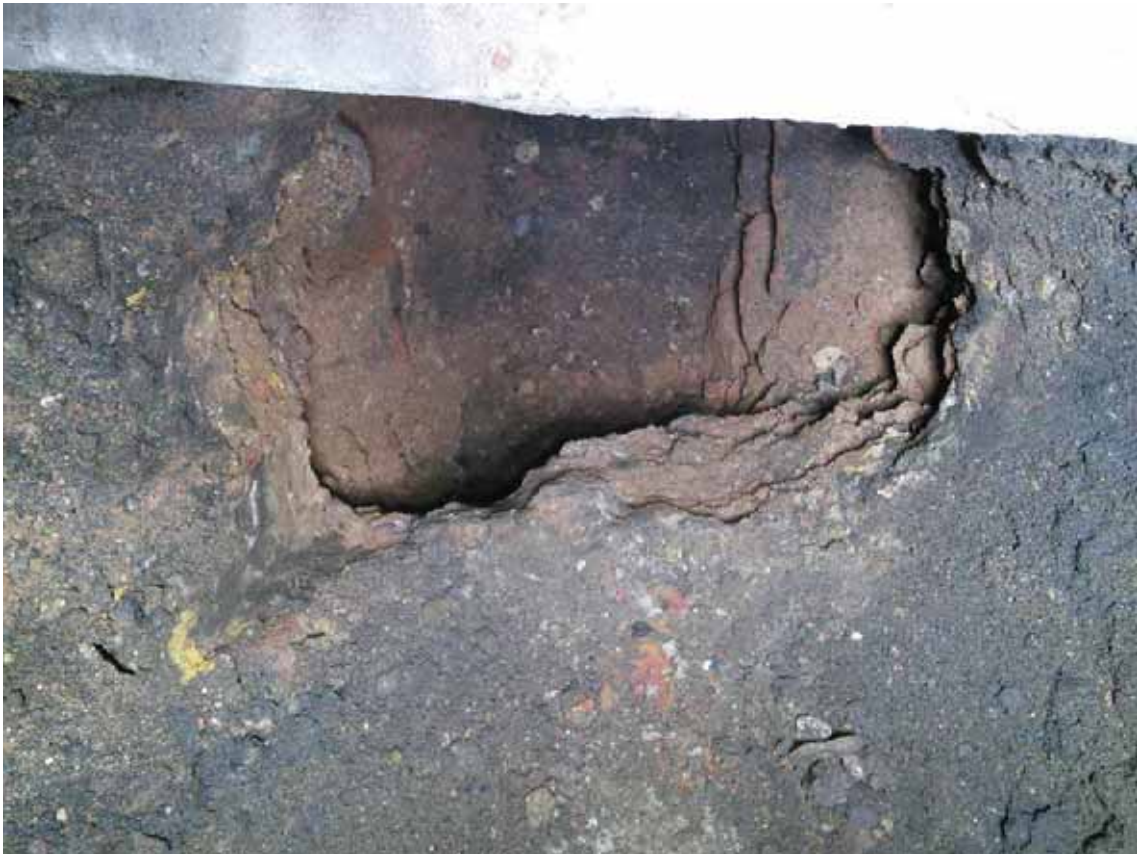
Hand Pit Drawing and Photographs HP03

In HP03, the brick wall continued below ground level. A concrete slab was encountered at 0.23m, with a thickness of 0.20m. The slab was undermined and the wall was observed to continue. No foundation was encountered within 0.73m of excavation.
