BUILDINGS AND TREES AT THE FORMER WATERGATE SCHOOL, SPEKE ROAD, LIVERPOOL

**UPDATED LICENSED BAT SURVEY AND ASSESSMENT
AND
INSPECTION FOR NESTING BIRDS**

April 2015

[ERAP Ltd ref: 2015/107]

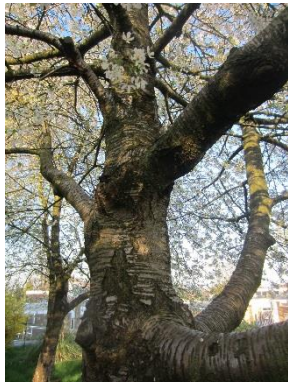
Tree Reference (refer to Figure 1)	Notes	Photographs	Category
T1: Cherry	<p>Semi-mature Cherry.</p> <p>Local areas of lifted bark on the surface of the trunk and larger branches only.</p> <p>None provide opportunities for use by roosting bats.</p> <p>No droppings or staining.</p>

- 4.4.1 There are no constraints, subject to the continued absence of nesting birds, on the removal of tree T9.
- 4.4.2 It is understood trees T1 and T2, the off-site Hornbeam and other trees will be retained. Tree protection measures in accordance with British Standard BS5837:2012 must be applied.

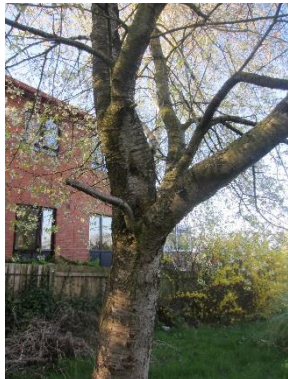
3
T2: Cherry	<p>Semi-mature Cherry.</p> <p>Local areas of lifted bark on the surface of the trunk and larger branches only.</p> <p>None provide opportunities for use by roosting bats.</p> <p>No droppings or staining.</p>

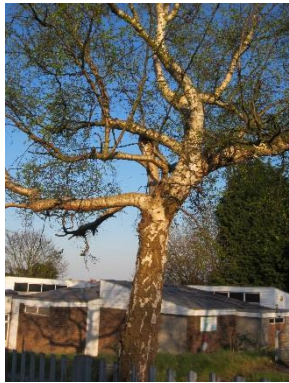
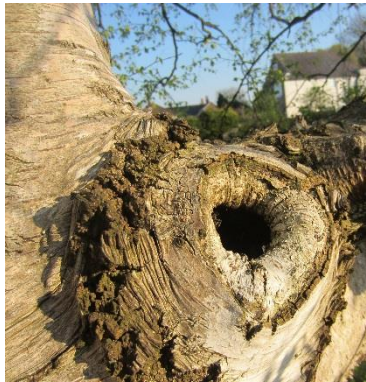
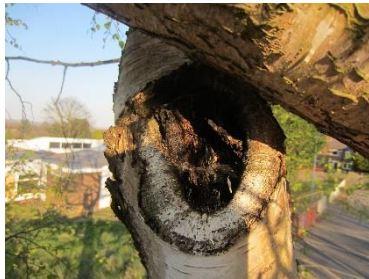
Tree Reference (refer to Figure 1)	Notes	Photographs	Category
T9: Silver Birch	<p>Mature Silver Birch.</p> <p>Upward facing holes on the trunk and main branches. All were inspected at height. All only extend less than 5cm and provide no opportunities for bat use.</p> <p>No bats, droppings or staining.</p>

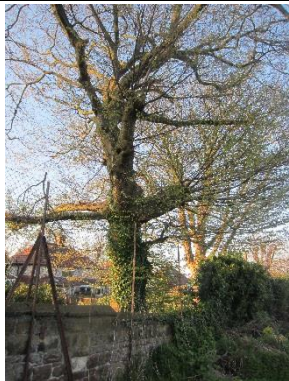
3
Off-site Hornbeam	<p>Mature Hornbeam.</p> <p>Off-site tree. Will not be affected by the works.</p> <p>Branches overhanging the site support no opportunities for use by roosting bats.</p>

3.3.2 No evidence of use of trees T1, T2 and T9 by roosting bats or nesting birds was detected. Following comprehensive inspections of the trees no features suitable for use by roosting bats are present and all trees are reasonably downgraded to Category 3 in accordance with Table 2.2. The off-site Hornbeam will not be directly affected by the proposals.

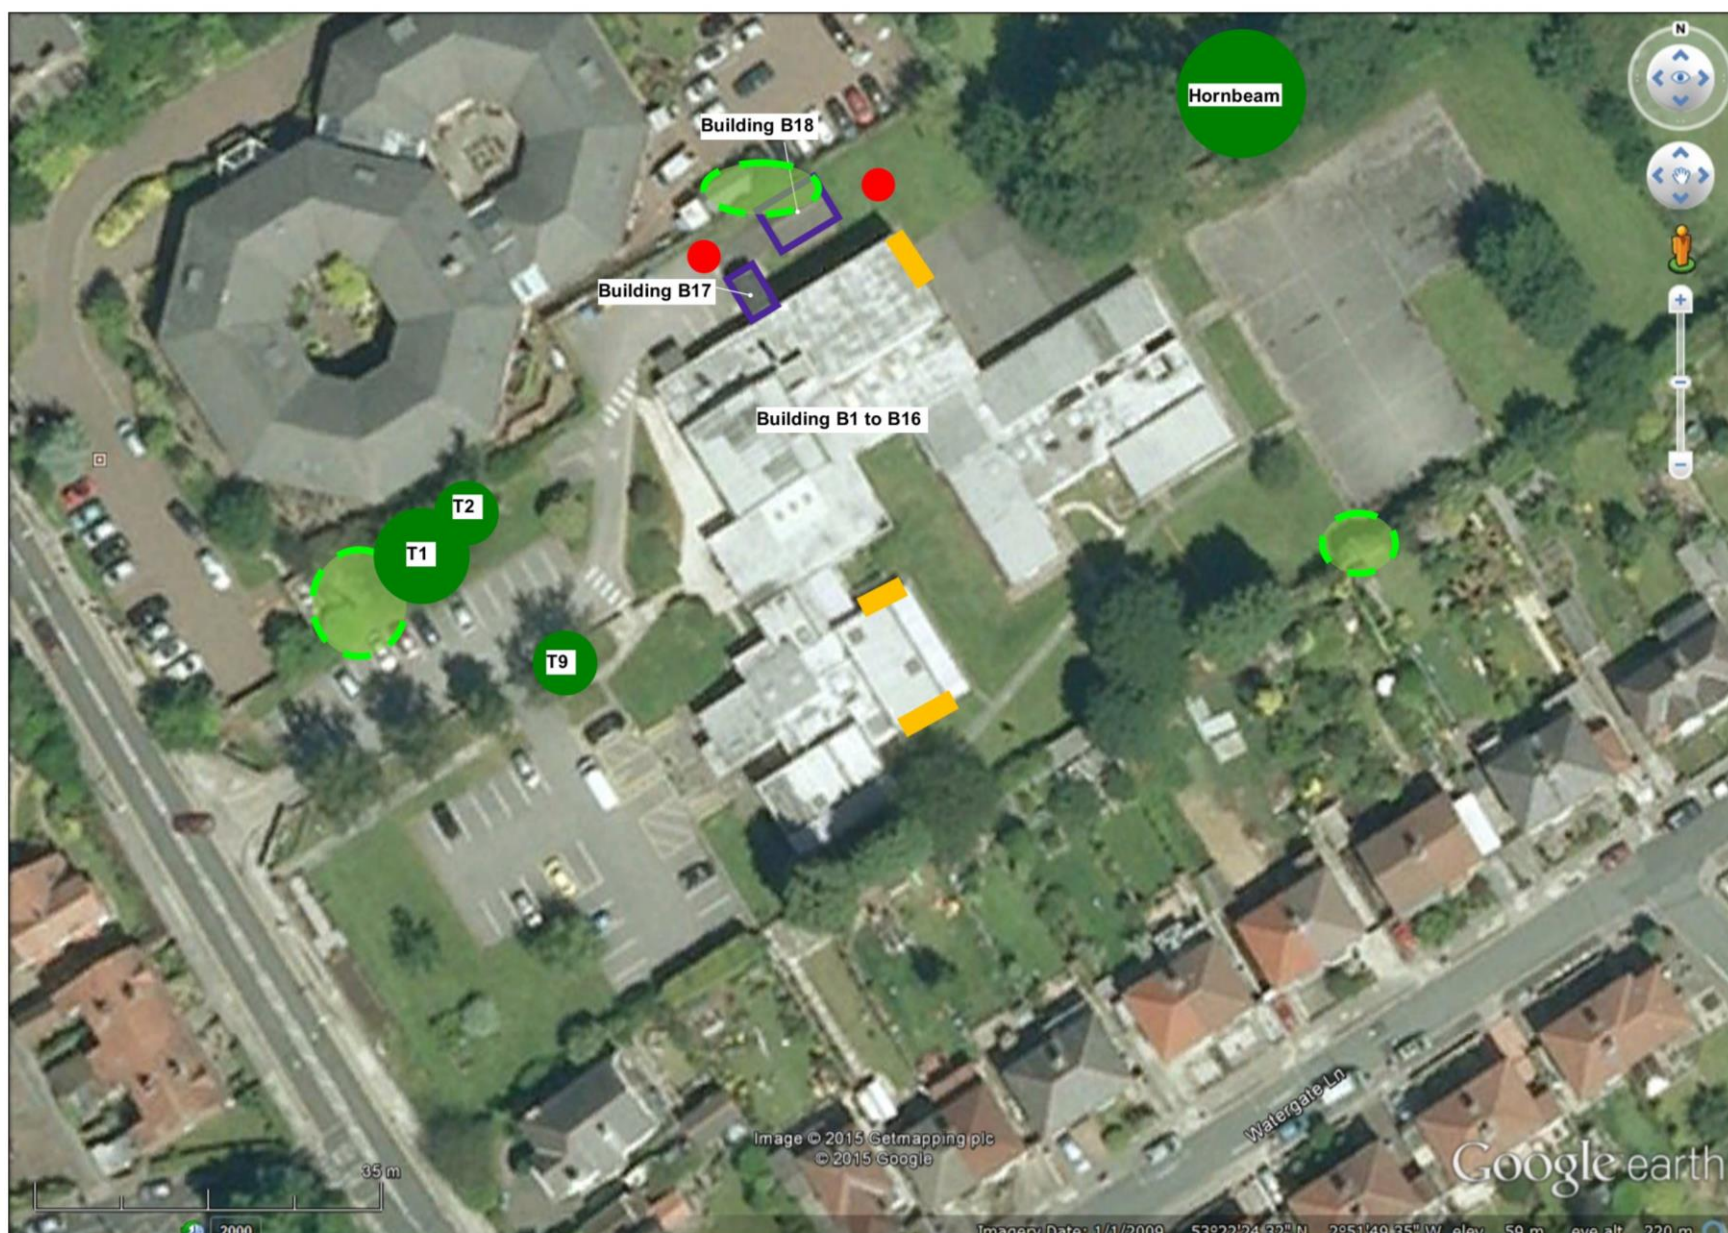
Scale: NTS **Drawing No.** Figure 1 **Date:** April 2015

Areas with damaged plastic fascia inspected for evidence of use by roosting bats, refer to **Photo 6**. Plastic fascia to be removed by hand.

Areas of dense Ivy and evidence of use by nesting Blackbird, refer to **Photo 2**. To remain undisturbed during demolition

Title: Plan to Show Results of Roosting Bat and Nesting Bird Survey

- 4.1.1 No evidence of use of the main school building by roosting bats or nesting birds was detected.
- 4.1.2 There are no constraints on the commencement of demolition although it is recommended that the areas of damaged plastic fascia in the three locations as annotated on **Figure 1** are removed by hand prior to full demolition.

- 4.6.1 Evidence of use of stands of dense Ivy on the site boundaries by nesting Blackbird was detected, refer to Figure 1. It is recommended that all boundary Ivy is retained and protected during the demolition operations. If required Ivy can then be cleared outside the bird nesting season (i.e. September to February inclusive).

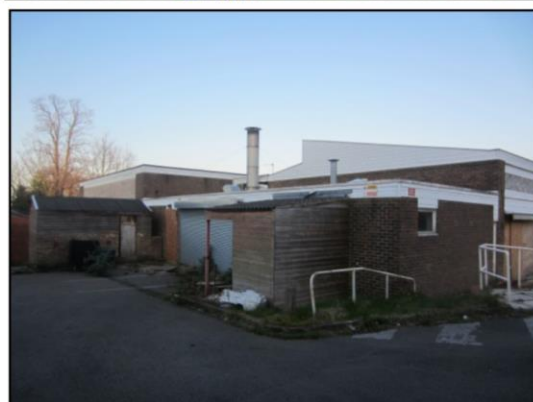
3.2.1 Building B1 to B16 is in a similar condition to that reported by Ribble Ecology (Nov-Dec 2014). Local areas of fire damage have occurred and small sections of plastic fascia have been removed/damaged.

Photo 1: General view of buildings B1 to B16

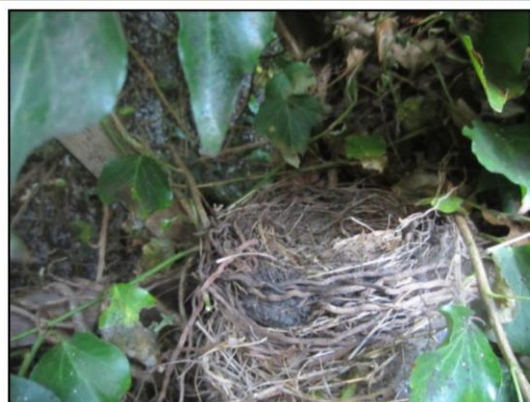
3.1.3 Old and recently constructed, but currently unoccupied, Blackbird nests were detected within dense stands of Ivy on the northern site boundary (adjacent to building B18) and at the southern site boundary, refer to **Figure 1**.

Photo 2: New but currently unoccupied Blackbird nest in dense Ivy adjacent to building B18

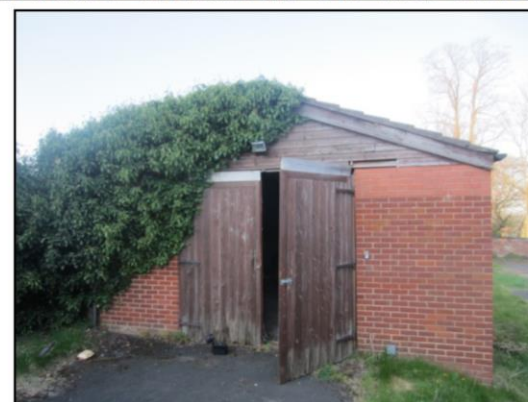
3.2.7 Building B18 is a brick and concrete block garage with a pitched tile covered roof.

3.2.8 Timber boarding is present on the western elevation and timber fascia boards are present to the southern elevation and east facing gable end. All fascia are tightly fitted against the elevation walls; no opportunities for bat access are present.

- 3.2.9 A single small (2cm by 2cm) gap is present at the roof verge of the west facing gable where the mortar has been damaged. Inspection with the borescope confirmed that this extended only 5cm. No bats or droppings were present.

Photo 3: Exterior of building B18

- 4.3.1 No evidence of use of building B18 by roosting bats or nesting birds was detected.
- 4.3.2 Owing to the suitability of the Ivy over the roof of building B18 for use by nesting birds it is recommended that the Ivy is removed before the 24th April 2015 (i.e. within 2 days of the survey). If this is not possible an updated inspection of the Ivy for nesting birds must be carried out prior to demolition if demolition is proposed between March and August inclusive. If active nests are detected the Ecologist will provide appropriate guidance but this is likely to involve leaving the building undisturbed until it is confirmed that the young birds have fledged.
- 4.3.3 During demolition it is recommended and entirely feasible to avoid the disturbance of the dense Ivy on the fence line adjacent to building B18.

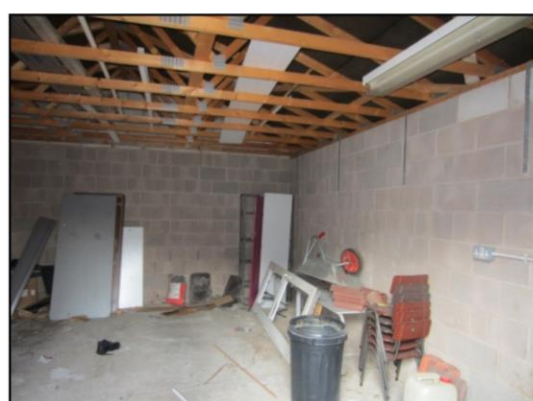
- 3.2.10 Internally the building was easily searched for bats and droppings. The roof timbers are visible and the roof is underlined with felt. No insulation is present. A timber plank covers the wall plate at eaves height.

- 3.2.11 No bats, bat droppings or prey remains were found inside building B18.
- 3.2.12 Mouse droppings (30+) were found amongst a stack of classroom chairs.

Photo 4: Interior of building B18; no bat roost.

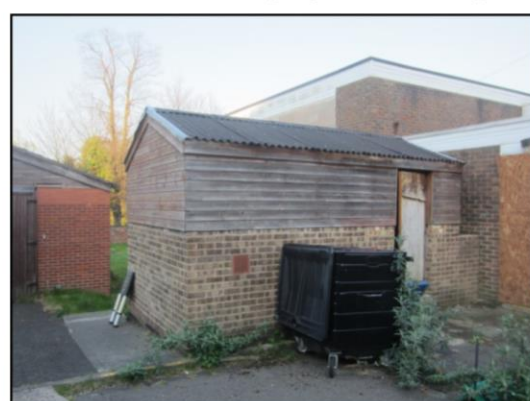
3.2.5 Building B17 comprises a part brick built, part timber single storey store with a pitched corrugated material covered roof.

3.2.6 No opportunity for, or evidence of, use by roosting bats was detected.

Photo 5: Building B17; no bat roost.

- 4.2.1 No evidence of use of building B17 by roosting bats or nesting birds was detected. There are no constraints on the commencement of demolition.

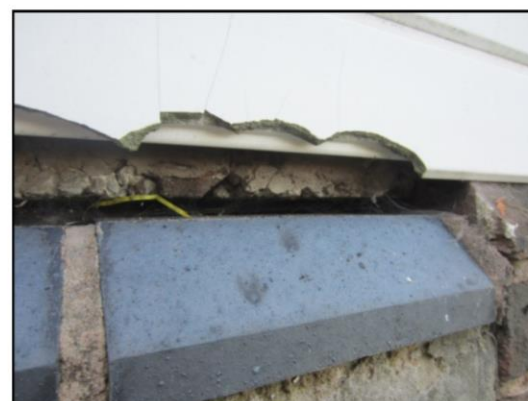
3.2.3 Narrow (1.5 cm high) gaps along the base of the plastic fascia are present in three locations around the building exterior, refer to **Figure 1**. All areas were examined from ladders with the borescope. No bats or droppings were detected. The gaps only extend approximately 10cm behind the fascia as timber battens prevent further or deeper access. As all areas were inspected thoroughly it is concluded that a comprehensive inspection was possible.

Photo 6: Gaps beneath damaged fascia

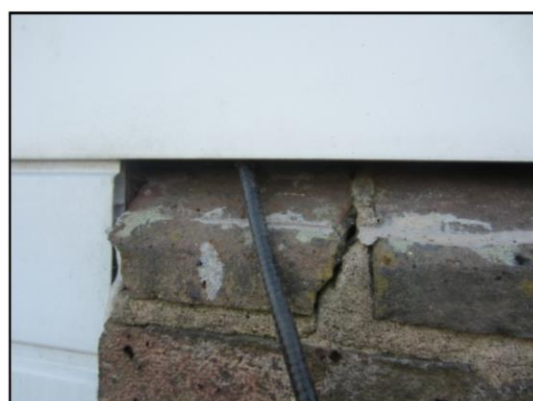
Photo 7: Inspection of gaps behind fascia with borescope.
