# Explosive Ordnance Desktop Threat Assessment

Site: **Prince's Dock, Liverpool**

Client: **Moda Living**

Ref: **6426TA**

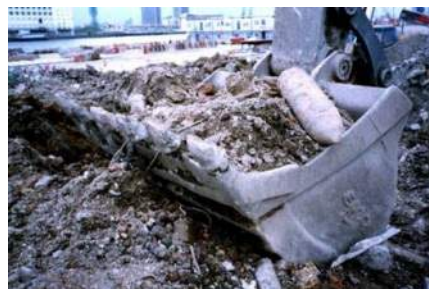
50kg bomb, London Docklands

Bomb Weight: 40-54kg (110-119lb)  
 Explosive Weight: c25kg (55lb)  
 Fuze Type: Impact fuze/electro-mechanical time delay fuze  
 Bomb Dimensions: 1,090 x 280mm (42.9 x 11.0in)  
 Body Diameter: 200mm (7.87in)  
 Use: Against lightly damageable materials, hangars, railway rolling stock, ammunition depots, light bridges and buildings up to three stories.  
 Remarks: The smallest and most common conventional German bomb. Nearly 70% of bombs dropped on the UK were 50kg.

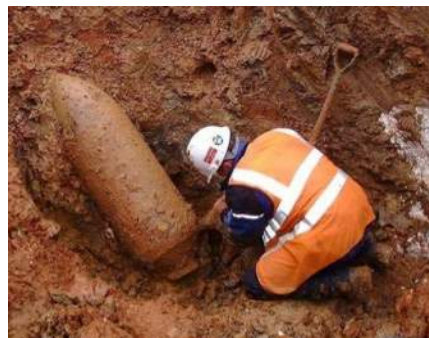
250kg bomb, Hawkinge

Bomb weight: 245-256kg (540-564lb)  
 Explosive weight: 125-130kg (276-287lb)  
 Fuze type: Electrical impact/mechanical time delay fuze.  
 Bomb dimensions: 1640 x 512mm (64.57 x 20.16in)  
 Body diameter: 368mm (14.5in)  
 Use: Against railway installations, embankments, flyovers, underpasses, large buildings and below-ground installations.

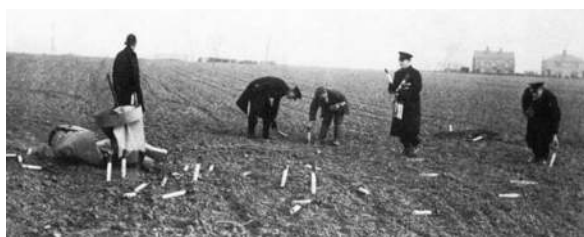
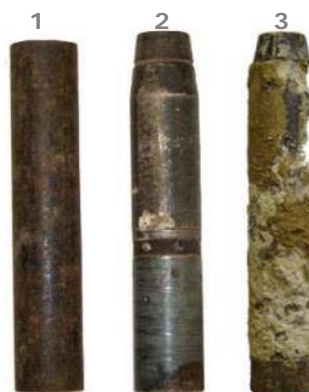
1. Scaffold pipe
2. Incendiary 1kg bomb
3. Incendiary bomb recently found on site in UK

Bomb weight: 1.0 and 1.3kg (2.2 and 2.87lb)  
 Filling: 680gm (1.3lb) Thermite  
 Fuze type: Impact fuze  
 Bomb dimensions: 350 x 50mm (13.8 x 1.97in)  
 Body diameter: 50mm (1.97in)  
 Use: As incendiary – dropped in clusters against towns and industrial complexes  
 Remarks: Jettisoned from air-dropped containers. Magnesium alloy case. Sometimes fitted with high explosive charge

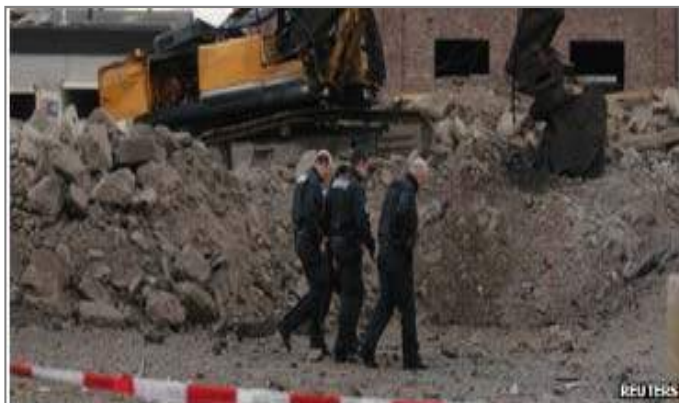
The bomb went off as the machine lifted up earth and debris

A World War Two bomb has exploded at a construction site near a west German town, killing a man and injuring eight others, police say.

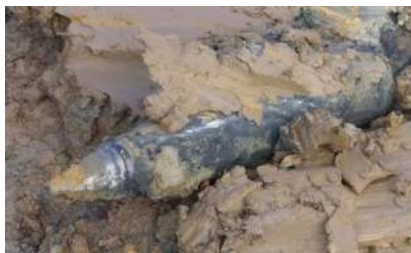
This AA shell was uncovered on a construction site in North London in February 2009.

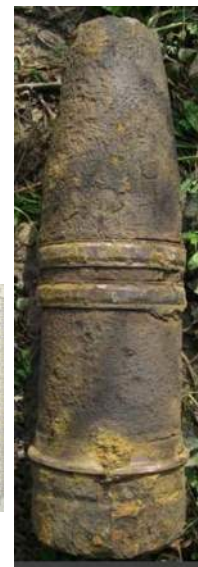
3.7 inch AA Projectile Minus Fuze

Weight: 12.7kg (28lb)  
 Dimensions: 94 x 360mm (3.7 x 14.7in)  
 Carriage: Mobile and Static Versions  
 Rate of Fire: 10-20 rounds per minute  
 Ceiling: 9-18,000m (29-59,000ft)  
 Muzzle Velocity: 792m/s (2,598ft/s)  
 Remarks: 4.5 inch projectiles were also commonly utilised

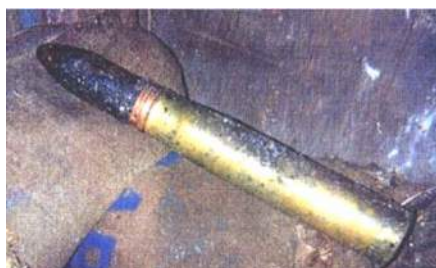
Unexploded 40mm Bofors projectile recovered from a marine environment

Weight: 0.86kg (1.96lb)  
 Dimensions: 40mm x 310mm (1.6in x 12.2in)  
 Rate of Fire: 120 rounds per minute  
 Ceiling: 23,000ft (7000m)  
 Muzzle Velocity: 2,890 ft/s (881m/s)  
 Remarks: Mobile batteries – normally few records of where these guns were located
