# Ecological Survey Report

Philharmonic Court

Project No. 854584

AUGUST 2012

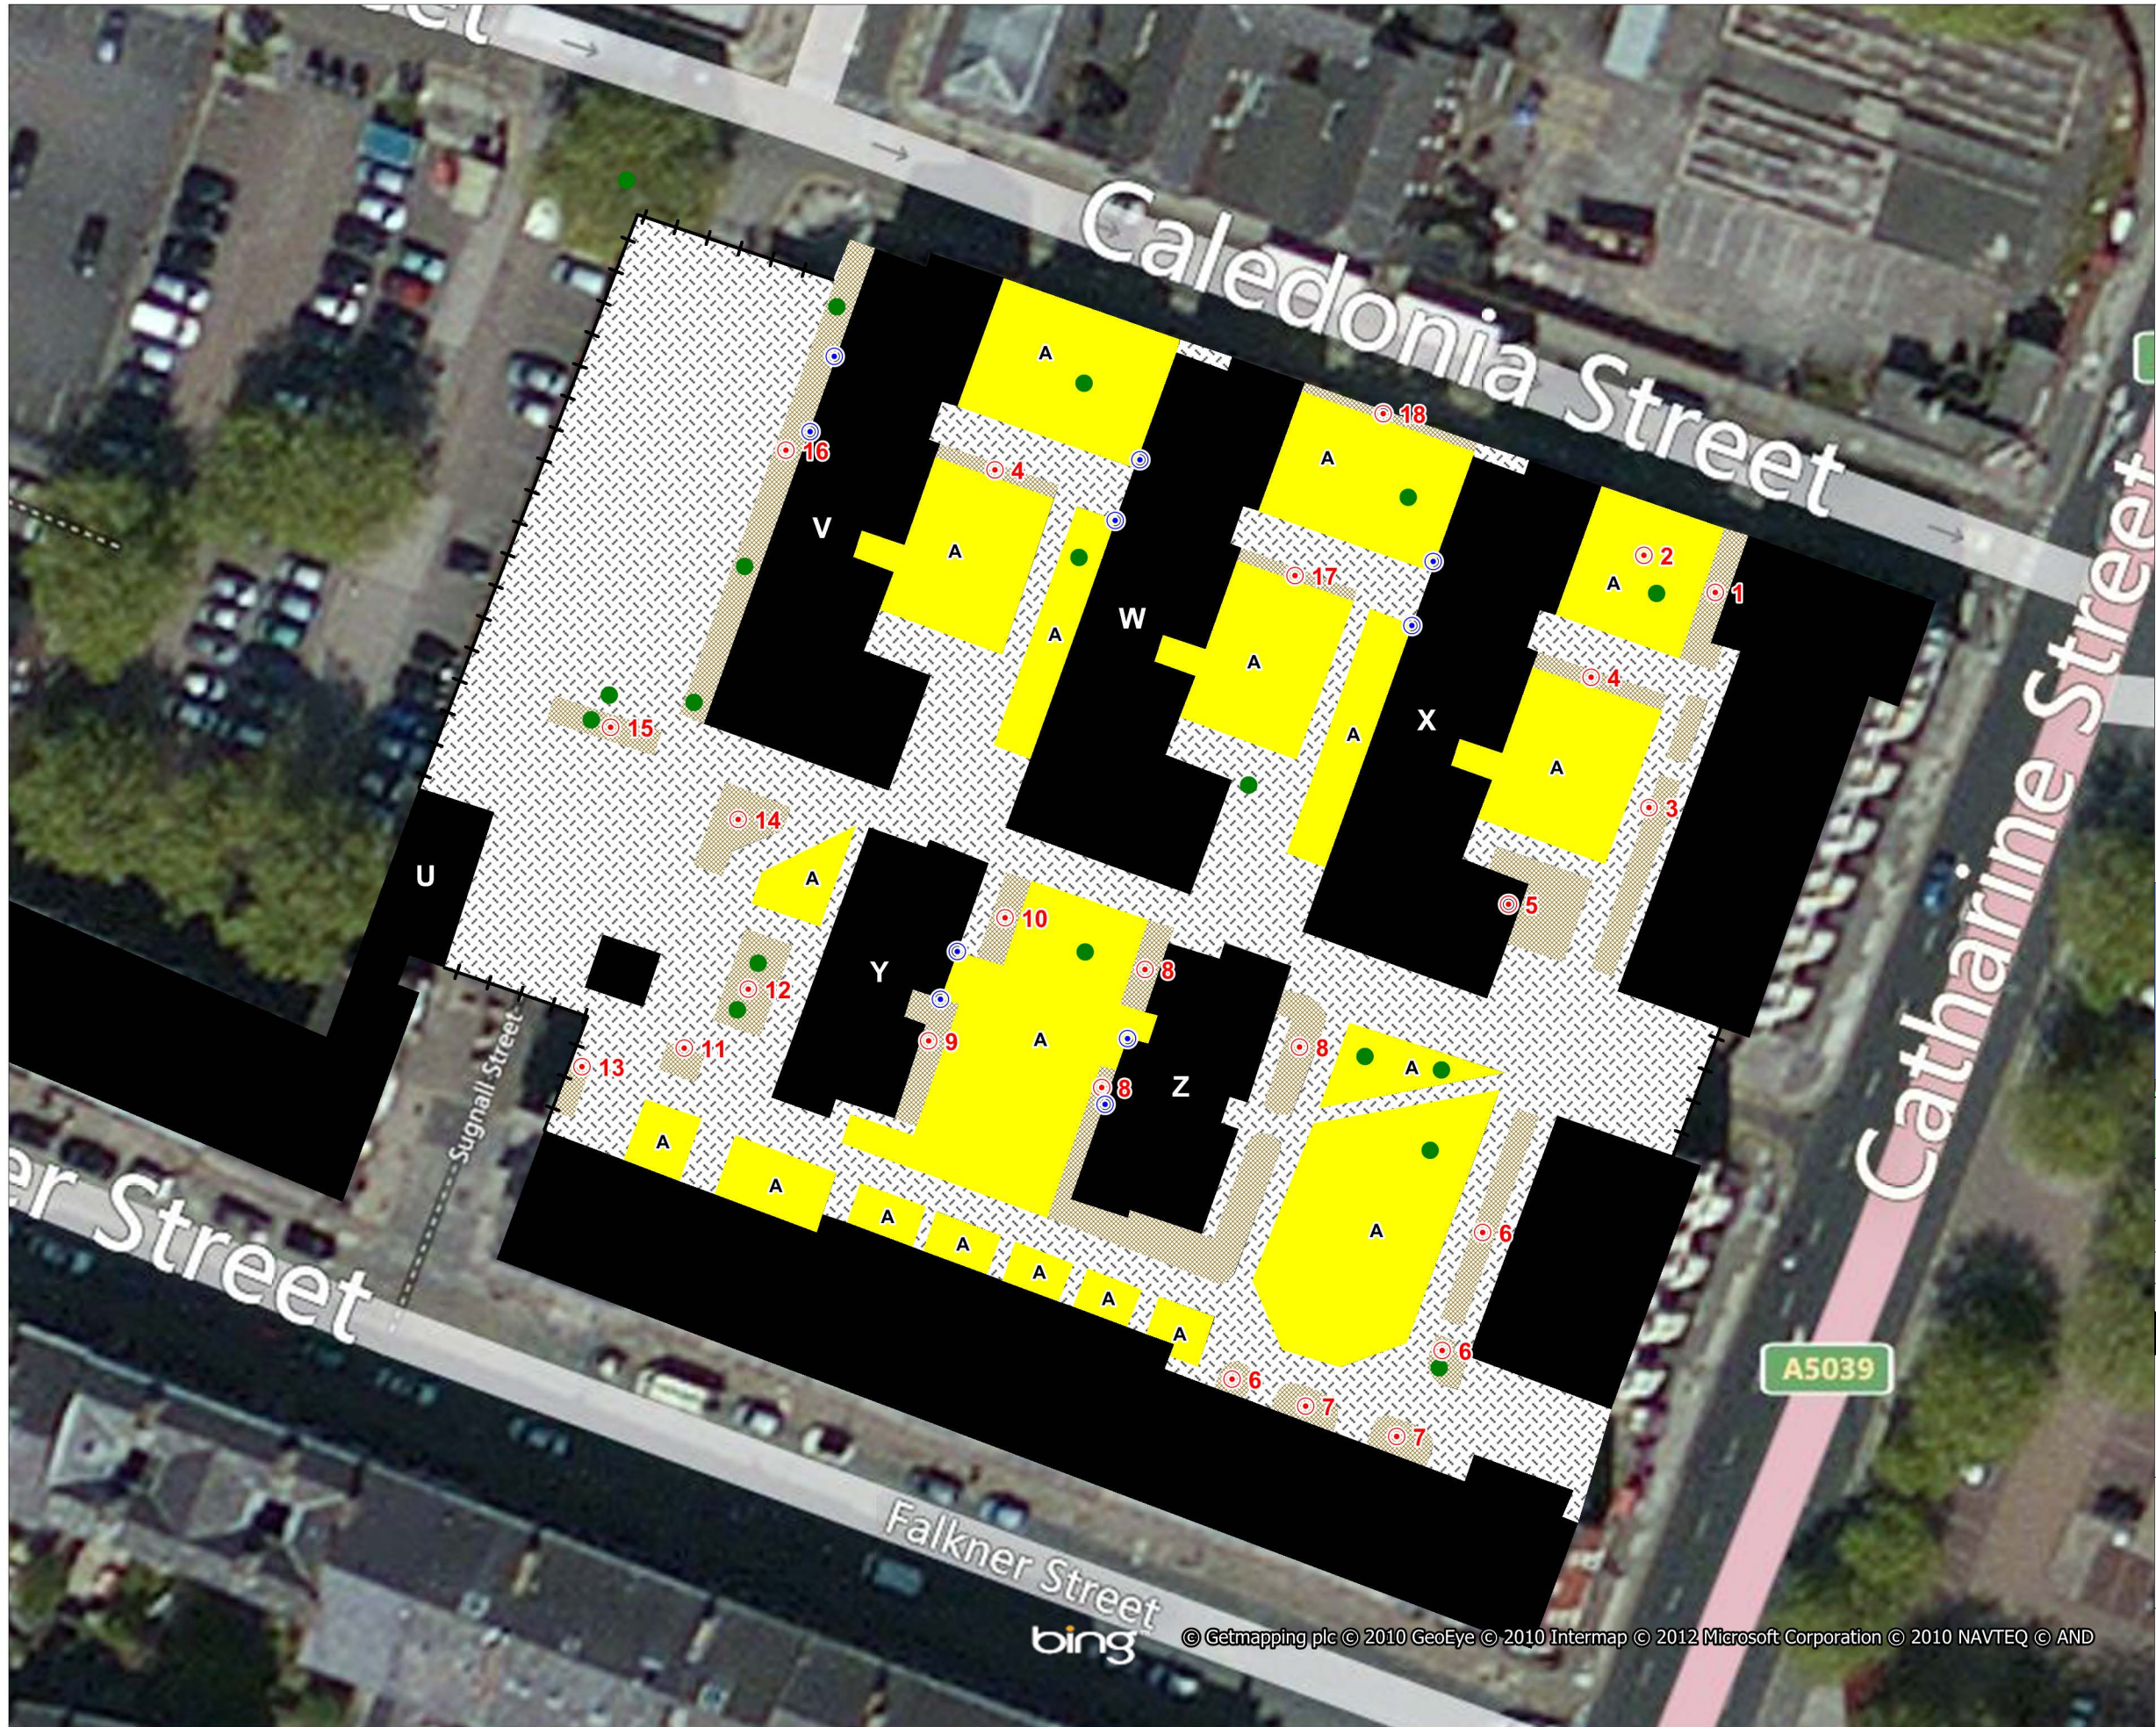
Figure 2  
Phase 1 and Bat Survey Results

Results from the external and internal building inspections are given below. Photographs are shown in *Appendix D*, and the locations and block numbers are shown in *Figure 2*.

- Amenity Grassland
- Building
- Hardstanding
- Introduced Shrub
- Fence
- Bat Note
- Target Note
- Tree

Target notes are shown in *Figure 2*.

*Bat Note 1* – Lead flashing on corner of bay windows with gap present underneath

However, as a precaution, should demolition of the building be undertaken between the months of April to September inclusive, reasonable avoidance measures should be taken when demolishing the building in order to avoid harm to bats. The lead flashing on the corners of the bay windows should be removed by hand, using hand-tools only.

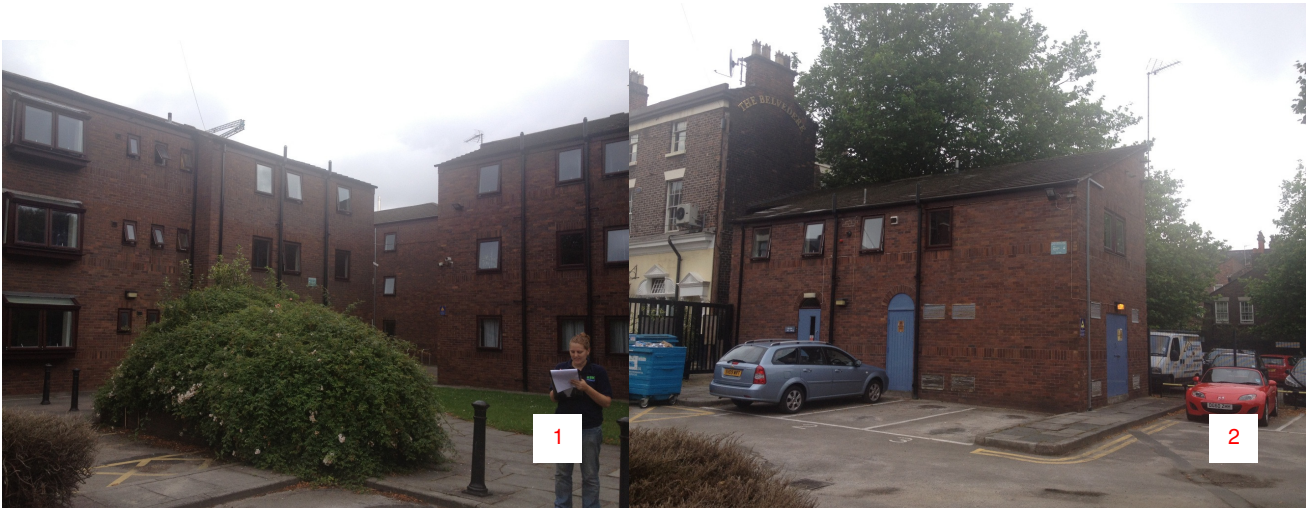
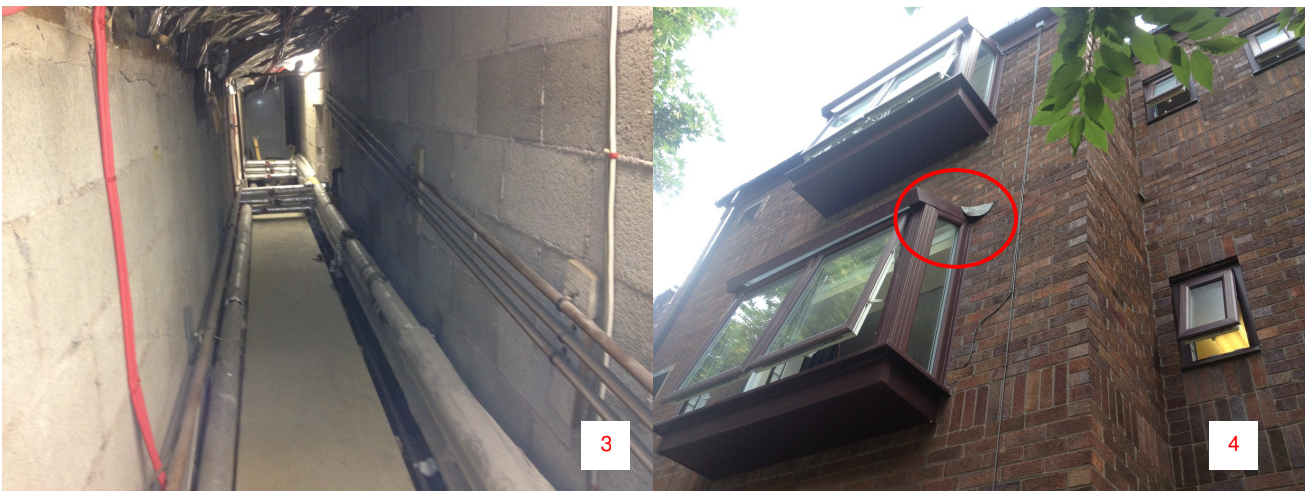
The buildings at Philharmonic courts are all of the same construction, built in the 1970's and comprising brick three storey buildings with interlocking clay tile pitched roofs in good condition with no missing or loose tiles. There is a single building (*U block, Figure 2*) that has a sloped roof and is only two storeys high. All of the buildings have weatherboarding present which is in good condition with no gaps or access points. On one aspect of each building are square bay windows on each floor (*Bat Note 1, Figure 2*), there is lead flashing on the top corners of each bay window which has a small gap which could provide roosting opportunities for a single bat (*Appendix D, Plate 4*). All the gaps were fully inspected, all of the gaps were heavily cobwebbed and no evidence of bats was recorded.

construction and dimensions. The roof voids are constructed of timber beams with a boarded floor and are insulated on the floor and ceiling with padded foil insulation material. The roof voids are narrow, approximately 2m high and span the whole length of the building, the internal voids were uncluttered and very warm with no visible access points for bats to enter the loft space. No evidence of bats was recorded within the roof void.

No evidence of roosting bats was found and the buildings surveyed provide limited roosting opportunities for bats. There are several shallow gaps at the junctions of the bay windows where lead flashing is present; no evidence of bats were found at the time of the survey.

- Plate 1: Three storey buildings at Philharmonic Court
- Plate 2: 'Block U' – two storey building
- Plate 3: Example of the internal loft space (same across all buildings)
- Plate 4: Lead flashing at the corner of the bay windows (circled)
