Harthill Depot, Calderstones Park, Liverpool, L18 3HU

**ECOLOGICAL SURVEY AND ASSESSMENT
(including a Licensed Bat Survey)**

August 2016

[ERAP Ltd ref: 2015/296]

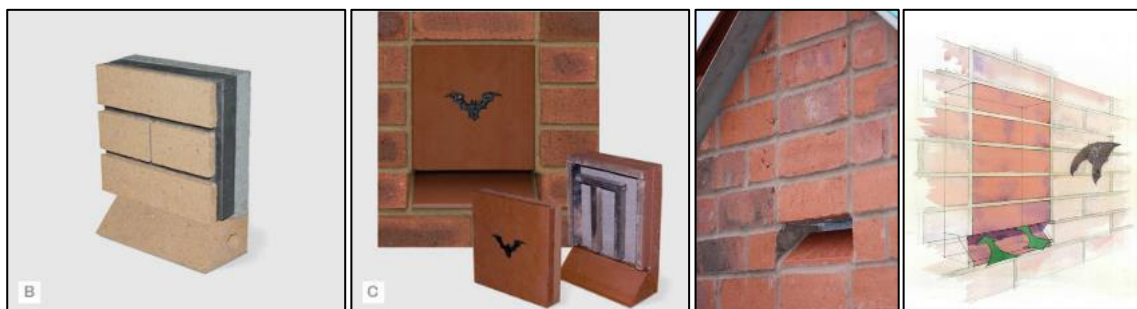
Insert 1: Example of commercially available bat access panels.

- 5.6.5 It is recommended that the development incorporates the installation of six commercially available bat access panels at the new buildings.
- 5.6.6 The bat access panels should be sited at least four metres above ground level, ideally facing or close to areas of landscape planting or existing linear features. The access panels should not be positioned over windows or doorways where bat droppings may become a nuisance. Once the development layout has been finalised, an Ecologist should advise on appropriate positions for the bat access panels. Suitable bat access panels are available from NHBS Ecology (www.nhbs.com) or Wild Care Shop (www.wildcareshop.com) and are presented at **Insert 1**:

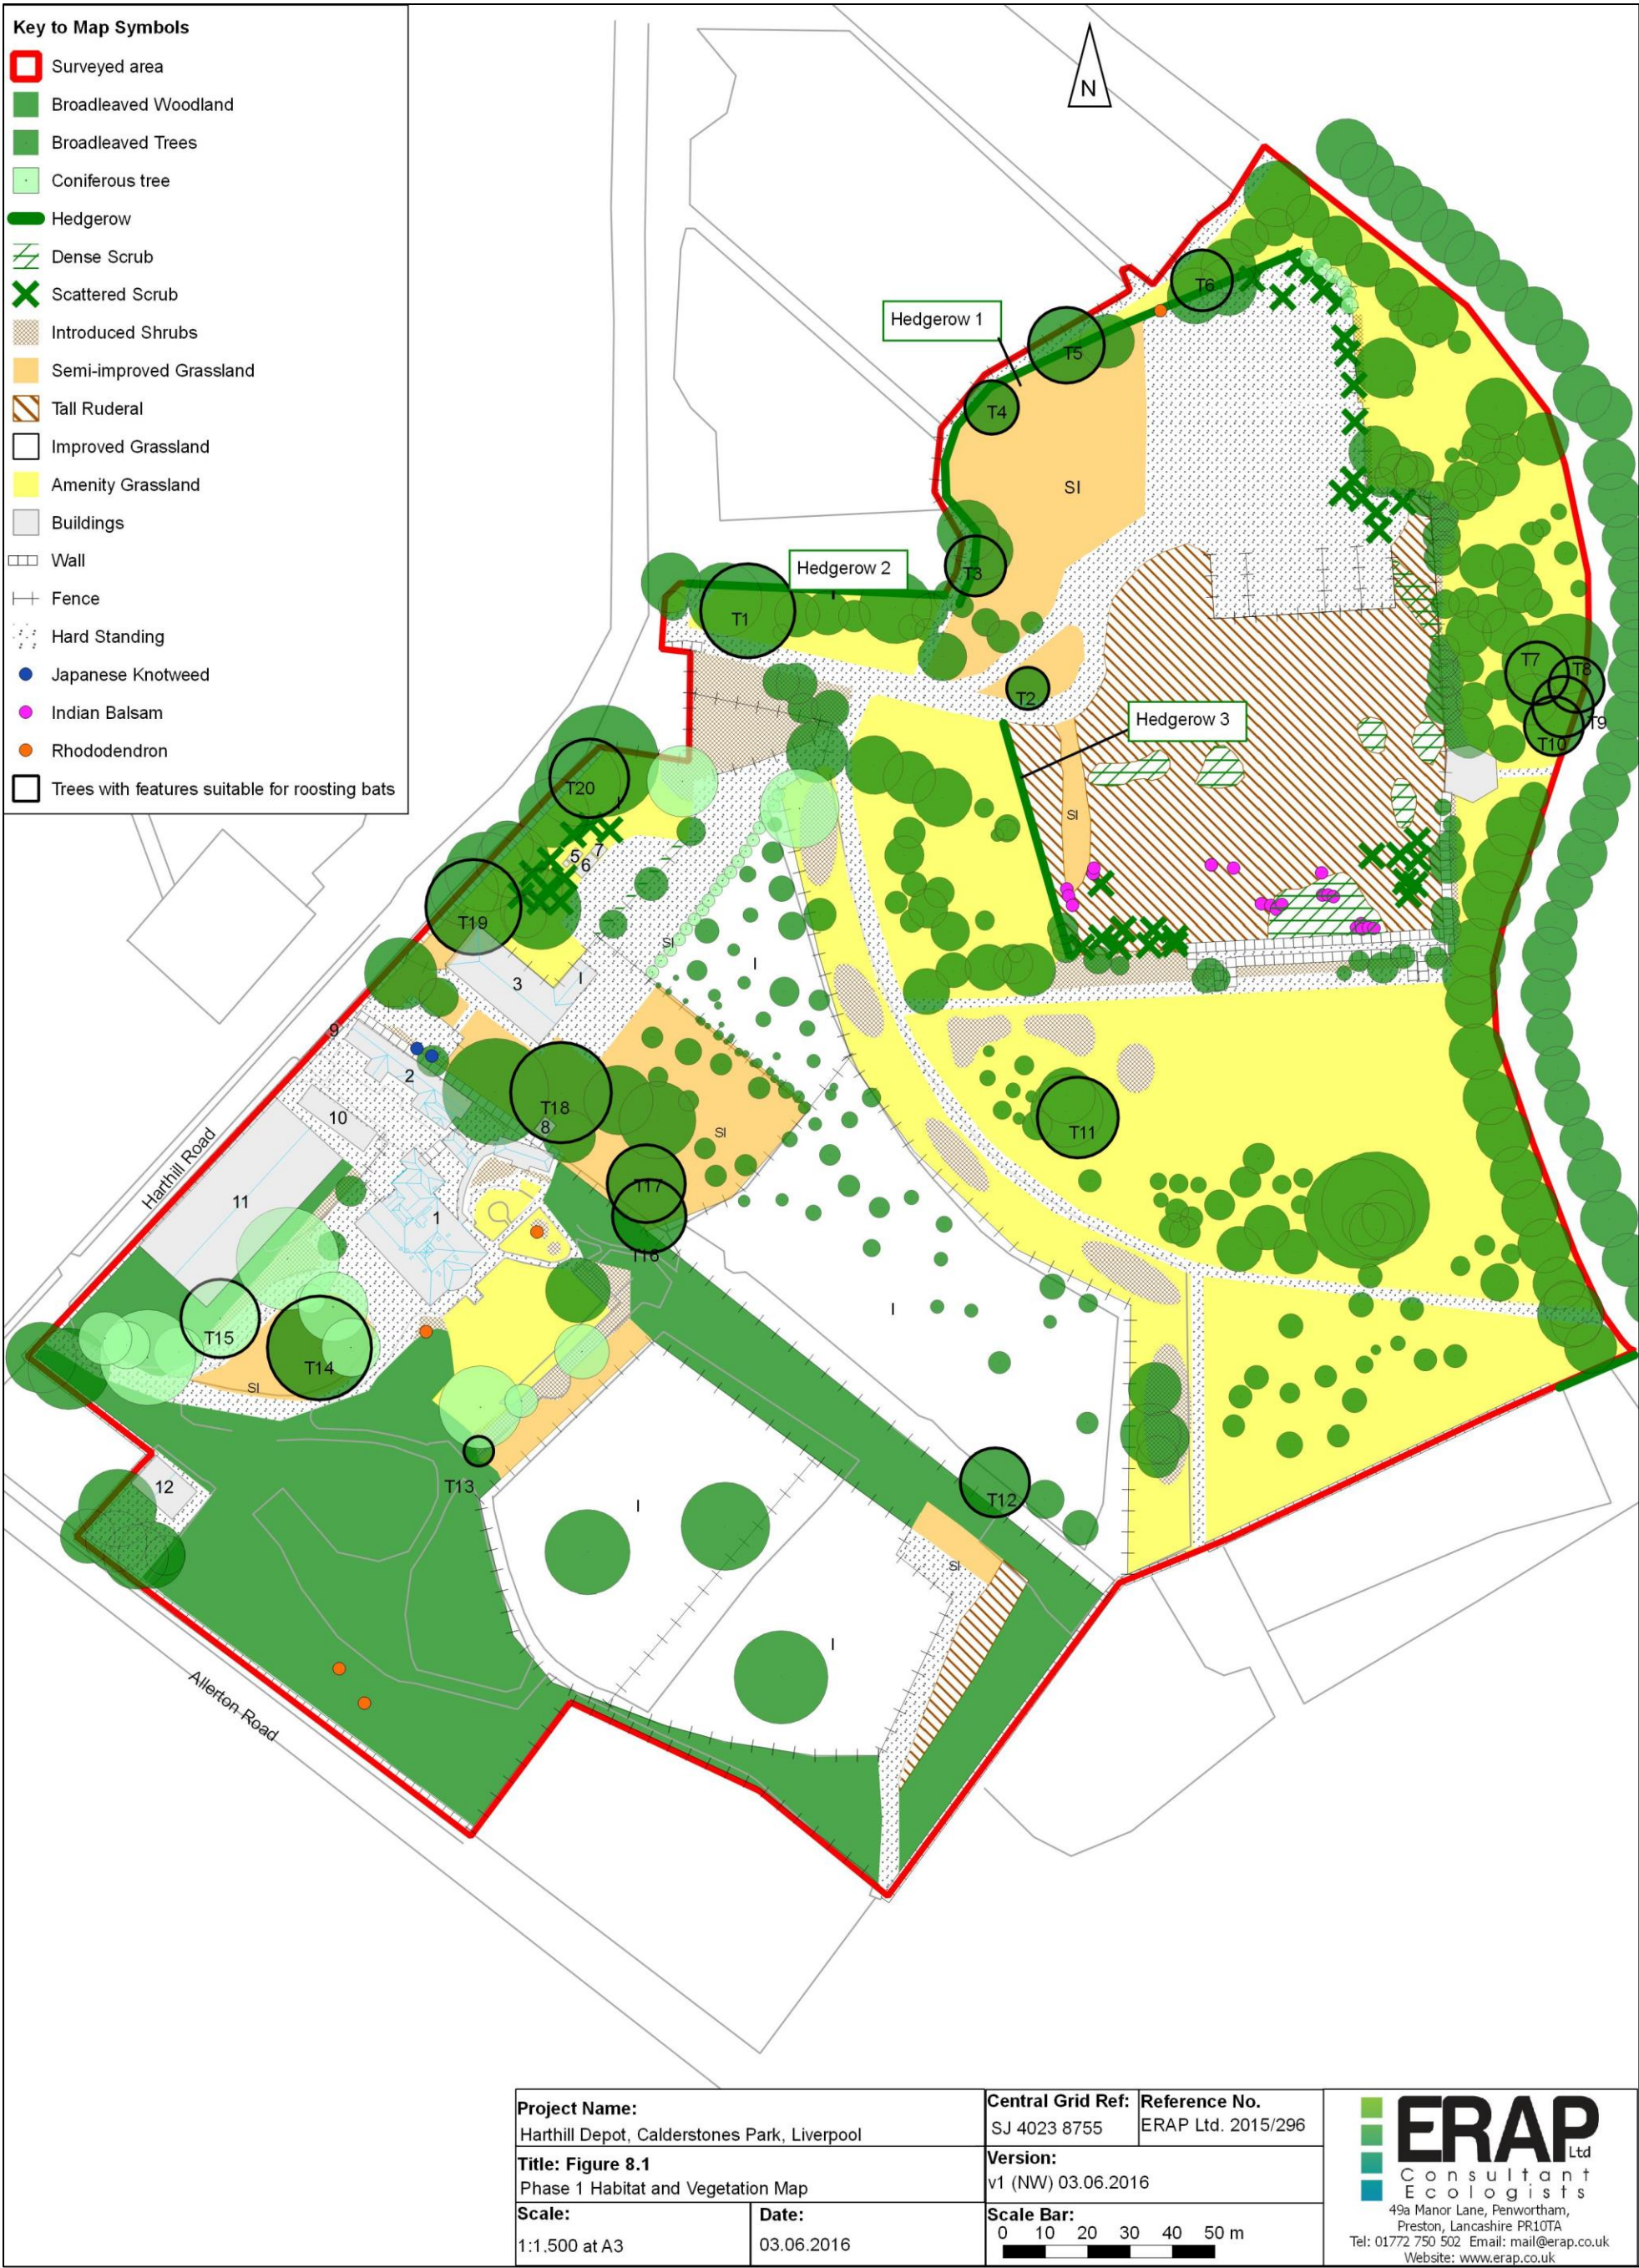
Figure 8.1: Phase 1 Habitat Map

- 3.2.23 As illustrated on **Figure 8.1** a small stand of Japanese Knotweed (*Fallopia japonica*) is present within the site adjacent to Calderkids Adventure Playground. In addition, very local stands of Rhododendron (*Rhododendron ponticum*) and Indian Balsam (*Impatiens glandulifera*) were detected within the Harthill Depot. All three species are listed on Schedule 9 of the *Wildlife and Countryside Act 1981* (as amended) which make it an offence to spread or cause the spread of these species in the wild.

- 5.4.1 It is an offence under the *Wildlife and Countryside Act 1981* (as amended) to cause the spread of Japanese knotweed, Rhododendron, and Indian Balsam in the wild. It is concluded that the preparation of an Invasive Species Management Plan is not necessary in this case and these species can be managed in accordance with the implementation of the Habitat Management Plan, described below.

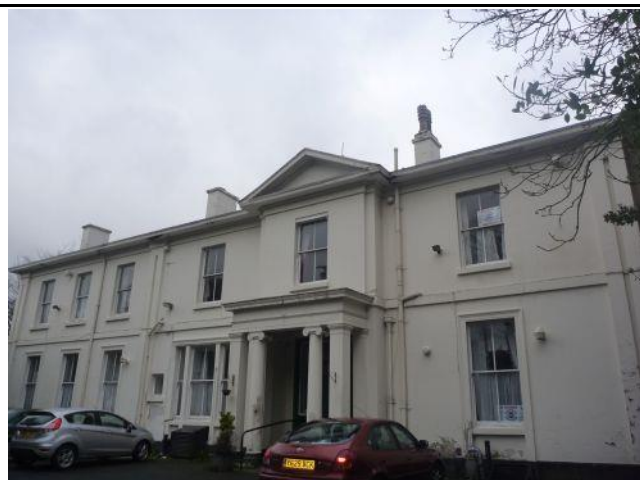
Photo 9.1: Building 1, south-western elevation.

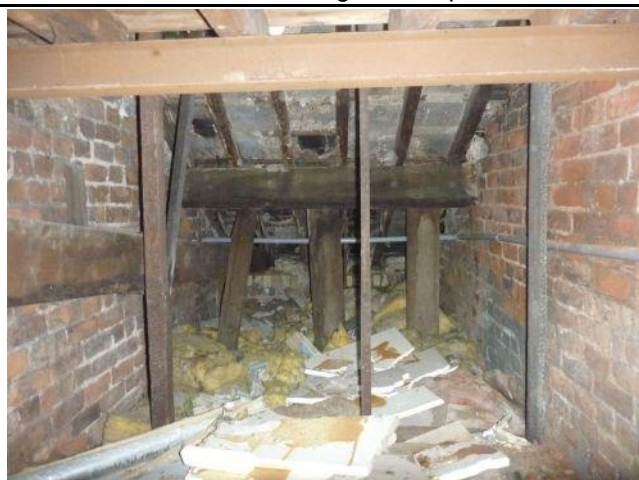
Photo 9.9: Building 1, roof void, north-eastern end.

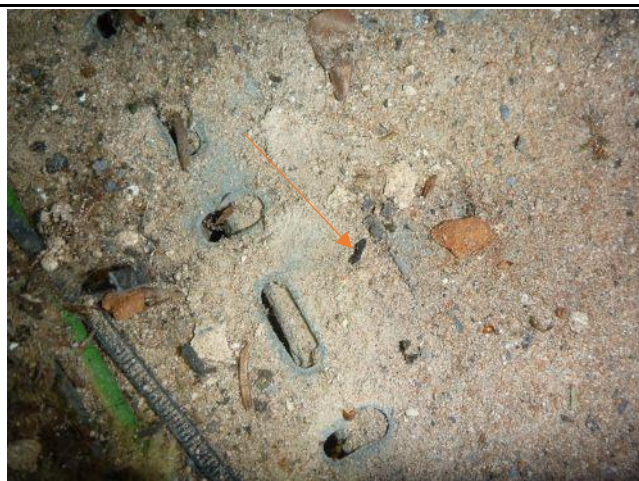
Photo 9.15: Building 1, showing close of up dropping.

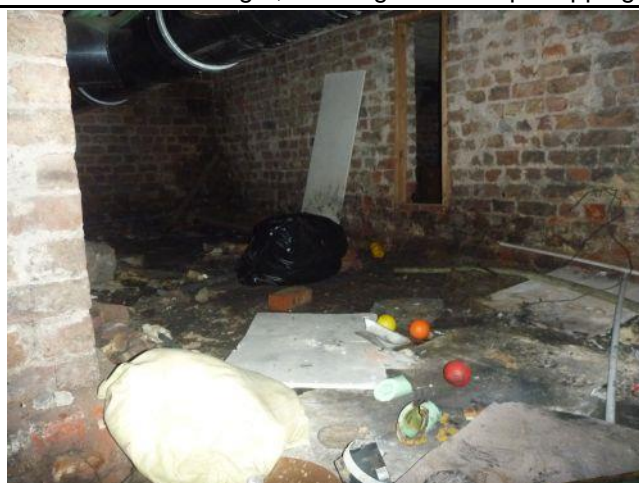
Photo 9.17: Building 1, cellar (asbestos was suspected within this area of the cellar and was not investigated further).

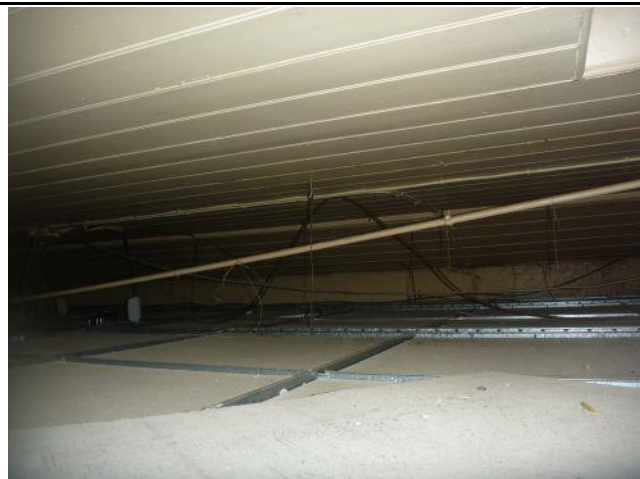
Photo 9.25: Building 1, section 1c showing vaulted ceiling above suspended ceiling.

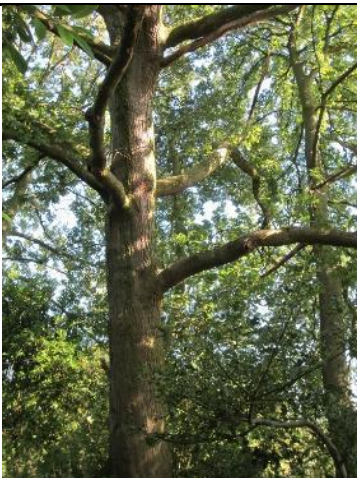
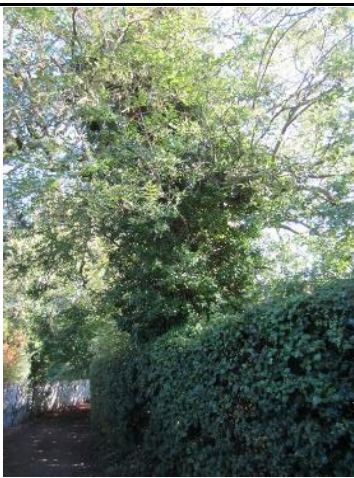
ERAP Ltd Tree Reference	Tree 1	ERAP Ltd Tree Reference	Tree 2
TBA Associates Tree Reference	5T (August 2015)	TBA Associates Tree Reference	88T (August 2015)
Species	Oak	Species	Sweet Chestnut
Features suitable for use by roosting bats	Cavity at lateral branch on south side	Features suitable for use by roosting bats	Deadwood present in the upper lateral branches. Wounds present on trunk but do not appear to lead to a cavity yet.

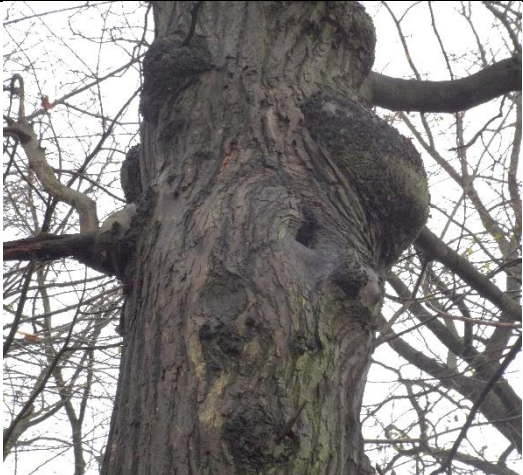
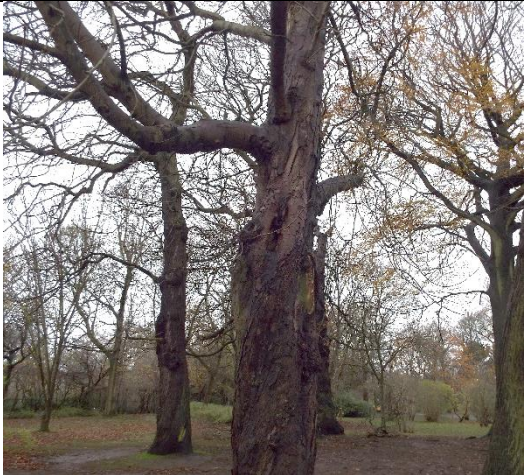
ERAP Ltd Tree Reference	Tree 7	ERAP Ltd Tree Reference	Tree 8
TBA Associates Tree Reference	49G	TBA Associates Tree Reference	49G
Species	Sweet Chestnut	Species	Sweet Chestnut
Features Suitable for use by roosting bats	Damaged limb containing possible crevice (20 cm x 2 cm) at 3 metres on the western elevation	Features Suitable for use by roosting bats	Missing limb with rot hole (5cm x 5cm) at 2.5 metres.

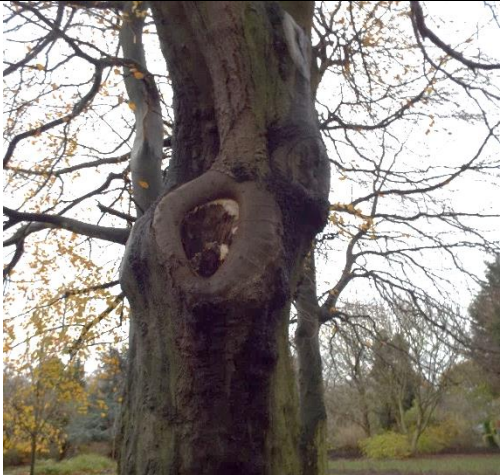
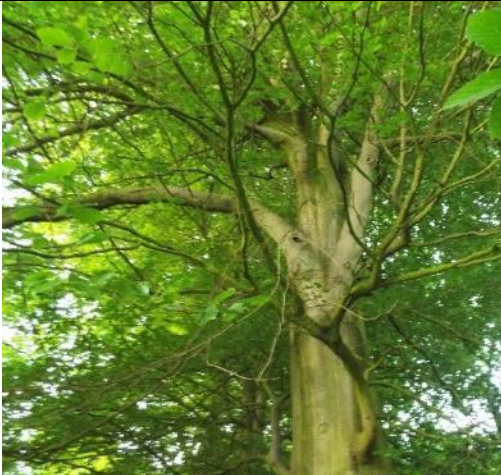
ERAP Ltd Tree Reference	Tree 9	ERAP Ltd Tree Reference	Tree 10
TBA Associates Tree Reference	49G	TBA Associates Tree Reference	50T (August 2015)
Species	Sweet Chestnut	Species	Horse Chestnut
Features Suitable for use by roosting bats	Two woodpecker holes (3cm x 3cm) at four metres on western elevation and one hole (3cm x 3cm) the eastern elevation at 6 metres.	Features Suitable for use by roosting bats	Missing limb at two metres on southern elevation with a hole (30cm x 10cm) and lifted bark throughout trunk.

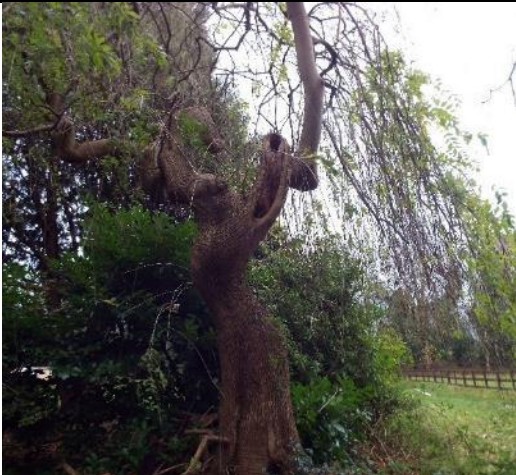
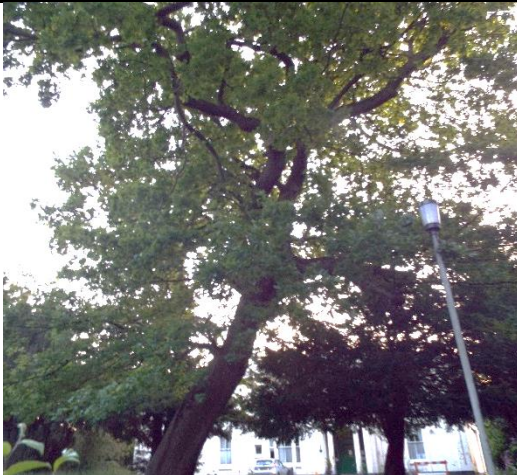
ERAP Ltd Tree Reference	Tree 11	ERAP Ltd Tree Reference	Tree 12
TBA Associates Tree Reference	63G (August 2015)	TBA Associates Tree Reference	157T (January 2016)
Species	Beech	Species	Beech
Features Suitable for use by roosting bats	Missing limb at two metres with hole (30cm x 30cm) on southern elevation.	Features Suitable for use by roosting bats	Small knot hole (4cm x 4cm) on eastern elevation at 6 metres.

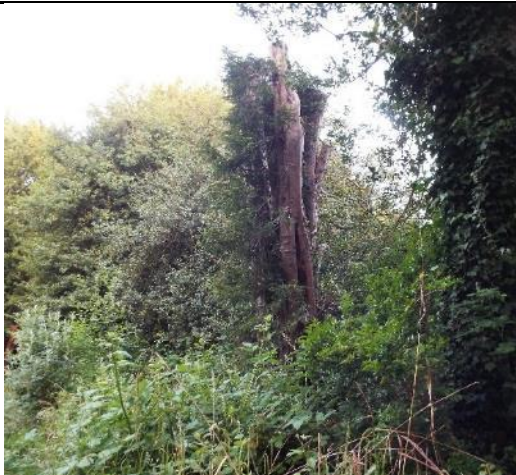
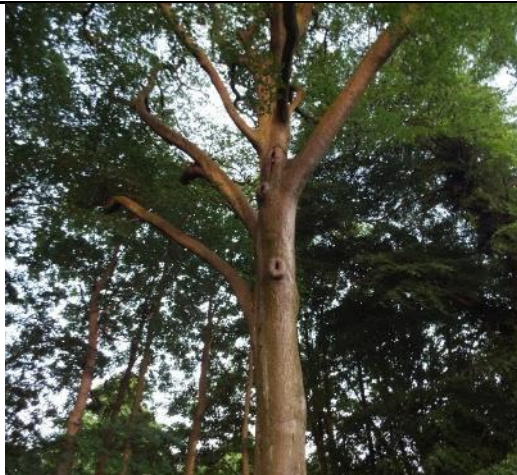
ERAP Ltd Tree Reference	Tree 13	ERAP Ltd Tree Reference	Tree 14
TBA Associates Tree Reference	77T (January 2016)	TBA Associates Tree Reference	83T (January 2016)
Species	Weeping Ash	Species	Oak
Features Suitable for use by roosting bats	Two holes (5cm x 5cm) on southern elevation at two metres .	Features Suitable for use by roosting bats	Missing limb at three metres on eastern elevation with small hole

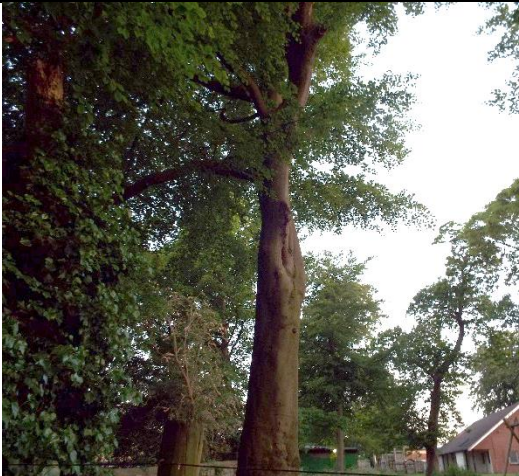
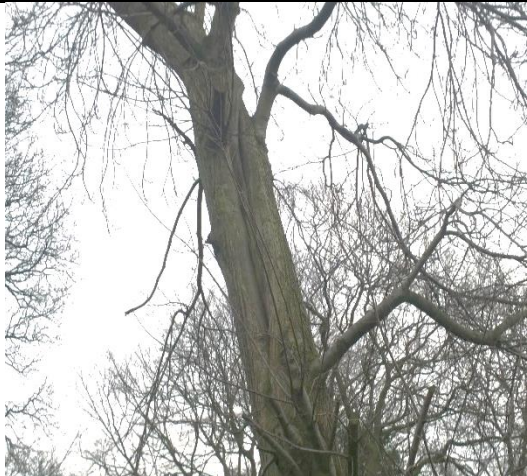
ERAP Ltd Tree Reference	T15	ERAP Ltd Tree Reference	T16
TBA Associates Tree Reference	91T (January 2016)	TBA Associates Tree Reference	166T (January 2016)
Species	Yew	Species	Beech
Features Suitable for use by roosting bats	Large split (50cm x 5cm) with internal cavity at 0.5 metres on southern elevation.	Features Suitable for use by roosting bats	Three knot holes on southern elevation at between 5 and 6 metres.

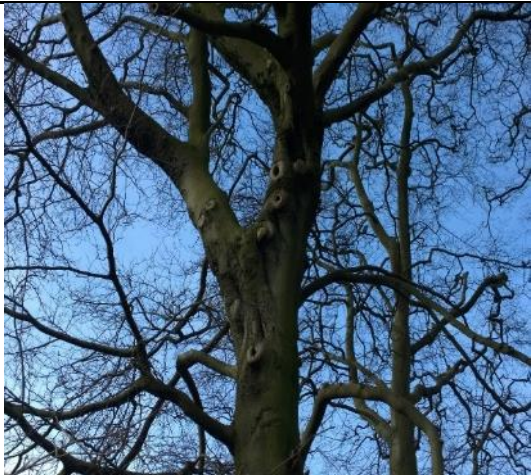
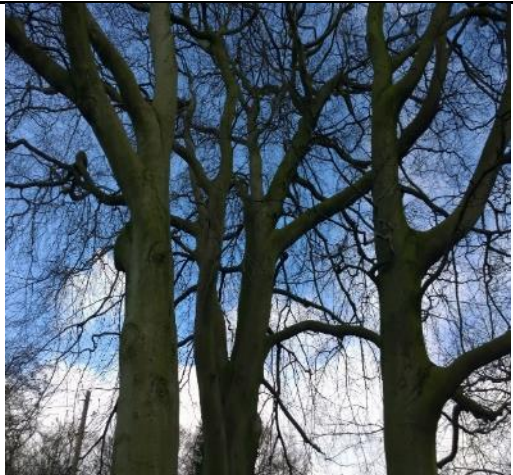
ERAP Ltd Tree Reference	T17	ERAP Ltd Tree Reference	T18
TBA Associates Tree Reference	190T (January 2016)	TBA Associates Tree Reference	192T (January 2016)
Species	Beech	Species	Sweet Chestnut
Features Suitable for use by roosting bats	Hole (5cm x 5cm) at point of missing limb at 6 metres on eastern elevation.	Features Suitable for use by roosting bats	Large split (1.5 metres x 5cm) at 2 metres on northern elevation.

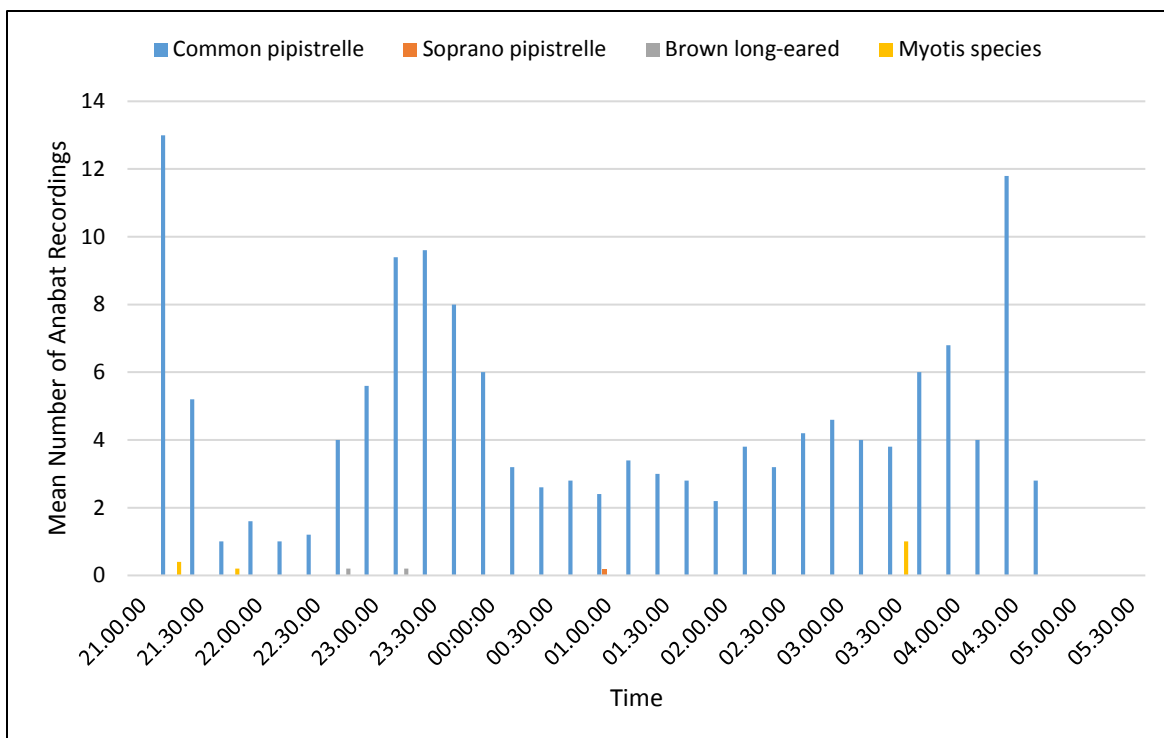
Graph 9.1: Mean Number of Anabat Recordings at Location 1 between 11th and 15th May

Date	Common pipistrelle	Soprano pipistrelle	Brown long-eared bat	Noctule	<i>Myotis</i> species	Total
11 th May 2016	198	1	1	0	0	200
12 th May 2016	237	0	0	0	1	238
13 th May 2016	93	0	1	0	1	95
14 th May 2016	57	0	0	0	1	58
15 th May 2016	131	0	1	0	0	132
Total	716	1	3	0	3

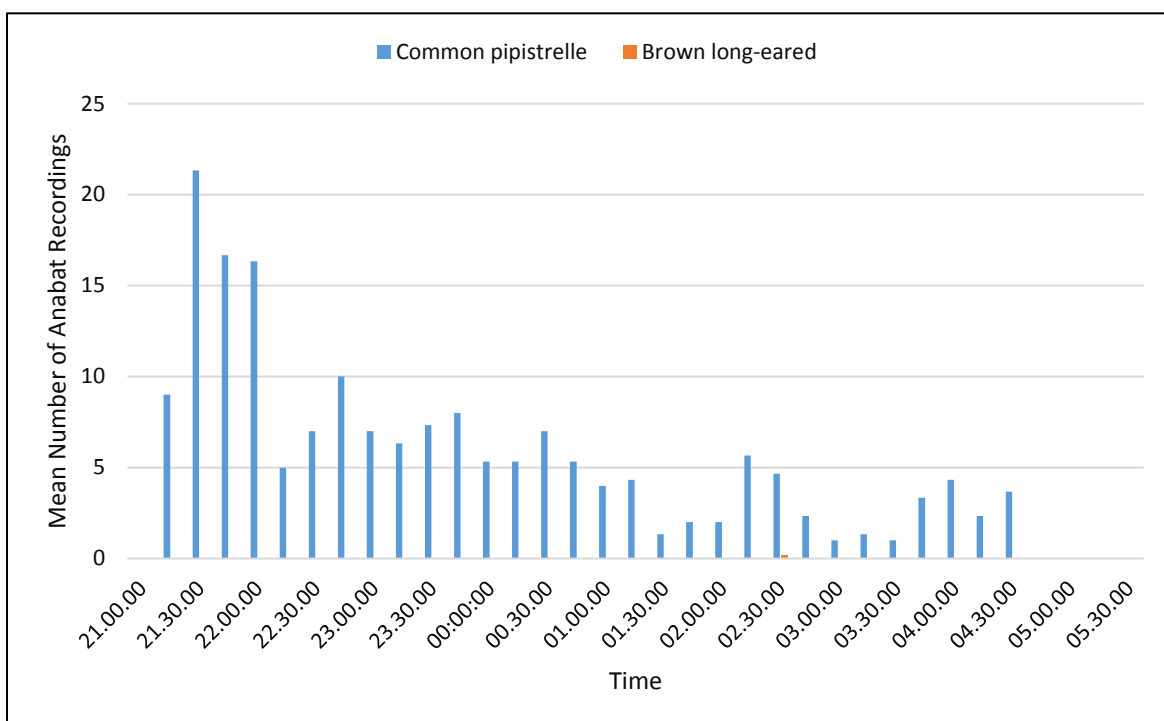
Graph 9.2: Mean Number of Anabat Recordings at Location 3 between 11th and 13th May

9.6.2 Note: The Anabat Express unit was recording noise files throughout this period, and gave no error messages within its log files. It can be reasonably assumed that the lack of recordings is due to a lack of bat passes at this location.

- 2.4.5 The Anabat Express unit deployed on the 11th May in Location 3 (refer to **Figure 8.5**) failed to record data during two of the five nights. However, data was collected during three nights and does not show significant levels of bat activity; it is possible to make reasonable assumptions regarding bat activity at this location from the data obtained. In addition, further surveys will be conducted during the remainder of the active season of 2016.
