EXPANSION OF ANFIELD ROAD STAND, ANFIELD

G1/1 - Phase I Geo-Environmental Desk Study

PHASE 1 GEO-ENVIRONMENTAL DESK STUDY REPORT

- Final
- December 2013

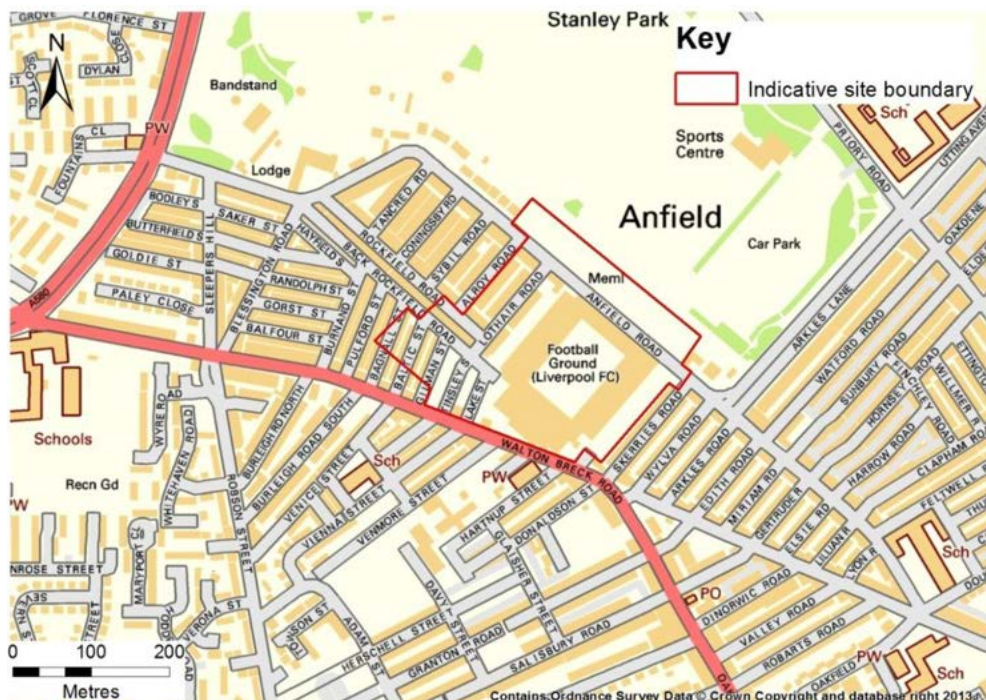
■ **Figure 1 - Site Location Plan**

Aspect	Description
Background	SKM has been commissioned to undertake a Phase I Geo-Environmental Desk Study for land at Anfield Stadium, Liverpool, Merseyside (see Figure 1). It is understood that the desk study is required to support the proposed redevelopment of the stadium complex.
Development	Indicative development proposals for the site available at the time of writing comprise the redevelopment of the existing stadium to facilitate increased seating capacity. The current proposals include addition to the existing Main Stand with a new seven storey three tier stand. Future options may also include the expansion of the Anfield Road stand. It is envisaged that the remaining site areas will be developed with a mixture of hard and soft landscaping and car parking however the scheme design has yet to be finalised.
Objectives	To characterise the environmental setting of the site, determine likely sensitive receptors and assess the potential current and historical sources of both on and off site contamination. To provide a preliminary assessment of the significance of environmental risks (if any). To identify any significant potential geotechnical constraints and provide preliminary geotechnical design recommendations. To provide recommendations with respect to intrusive site investigation.

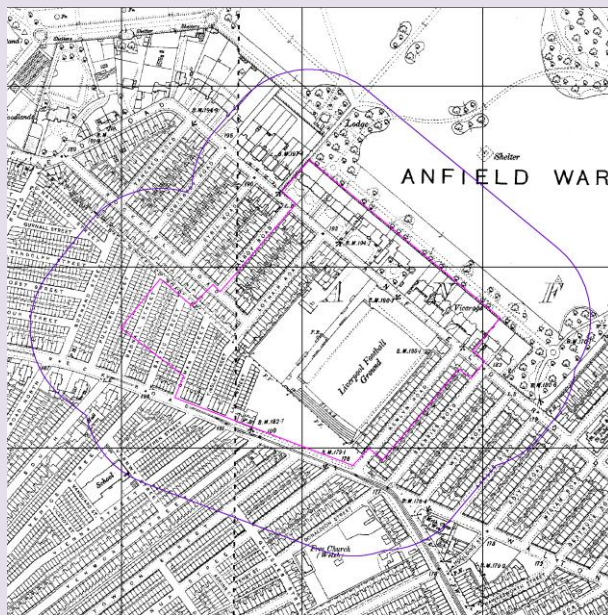
On Site: The 1908 OS map shows further residential properties had been developed in the west of the site, associated with Baltic Street. The stadium is now denoted as Liverpool Football Ground.

Off-site: The quarry to the south is no longer shown.

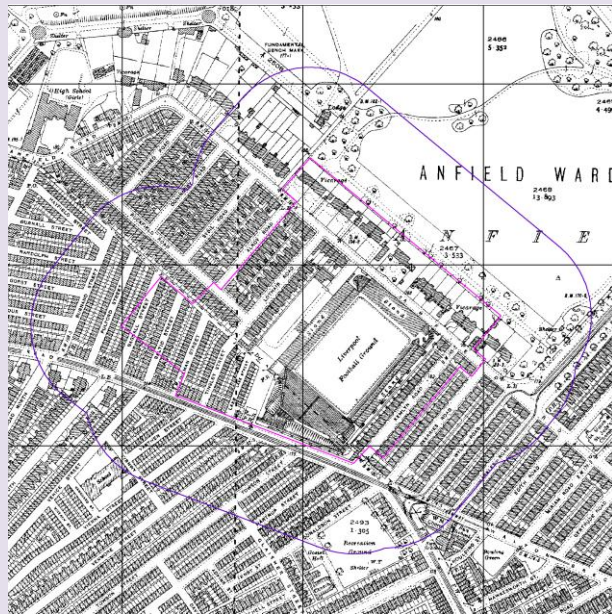
On site: The 1927 OS map shows that new stands had been constructed associated with the football ground. An embankment is now indicated to the southwest of the stadium, this being used in the construction of the kop stand

Off Site: No significant changes noted.

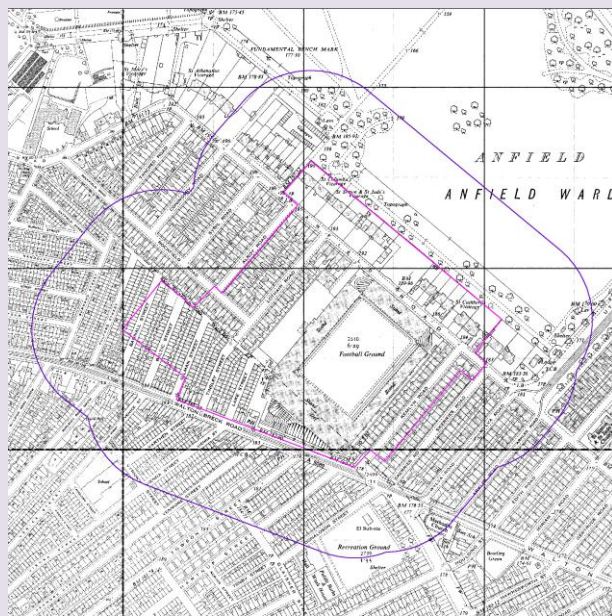
1951-55

On site: No significant changes.

Off site: No significant changes noted.

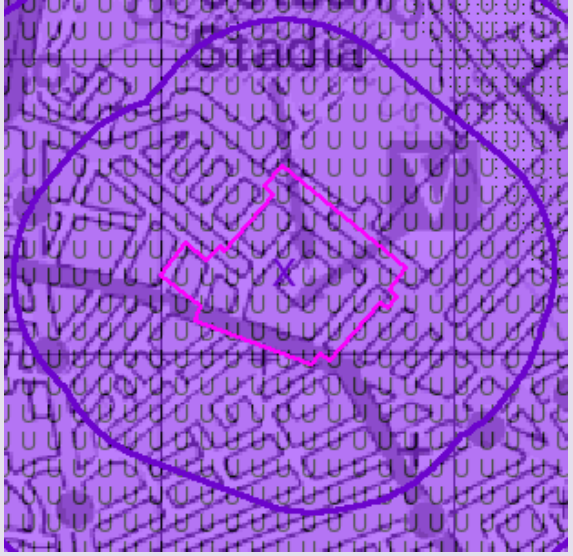
<p>Geological Classes</p> <p>Major Aquifer (Highly Permeable)</p> <p>Soil Classes</p> <p>High (H) 1, 2, 3, U Intermediate (I) 1, 2 Low</p>

<p>Low Sensitivity (M1). Reasons: Principle Aquifer – moderate vulnerability. The site does not lie within an SPZ and no sensitive groundwater abstractions are located within 1km.</p>

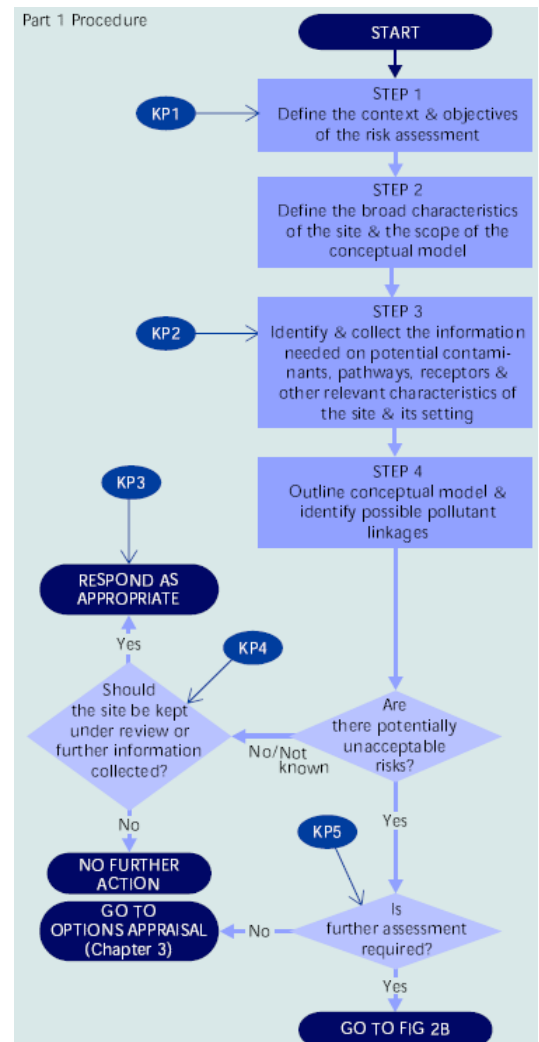
Phase 1 Preliminary Risk Assessment Flowchart

Extracted from CLR11, Environment Agency, 2004
