PRELIMINARY
GEO-
ENVIRONMENTAL
INVESTIGATION
Of land at
Goodlass Road,
Speke

Project No. 11029/G/1
February 2011

Speke Business Park Limited
Kenyon Road
Lomeshaye Industrial Estate
NELSON
Lancashire
BB9 5SP

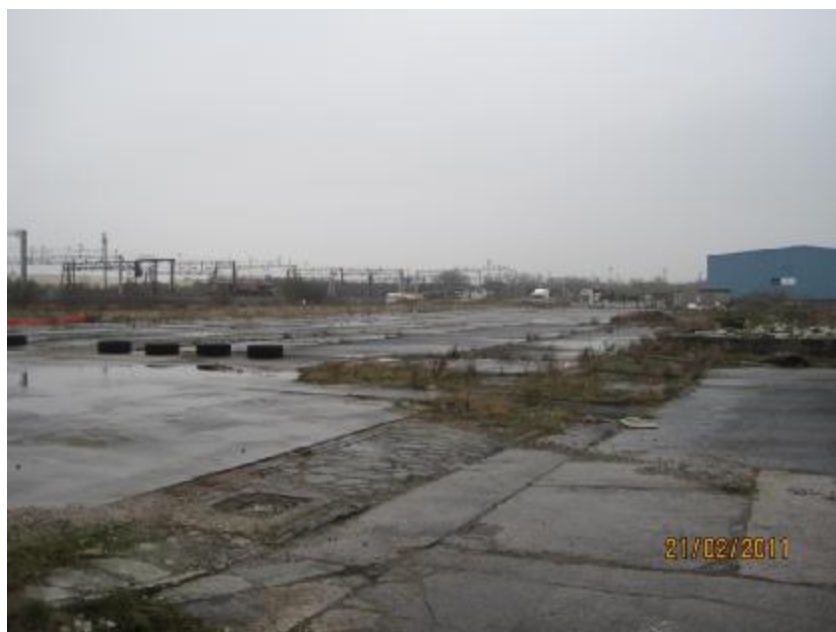
The site is located off Goodlass Road in a mixed industrial and commercial area. A railway line runs on an embankment parallel to the southern site boundary fence. A new office block is situated close to the eastern boundary and older factory buildings are located to the north and west. The latter comprises the premises of Eleco Timber Frame Ltd to which access is gained across the southern part of the site under consideration. A perimeter fence with gate is present along the north and east.

Plate 1: An overview of the site looking west

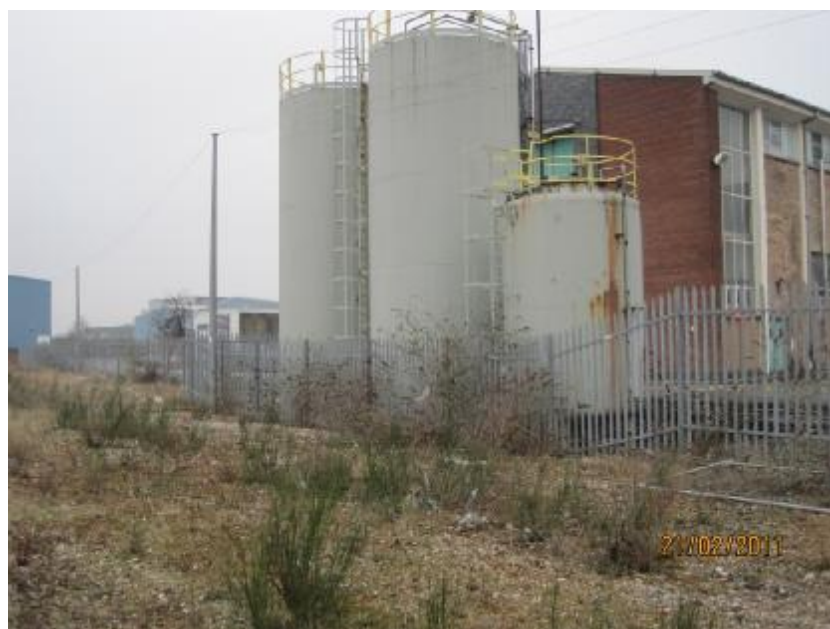
A concrete bund with drain is present at the northern site boundary close to several large above ground storage tanks located in the adjacent factory premises.

Plate 2: Off-site storage tanks (unknown content) near northern site boundary

- Possible leaks from above ground storage tanks situated to north at operational factory (Possibly Becker Industrial Coatings).

Method	Purpose
Enquiries made of adjacent industrial premises operator.	To establish current condition of ASTs close to northern perimeter and whether there have been any historic leaks or spills.
Drainage survey	To sample contaminated silt in drains and identify possible contaminant migration pathways.
Trial Pits	To determine the general nature of soils underlying the site, including the nature, distribution and thickness of made ground nature, degree and extent of any contamination, proportion of undesirable elements e.g. biodegradable matter, foundations etc & suitability of the ground for founding new structures.
Window Sample Boreholes	Recovery of shallow soil samples for chemical and geotechnical testing purposes. The purpose of the testing would be to provide information on contamination levels and also to allow for geotechnical testing and classification purposes.
	In order to characterise groundwater and ground gases / vapours. All boreholes will be monitored in line with CIRIA guidance.

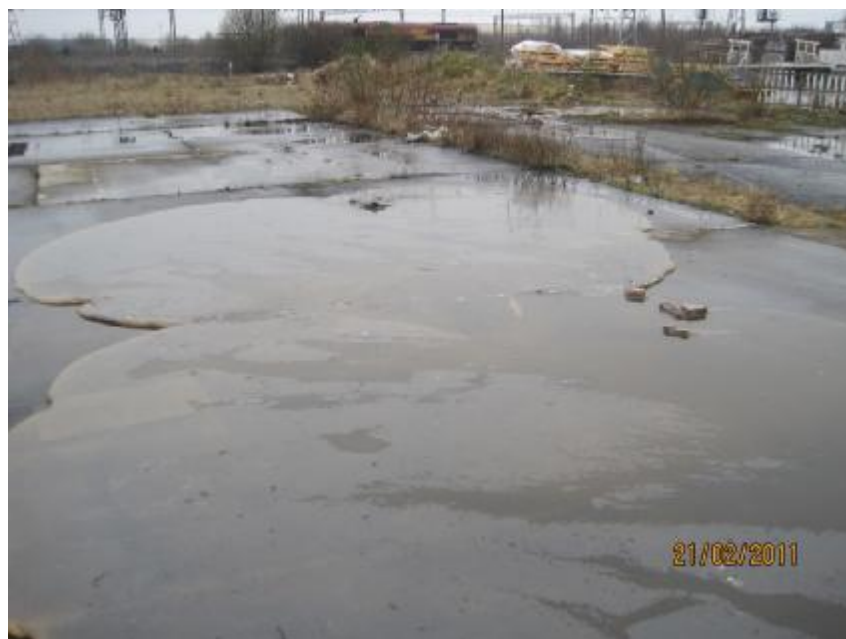
In addition, several large surface accumulations of a clear gel/resin-like substance were observed in the vicinity. These are present overlying the mounds of fly-tipped waste and also present as congealed pools on the hard standing in this area, and have a pungent odour.

Plate 3: Gel/resin-like substance dumped on the site

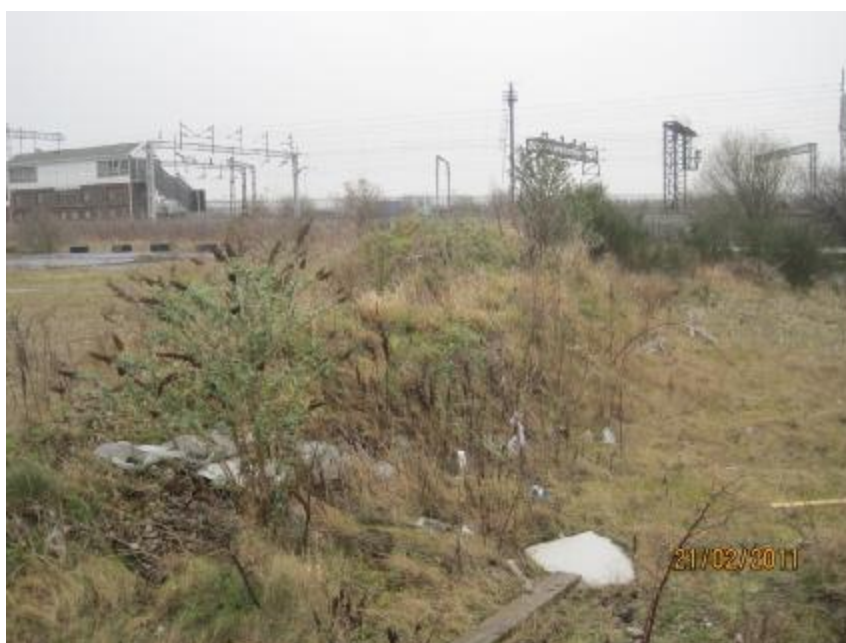
A small disused building containing waste material and several large mounds of apparently fly-tipped waste are present in the west. The waste comprises crushed concrete and bricks, aggregate, metal, polythene, wood, and plastic.

Plate 4: Mounds of fly-tipped waste in west of site

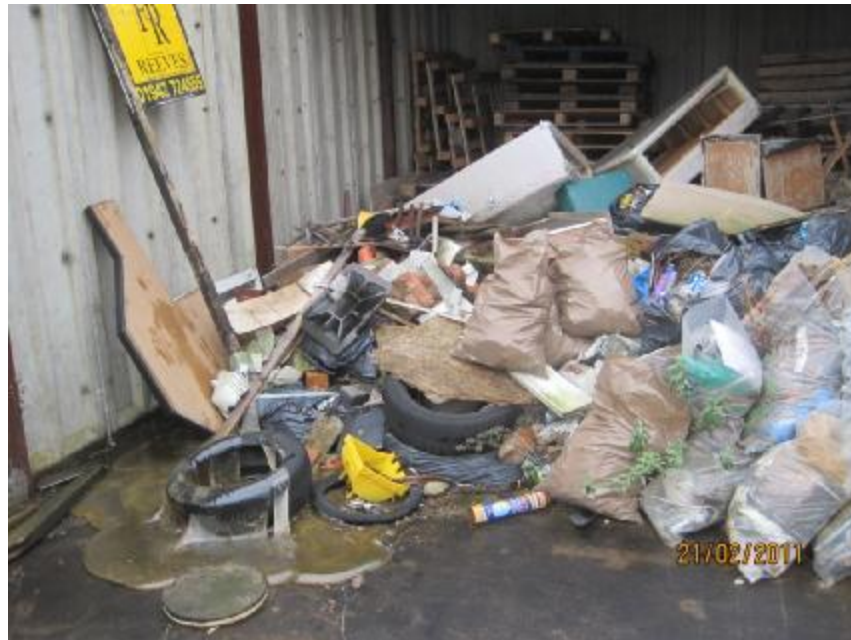
Plate 5: Hut on site containing waste.

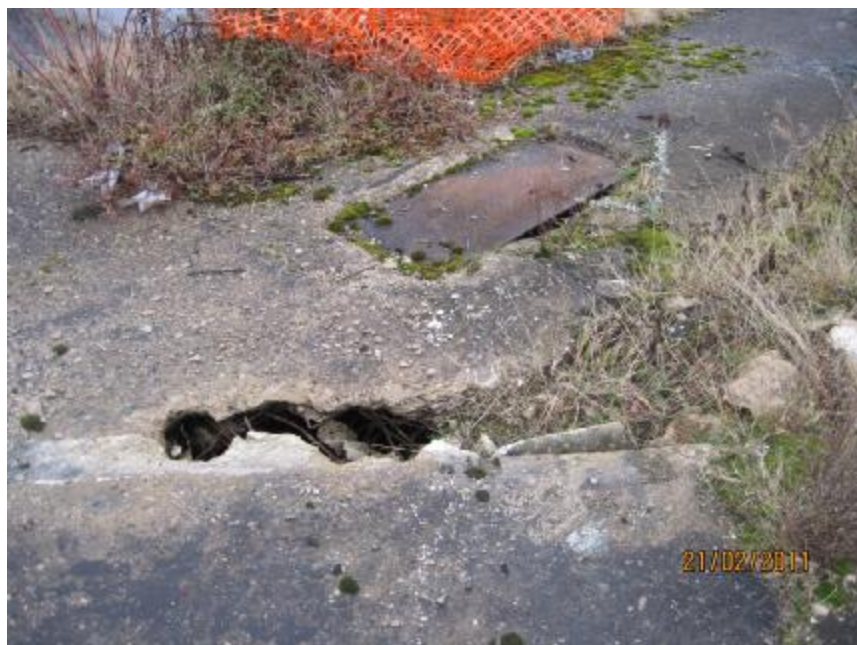
A void was noted in the reinforced concrete hard standing towards the centre-east of the site. Several underground pipes were exposed, close to a steel plate manhole cover.

Plate 6: Void exposing metal pipes beneath reinforced concrete hardstanding

Redundant in-ground structures are likely to be present including pipes, drains, service ducts and storage tanks. These will require breaking out during the demolition of existing buildings. Foundations that conflict with relict foundations should be taken to greater depth than the relict foundations and into natural ground of adequate bearing capacity.

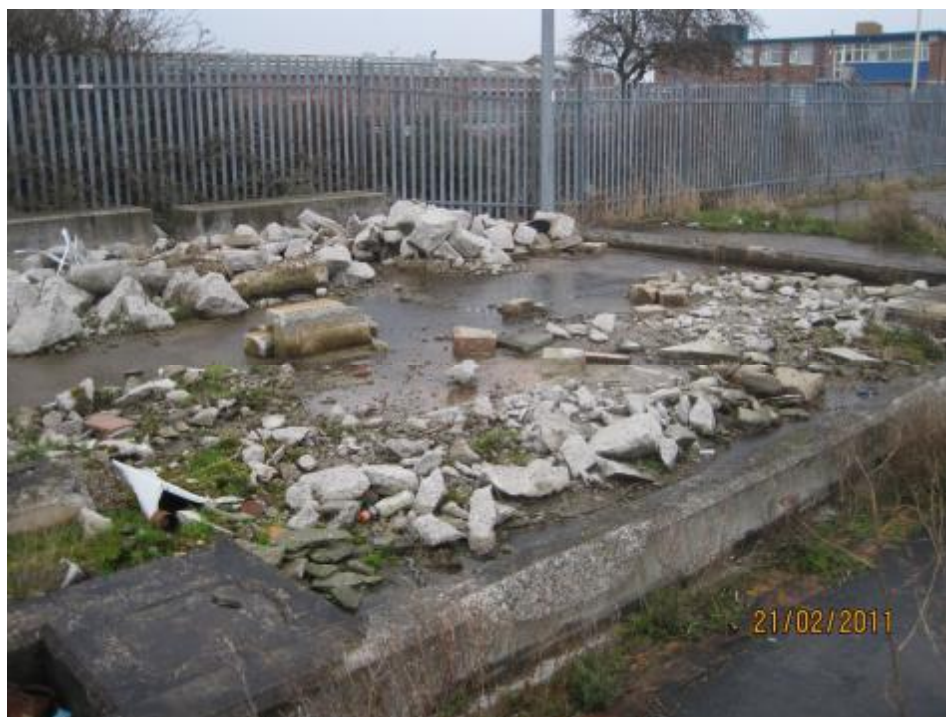
Plate 7: Bund at northern site boundary

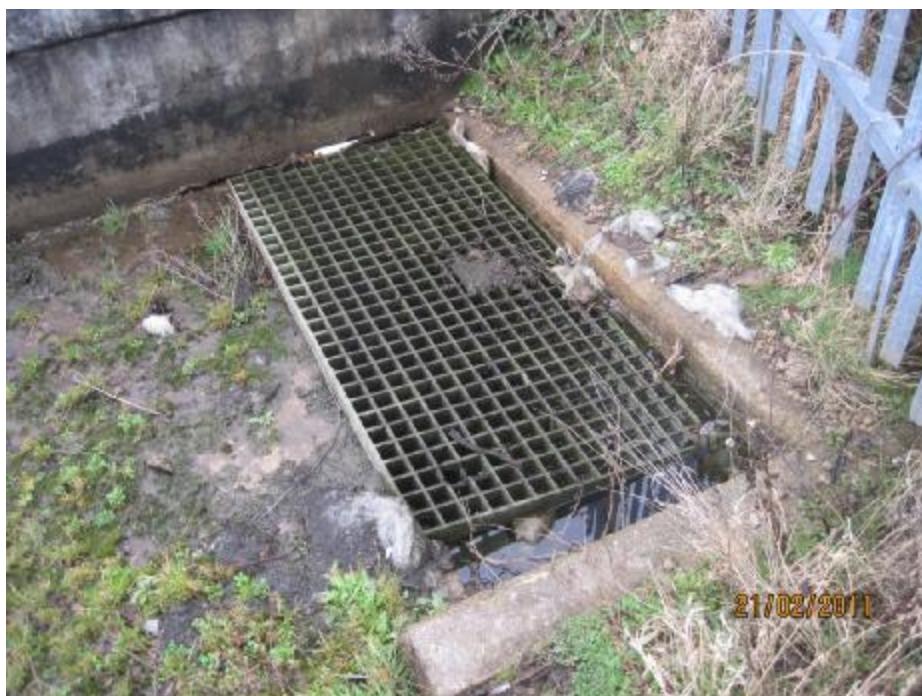
Plate 8: Drain adjacent to bund at northern site boundary

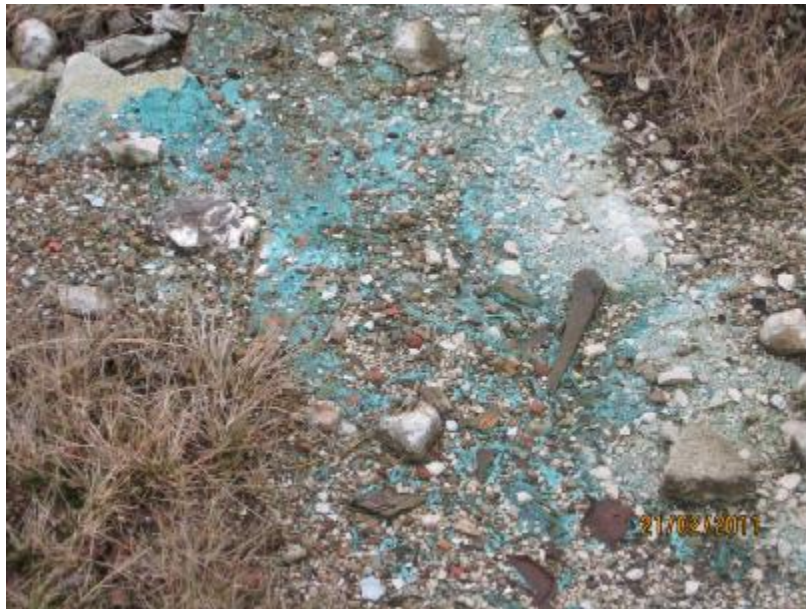
Evidence of paint was observed at two locations where bright blue and green colouration of the ground was visible.

Plate 9: Possible paint spill

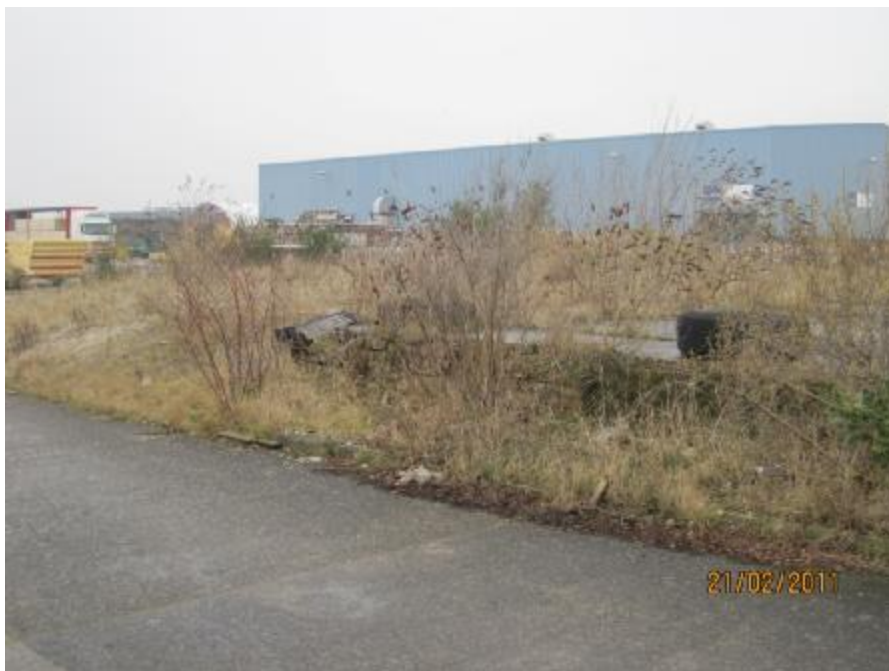
The ground profile is mainly level in the north, comprising weathered concrete former building floors and hard standings. There is a step change down in the western and south western areas associated with former access roads.

Plate 10: Looking north west showing raised development platform of former paint factory buildings

The ground conditions are likely to vary across the site as a result of previous upfill operations to construct the terrace on which the former factory complex was built.
