Geotechnical Assessments

Duke St, Liverpool – Stage 1 Preliminary Trial Pit Investigation

1.0 Introduction

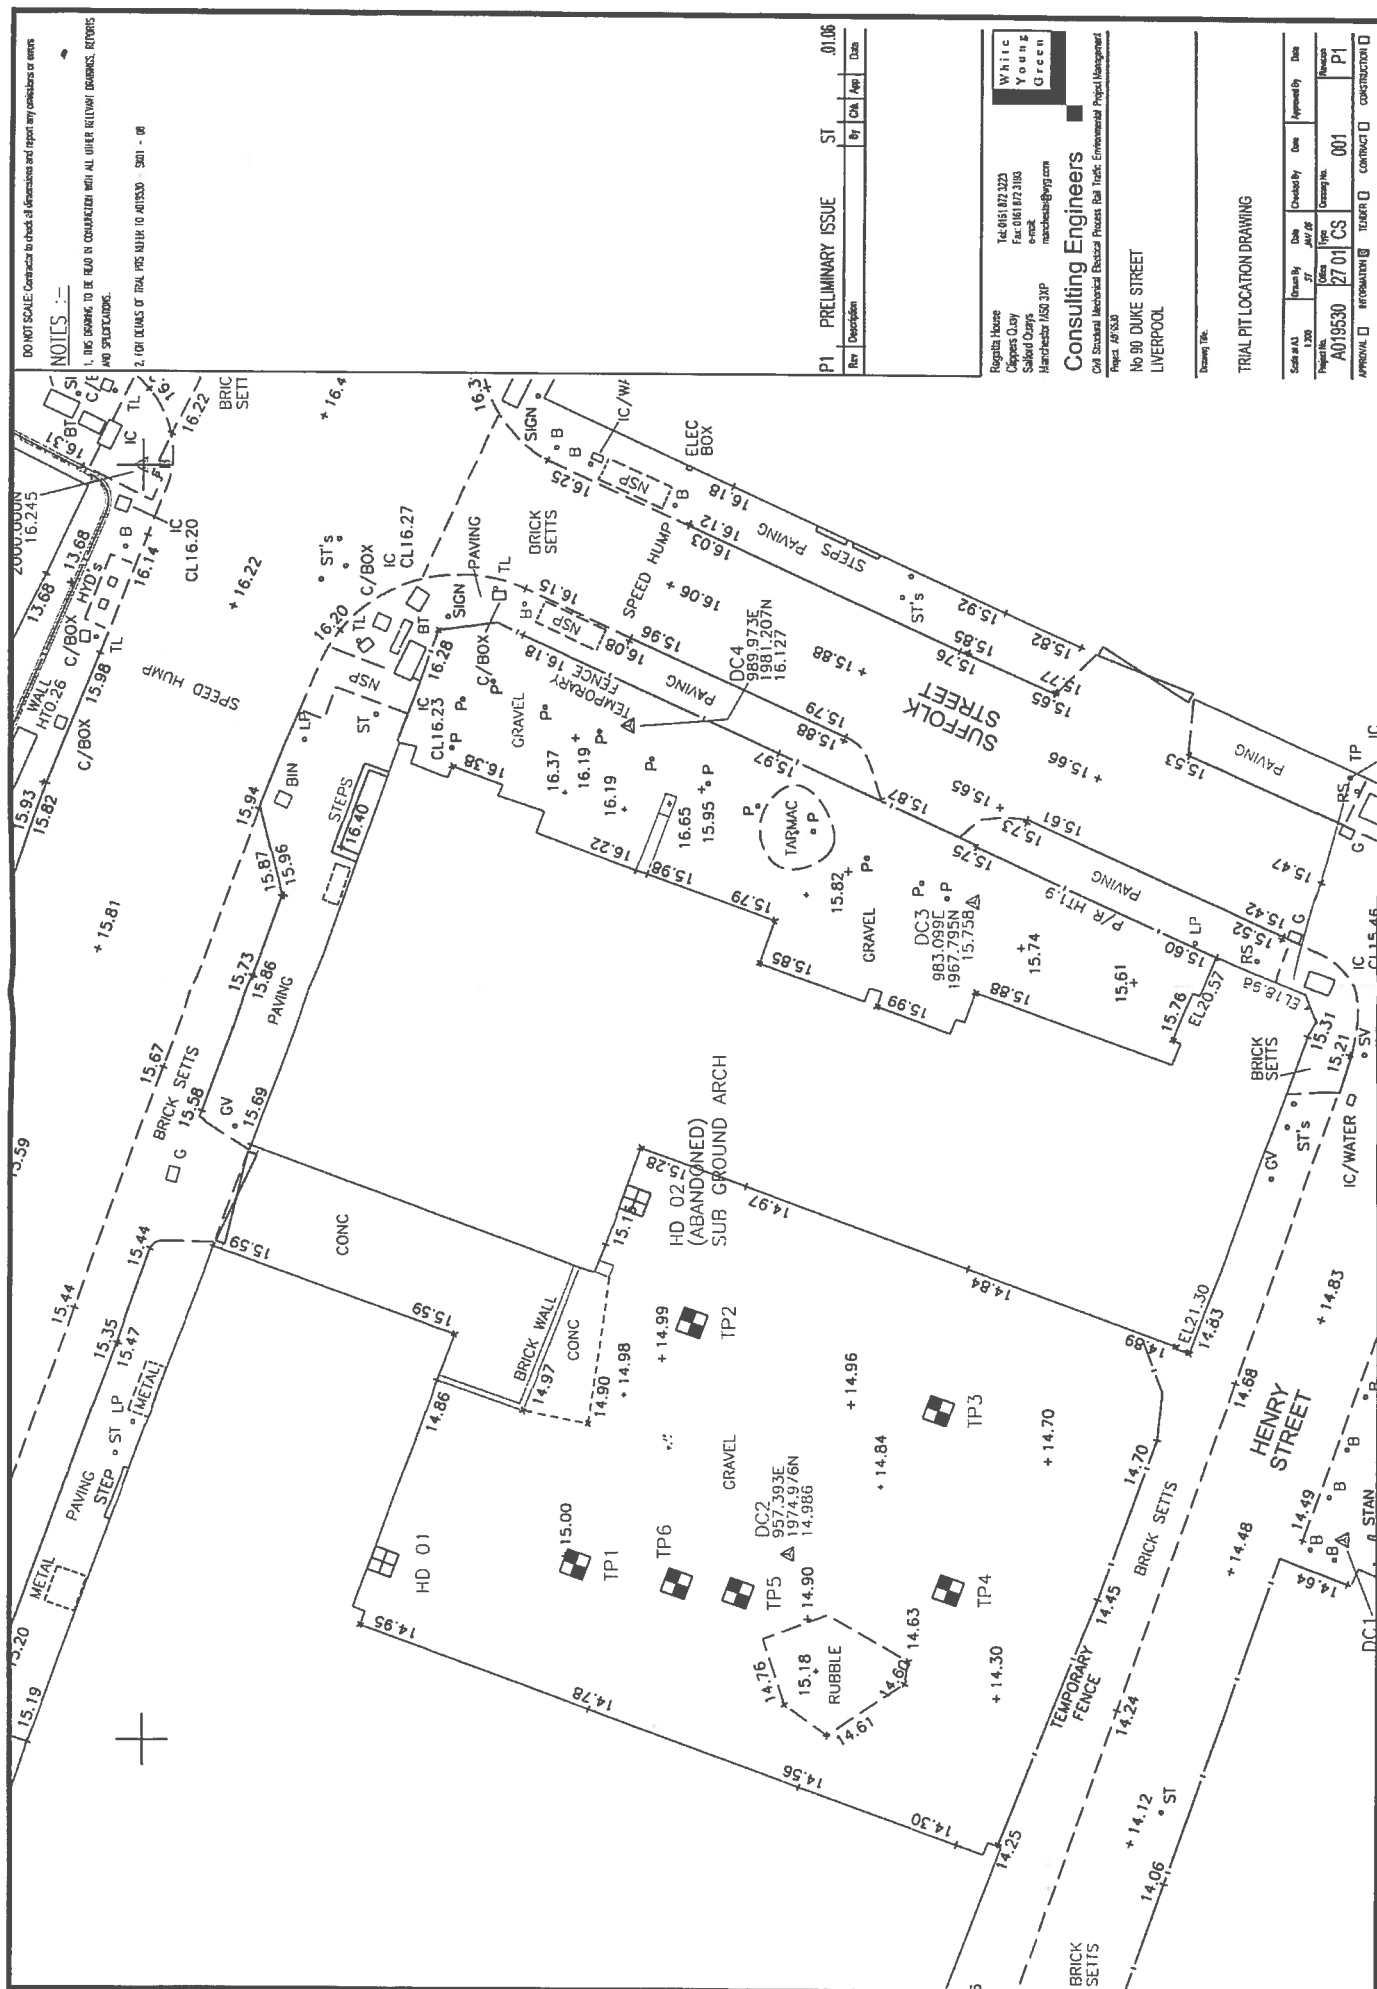
PO1 – TP1

Limited access and site debris dictated location of pit. Excavation located a brick step out at 1.675m depth, however, masonry extended beyond a depth of 2.6m. Due to the nature of the fill (loose granular material) the sides of the excavation were unstable; therefore the pit was abandoned at a depth of 2.6m. Excavated material was dark brown sandy fill containing many brick fragments for the full depth of the excavation.

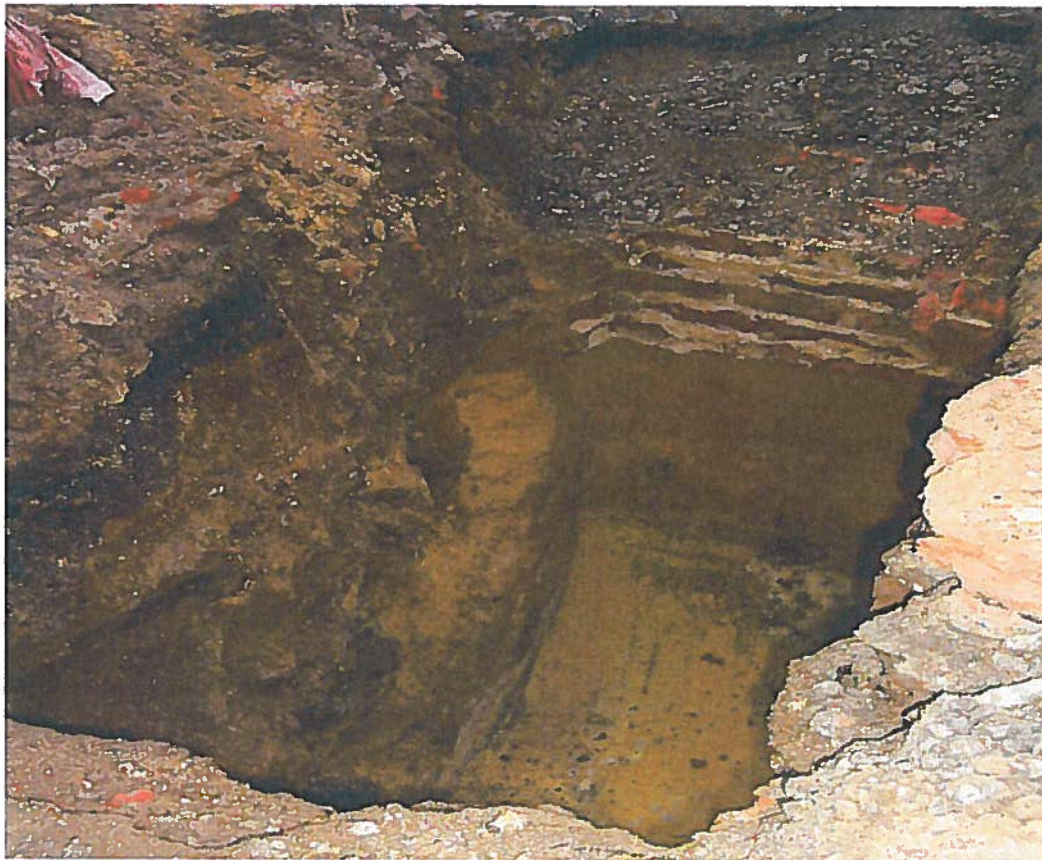
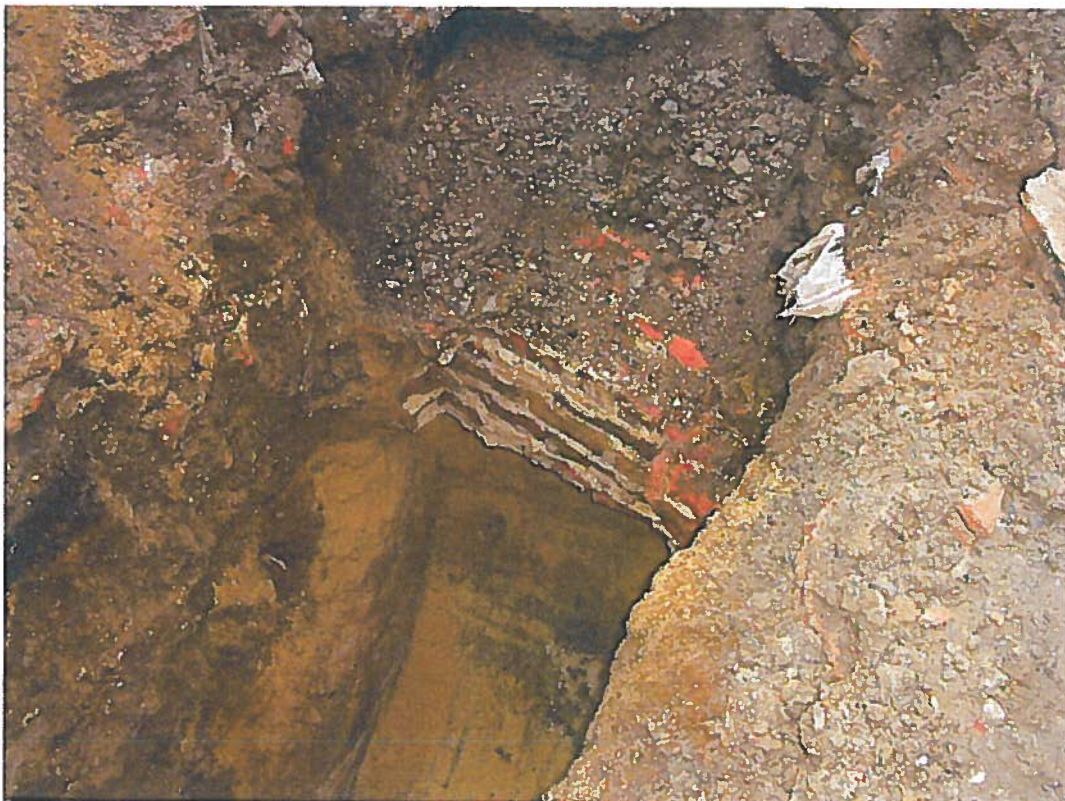
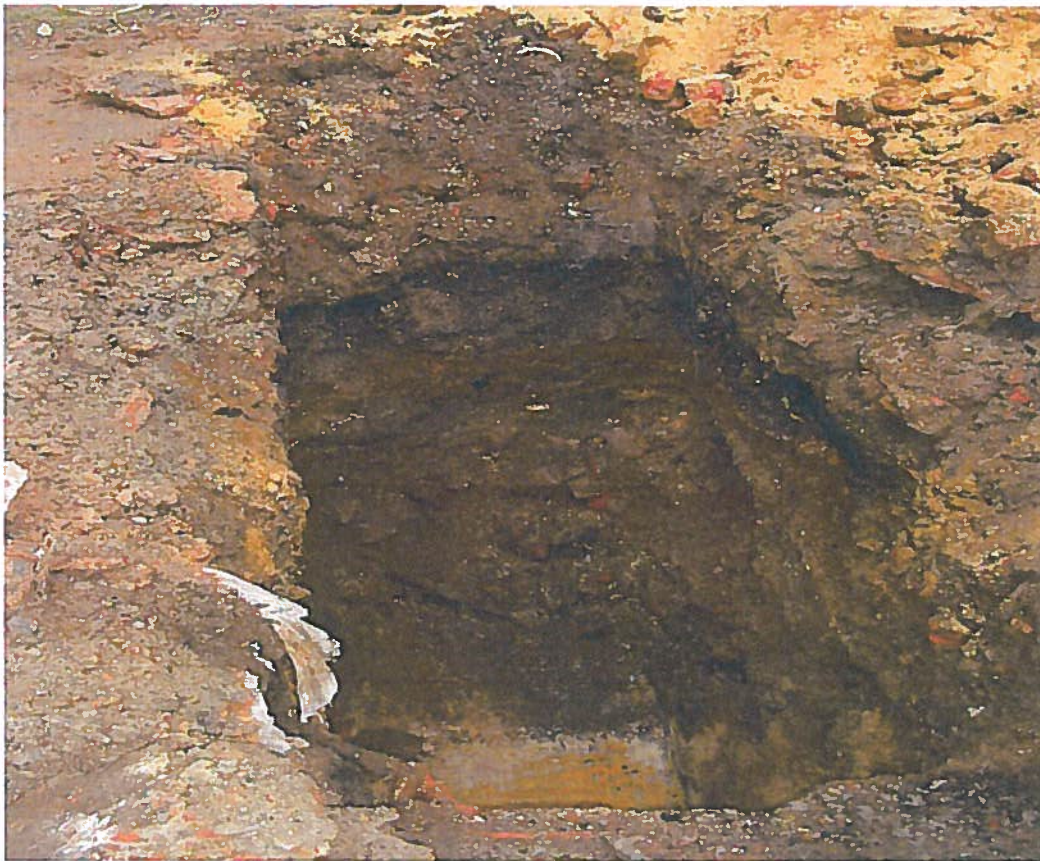
Trial Pit 1 (Refer to trial pit logs and photos P01-P03)

Dark brown sandy fill containing many brick fragments was found to a depth of 2.4m. Light yellow sand was found beneath this depth to the termination of the trial pit at 3.0m. Sand appeared to be initially loose and became denser as the excavation progressed. Although described in a report by WS Atkins (dated April 2002) as weathered sandstone, a rock stratum was not encountered. Depth of fill material varied in each face of the pit. A buried masonry foundation was also encountered in the fill material. Sides of pit were not stable in fill but remained vertical in sand. Trial pit was dry when terminated.

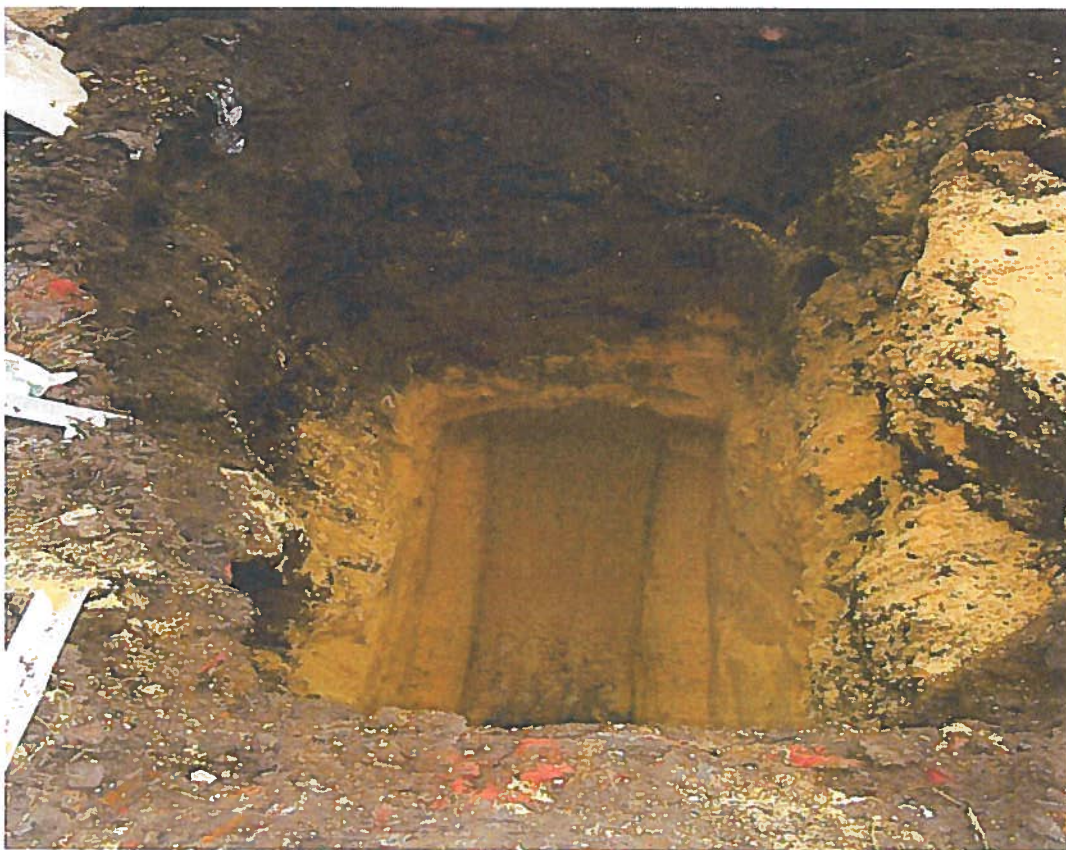
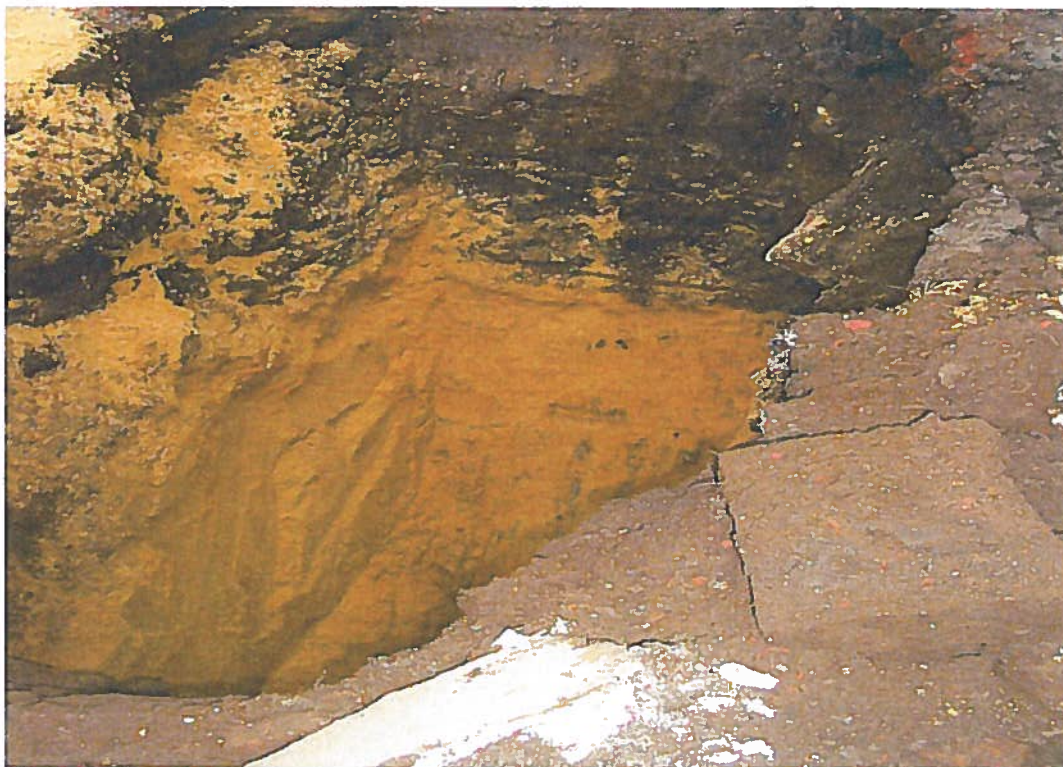
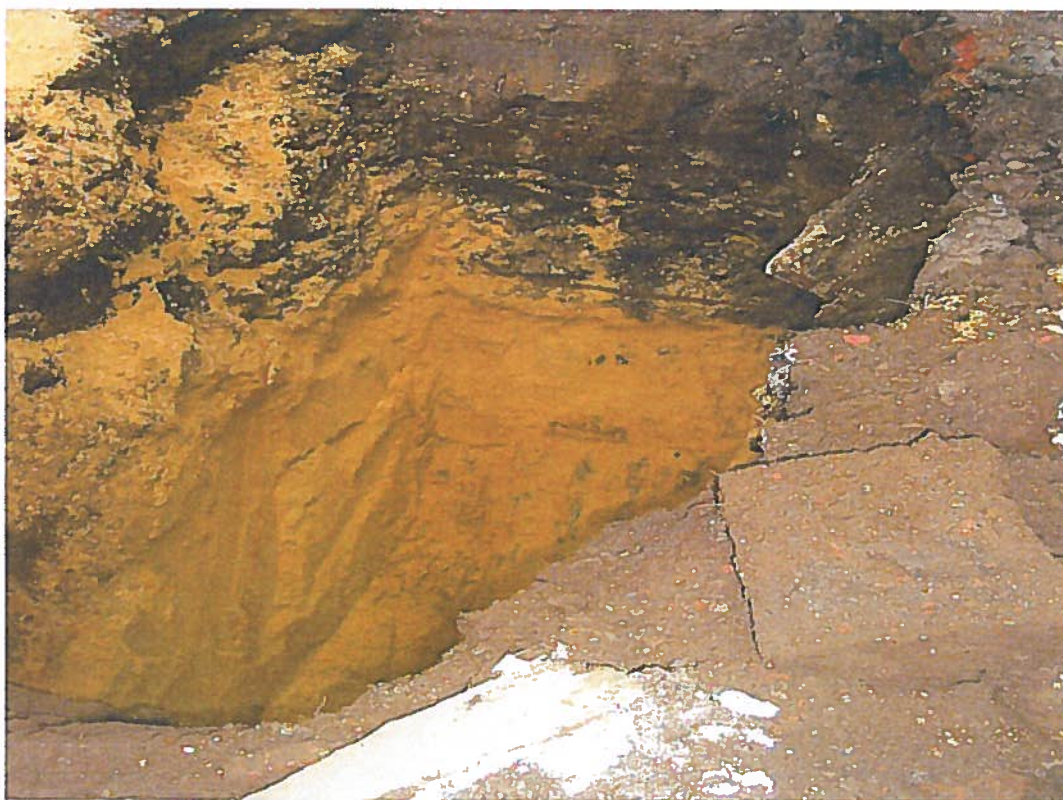
PO4 - TP 2

Trial Pit 2 (Refer to trial pit logs and photos P04-P06)

Dark brown sandy fill containing many brick and concrete fragments was found to a depth of 1.8m. Light yellow sand was found beneath this depth to the termination of the trial pit at 3.5m. Sand appeared to be initially loose and became denser and darker as the excavation progressed. A rock stratum was not encountered. Sides of pit were not stable in fill but remained vertical in sand. Trial pit was dry when terminated.

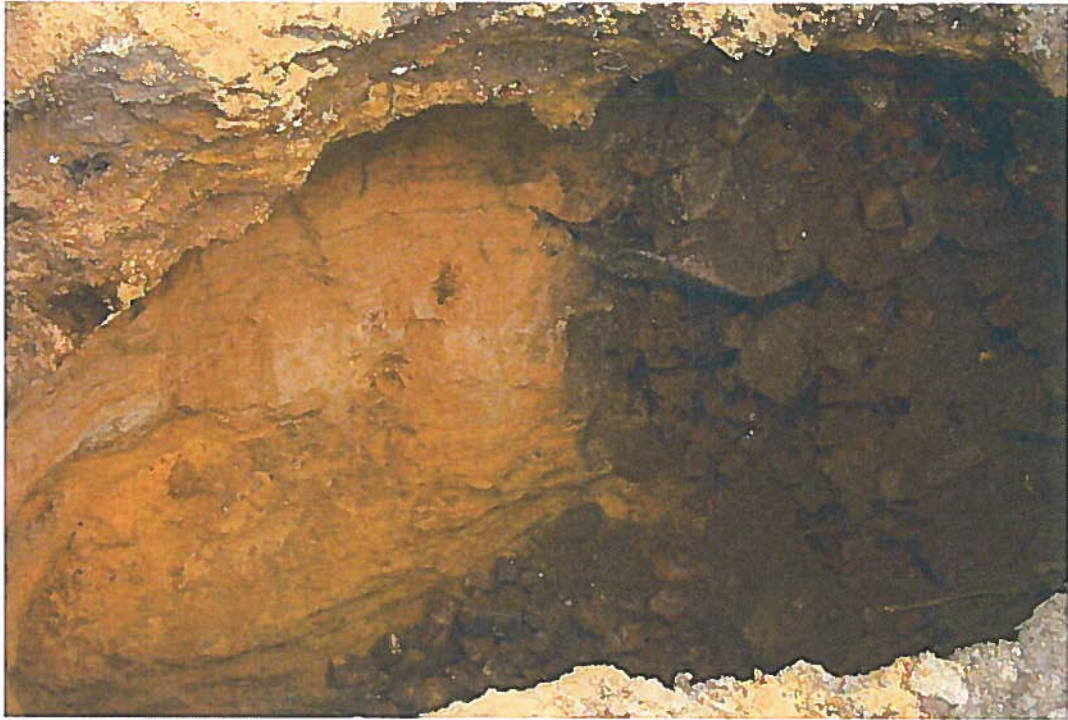
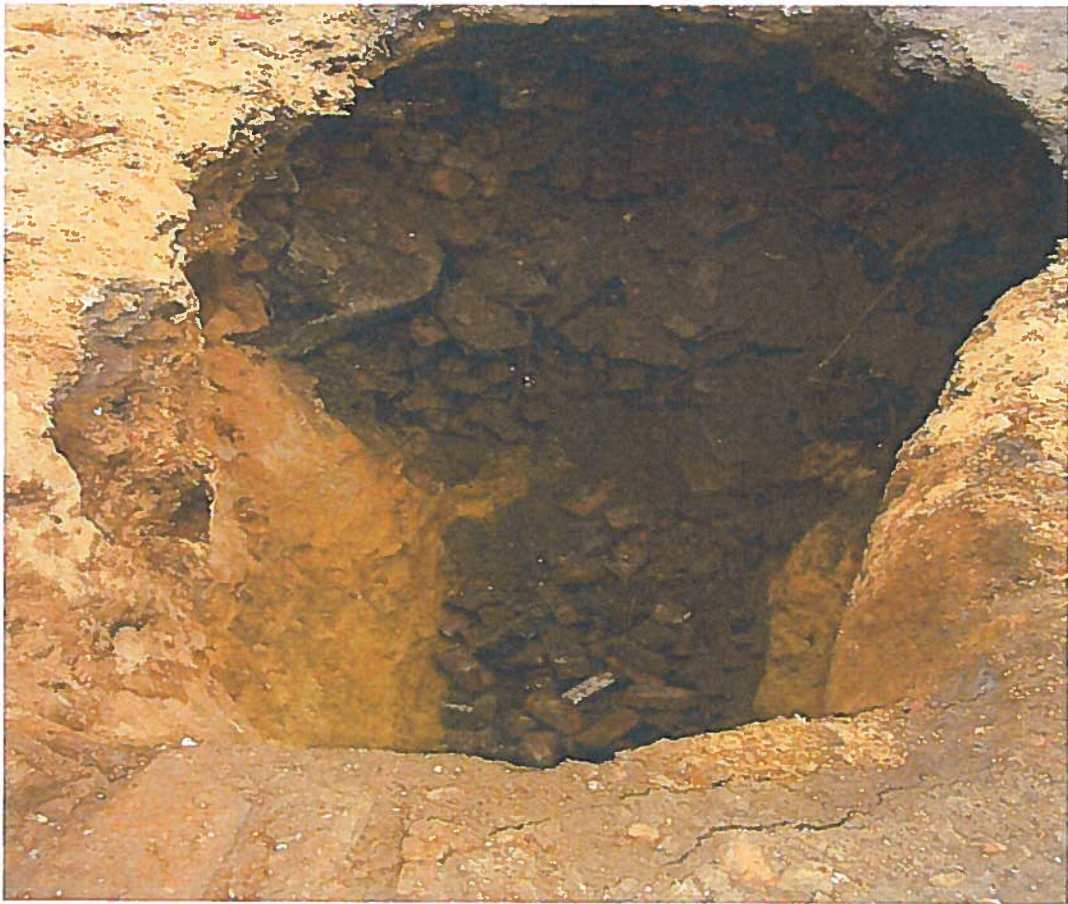
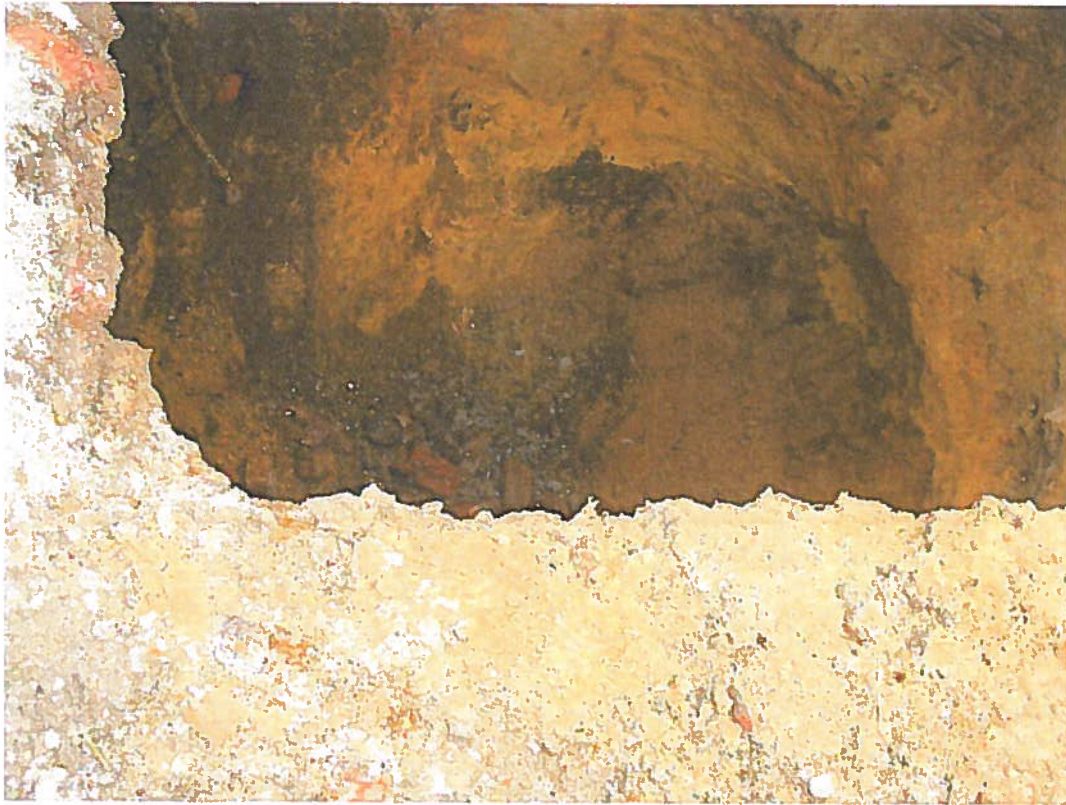
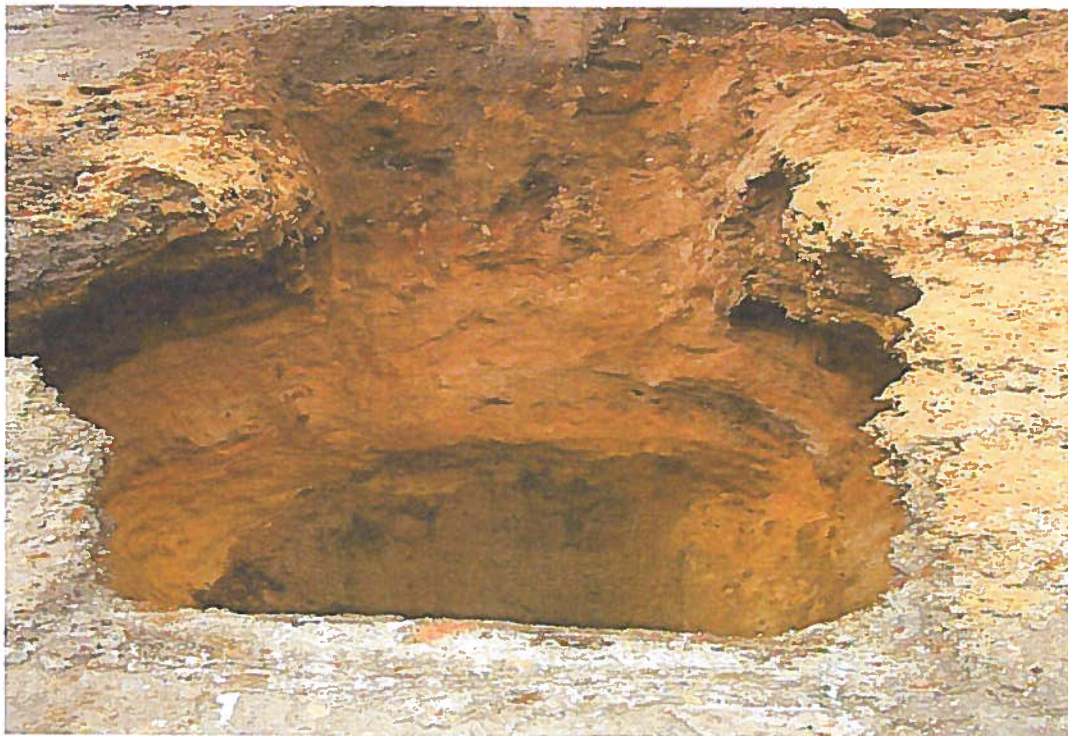
P07 - TP 3

Trial Pit 3 (Refer to trial pit logs and photos P07-P10)

Dark brown sandy fill containing many brick and concrete fragments was found to a depth of between 1.0m and 2.6m. Light yellow sand was found beneath this depth to the termination of the trial pit at 3.4m. Sand appeared to be initially loose and became denser and darker as the excavation progressed. A rock stratum was not encountered. Sides of pit were not stable in fill but remained vertical in sand. Trial pit was dry when terminated. The trial pit appeared to be at a junction between differing depths of fill.

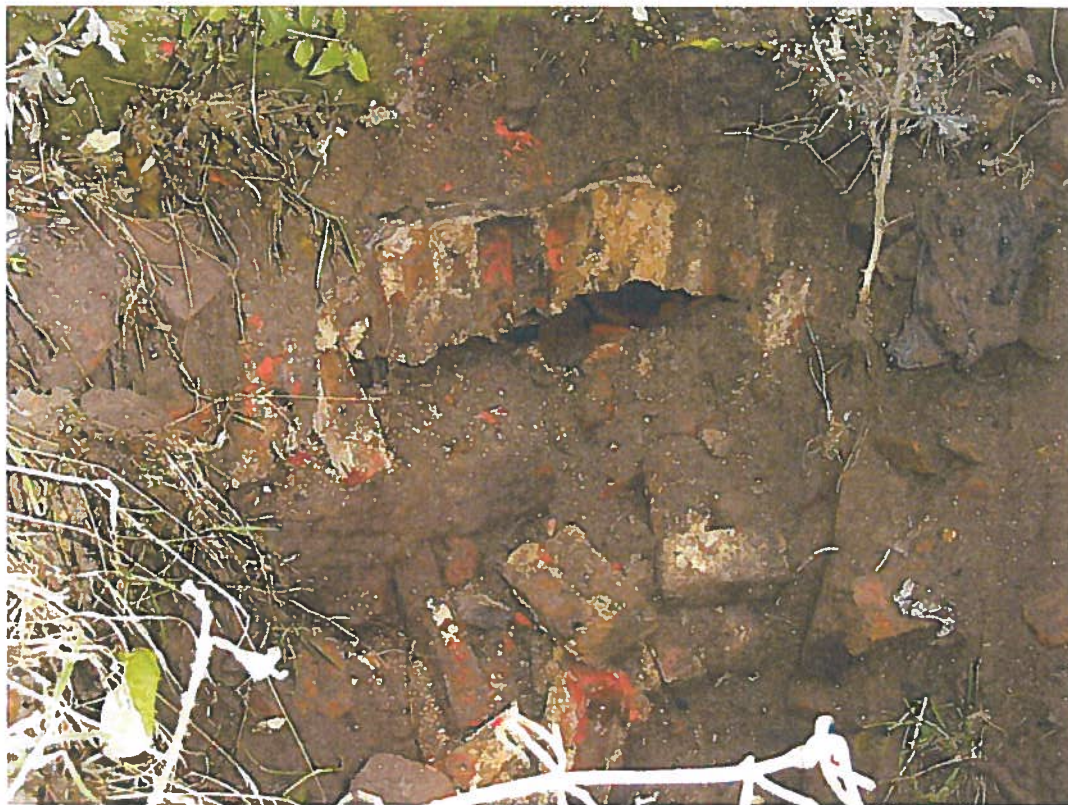
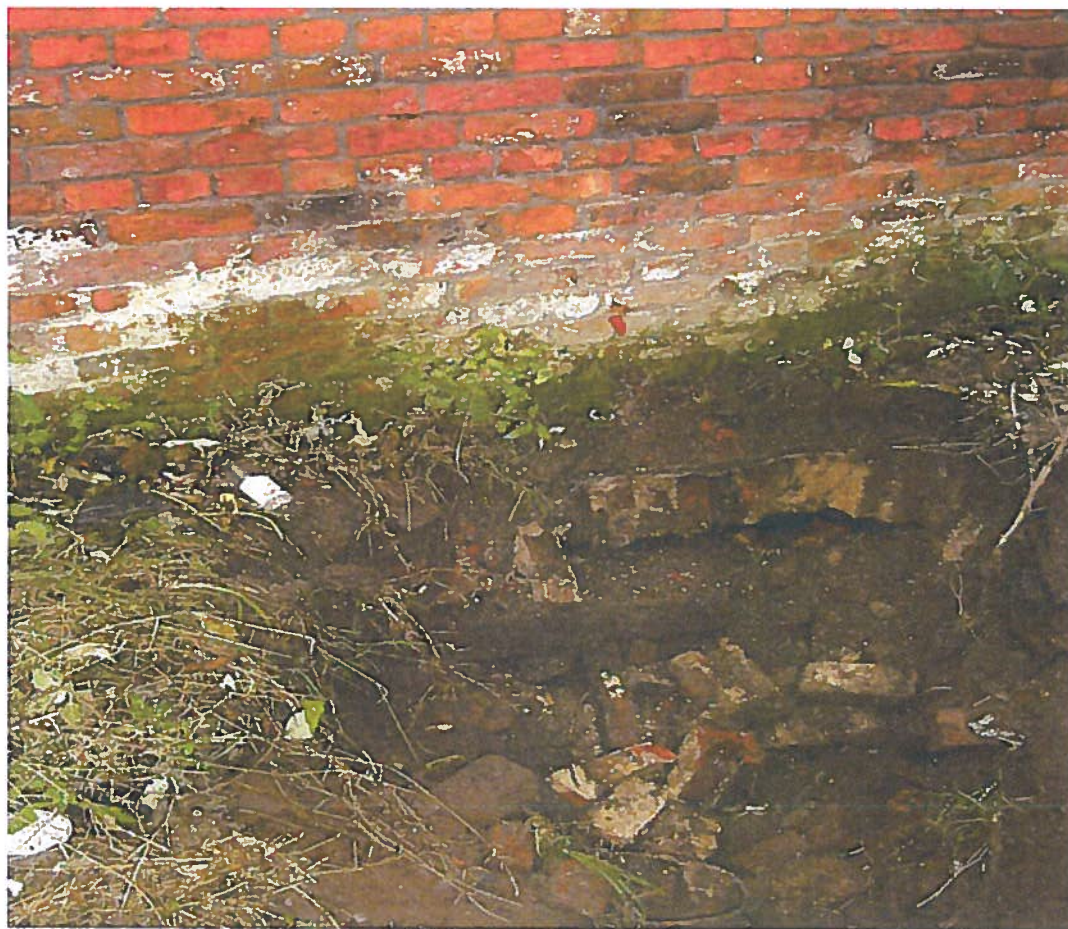
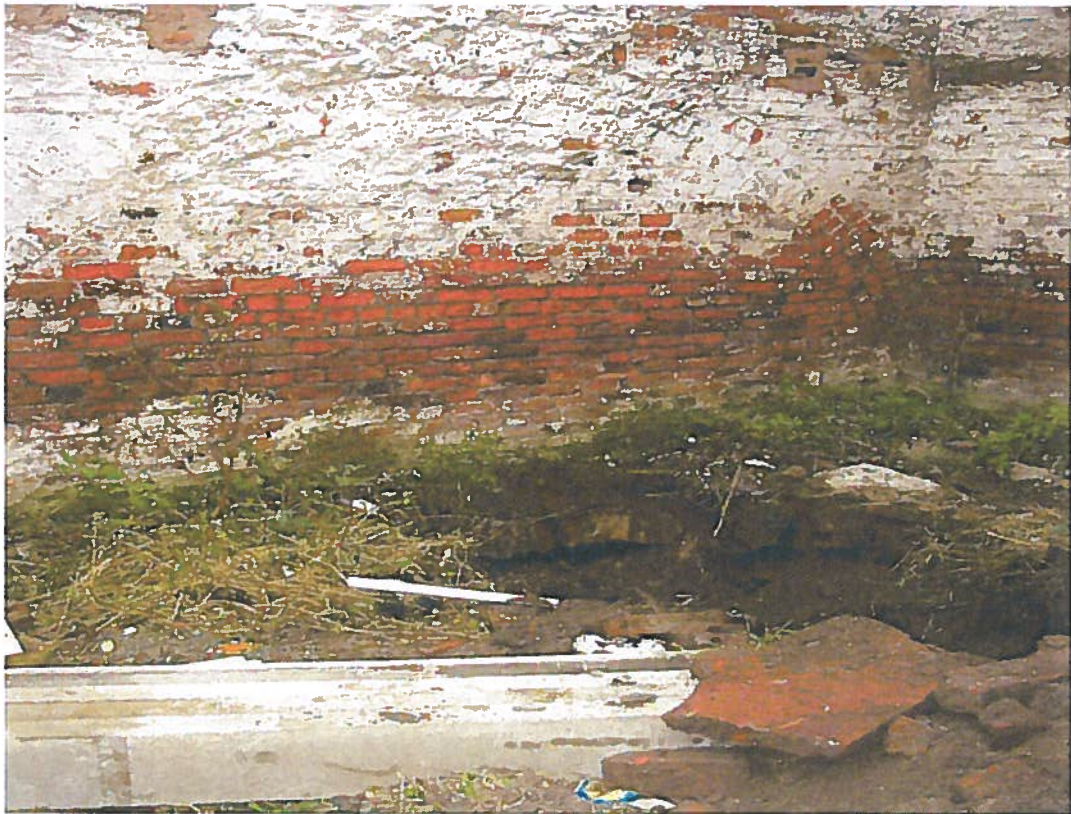
P12 - H 002

Hand Dug Pit 2 to the rear of 86 Duke St (Refer to trial pit logs and photo P13-P15)

Excavation located the top of an open arch at a depth of 400mm. Due to the uncertainties of interfering with the unexpected basement structure and potential to affect the existing building, the excavation was abandoned. Excavated material was dark brown sandy fill containing many brick fragments for the full depth of the excavation.

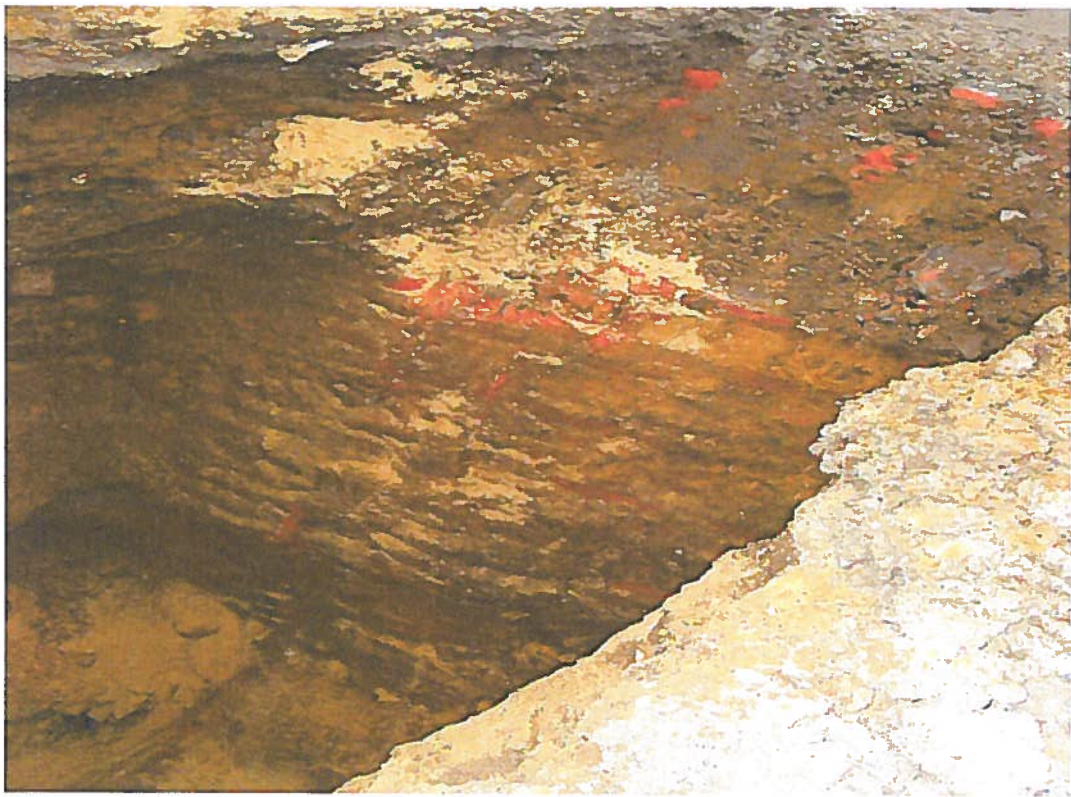
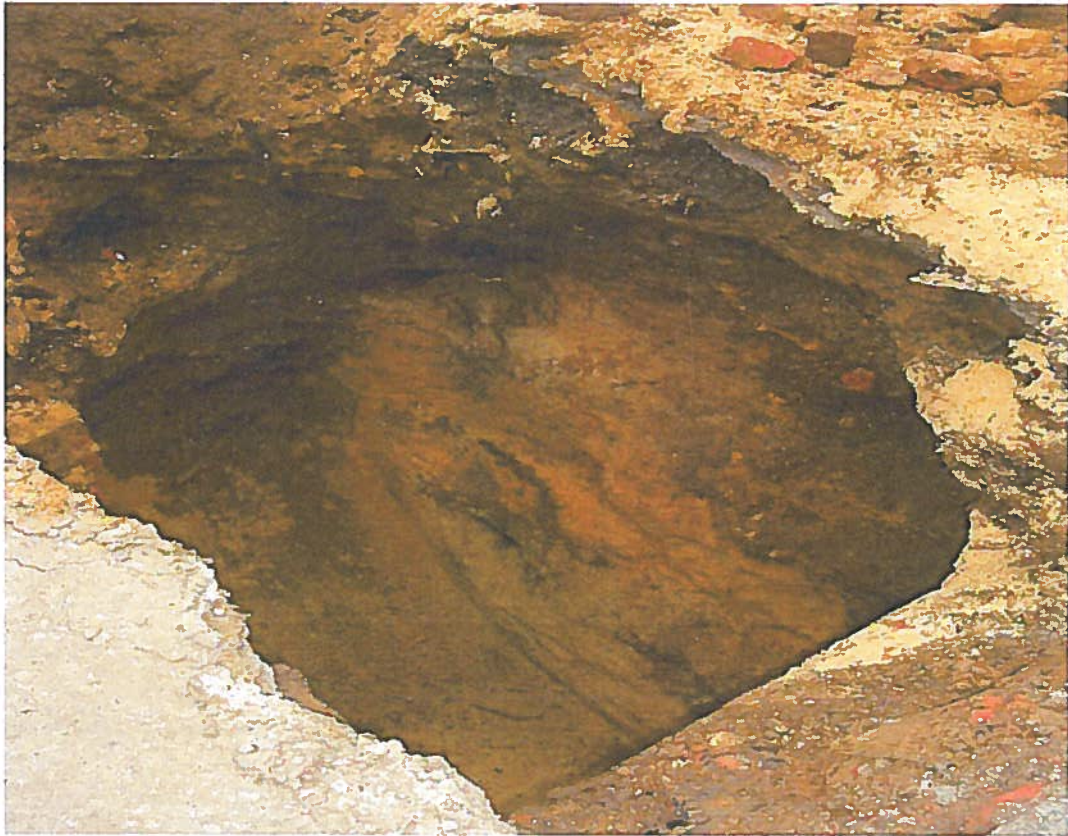
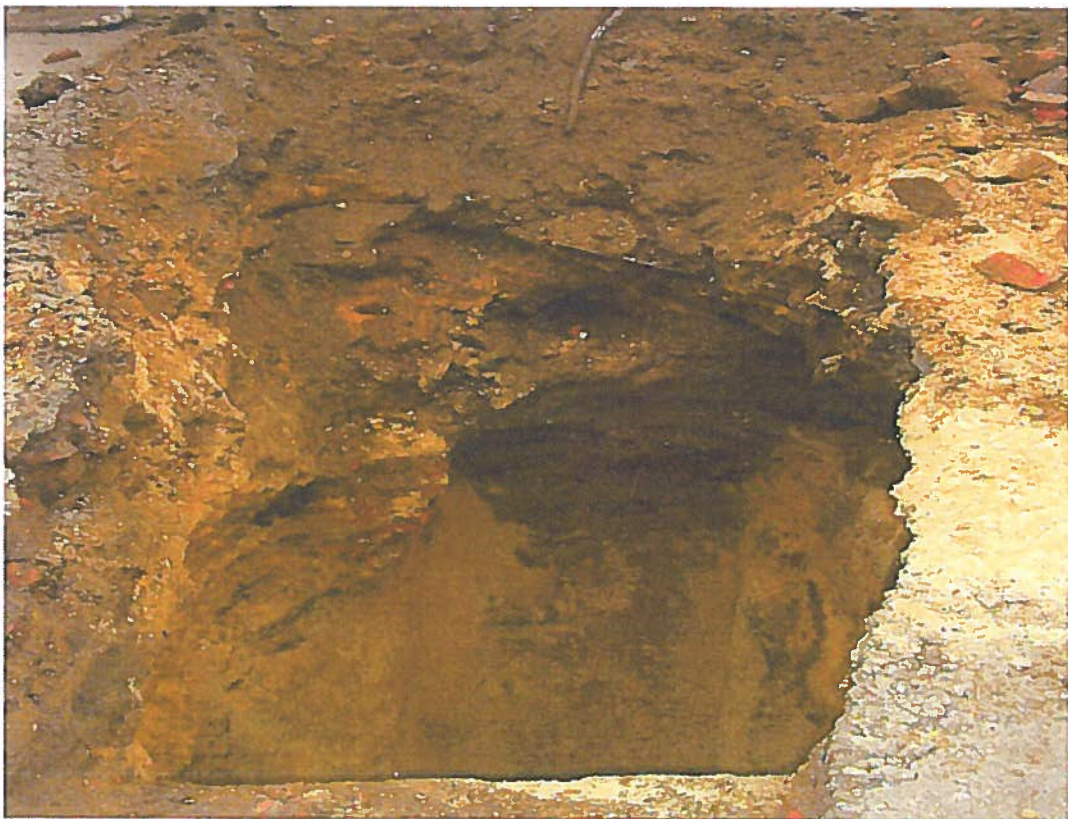
P15 – TP 4

Trial Pit 4 (Refer to trial pit logs and photos P14-P16)

Dark brown sandy fill containing many brick fragments was found to a depth of between 1.0m and 2.5m. Light yellow sand was found beneath this depth to the termination of the trial pit at 3.4m. Sand appeared to be initially loose and became denser as the excavation progressed. A rock stratum was not encountered. Sides of pit were not stable in fill but remained vertical in sand. Trial pit was dry when terminated. Depth of fill varied around the trail pit. A masonry wall was observed to a depth of 2.6m in one face.

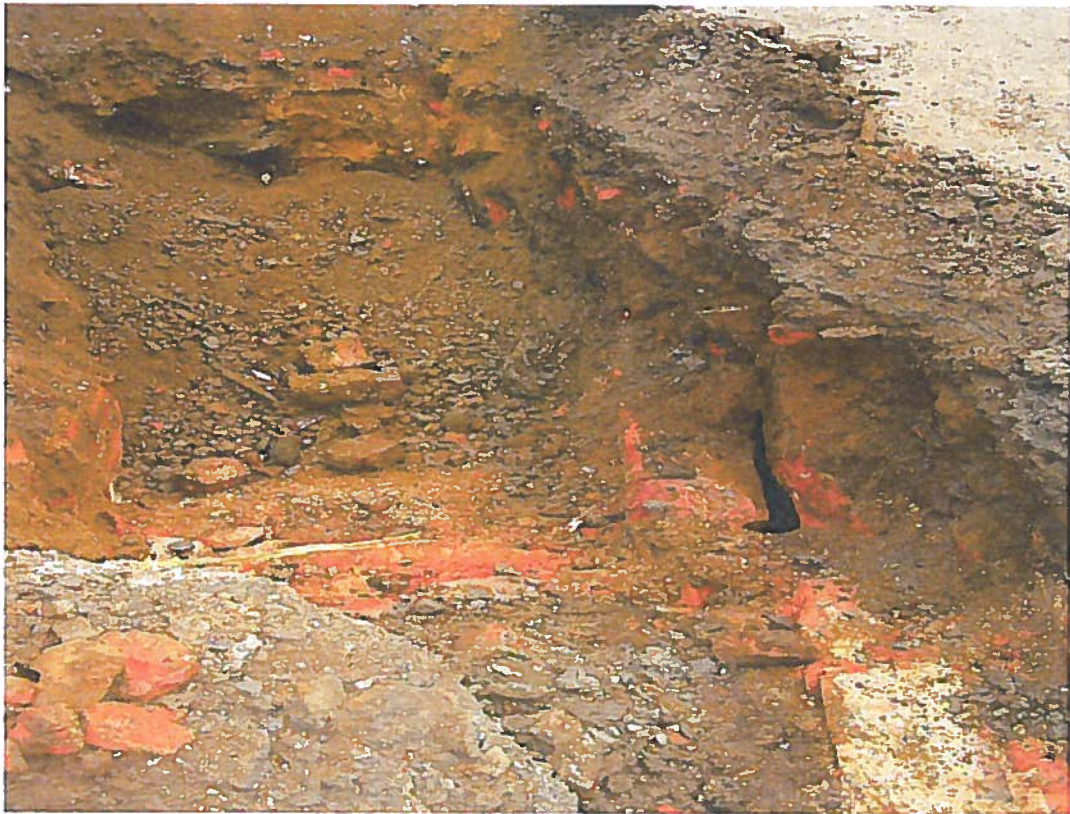
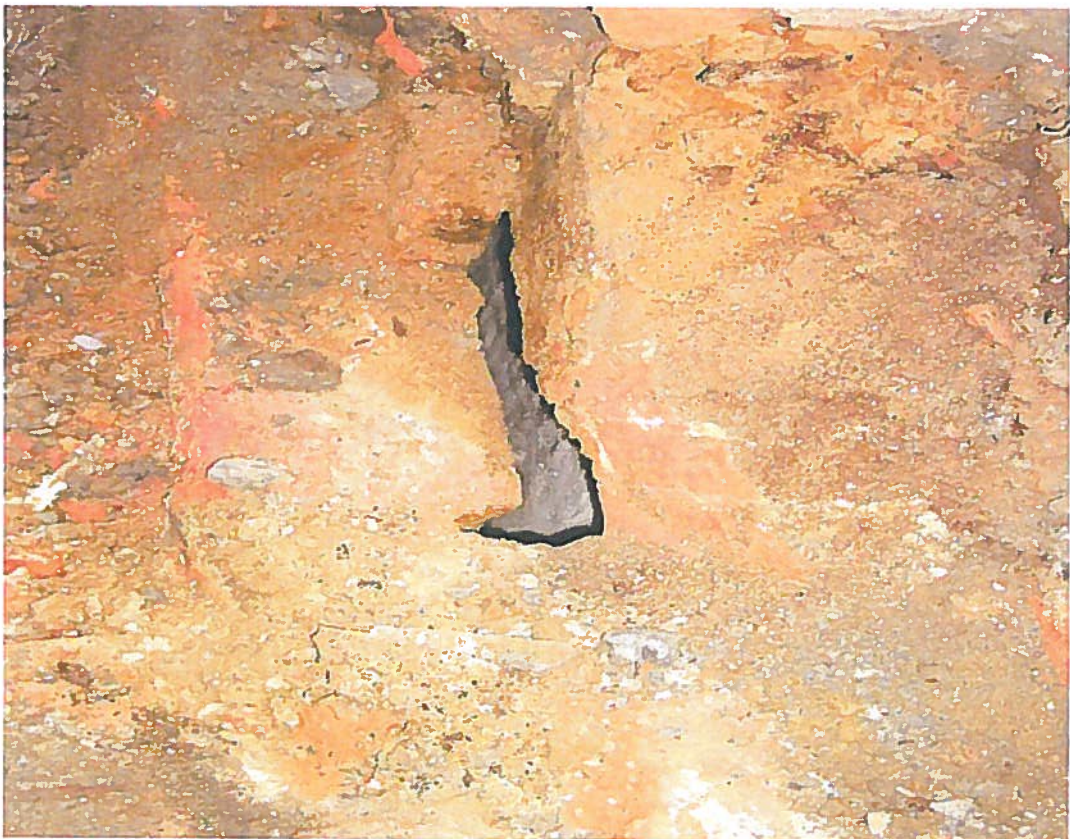
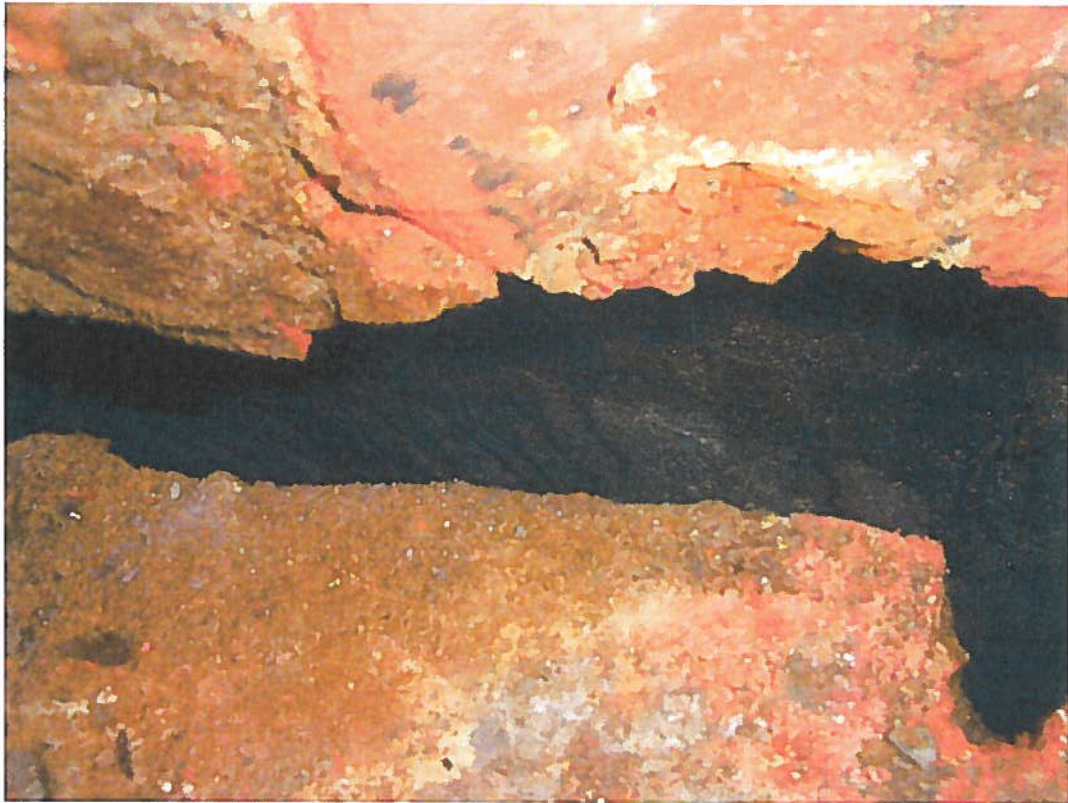
P18 - TP 5

Trial Pit 5 (Refer to trial pit logs and photos P17-P19)

Excavation appeared to be located over a series of intersecting, buried masonry walls. Dark brown sandy fill containing many brick fragments was noted between the walls. At a depth of approximately 900mm the top of a brick arch was identified. There appeared to be a 100mm void beyond the arch ending at a concrete wall. The trial pit was abandoned at a depth of 1m due to the obstructions noted.

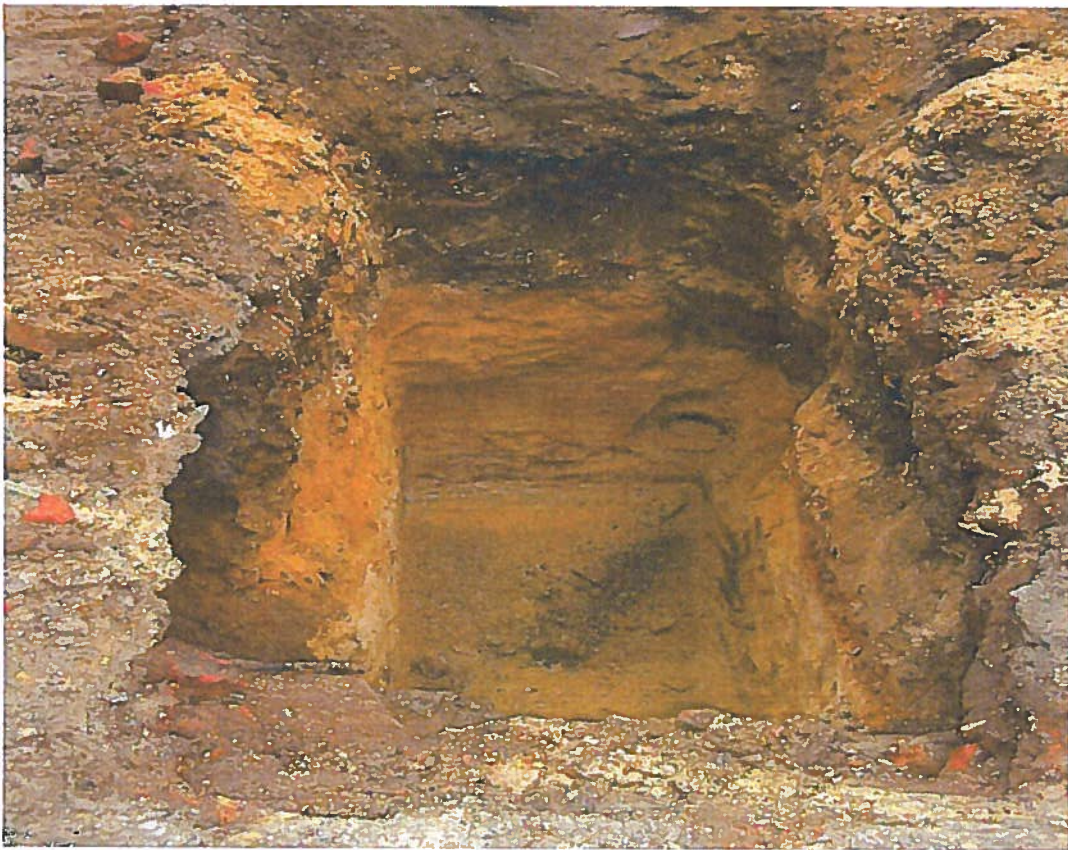
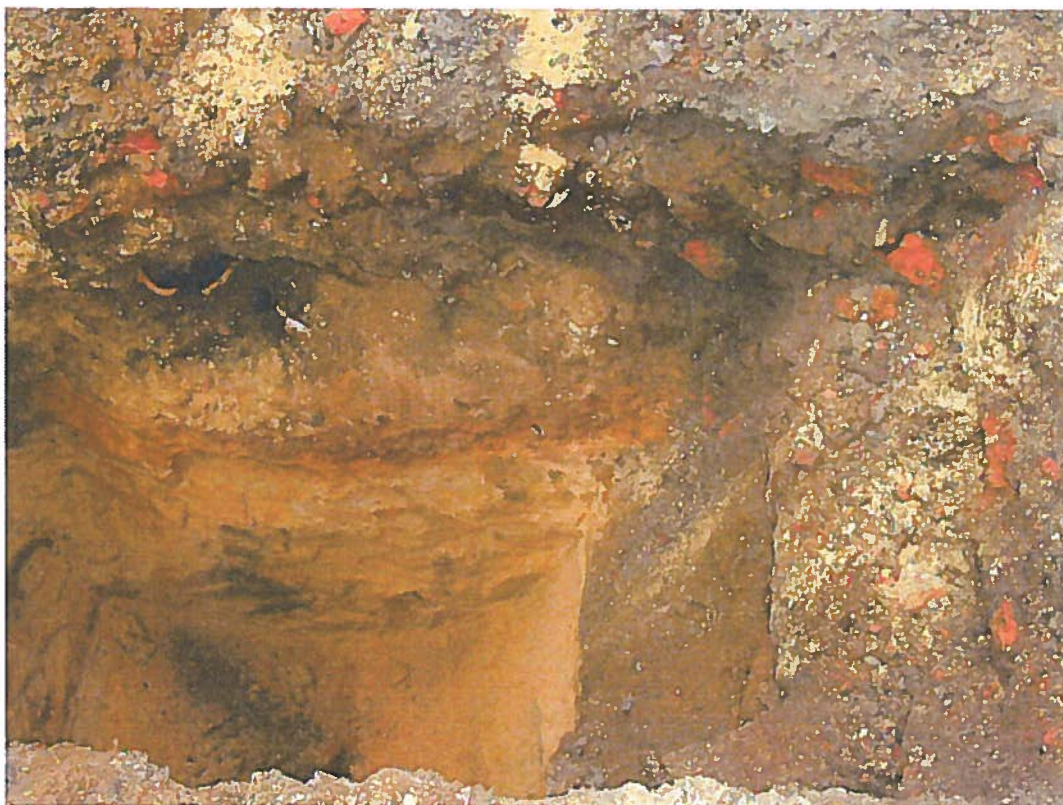
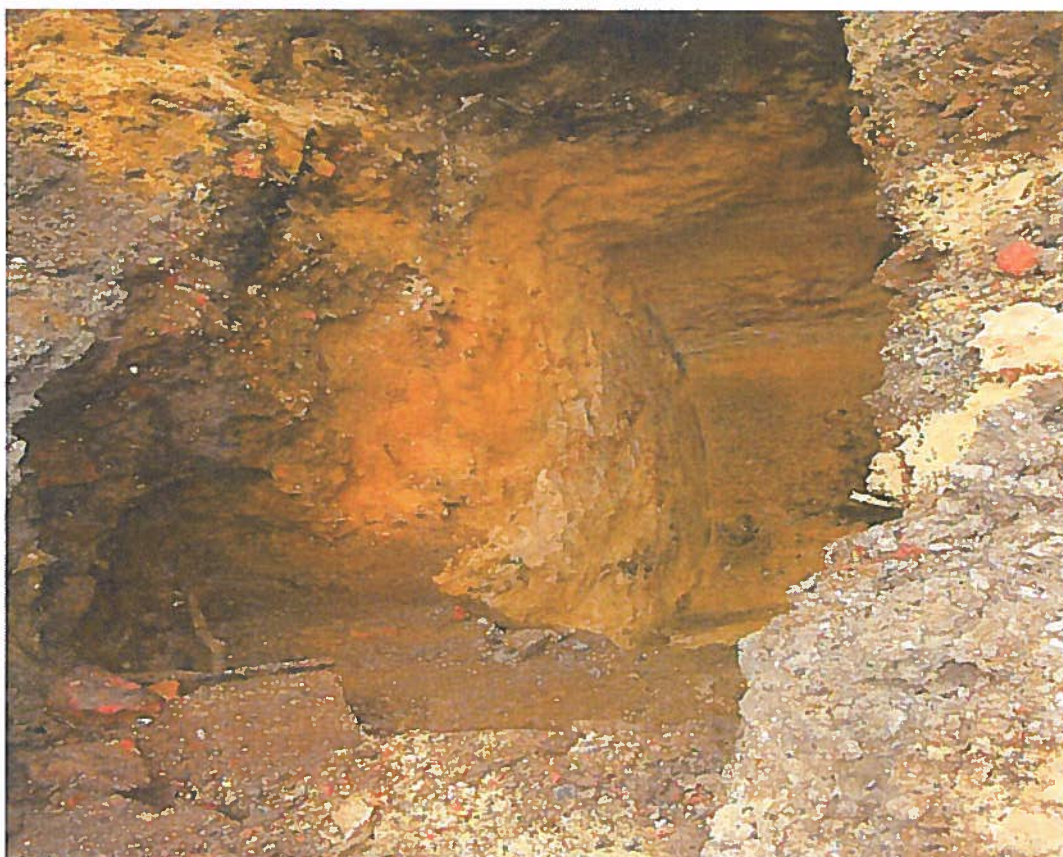
P21 – TP 6

Trial Pit 6 (Refer to trial pit logs and photos P20-P22)

Dark brown sandy fill containing many brick and concrete fragments was found to a depth of between 1.45m. Light yellow sand was found beneath this depth to the termination of the trial pit at 2.3m. Sand appeared to be initially loose and became denser as the excavation progressed. A rock stratum was not encountered. Sides of pit were not stable in fill but remained vertical in sand. Trial pit was dry when terminated.
