Geotechnical Assessments

Duke St, Liverpool – Stage 1 Preliminary Trial Pit Investigation

1.0 Introduction

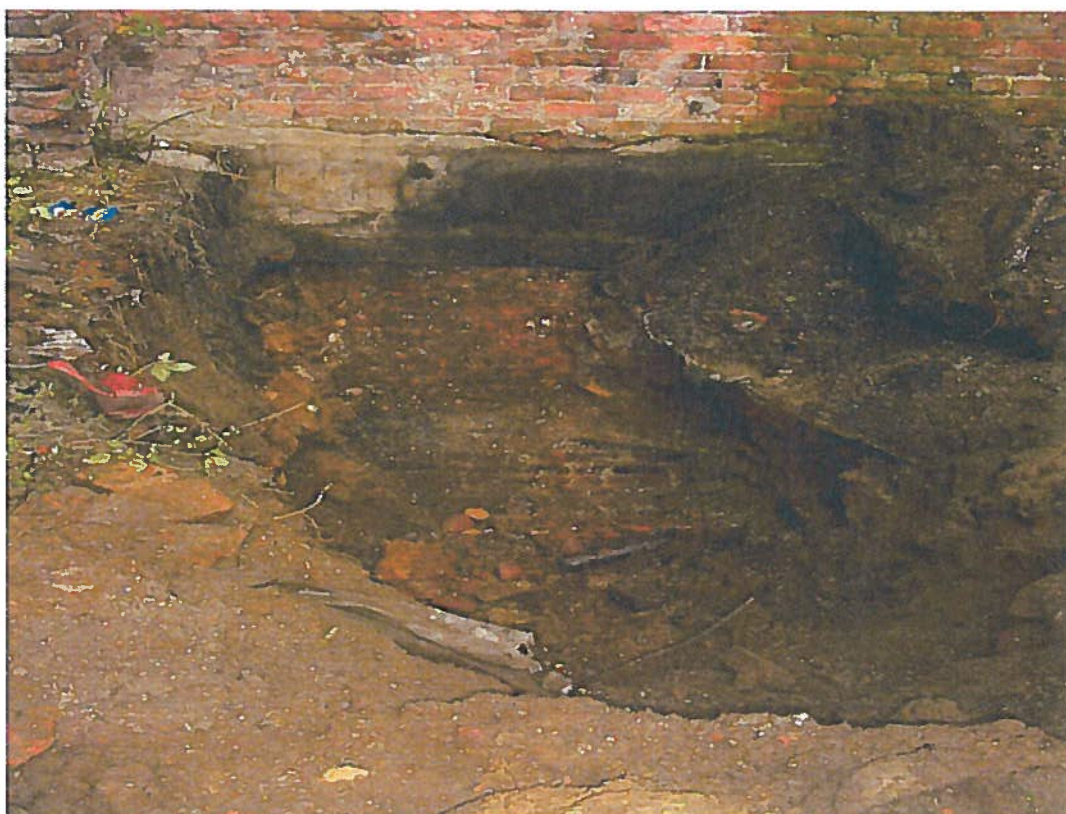
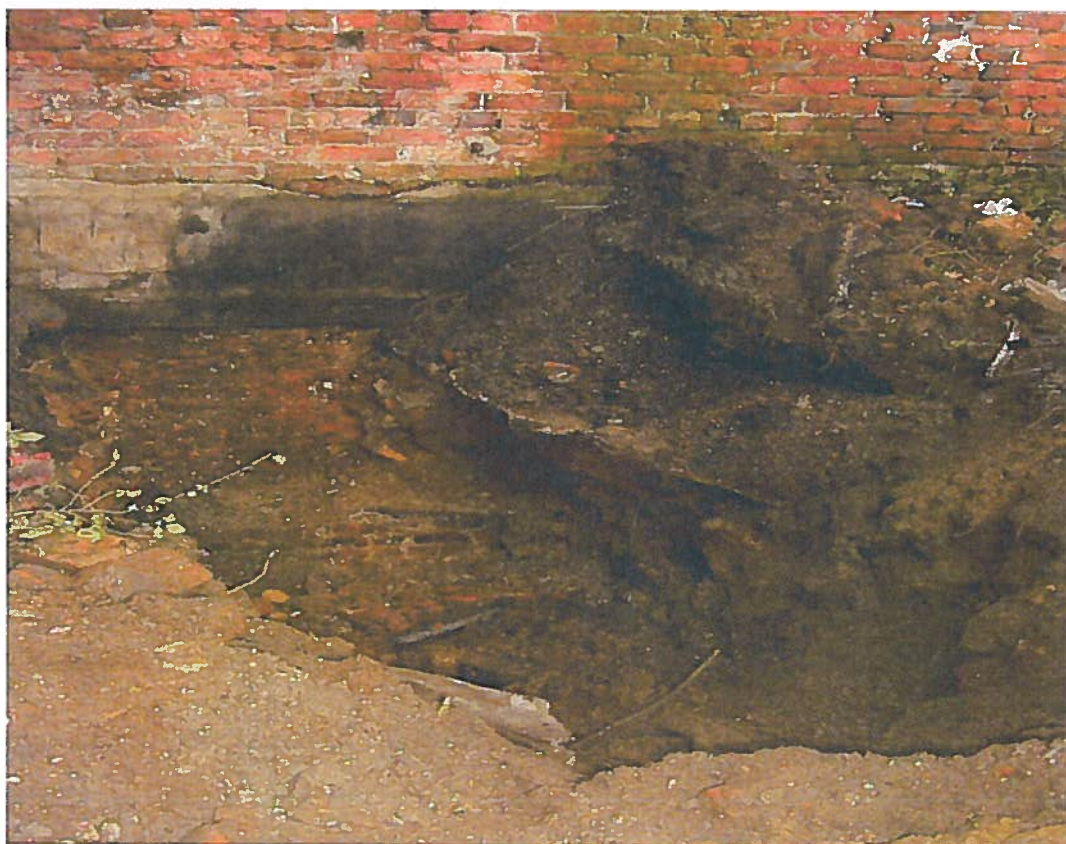
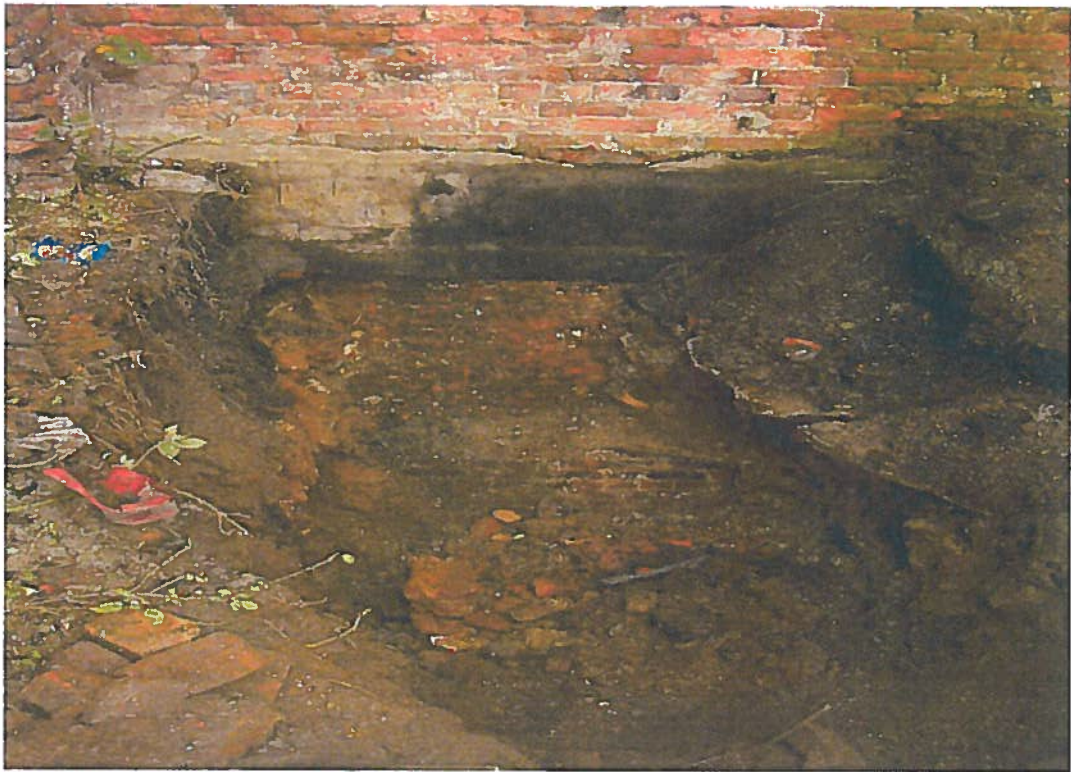
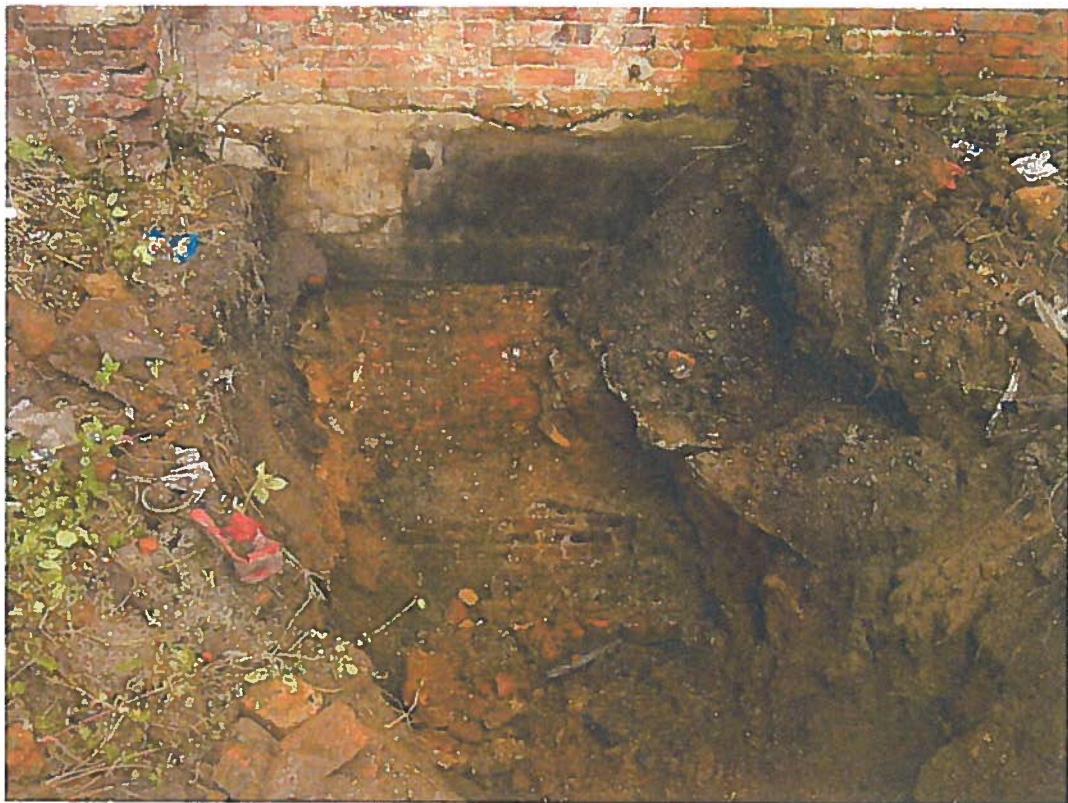
P24 - H001

Hand Dug Pit 1 to the rear of 82/84 Duke St (Refer to trial pit logs and photo P23-P25)

Limited access and site debris dictated location of pit. Excavation located a brick step out at 1.675m depth, however, masonry extended beyond a depth of 2.6m. Due to the nature of the fill (loose granular material) the sides of the excavation were unstable; therefore the pit was abandoned at a depth of 2.6m. Excavated material was dark brown sandy fill containing many brick fragments for the full depth of the excavation.

Excavations adjacent to 82/84 Duke St to form new basements will likely require underpinning of the existing foundations to 82/84 Duke St in car park. This can only be confirmed by carrying out further investigation in order to prove the existing foundation depth. Further investigation will also be required in order to determine existing building foundations to 86-90 Duke St and the building on the North West boundary. This investigation will determine further the details of underpinning requirements.

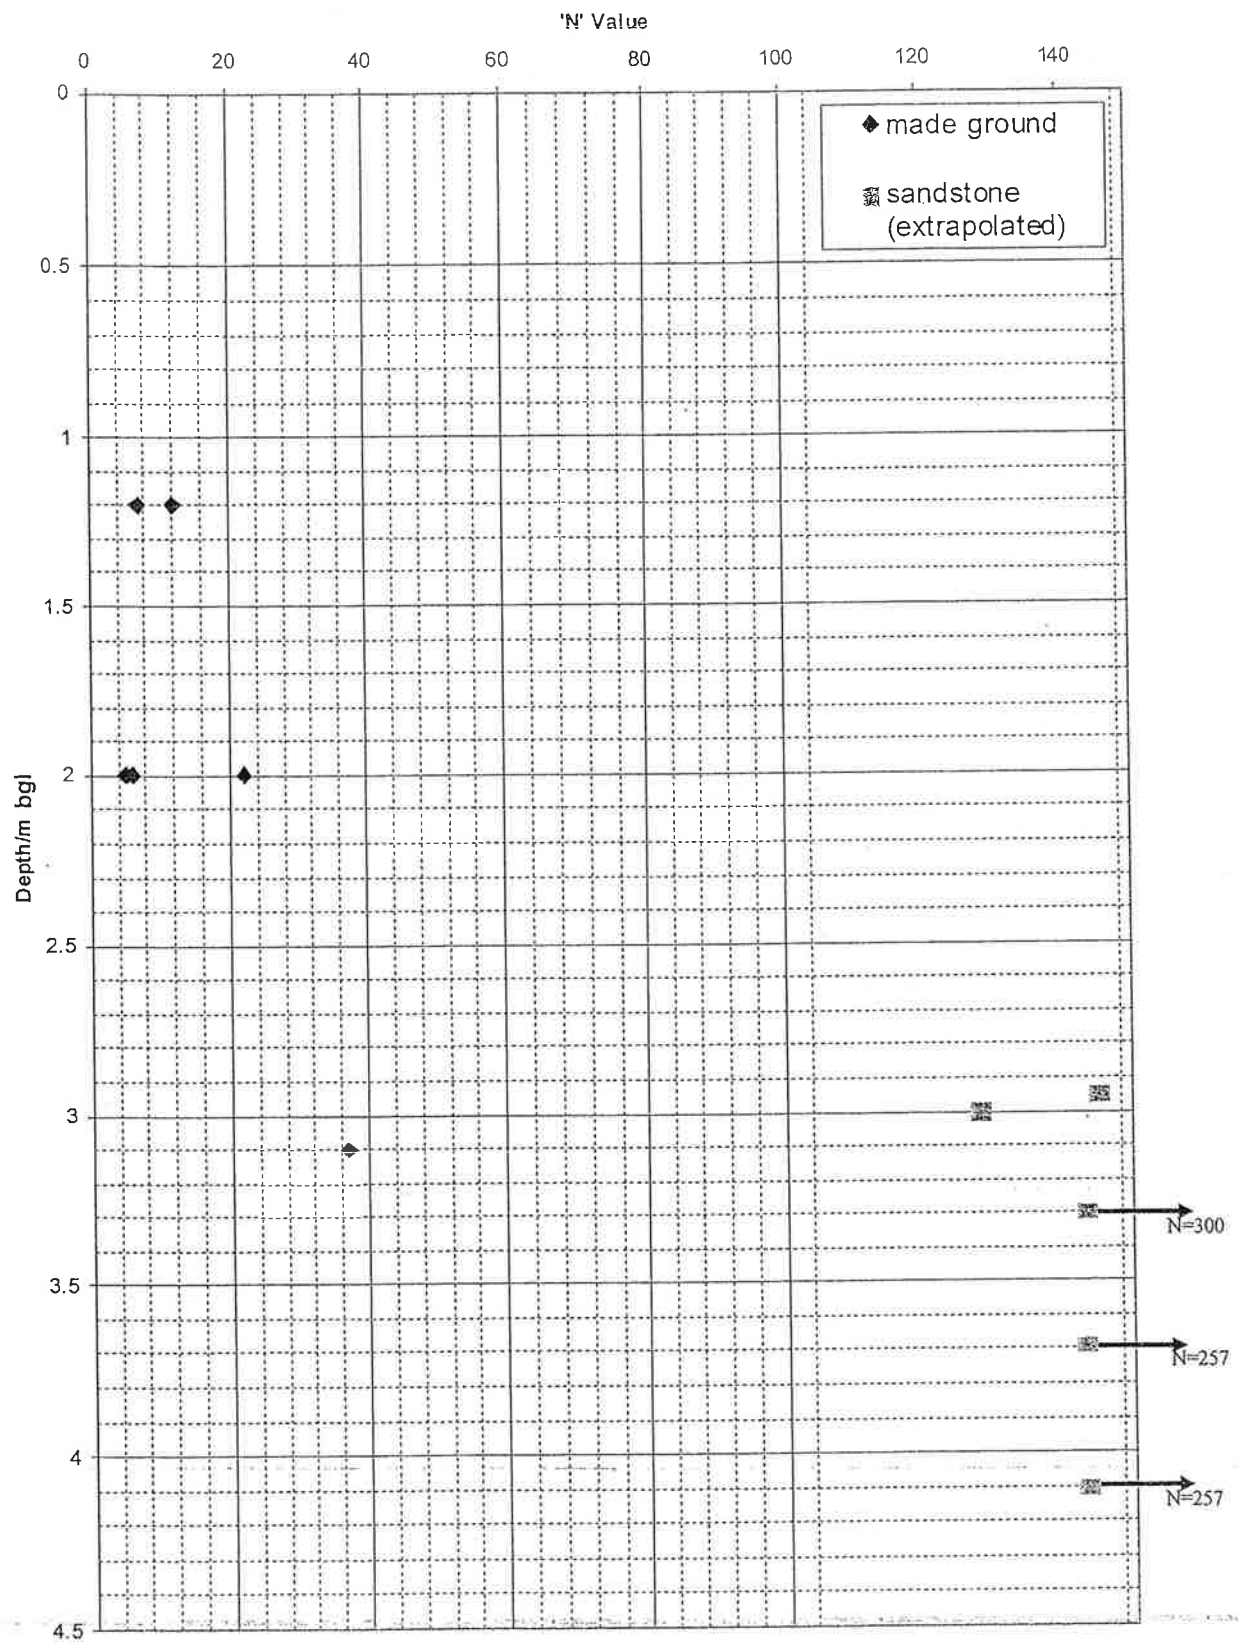
Figure 4

SPT 'N' Values versus Depth
