HARDMAN HOUSE 11-33 HARDMAN STREET LIVERPOOL

CONSERVATION STATEMENT

August 2012

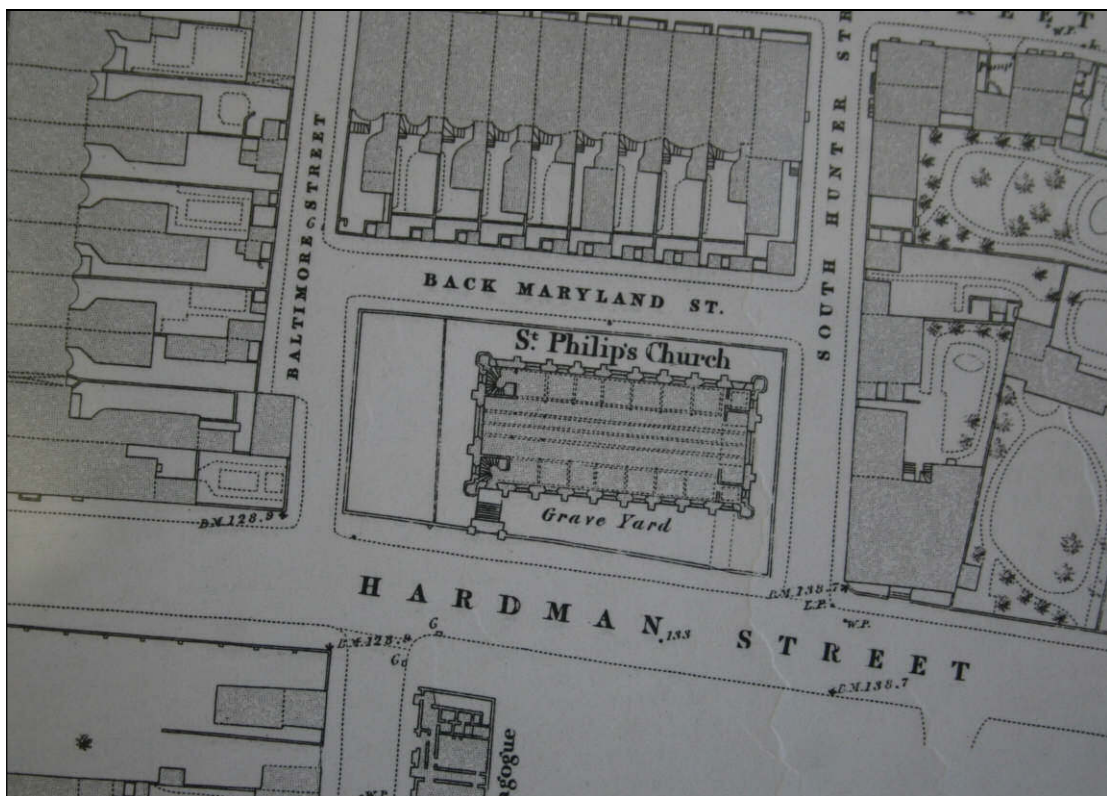
St Philip's Church, Hardman Street, OS map 1848

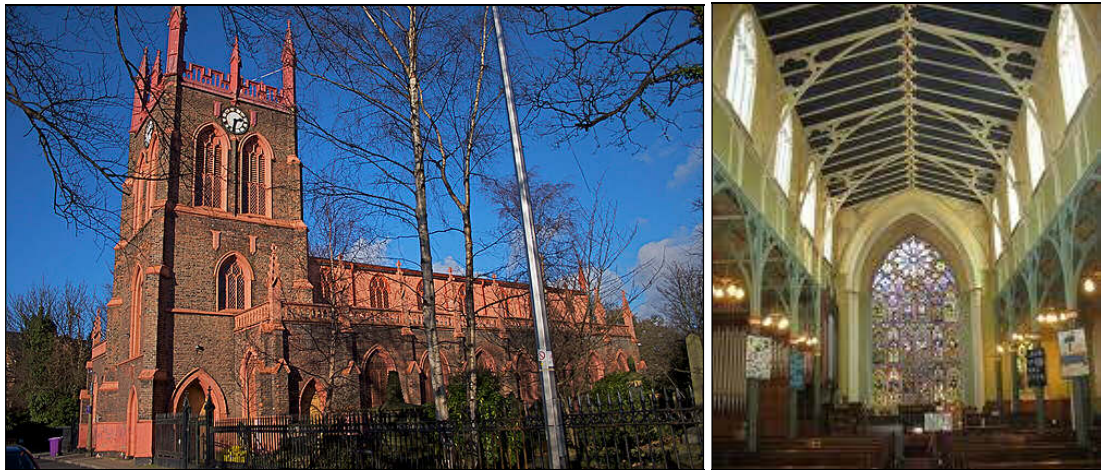
St Michael-in-the-Hamlet, Toxteth, exterior and interior

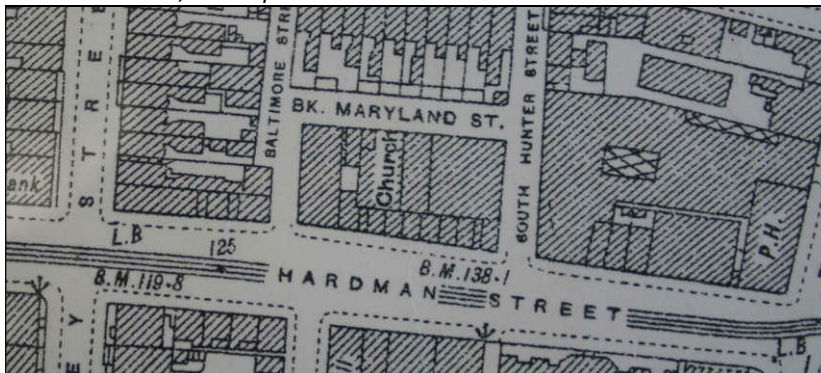
Hardman House, OS map 1927

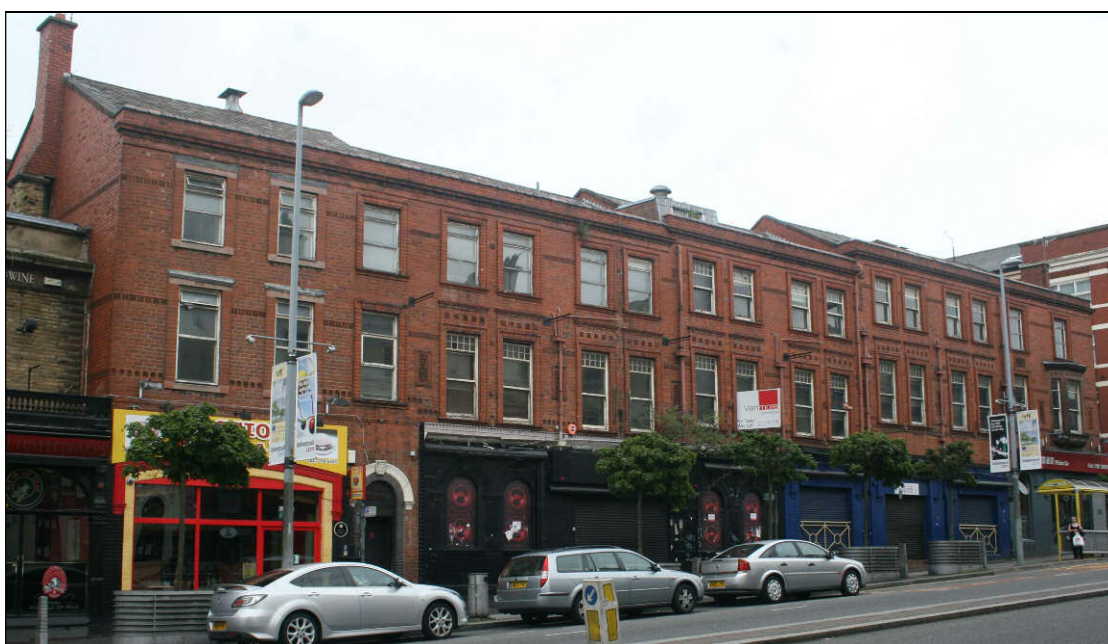
- 3.3 The front elevation is faced in red pressed brick, with band courses of ornamental bricks and moulded brick architraves to the windows. A stone oriel window, possibly re-used from another building, is incorporated at first floor level at the corner with South Hunter Street. Each of the units had an arched doorway opening onto Hardman Street with a shopfront, but most have been altered or removed. The side and rear elevations are of pressed brick with common brick panels, and the windows are of simpler design with segmental arches. Three gabled roofs covered in blue slate extend the length of the building to South Hunter Street with valleys between.

View from Hardman Street

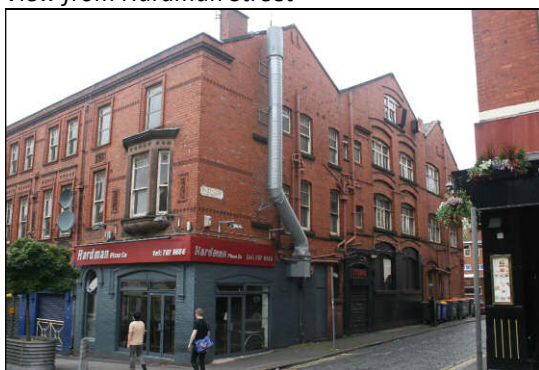
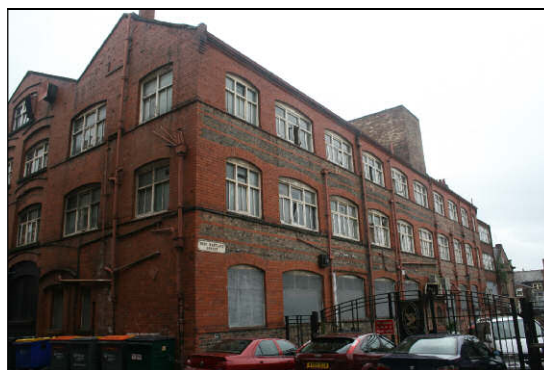
View from Hardman Street looking north west View from South Hunter Street looking south west

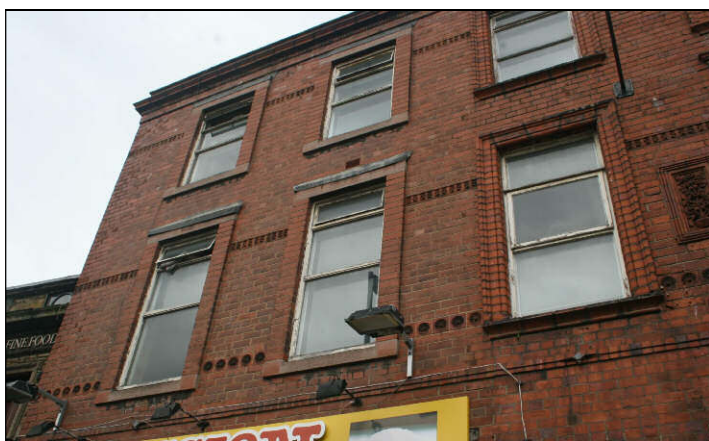
- 3.4 The two westernmost bays have been rebuilt since World War II at both the front and rear of the building. The rebuilt section of the front elevation is in a simplified style, reusing some original brickwork, but without the moulded specials. The rear elevation to Back Maryland Street is rebuilt with a flat roof and horizontal windows.

Rebuilt frontage to Hardman Street

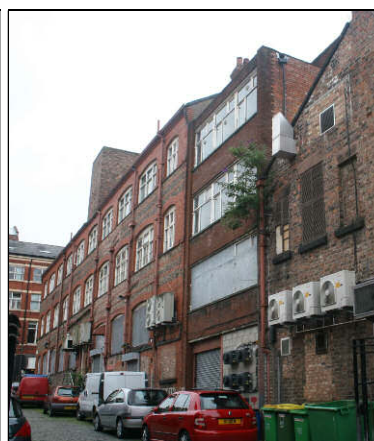
Rebuilt rear facade

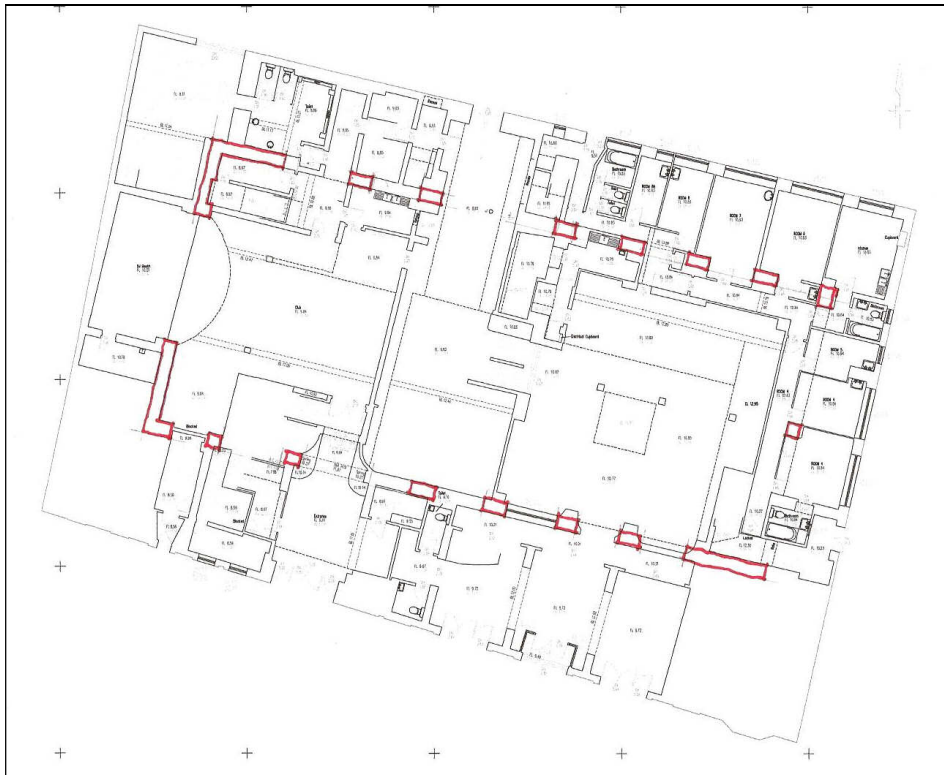
- 3.5 The interior of the building has been greatly altered at all three levels. By examining the current building fabric, together with the measured survey and the 19th century drawings of the church, it is possible to deduce what potentially remains of the original outer walls. This is shown in red on the survey plans below.

Existing ground floor plan showing possible sections of original walls

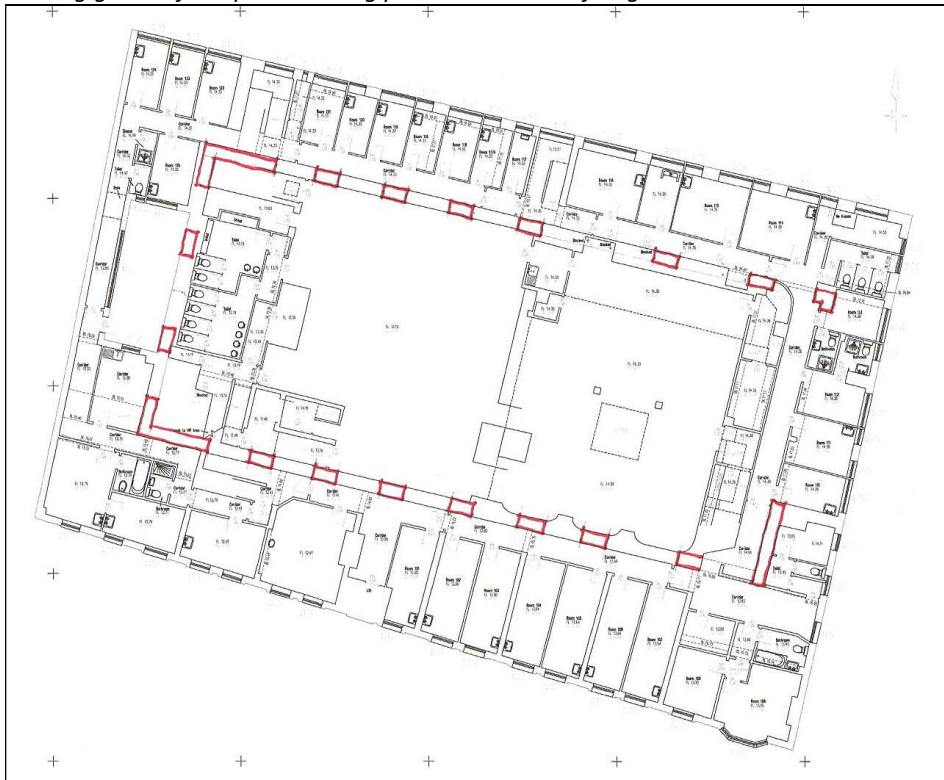
Existing first floor plan showing possible sections of original wall

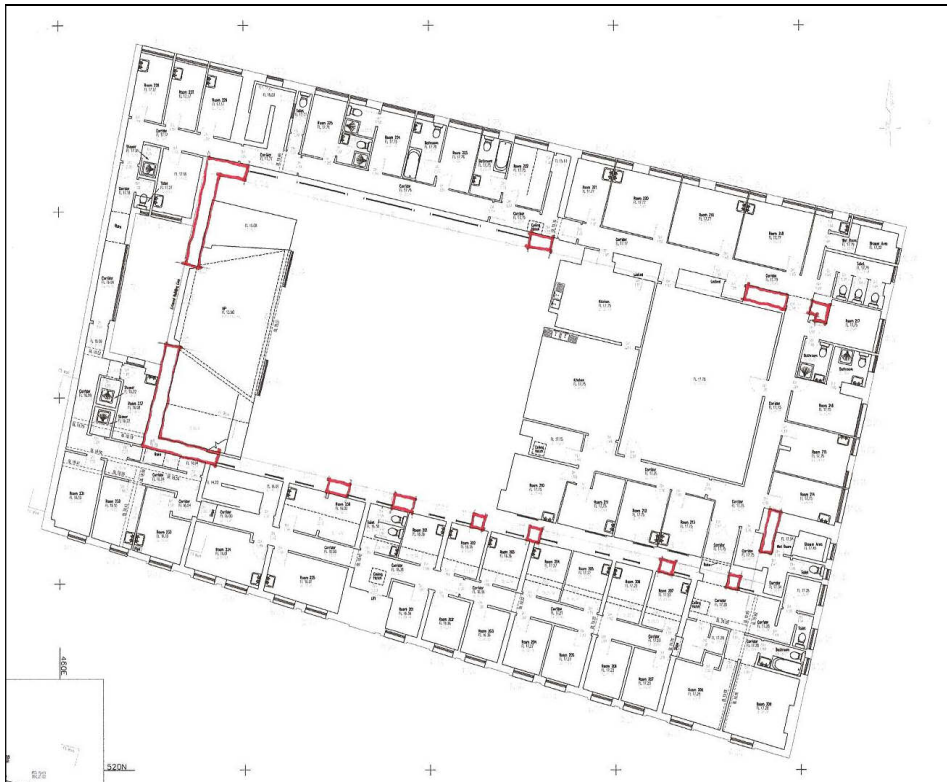
Existing second floor plan showing possible sections of original wall

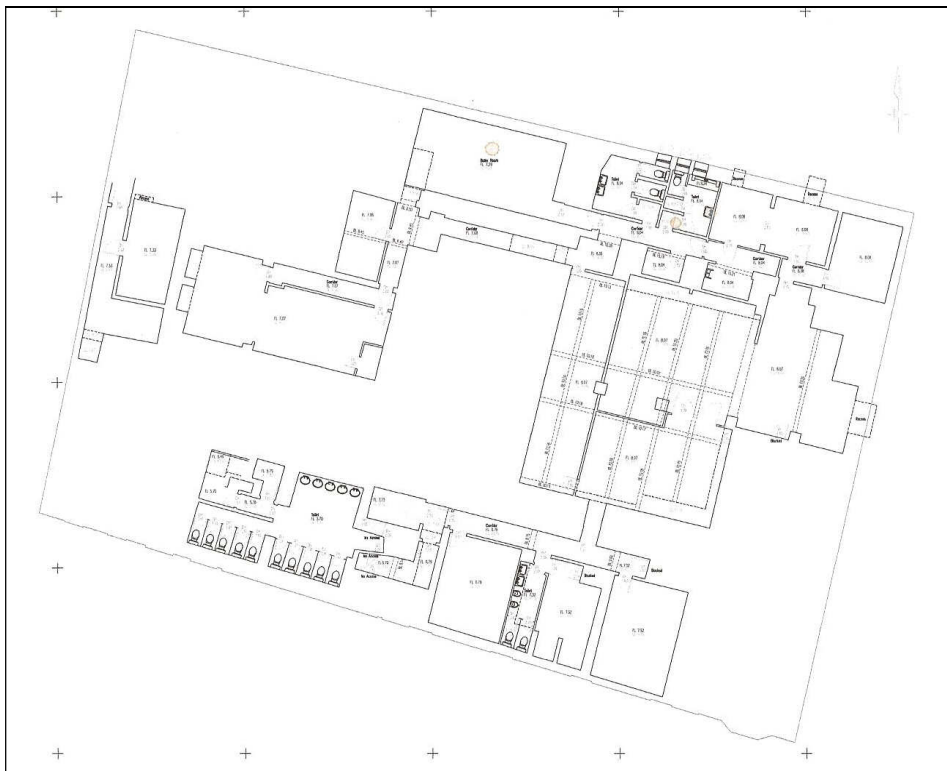
- 3.6 It is possible that more remains at basement level, but this cannot be determined with any accuracy, since the extent of the basements is not clear, and many areas appear to have been infilled. Nor is it known whether the church originally had a basement. The existing basement survey is reproduced below.

Existing basement plan

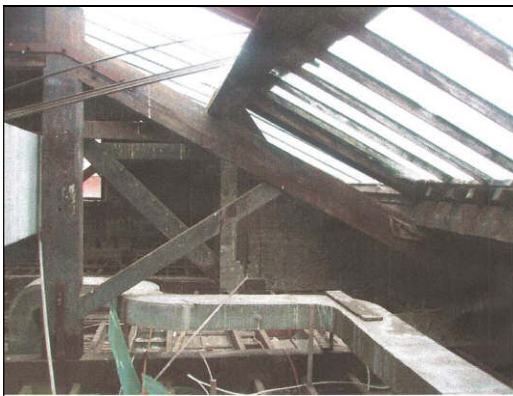
- 3.8 The existing roof trusses have been examined in detail, and two forms exist, each of a differing pitch. The main part of the roof is of a steeper pitch and consists of a series of Queen Post timber trusses of late 19th century form and design. These span the full width of the original church, without intermediate supports. The east end of the roof has timber trusses of a shallower pitch, incorporating steel tie bars. The latter are either late 19th century or early 20th century in form, and also span the full width. The roof covering of slate is underlined with black painted MDF boarding (which superficially has the appearance of slate).

Timber roof trusses

- 4.3 The conversion of the building from a church to a Salvation Army Barracks in 1882-84 probably necessitated the removal of the internal cast iron columns, galleries and spiral staircases to create a large open space suitable for activities, as well as for meetings and functions. This would have led to re-roofing, and the form of the timber trusses now found within the building can be dated to the late 19th century.

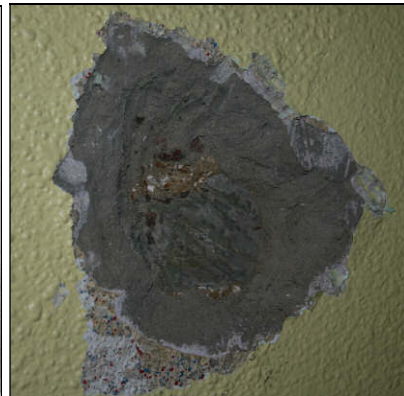
- 3.7 It is known that the original walls of the church were built of brick, and were faced in a thin render externally. The walls shown in red on the plans are of brick, but have been coated with a thick layer of plaster, so the original finish cannot be seen, except where it has been opened up. None of the external buttresses or the corner turrets remain. The spiral staircases have been removed, and no cast iron columns survive within the building.

Modern plaster facing to original walls of church

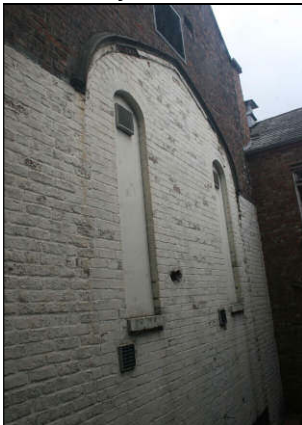
- 3.9 The east gable wall has been largely removed. The west gable, however, survives to a much greater extent. An open light well exists outside what was the main west window of the church, which can be seen in outline, although the cast iron tracery has been removed and infilled in brick. Two lancet windows, which subsequently replaced the iron window have also been removed and blocked up. The cast iron Tudor-arched hood mould is the only feature that remains of the original window.

Original gable wall showing outline of west window and cast iron hood mould
