# WOOLTON ROAD ALLERTON

## Geophysical Survey Report

Client:	Redrow Homes Limited
Local Authority:	Liverpool City Council
NGR:	341335,385990
Planning App ref:	Pre determination
Author(s):	Poole, B.
Doc Ref:	LP2292C-GSR-v1.4
Date:	October 16

## Woolton Road, Allerton, Liverpool Site Code: All-Liv/MAG16

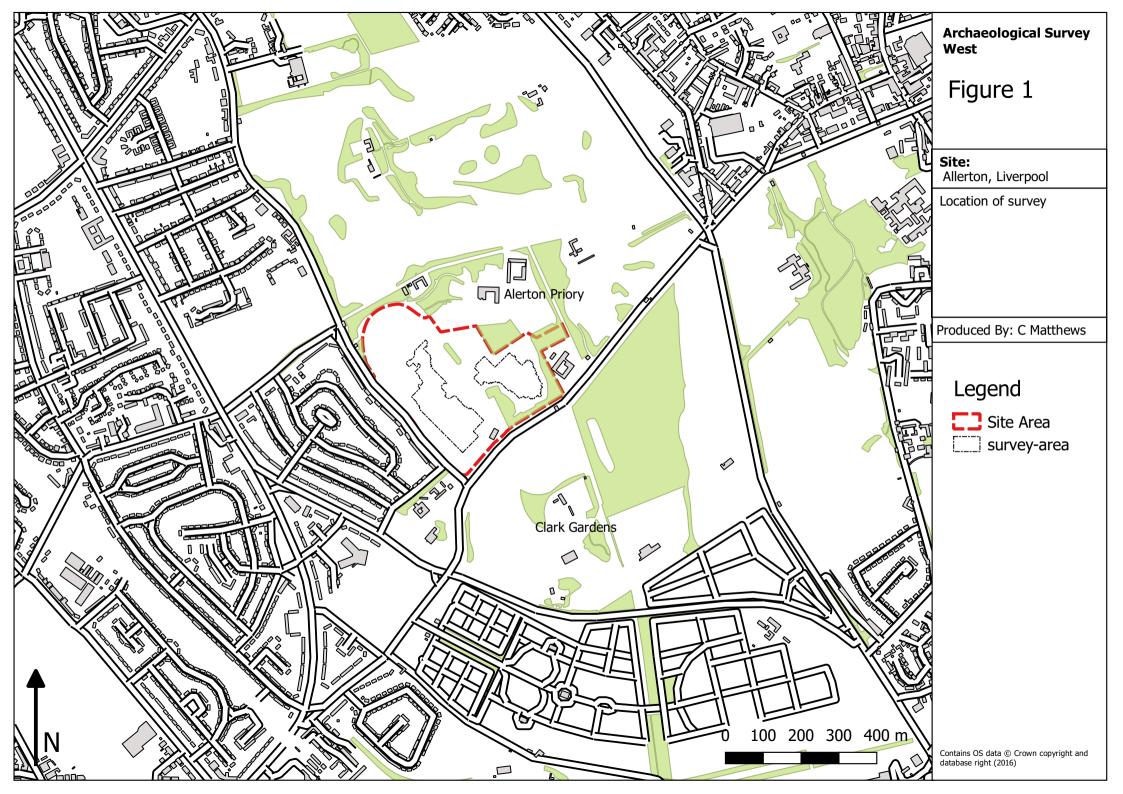
This report presents the results of an archaeological geophysics survey of 3.6 hectares of land located adjacent to Allerton Road and Allerton Priory (NGR SJ413858) [fig. 1].

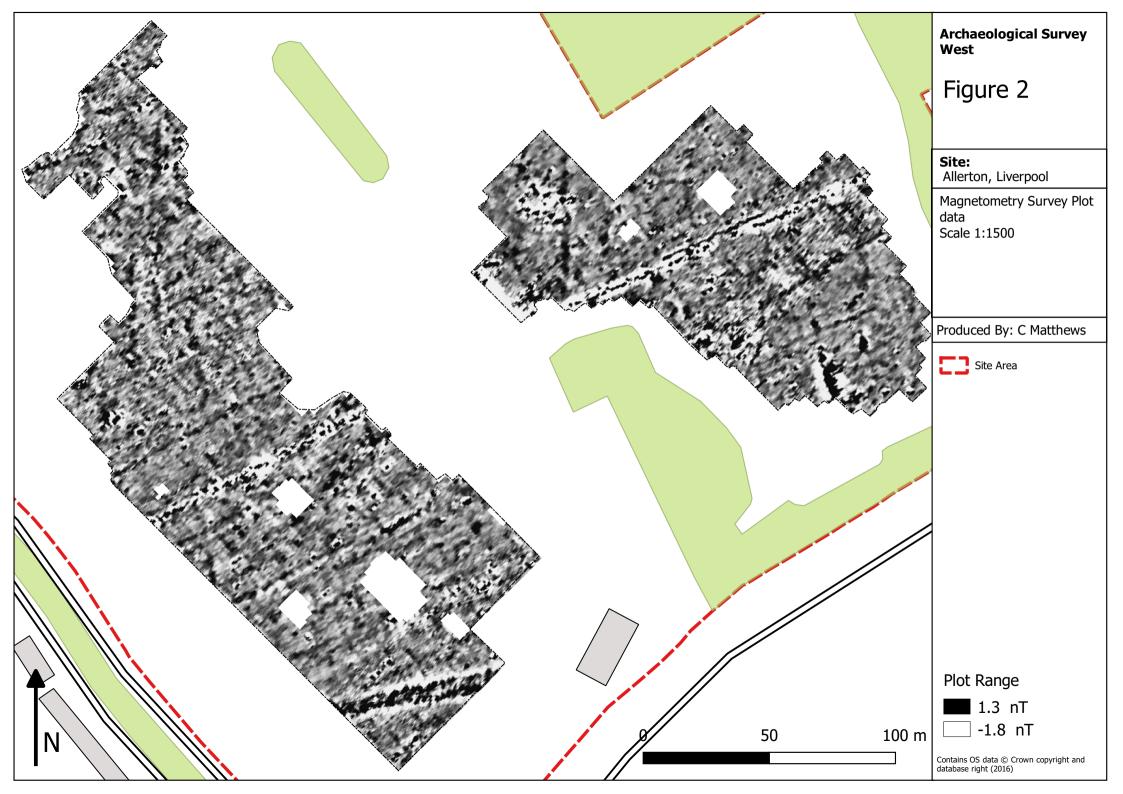
De-stripe: median, all Sensors De-stagger: all grids, both by: -1 intervals De-Spike: Threshold 1, Window size 3x3 Interpolate: Y Doubled Clip: from -1.80 to 2.20 nT

A range of clip values were used during the interrogation of the data and it was found that those detailed above provided the greatest clarity while retaining the most readings.

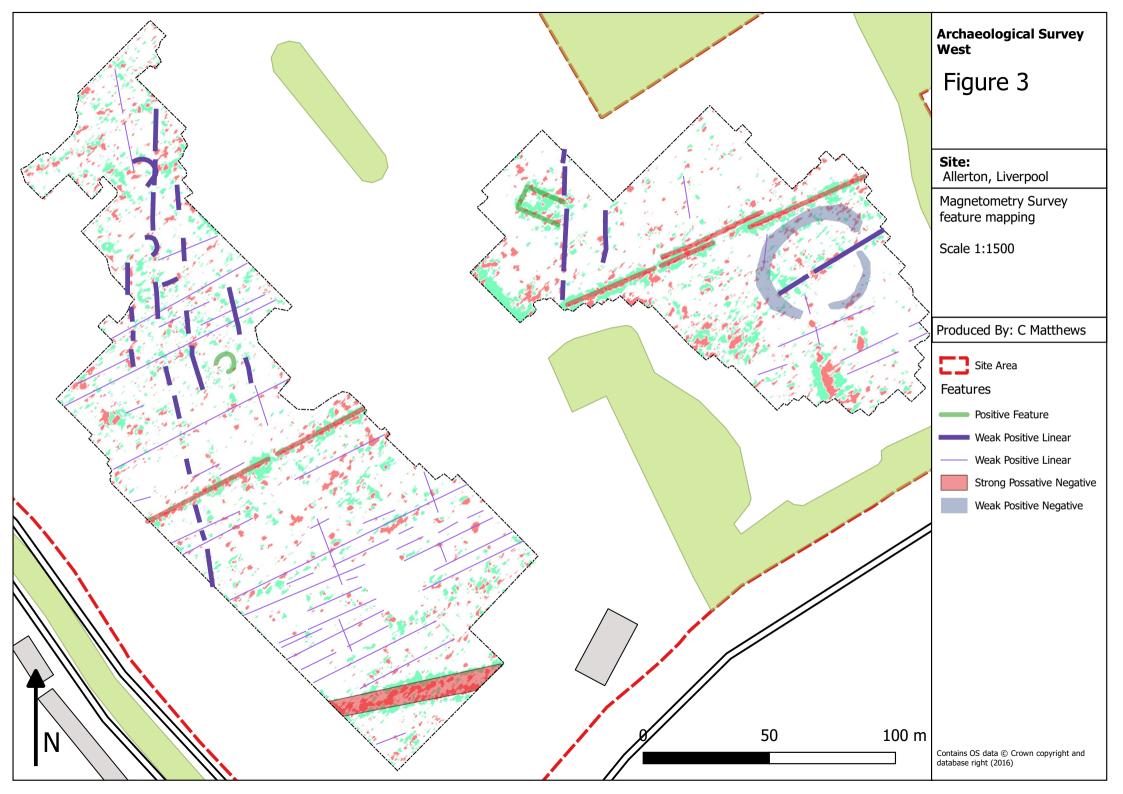
Data collected in the field was then download and processed using TerraSurveyor software version 3.0.25.0 [fig.3]. This allows the survey data to be collated and manipulated to enhance the visibility of anomalies. Full survey and processing metadata can be seen in appendix 1. The processing steps taken are as follows:

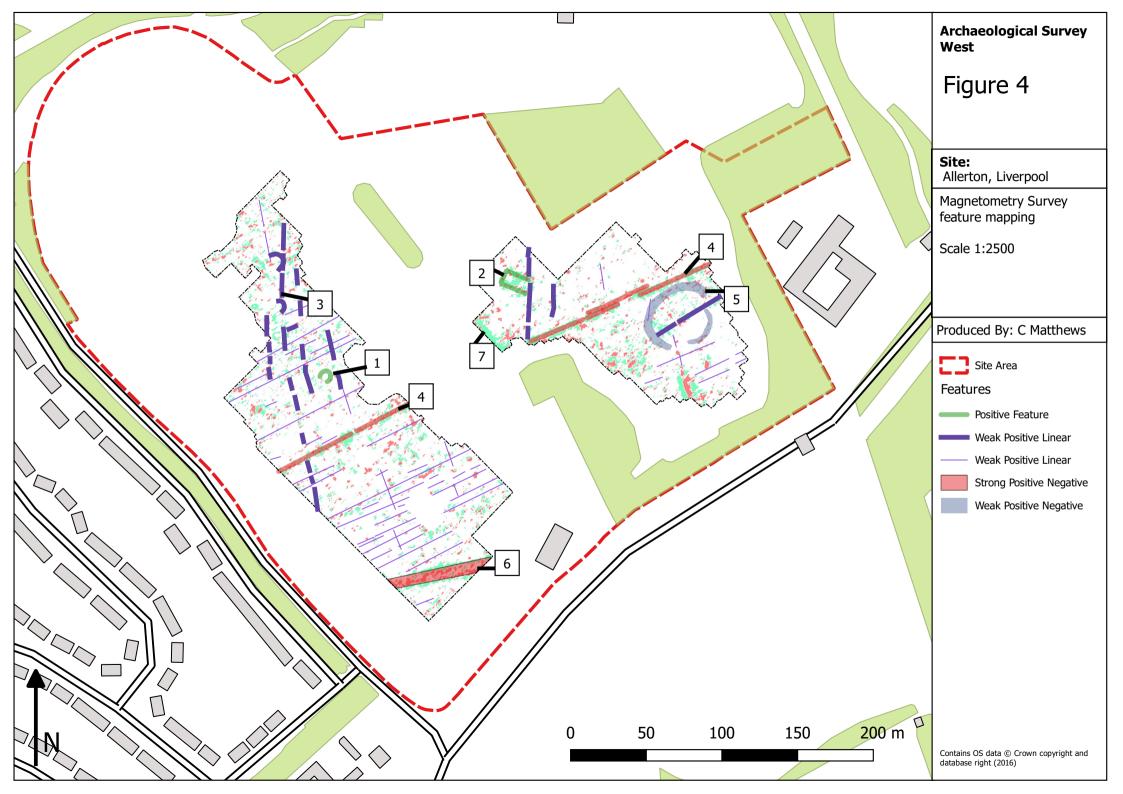
The survey data shows a number of anomalies, some of which present archaeological potential. The most prominent of these include firstly a discreet positive circular anomaly [fig.4, 1] of 7m in diameter, which may resemble early occupation although this may also form a geological feature. The second is a semi-rectangular grouping of ferrous spikes [fig.4, 2], which may represent a structure although this may also be the result of random metallic deposits. The third is an area of positive negative noise within the smaller survey area which appears to form a large circular feature [fig 4, 5], however, this may be an illusion created by the combination of overlying liniears which intersect over this area.

The most noticeable features are in the form of several linears. A strong positive negative anomaly divides the site and likely represents either a service or the remnants of a metal fence [fig 4, 4]. The later is indicated by the ferrous spikes appearing to be broken up rather than forming a continuous positive negative linear (as expected from most ferrous service lines).

A wide positive negative linear appears in the southern area of the survey [fig 4, 6]. The anomaly does not appear to resemble a primary ferrous composition, however, it may indicate the presence of fired material such as brick. The location and direction of this feature suggests that it may be connected to the former pavilion.

The large and small fields appear to be divided by a substantial service as indicated by the strong negative response in the south western portion of the smaller survey area [fig 4, 7].

The site is widely covered by weak positive linears running north south and east west. The north south linears (which run parallel to the possible fence [feature]) appear to from regular ploughing over a large open area. The wider and less organized east-west positive linears may represent earlier ploughing or low fired ceramic field drains.

- **3.2.**Crossing the site in a northeast-southwest alignment is a strong anomaly (No4), which may represent the remnants of a metal fence line. However, it is more likely that this actually represents a modern buried cable.
- **3.3.** A wide linear (No6) appears in the southern portion of the survey area, thought to be of fired material such as brick. It is likely that this represents a buried service, such as a culvert or drain dating to the Post Medieval or Modern period.
- **3.4.**Running north-south in the centre of the study area is a linear (No7) which is thought to be a modern buried service.

3.5.The site is widely covered by weak positive linears running north-south and east-west. These are thought to represent ploughing activity, which includes anomaly no 3.

- **3.6.**A small circular anomaly (No1) may represent evidence of early settlement, however it is more likely that this is a geological feature. This anomaly lies outside of the areas of impact.
- **3.7.**A grouping of ferrous spikes (No2) has been suggested as possibly representing a structure. However, the nature of the spikes is more suggestive of a random spread of metallic points, probably waste form modern activity. This anomaly lies outside the areas of impact.
- **3.8.** A large circular feature (No5) can be seen in the east of the study area. This has been suggested as representing an enclosure, however on closer examination it appears that these are overlying linears which intersect in this area and could relate to later

- **3.10.**It is suggested that anomalies 4, 6 and 7 are not investigated as they appear to be modern intrusions, likely Post Medieval to Modern services. It is also suggested that the agricultural linears, including anomaly 3, are not targeted as these are thought to represent Post Medieval ploughing activity. Anomalies 1 and 2 lie outside the areas of impact and as such will not be disturbed by groundworks and have been excluded from further investigation.

- **3.11.**Target trenches are suggested on anomaly 5. This is based on the potential that this may relate to earlier settlement activity. It should be noted that although the geophysics surveyor has indicated a potential early origin for the features, the data is not wholly convincing and this could represent geological or modern activity.
