ISSUED FOR PLANNING ONLY, NOT FOR CONSTRUCTION

Rev. No.	Scale	Date	Des. By	Chkd. By	Issue
	1:100@A1	17/06/2015	J. Lynch	Tim Dermody	PLANNING

Project:	Tobacco Warehouse at Stanley dock Stanley Dock, Liverpool
Title:	GATES SOUTH-EAST EXISTING & PROPOSED
Client:	Stanley Dock Properties Ltd.
Dwg. No.	PA-422
Job No.	1523

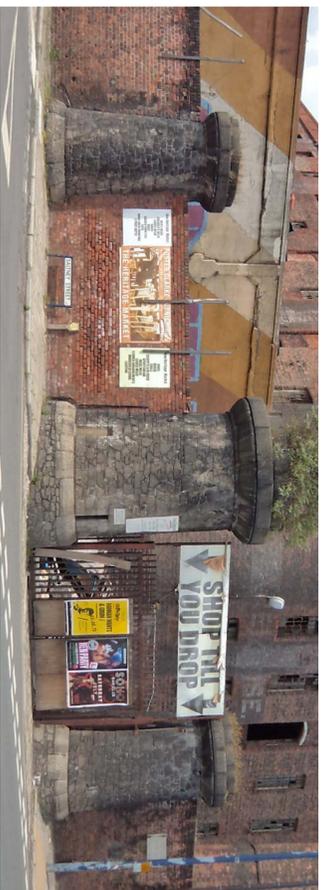
IMAGE REFERENCE: EXISTING ENTRANCE CONDITION AT CORNER OF SALTNEY & GREAT HOWARD STREET.

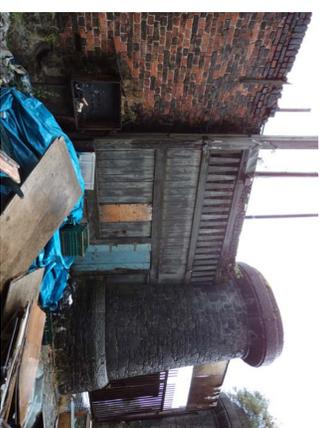
IMAGE REFERENCE: SITE INTERNAL VIEW - FIXED SLIDING GATE

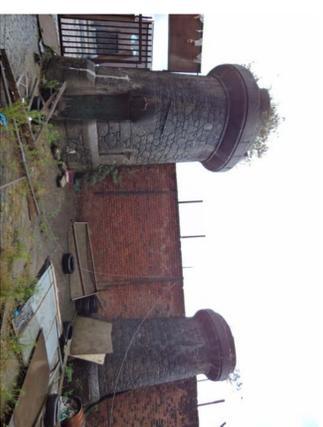
IMAGE REFERENCE: SITE INTERNAL VIEW - EX. BRICK WALL INFILL

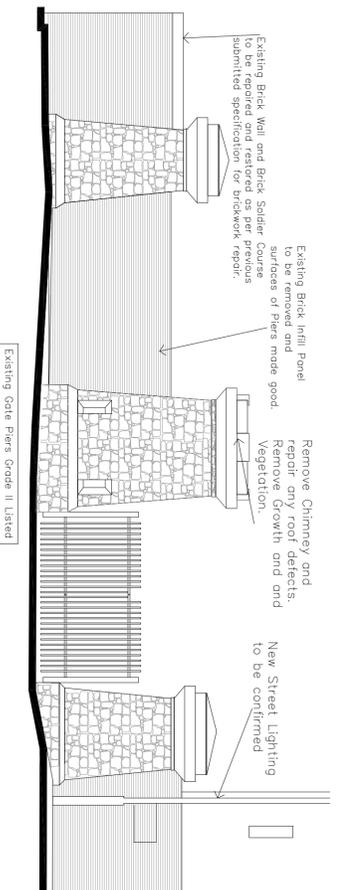
1 Existing Elevation  
PA422 1:100

Existing Brick Wall and Brick Solder Surfaces of Piers made good. To be repaired and restored as per previous submitted specification for brickwork repair.

Remove Chimney and Repair any roof defects. Remove Growth and Vegetation.

New Street Lighting to be confirmed.

Existing Gate Piers Grade II Listed

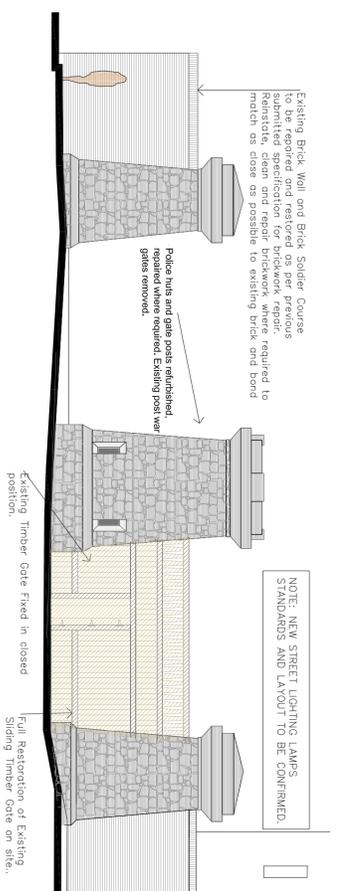
3 Elevation Detail Proposed  
PA422 1:100

Existing Brick Wall and Brick Solder Course to be repaired and restored as per previous submitted specification. Repoint, clean and repair brickwork where required to match as close as possible to existing brick and bond.

Police huts and gate posts refurbished, repaired where required. Existing post wall gates removed.

Existing Timber Gate Fixed in closed position.

Full Restoration of Existing Sliding Timber Gate on site.

NOTE: NEW STREET LIGHTING LAMP STANDARDS AND LAYOUT TO BE CONFIRMED.

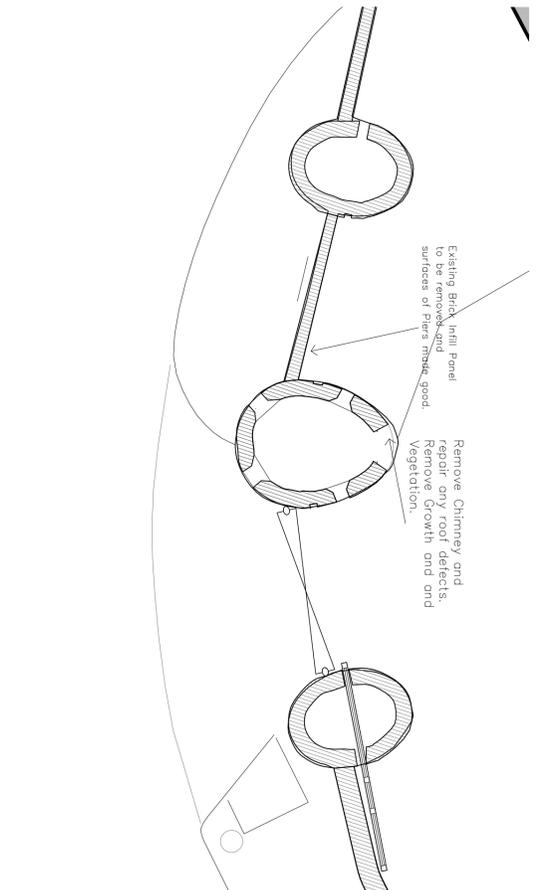
2 Plan Existing  
PA422 1:100

Existing Brick Infill Panel to be removed and surfaces of Piers made good.

Remove Chimney and repair any roof defects. Remove Growth and Vegetation.

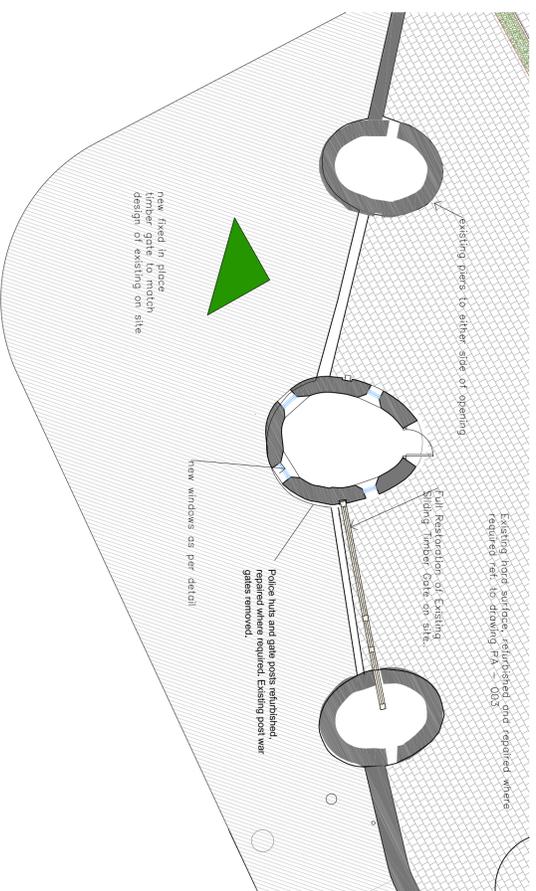
4 Plan Detail Proposed  
PA422 1:100

Existing pier to either side of opening.

new fixed in place timber gate to match design of existing on site.

Full Restoration of Existing Sliding Timber Gate on site.

Existing Iron and Stone, damaged and repaired where required. Refer to Ref. as drawing PA-005.

Police huts and gate posts refurbished, repaired where required. Existing post wall gates removed.

new windows as per detail.
