**PHASE 1
GROUND CONDITION
SURVEY**

**Residential Apartments
Clegg Street
Liverpool
L5 3LD**

Report Ref: 10/1085/001

PHASE 1 GROUND CONDITION SURVEY REPORT PROPOSED RESIDENTIAL APARTMENTS, CLEGG STREET, LIVERPOOL

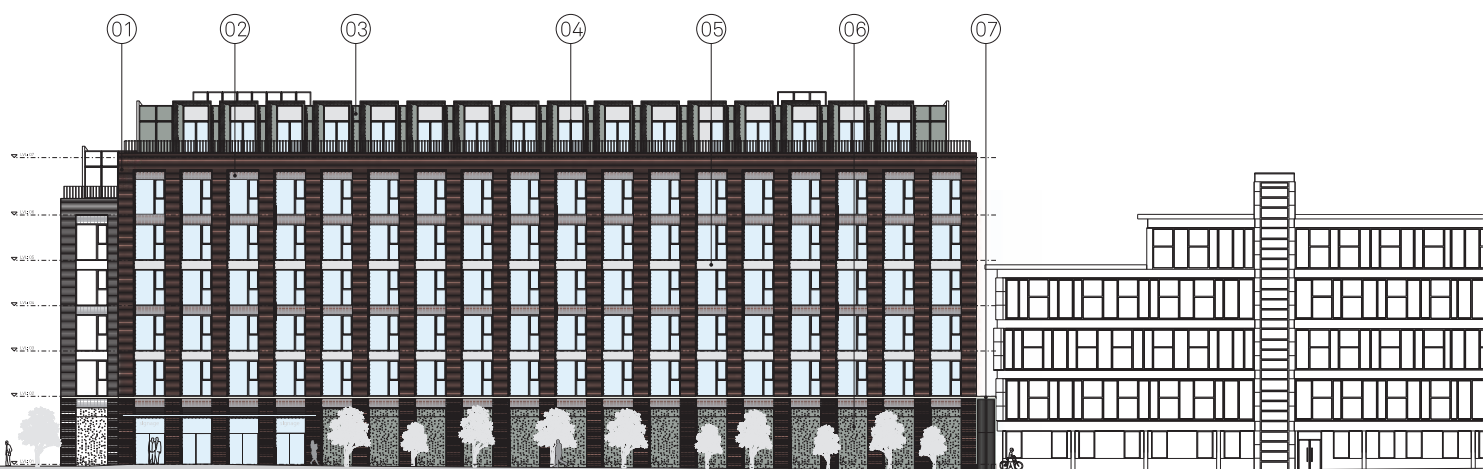
Drawing Title
Elevation 01

1. Autumn Red Brick Stretcher Bond
2. Autumn Red Brick Stack Bonded
3. Aluminium Rain Screen Cladding - Colour TBC
4. Aluminium Window Curtain Walls and Doors - Colour TBC
5. Opaque Glass Infill Panel - Colour TBC
6. Perforated and Embossed Aluminium Cladding - Colour TBC
7. Stone / Concrete Feature Cornice
8. Aluminium / Glass Canopy
