# PHASE 2 GROUND INVESTIGATION

Lidl Great Britain Ltd  
Childwall Road, Wavertree

714.02.01  
May 2020

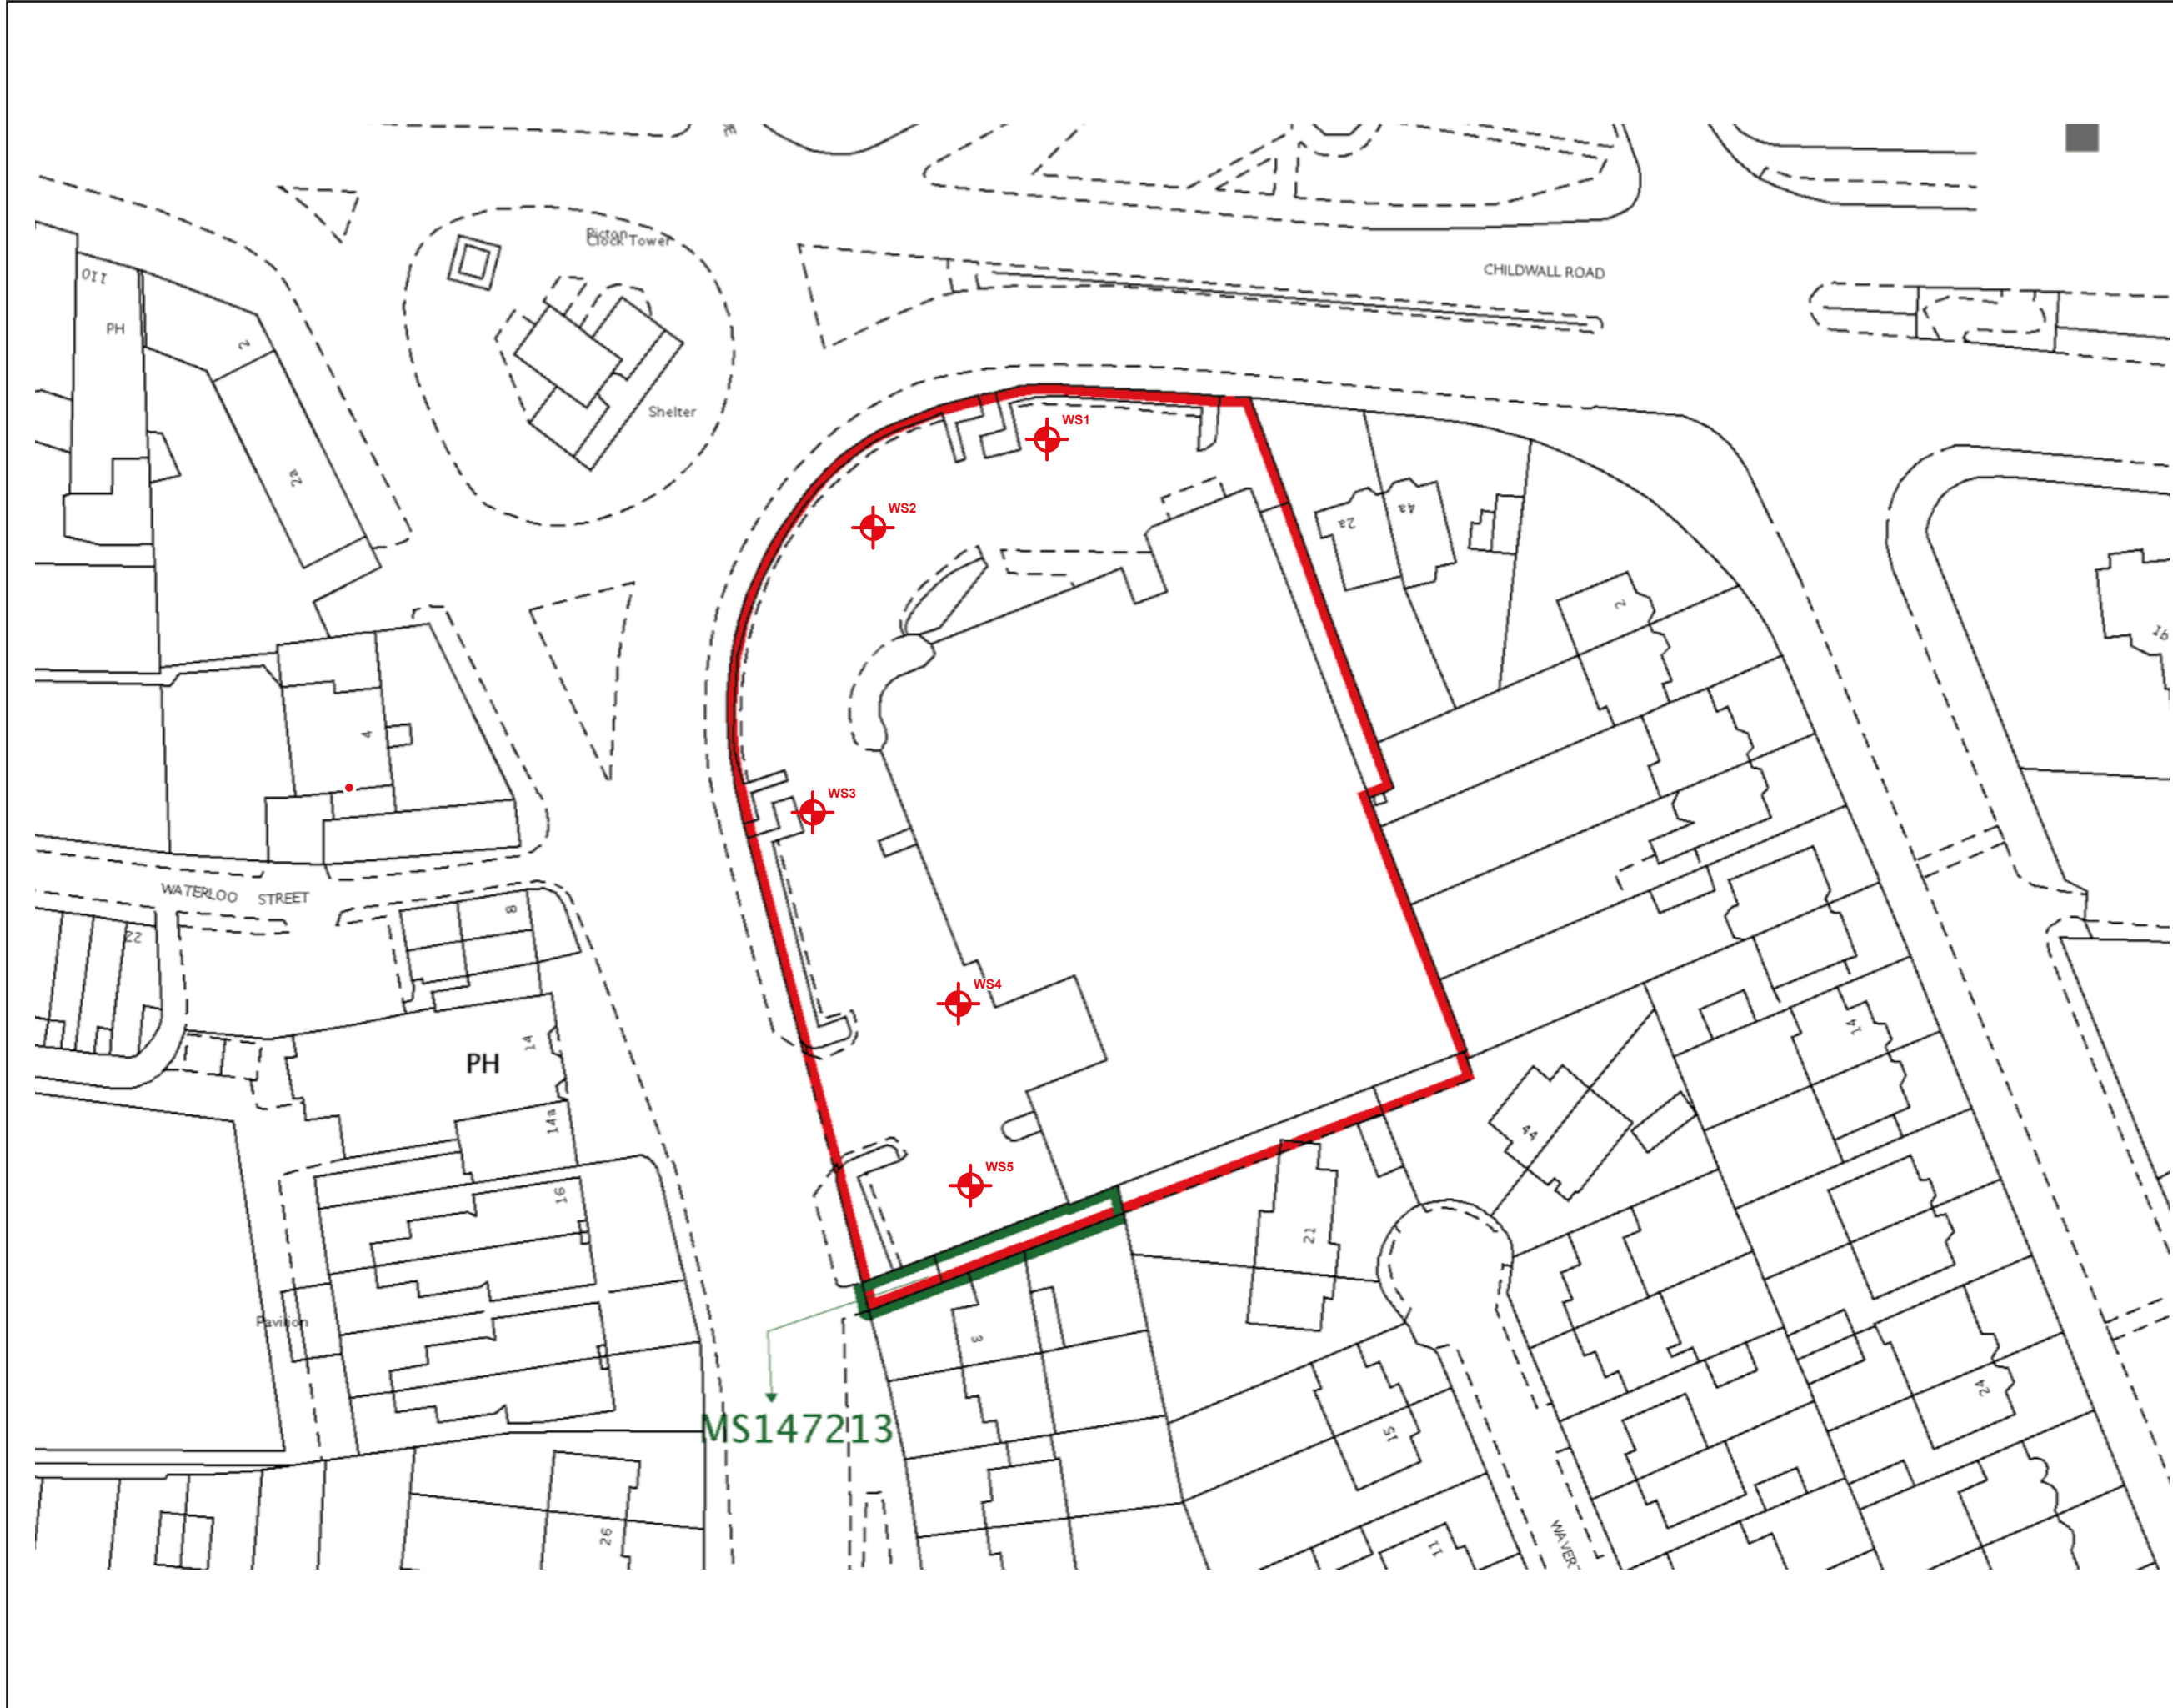
| Figure 2 | Existing Layout and Exploratory Location Plan |

The investigation comprised the drilling of eight (5 No) window sample holes (WS1 – WS5) at locations indicated on **Figure 2** on 2<sup>nd</sup> April 2020. The Coop retail store on-site was still active at the time of Remada's intrusive investigation, restricting access to just the existing store's car park area to minimise disruption.

Due to the operational nature of the Coop food store at the time of Remada's investigation, all five exploratory holes were located within the car park area, as indicated in **Figure 2**. Across the Coop store car park area, made ground was found to extend to depths of between 0.27m and 0.8m bgl, resting directly upon weathered sandstone bedrock. SPT refusals (N value > 50) were recorded within this latter stratum at depths of between 0.6m and 0.9m bgl. Due to the minimal presentation, the corrected N-values for full depth would be more than ten times greater.
