**Buildings at 86 – 90 Duke Street,
Liverpool**

Bat Roost Assessment Survey Report

for the Langtree Group

Report Reference:	SE479/J/03/JO
Author:	Richard Castell
Checked + approved by:	Dr David Hackett
Version:	3 rd

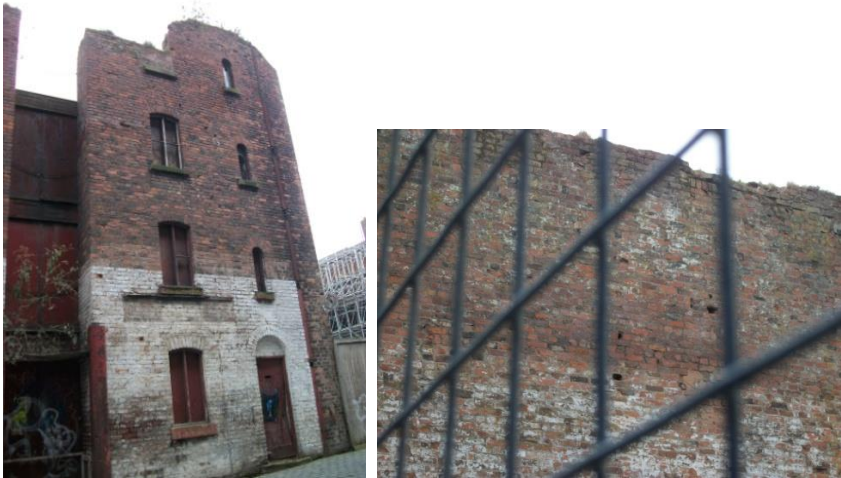
<p>It is not clear externally how much of this building remains. The view from Google Maps suggests that there is no interior of this building but that there is a large amount of vegetation growing within the enclosing walls which could provide feeding habitat. Cavities in brick work mainly on east sidewall overlooking open space. One cracked and one open window to front. The brickwork will be warmed by the sun on the south and east side.</p>	Low – offers a small number of potential (opportunistic) roosting sites in brickwork but unlikely to be a maternity site.
2	71 Henry Street

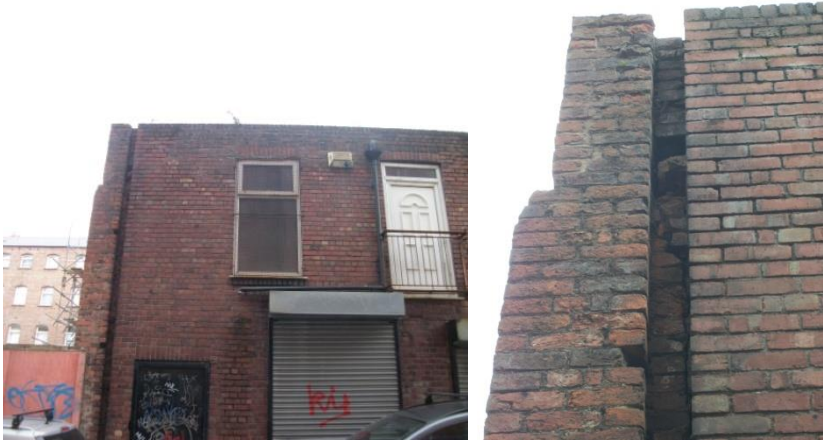
<p>Some gaps in mortar on roof visible from east side. Cracks in crevice of brickwork on left side of frontage to Henry Street. Some parts of roof removed but there appears to be an intact flat roof section to rear. Gaps under barge board of flat roof. Dead rat observed in front of building. Further rats likely to be in this building as rat-sized hole observed at bottom of door.</p>	Low – offers a small number of potential (opportunistic) roosting sites mainly in crevice in brickwork but unlikely to be a maternity site.

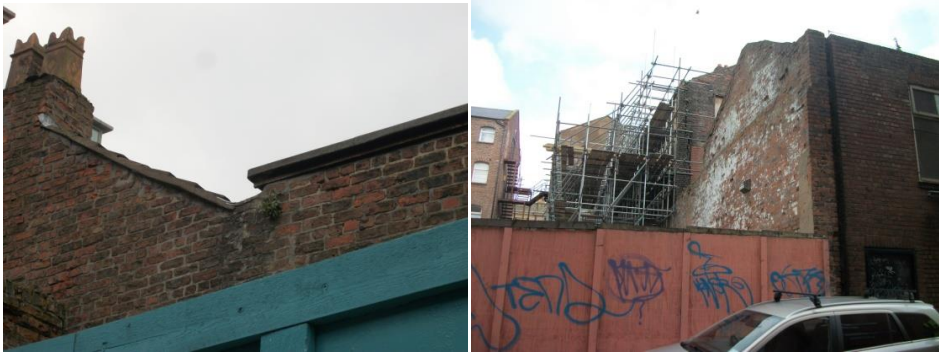
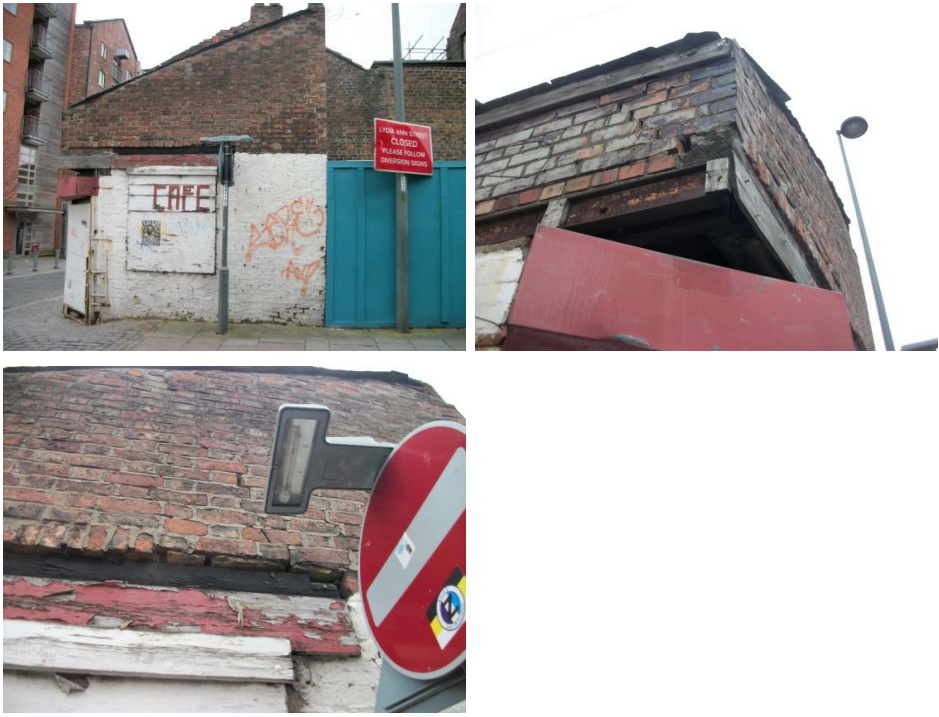
3	Former cafe, 14 Suffolk St

Gaps under brickwork by corner door, above wooden beam, above window and under a slate tile on roof.	Low – offers a small number of potential (opportunistic) roosting sites but unlikely to be a maternity site

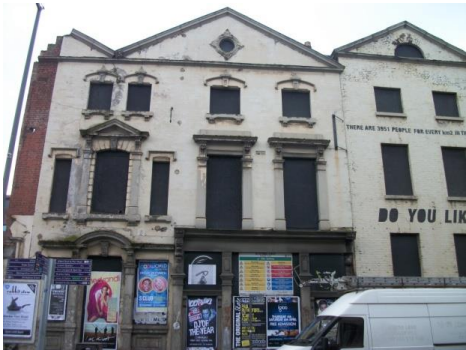
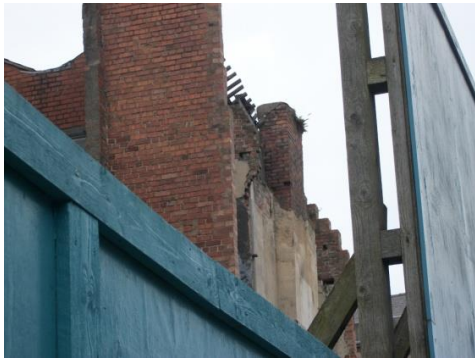
<p>Building 4 is the remains of the redbrick building (shown on the left of the Duke Street frontage in this photograph). It is a long thin building which historically extended along most of the length of Suffolk Street. Only the wall shared with the neighbouring property appears to remain. A few crevices were observed in brickwork but they did not appear to be deep or enclosed sufficiently to provide adequate roost potential for bats. However closer observation was not possible due to fencing and boarding around this portion of site.</p>	Very low
5	88-90 Duke St (centre of Duke St frontage)

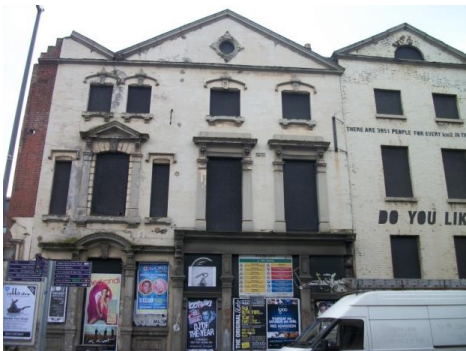
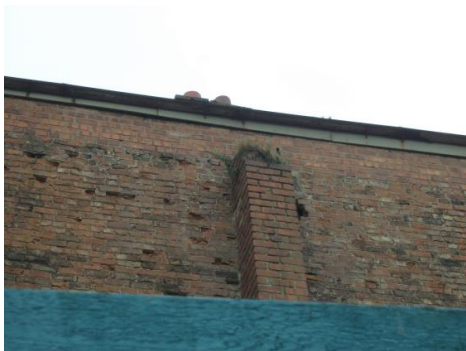
<p>Building 5 is the middle building shown in this photograph. The façade facing Duke Street looks intact and has tightly boarded windows and doors which appeared to offer no entry points for bats. Viewing the east side of this building from behind the fencing, along Suffolk Street, revealed holes and crevices in brickwork. The west side of the rear of this building is partly held up by scaffolding, situated in the central area of bare ground to the rear. There is potentially a loft void in the pitched roof.</p>	Low - offers a small number of potential (opportunistic) roosting sites in crevices along east side but unlikely to be a maternity site. However potential loft void could not be assessed as internal inspection of buildings was not possible during this survey.

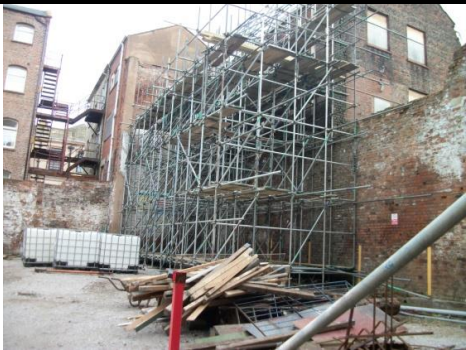
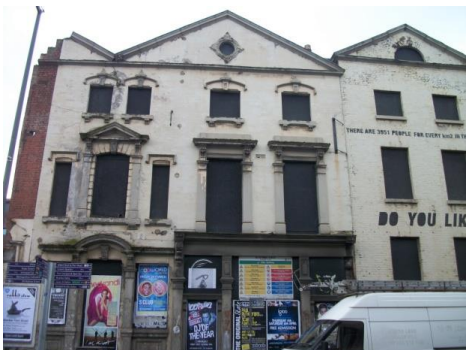
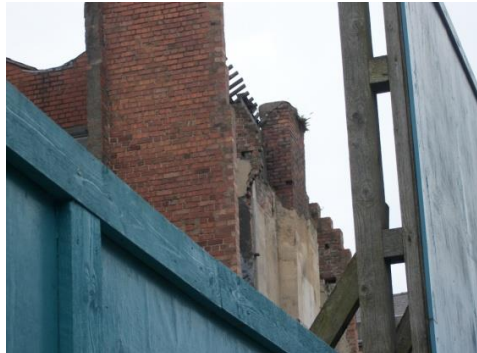
6	86 Duke St (right of Duke St frontage)

<p>Building 6 is the right-hand building shown in this photograph. The façade facing Duke Street and the west side looks intact and has tightly boarded windows and doors so offered no bat entry points. The east side and the rear of the property adjoin Building 5.</p> <p>There is potentially a loft void in the pitched roof.</p>	<p>Very low as building is tightly sealed on all exposed sides. However potential loft void could not be assessed as internal inspection of buildings was not possible during this survey.</p>

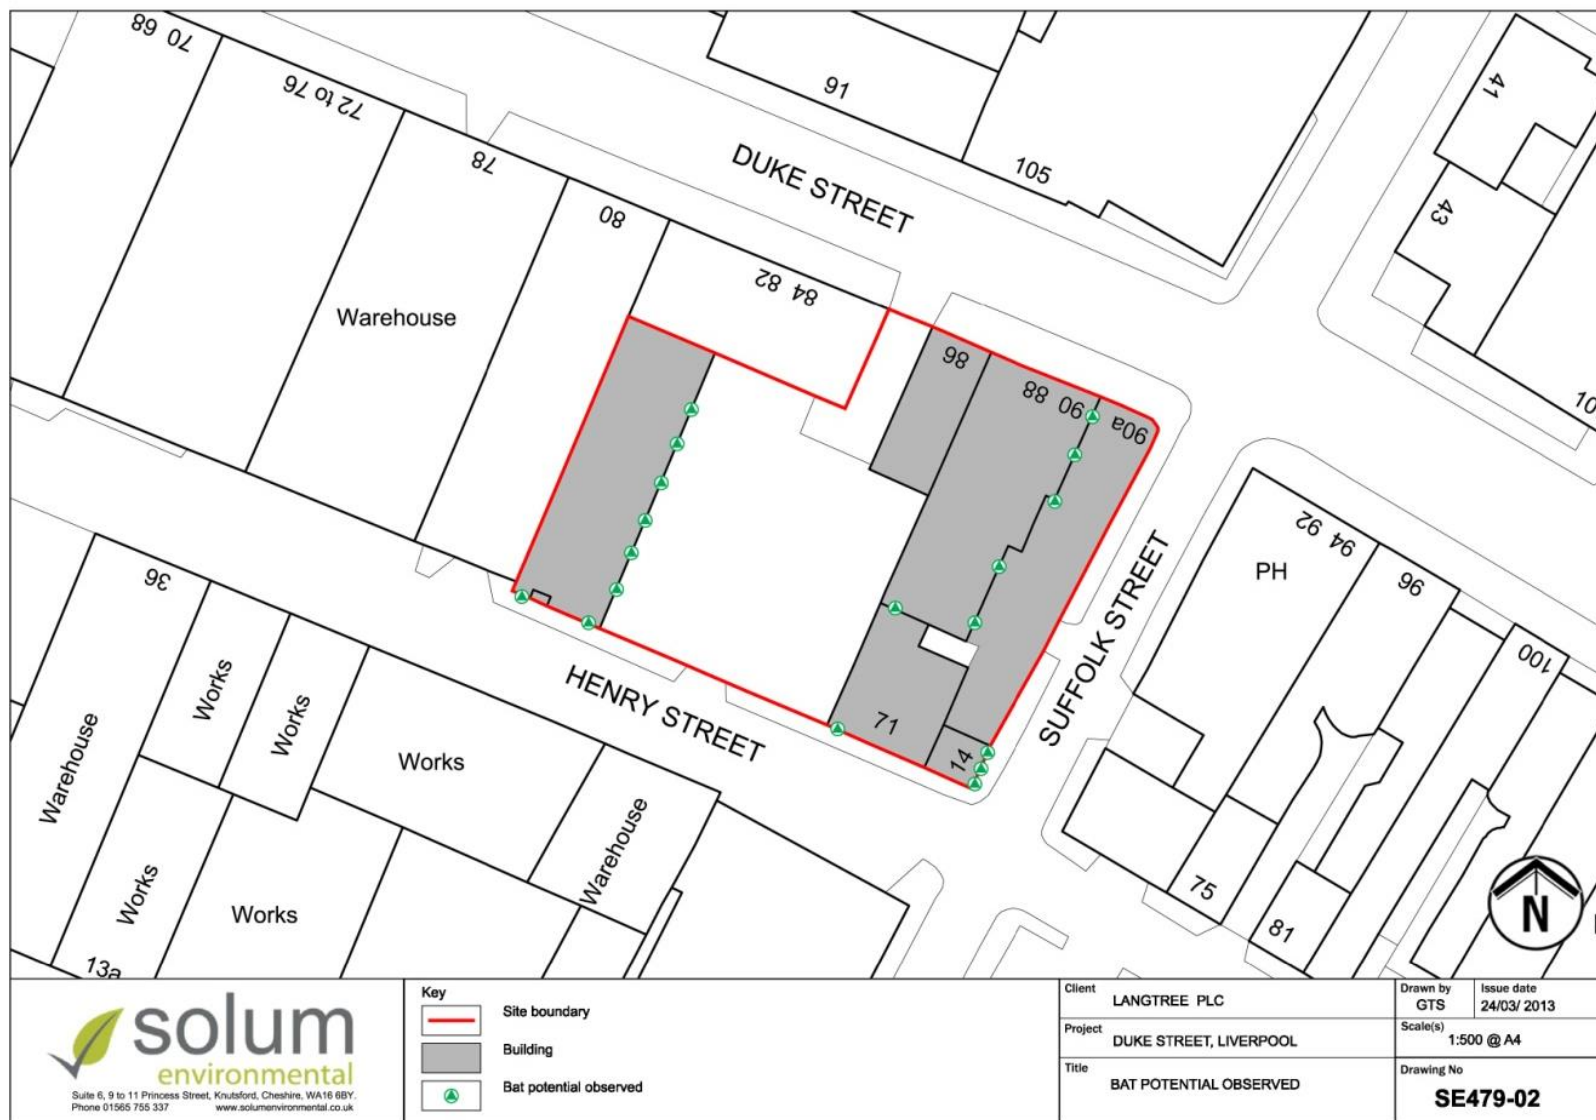
Plan 4 : Bat Roost Potential of Collection of Buildings

- 5.3.1 Table 1 below provides photographs and descriptions of each building and sets out an assessment of each building's potential to support bats.
- 5.3.2 Plan 4 below shows the approximate locations of features on this collection of buildings which showed potential for roosting bats.

- 6.5 Restricted access to the buildings only permitted a preliminary assessment of their potential to support roosting bats, the probability of which was deemed as low. However given that the presence of bats could not be ruled out, the following actions are recommended for this site:

- If possible (should suitable planning consent or demolition notices be in place) a 'soft-strip' demolition should be undertaken outwith the hibernation and summer activity periods (see Appendix 1), as guided by a qualified bat ecologist. During this demolition a licensed bat ecologist should be present on site at all times to legally handle and safely remove any bats found to be roosting within these buildings. Further details are given at Appendix 2.

- If this is not possible (given the timescales for consideration of planning applications) then best practice guidelines outlined set out in the Bat Conservation Trust guidelines should be followed, in order to confirm the presence or absence of a roost (Hundt L, Bat Surveys: Good Practice Guidelines 2nd edition, published 2012). This would require a single dusk emergence /activity or dawn re-entry / activity survey to be carried out at this site between May and September inclusive (the optimum time being May to August). In line with BCT guidelines a minimum of three surveyors would be required to cover all sightlines of the building. Should any bats be found emerging or re-entering any of these buildings during this survey then the building would be confirmed as hosting a bat roost and no works should be carried out on the building until a licence to derogate from the Conservation of Habitats and Species Regulations 2010 is obtained from Natural England.
