**PHASE I
GEO-ENVIRONMENTAL
DESK STUDY**

**Proposed Development
St James Court
St James Street
Liverpool
L1 0NB**

Report Ref: 10/1004/001

PHASE 1 GEO-ENVIRONMENTAL APPRAISAL REPORT ST JAMES COURT, LIVERPOOL

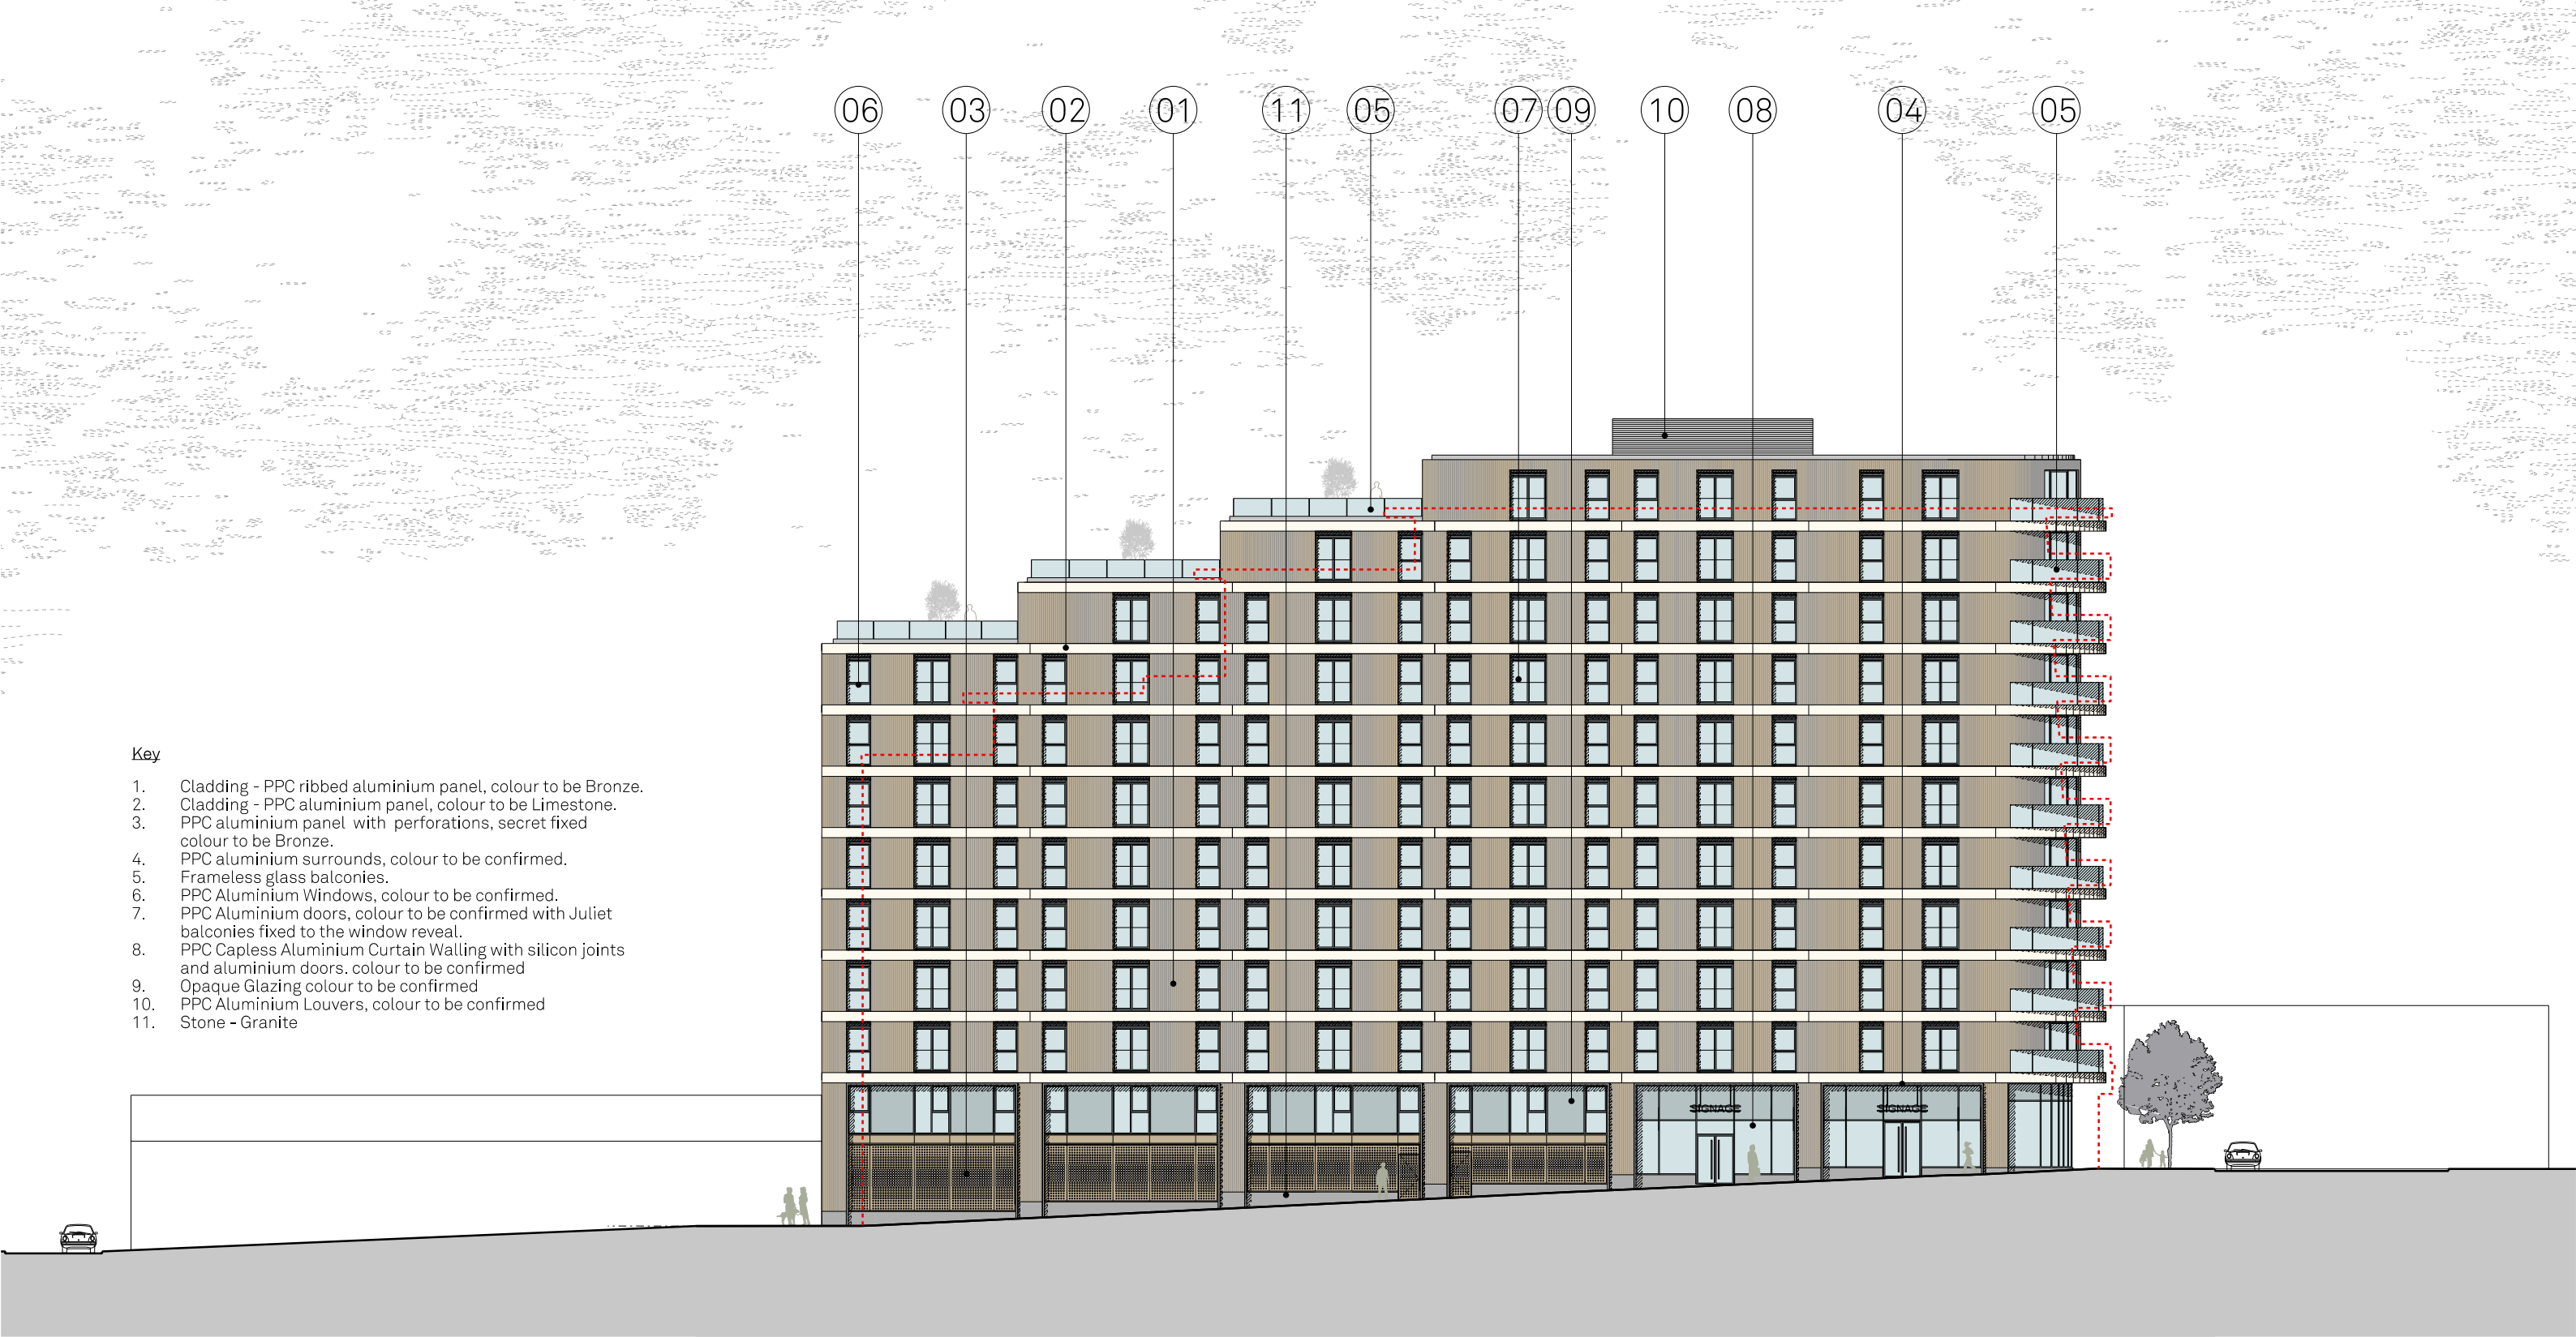
Drawing No.
02-05-001D

1. Cladding - PPC ribbed aluminium panel, colour to be Bronze.
2. Cladding - PPC aluminium panel, colour to be Limestone.
3. PPC aluminium panel with perforations, secret fixed colour to be Bronze.
4. PPC aluminium surrounds, colour to be confirmed.
5. Frameless glass balconies.
6. PPC Aluminium Windows, colour to be confirmed.
7. PPC Aluminium doors, colour to be confirmed with Juliet balconies fixed to the window reveal.
8. PPC Capless Aluminium Curtain Walling with silicon joints and aluminium doors. colour to be confirmed
9. Opaque Glazing colour to be confirmed
10. PPC Aluminium Louvers, colour to be confirmed
11. Stone - Granite

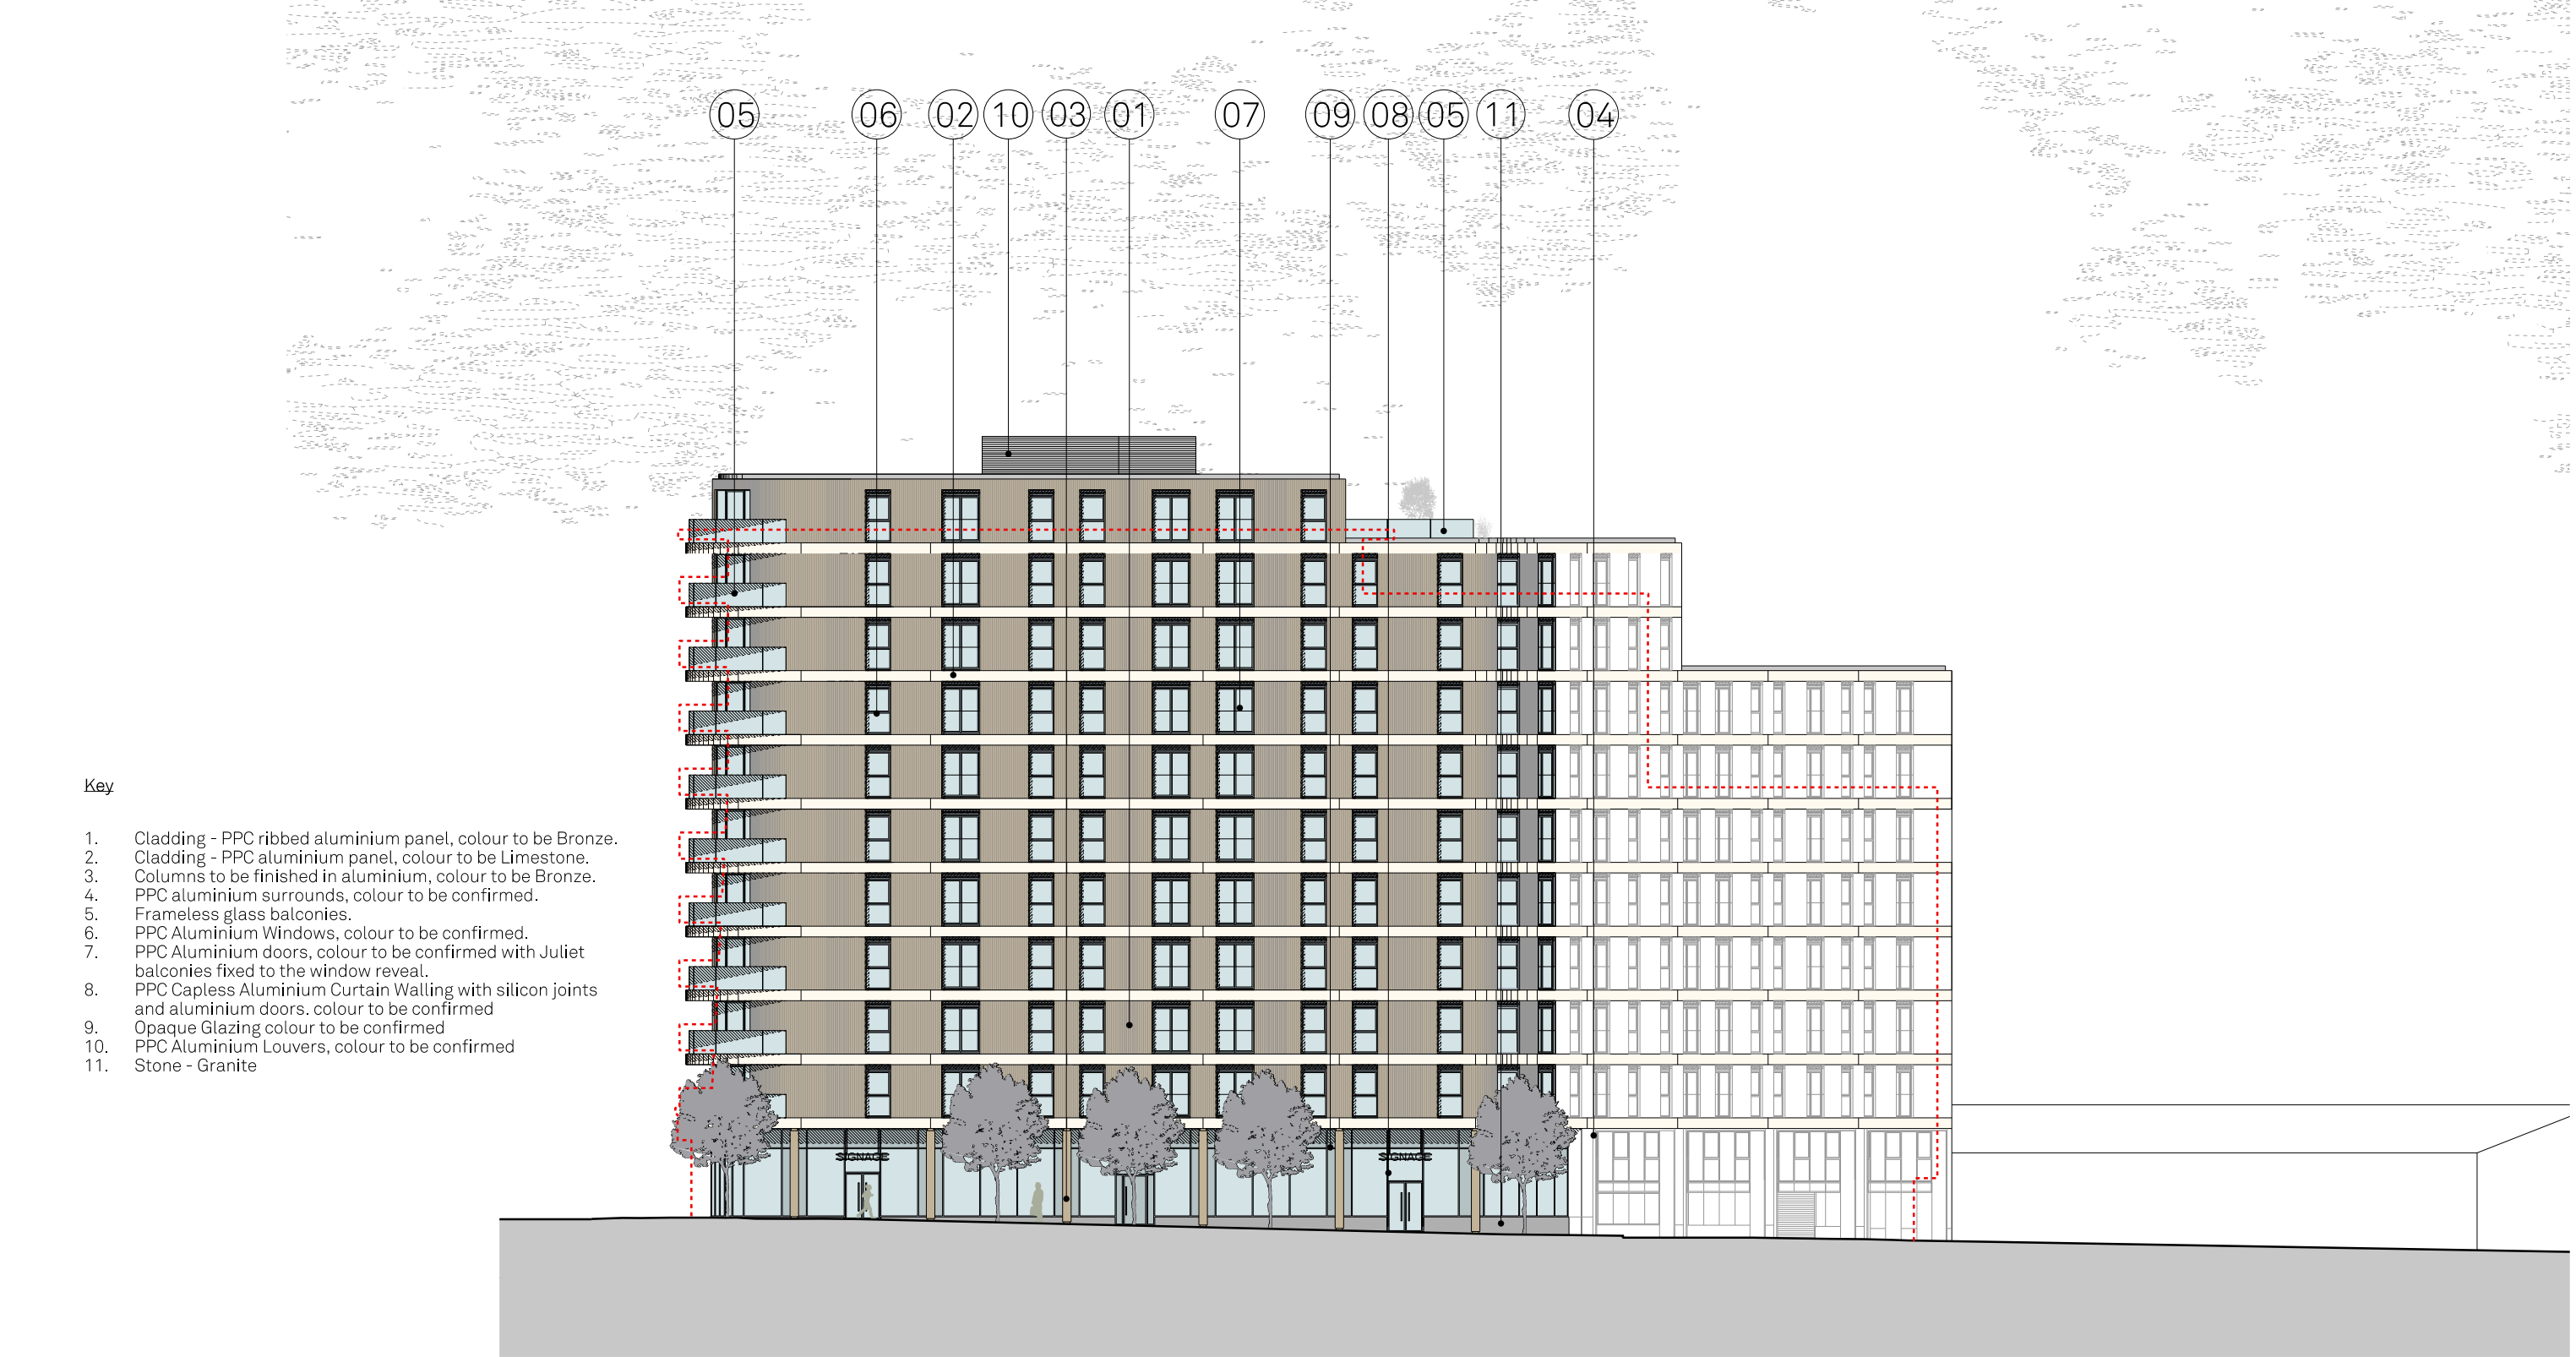
1. Cladding - PPC ribbed aluminium panel, colour to be Bronze.
2. Cladding - PPC aluminium panel, colour to be Limestone.
3. Columns to be finished in aluminium, colour to be Bronze.
4. PPC aluminium surrounds, colour to be confirmed.
5. Frameless glass balconies.
6. PPC Aluminium Windows, colour to be confirmed.
7. PPC Aluminium doors, colour to be confirmed with Juliet balconies fixed to the window reveal.
8. PPC Capless Aluminium Curtain Walling with silicon joints and aluminium doors. colour to be confirmed
9. Opaque Glazing colour to be confirmed
10. PPC Aluminium Louvers, colour to be confirmed
11. Stone - Granite
