## EXECUTIVE SUMMARY

The purpose of this report is to assess the potential for disposing of surface water through a Sustainable Drainage System (SUDS) at 18 Livingstone Drive, Liverpool, L17 4LR.

18 Livingston Drive

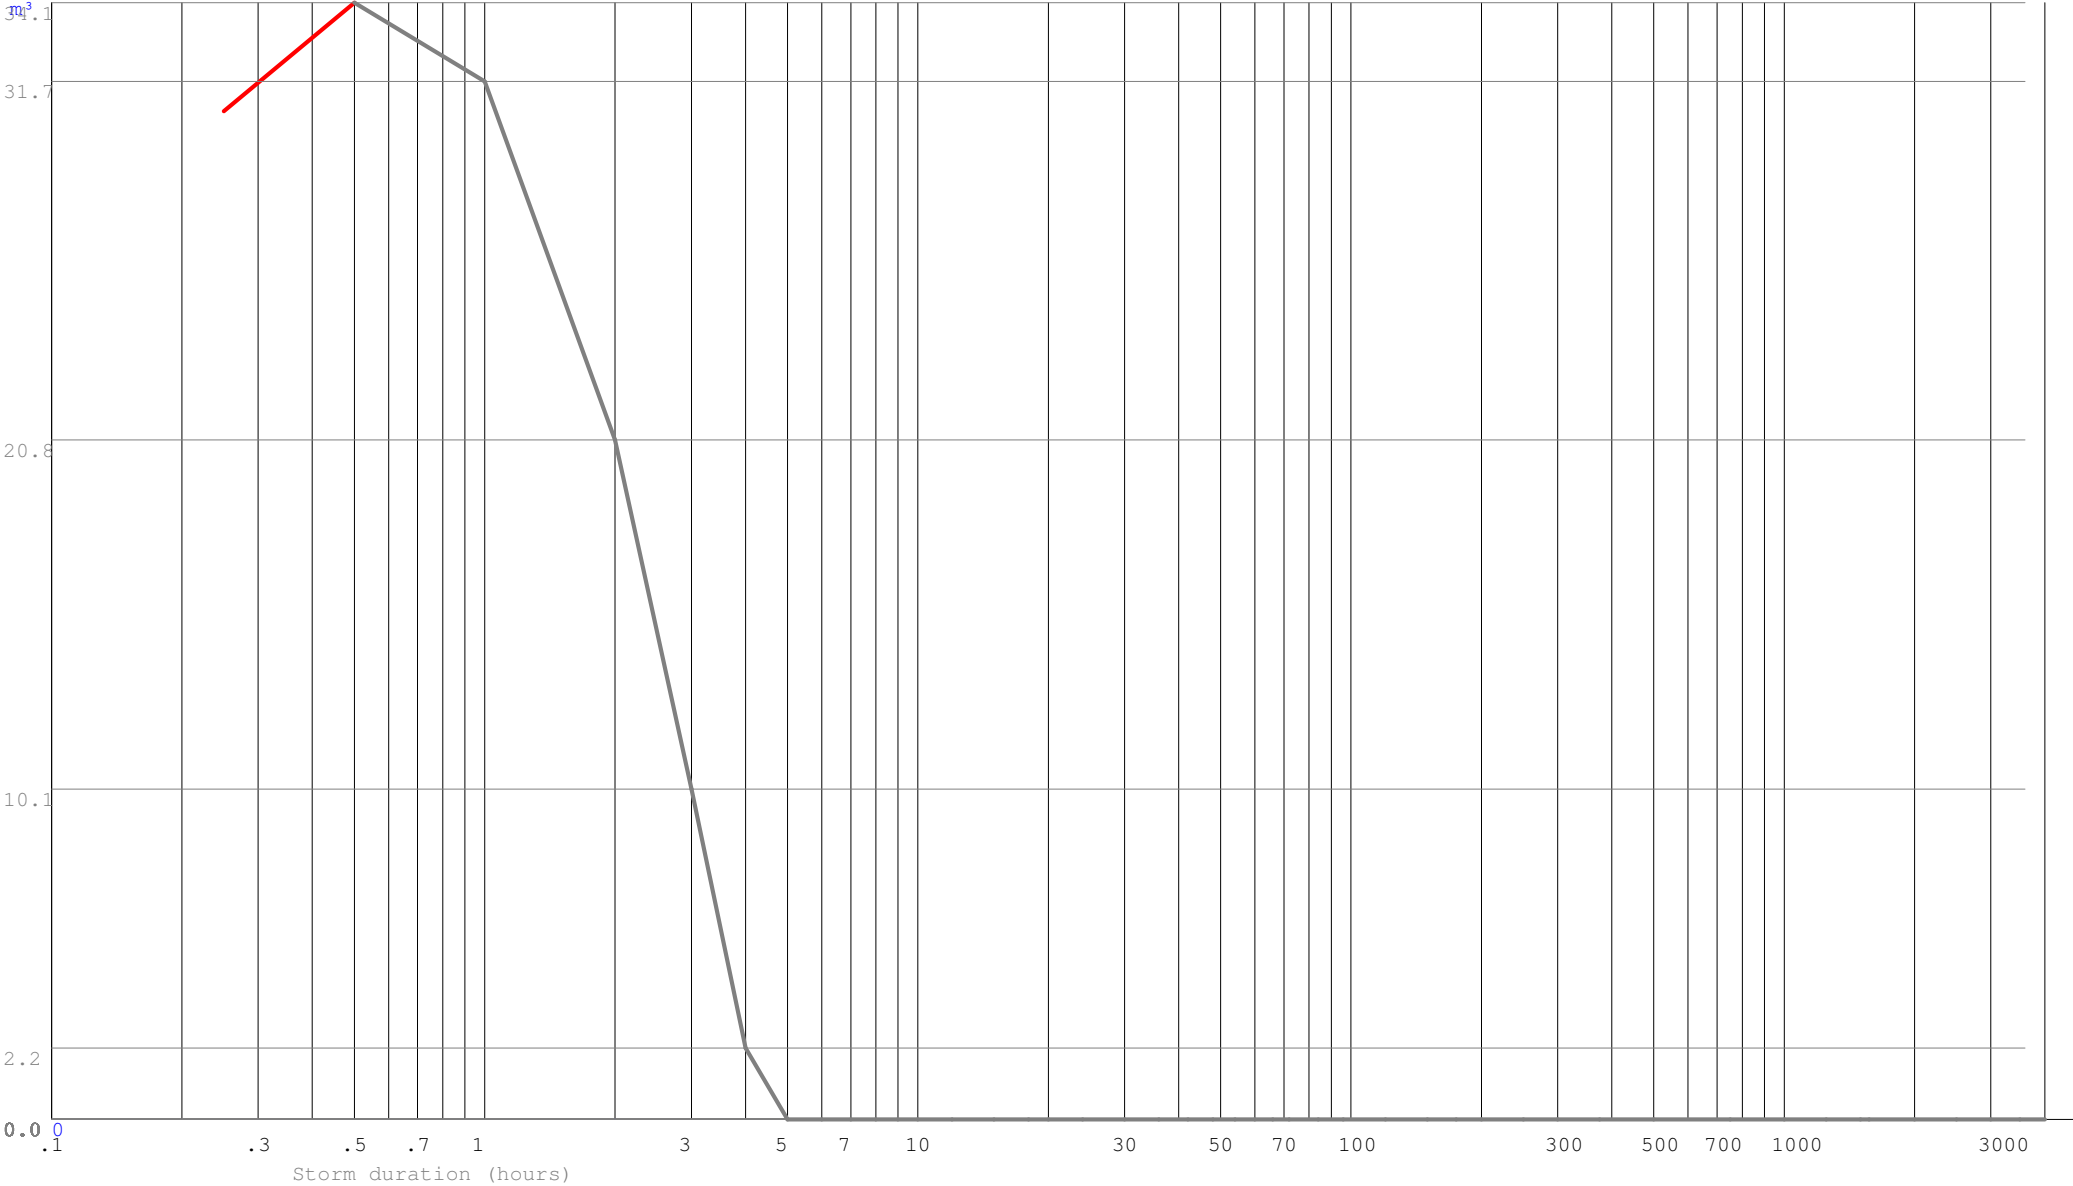
Sequential storage volume at specific storm durations.

The size of the storage has been calculated such that the proposed development has the capacity to accommodate the 1 in 100 year rainfall event including a 30% increase in rainfall intensity that is predicted to occur as a result of climate change. Consequently, all areas drained have been designed to accommodate a 100 year (+30% climate change) storm event. An attenuation storage volume of 34.10m<sup>3</sup> will be required.
