# Tree Survey and Constraints Report

Erskine Road, Liverpool

Report prepared for Baltic 1014 Ltd

Detail:  
Tree Constraints Plan

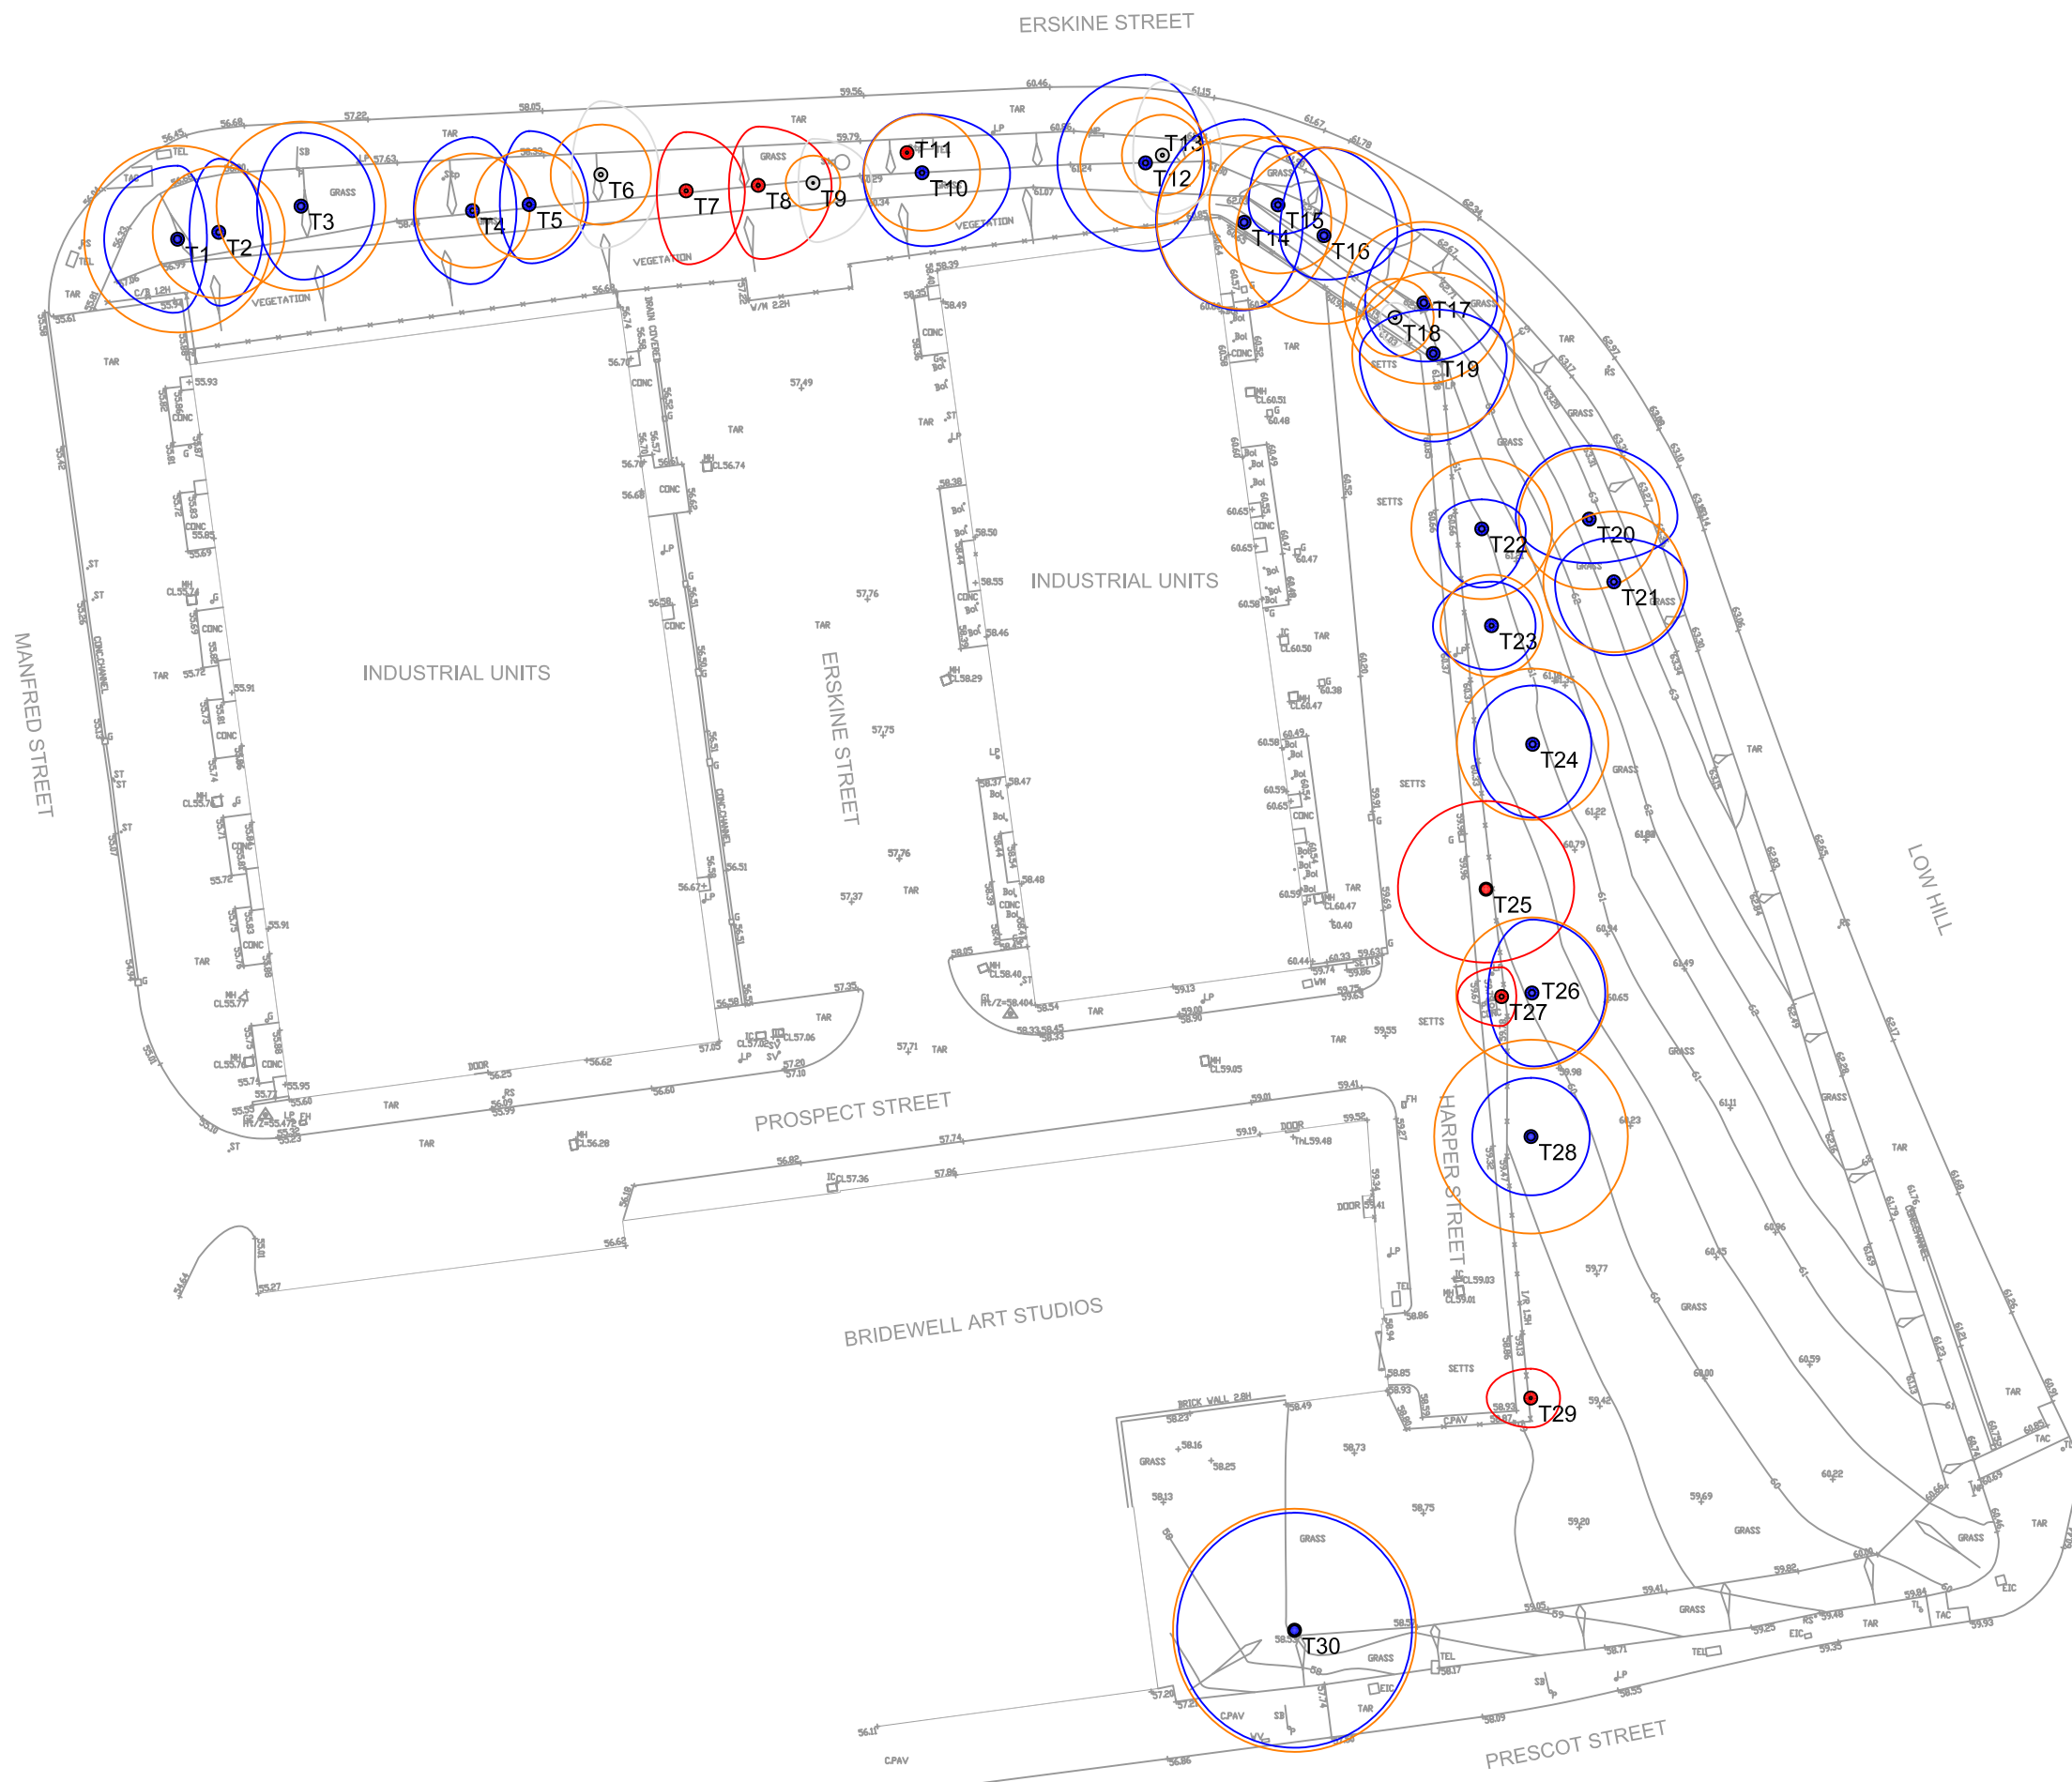
TREE CONSTRAINTS PLAN

- 6.1 Thirty individual trees have been surveyed. In summary, retention value A (0), retention value B (19), retention value C (4). Category U (6)
- 6.2 The position of T25 has been amended, as the position delineated on the topographical survey was incorrect.

- 6.3 Six trees have been recommended for removal (T7, T8, T11, T25, T27, T29) as they have been identified as having structural or physiological defects that make them unsuitable for retention.

Root Protection Areas (RPA's) have been identified and are based on BS5837:2012
