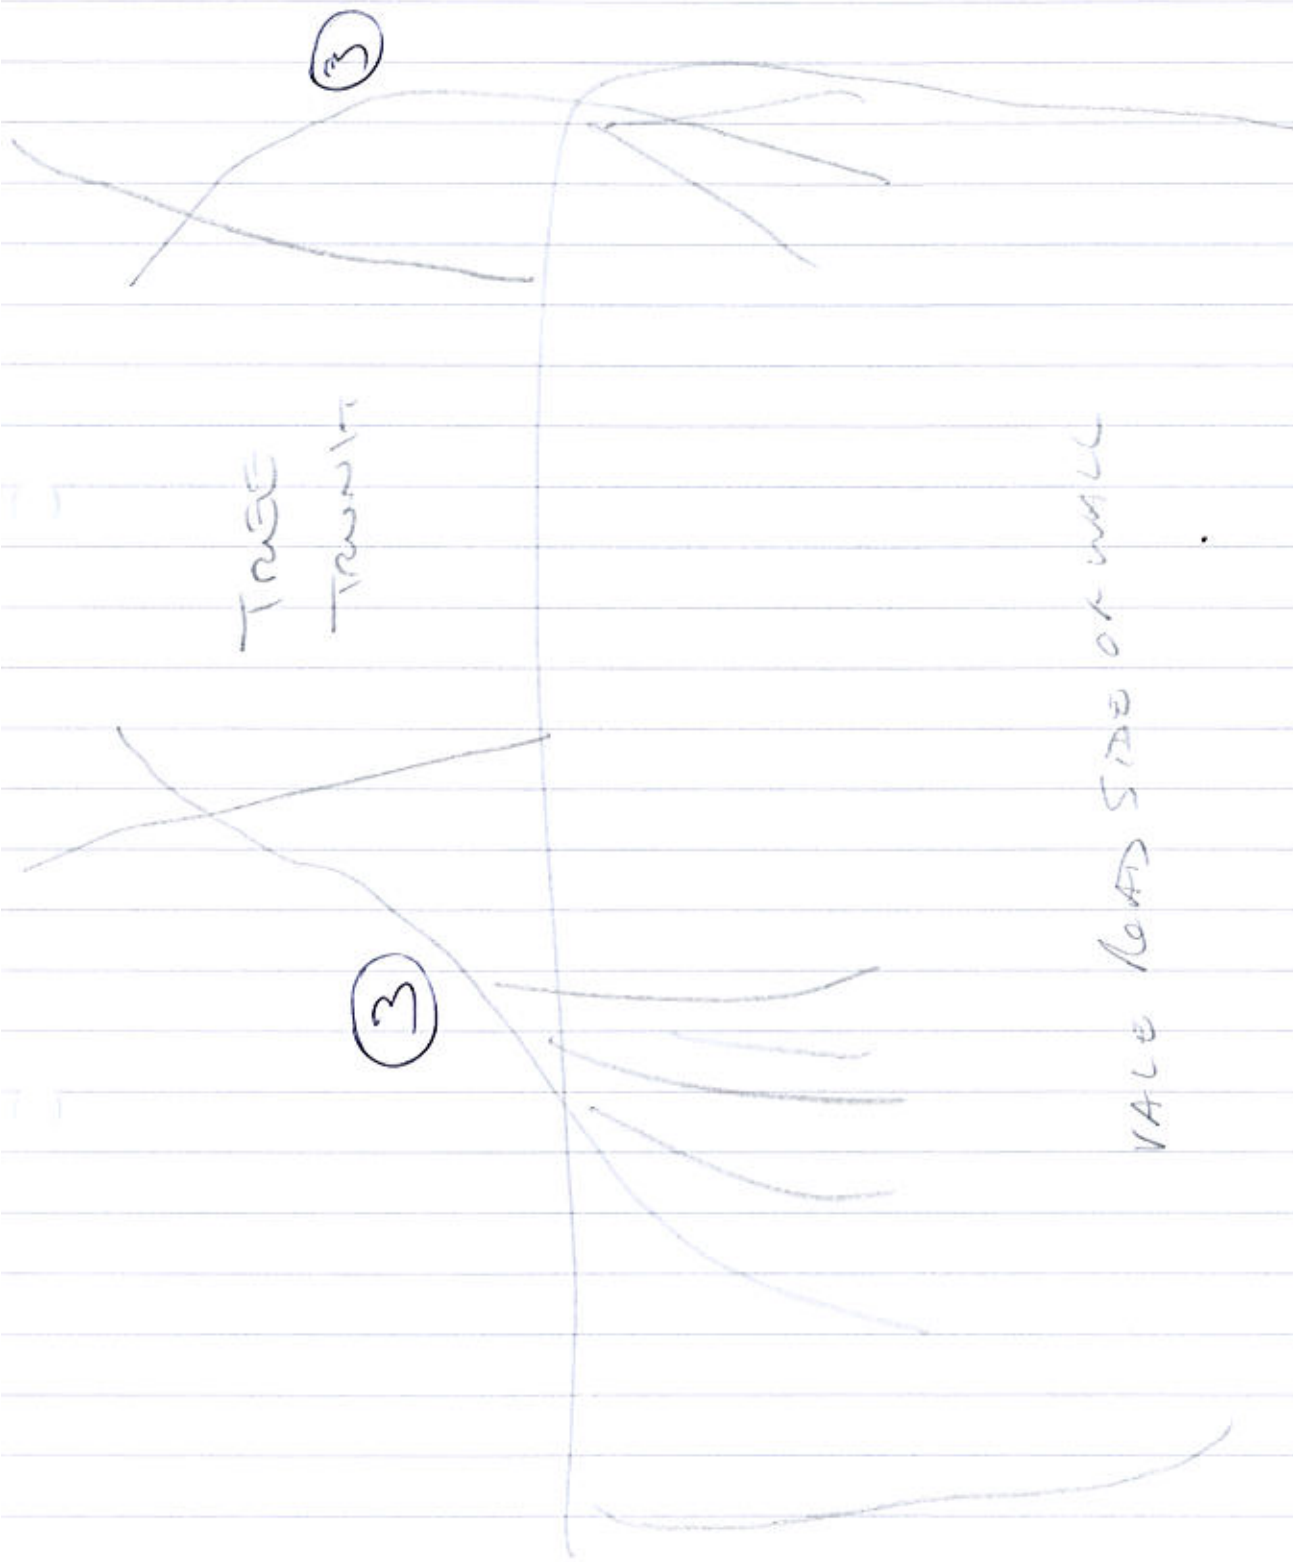
VALE ROAD SIDE OF WALL

- ③ Over hanging branches of DATE tree, over a public pavement on Vale Road.

⑦ This is a large branch which sometimes hits the road and is carrying a lot of weight we think this is causing the tree to grow closer against the wall.

Beech Tree

Top of wall has angled bricks along the top layer. This is being pushed out due to pressure.

Previous work done to wall
