## ARBORICULTURAL IMPACT ASSMENT For a proposed development

**Upper Parliament Street** Toxteth, Liverpool

**Report Ref:** DTCL.119.AIA.2017

> **Report Date:** 09 March 2017

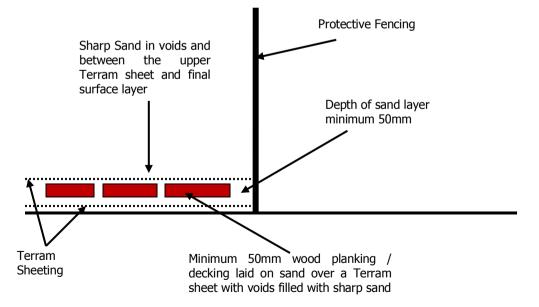
Figure 2 Ground Protection for Construction close to the RPA

3.8.2 Because the proposed construction would come close to the RPA of T4 (Robinia pseudoacacia) and **T61** (*Platanus x hispanica (acerifolia)*) temporary ground protection to protect the RPA from construction activity would be installed as shown in Figure 2. below

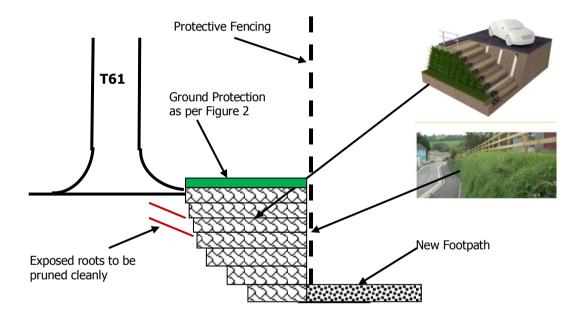
Figure 3: Air Spade Excavation, Root Pruning and Retaining Detail

- 3.9.3 Before excavation of the mound/bund using mechanical plant the area of the root zone to the east of the excavation line (yellow arrows in Photographs 14A & B) would be excavated using compressed air via an Air Spade to a depth of 1000mm to expose any roots, please refer to Appendix 1 for details of the Air Spade methodology.
- 3.9.4 Once the roots are exposed and large woody roots would be cut cleanly using a purposed produced hand saw and secateurs for smaller diameter roots. The exposed face of the pruned roots would be retained using stratified CellWeb™ panels. These provide very strong retaining ability as shown in Figure 3. The front edge of the CellWeb panels would be seeded / turfed to provide a natural finish.

Sketch Drawing Not To Scale – for Illustrative Purposes Only

3.9.5 Following the excavation, root pruning and stabilisation, the tree would be subjected to a programme of tree health care (THC) using bio-stimulant fertilizers, mycorrhizal suspensions and Biochar. The entire root zone of T61 would be decompacted using compressed air injected into the soil with the Air Spade and released at 20 - 30 bars. The entire root zone area of the tree would be treated with an organic mulch of composted wood chip, forest bark or equivalent to a minimum depth of 75 cm.

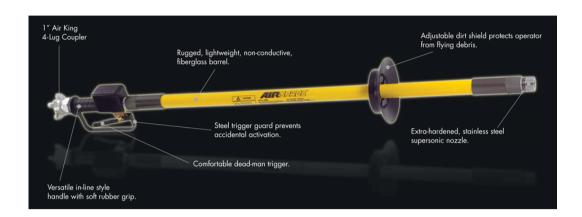
Picture 1: This shows the excavation process using an Air Spade

Air Spade® excavation for the installation of services

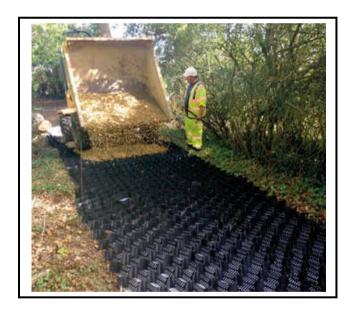
**ProtectaWeb™ Structure**

Installation of ProtectaWeb™ on site

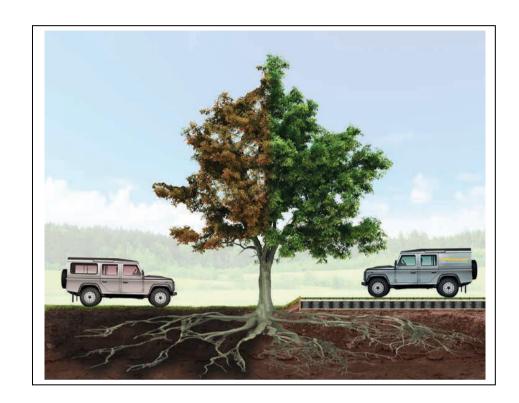
Further detail of ProtectaWeb™ Cellular Confinement System

A schematic diagram showing how a cellular confinement system allows the percolation of air & water to the roots below.

3.9.7 The new footpaths can be installed in proximity to **T61** using a 'no dig' methodology that utilises a proprietary cellular confinement system. The systems recommended are the CellWeb™ or ProtectaWeb™ confinement systems which spread the load as detailed in Appendix 2. The final surface for the cellular confinement system shall either porous tarmac or block paviors.
