## **Redrow Homes (Lancashire)**

### **Ground Investigation Report**

**Watergate School, Speke Road,  
Woolton, Liverpool**

**REPORT NO: 14RED080/GI**

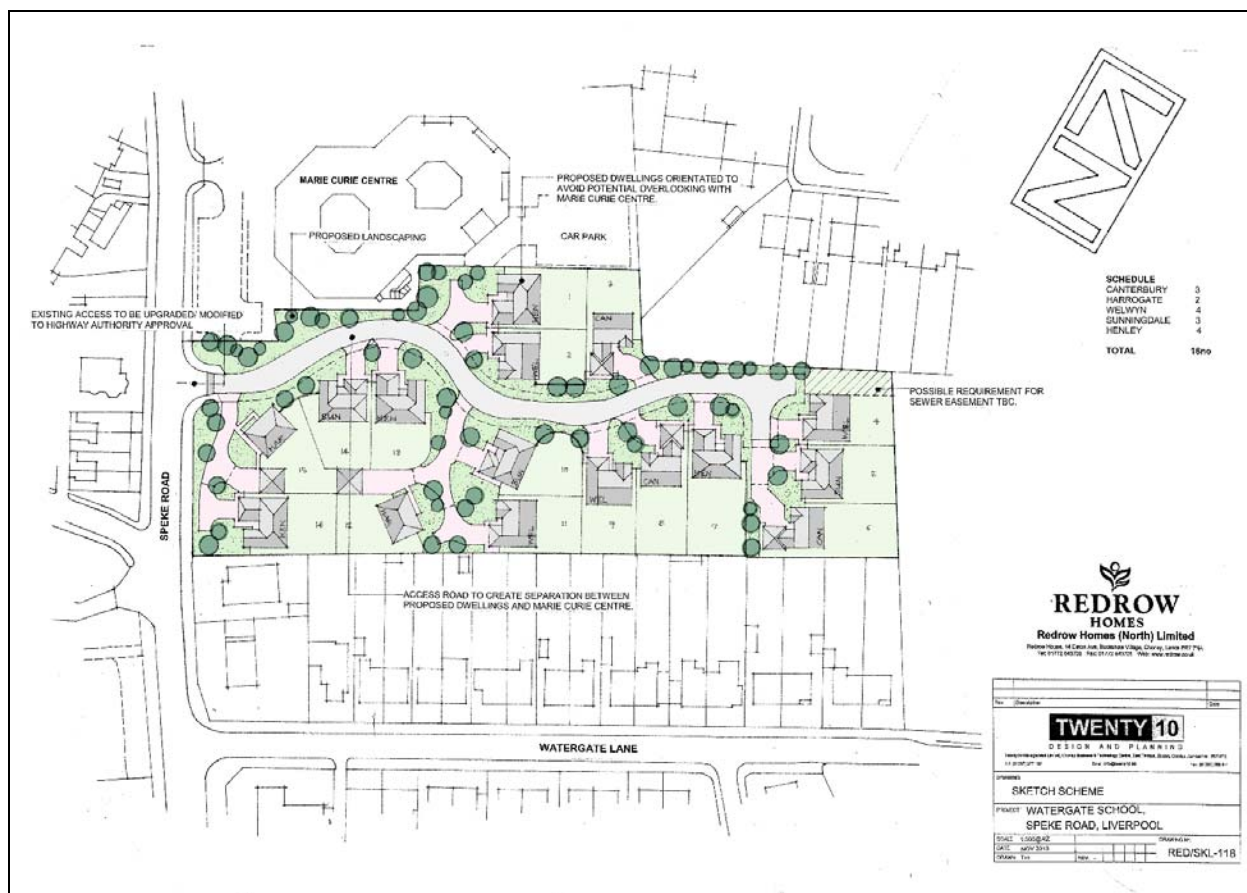
*Sketch Scheme of Proposed Layout at proposed development: Wategate School, Speke Rd, Liverpool.*
