Document Title:	Arboricultural Implications Assessment									
Document Author:	Matthew Harmsworth, tech.arbor.a, DipRS, RPQ-s									
Project Manager:	Matthew Harmsworth									
Project Title	Norfolk Street / St James Street, Liverpool									
Revision History										
Date:		Version No.		Summa	ary of Changes:					
21st April 2015			1.0	First dra	aft					
22nd April 2015			1.0	Final issue						
Approvals										
Approved by:	Signa	ture	Date:		Version:					
Matthew Harmsworth		larmsworth	22.04.2015			1.0				
Distribution										
Name:	Title:		Date:		Version:					
Richard Gee Project		ct Manager	22.04.2015			1.0				
Re-Survey Date										
Survey Type:		Lifecycle:		Re-surv	vey Date:					
BS5837: 2012		Planning only		Not applicable

Report no: 15_5837_04_06

Arboricultural implications assessment to BS 5837 of trees at: Norfolk St / St James St, Liverpool.

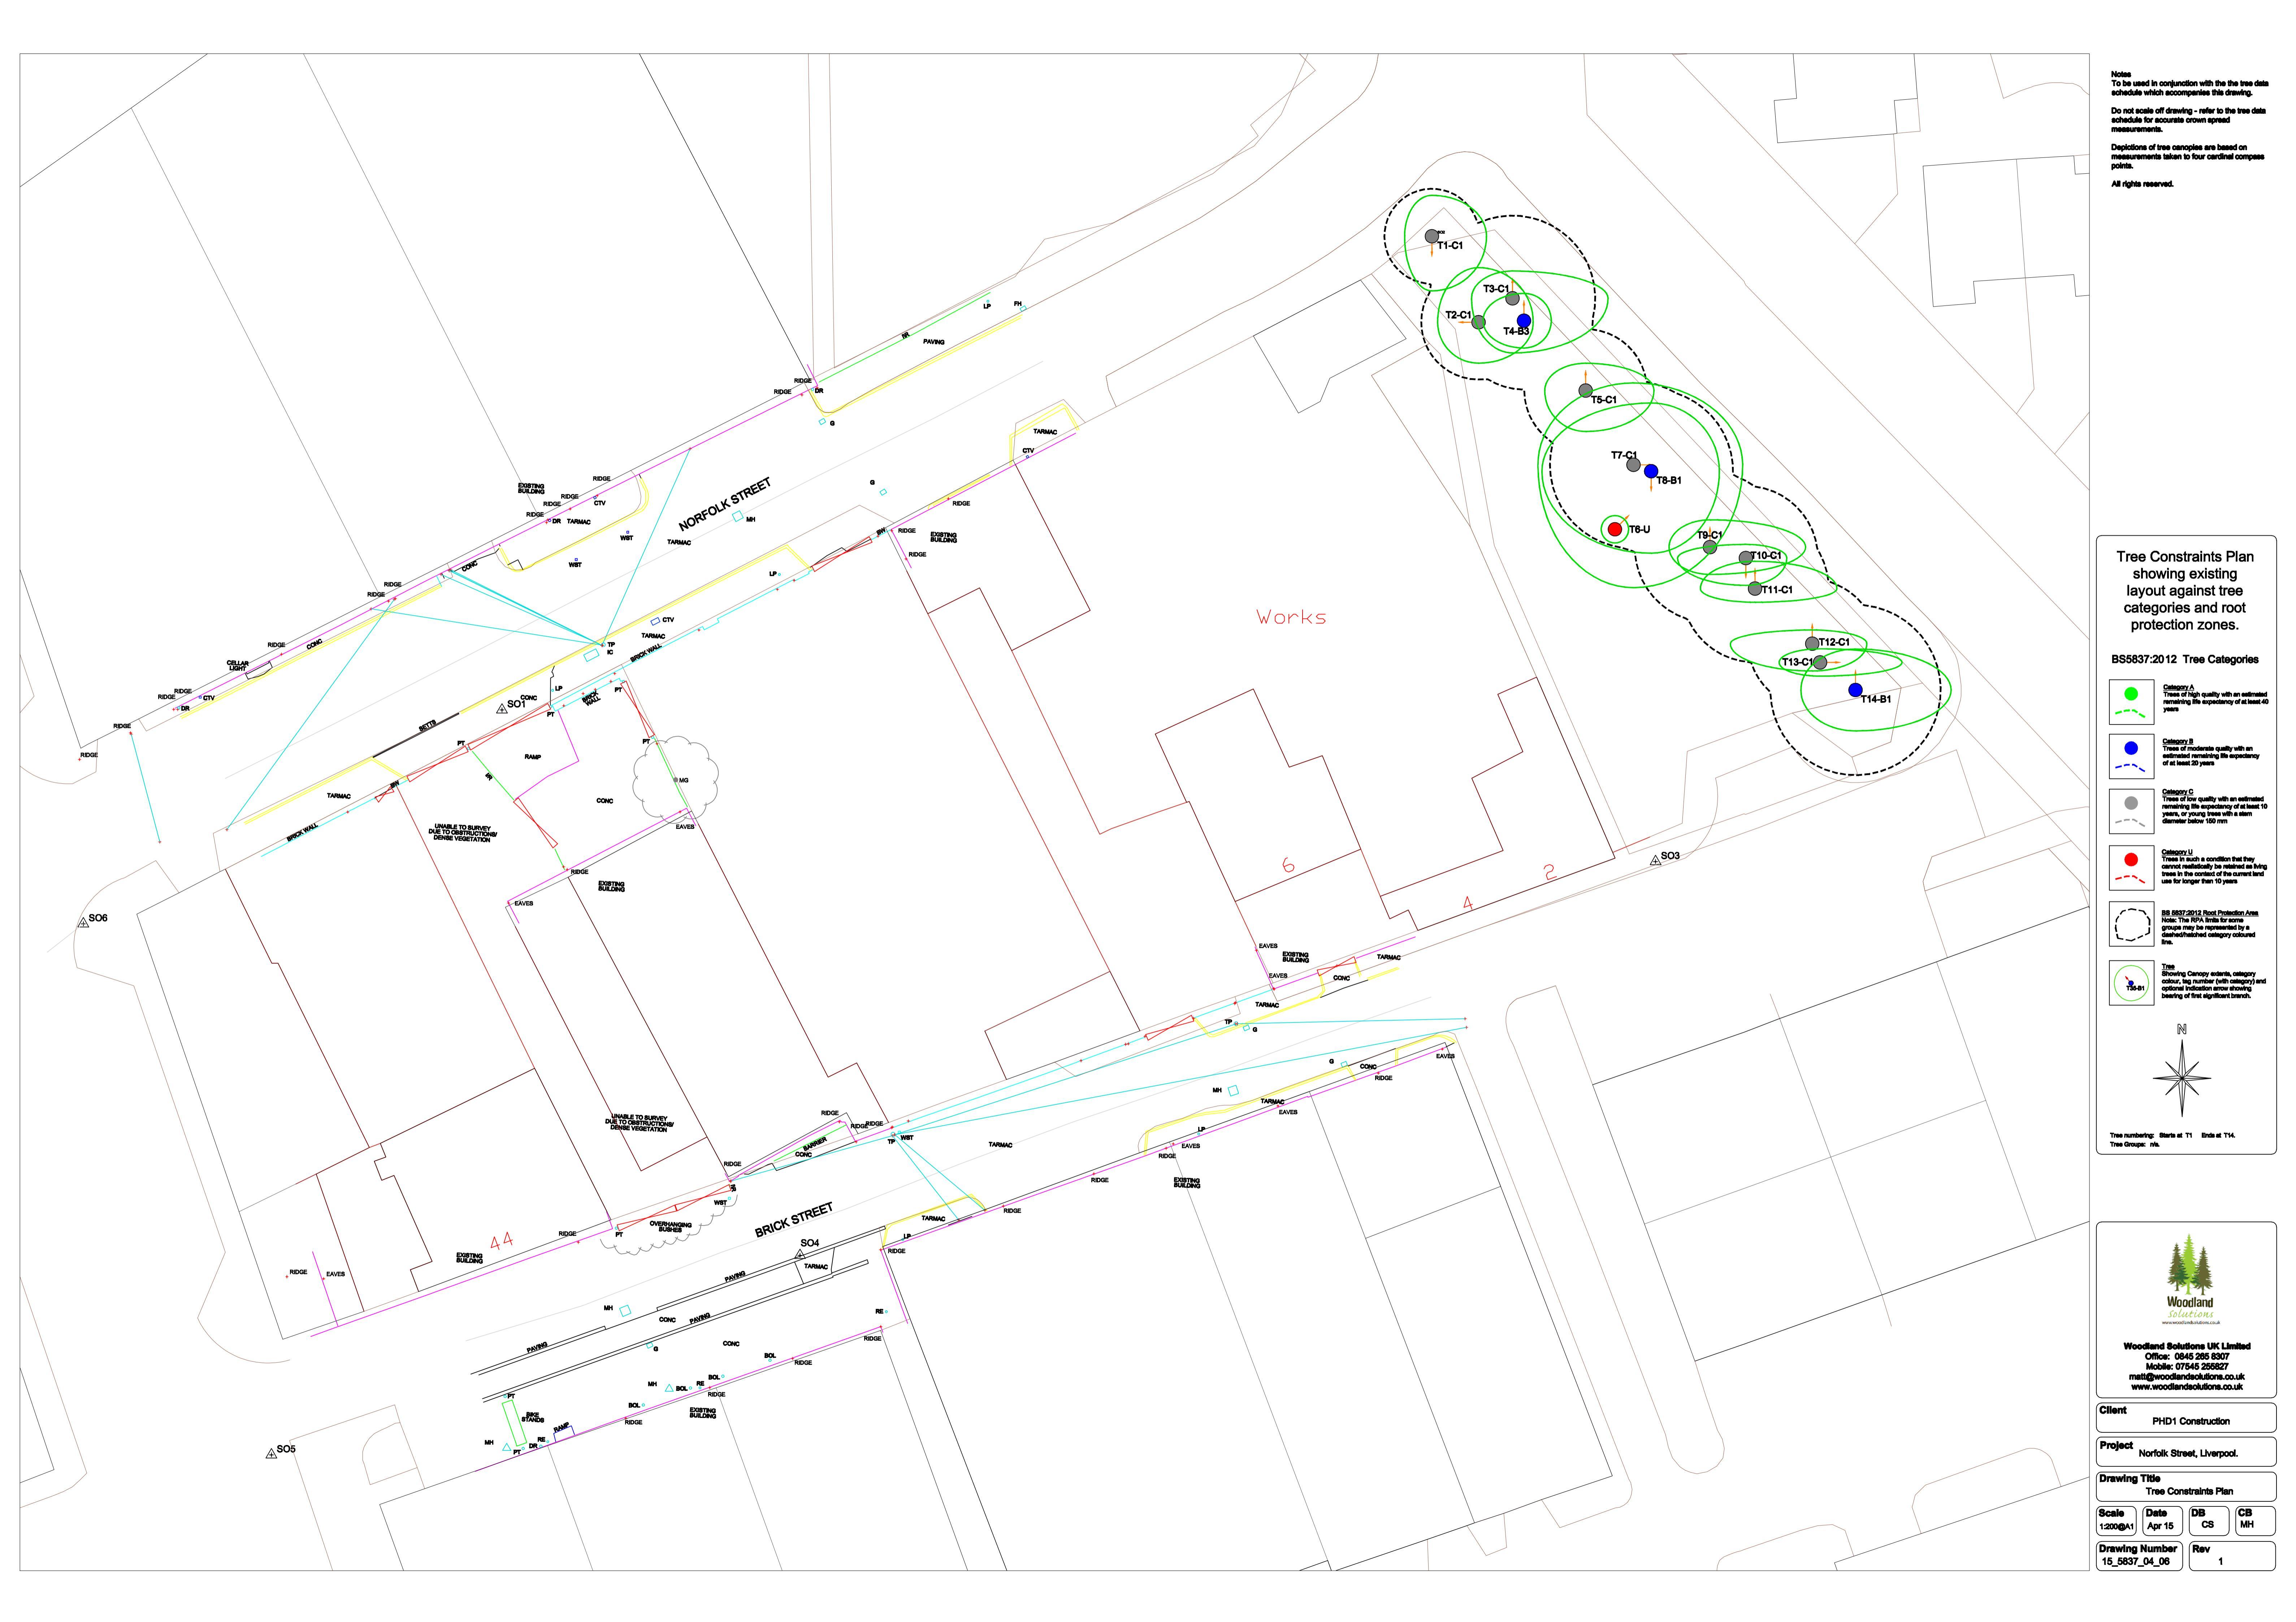
APPENDIX 3 - Tree Constraints Plan (2 sheets)

- 5.3 We would expect the Local Authority will wish to see these trees retained. As such excavation within the root protection areas highlighted on the appended tree constraints plan should be avoided. If this is a major design constraint then removal maybe possible if (as mitigation) at least 10 trees of heavy standard size are specified as replacements. These would need to be both robust and sustainable; located in dedicated tree pits with irrigation systems installed.
- 5.9 Tree removal and protection measures should be set down in an arboricultural method statement with a clear and concise tree protection plan suitable for the site manager and contractors to refer to.
