1 Summary 4

1 Summary

This report advises on the findings of an intrusive investigation to determine the building fabric and general condition at the above. Aspects of the premises were inspected by BDI at the time of investigations. This report does not constitute a structural survey or building condition survey.

It is proposed to convert the existing synagogue into residential apartments with internal amenity space.

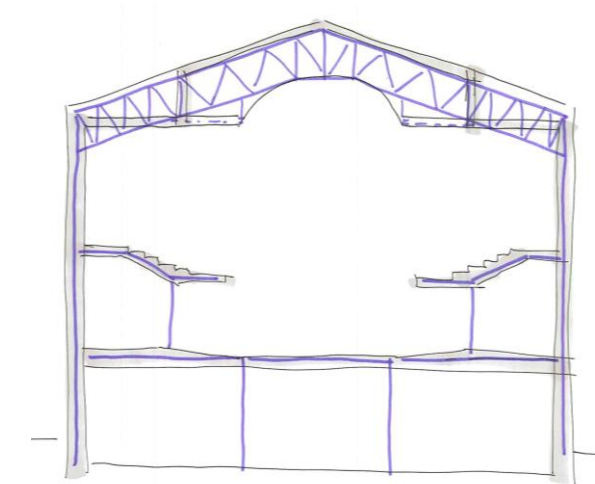
Truss elevation indicating original configuration

The load on the truss connections is significant. Given the high load concentration of load, current state of corrosion and possible effects of previous fires, it is our opinion that the truss connections are prone to brittle fracture. Brittle fracture of a truss connection would be catastrophic as the truss has little redundancy.

The notable movement observed within the roof structure at the time of the survey suggests that the roof is subjected to repeated fluctuating loads causing movement. Fatigue of the structure owing to this fluctuation is likely which could lead to joint failure at stress concentration points.

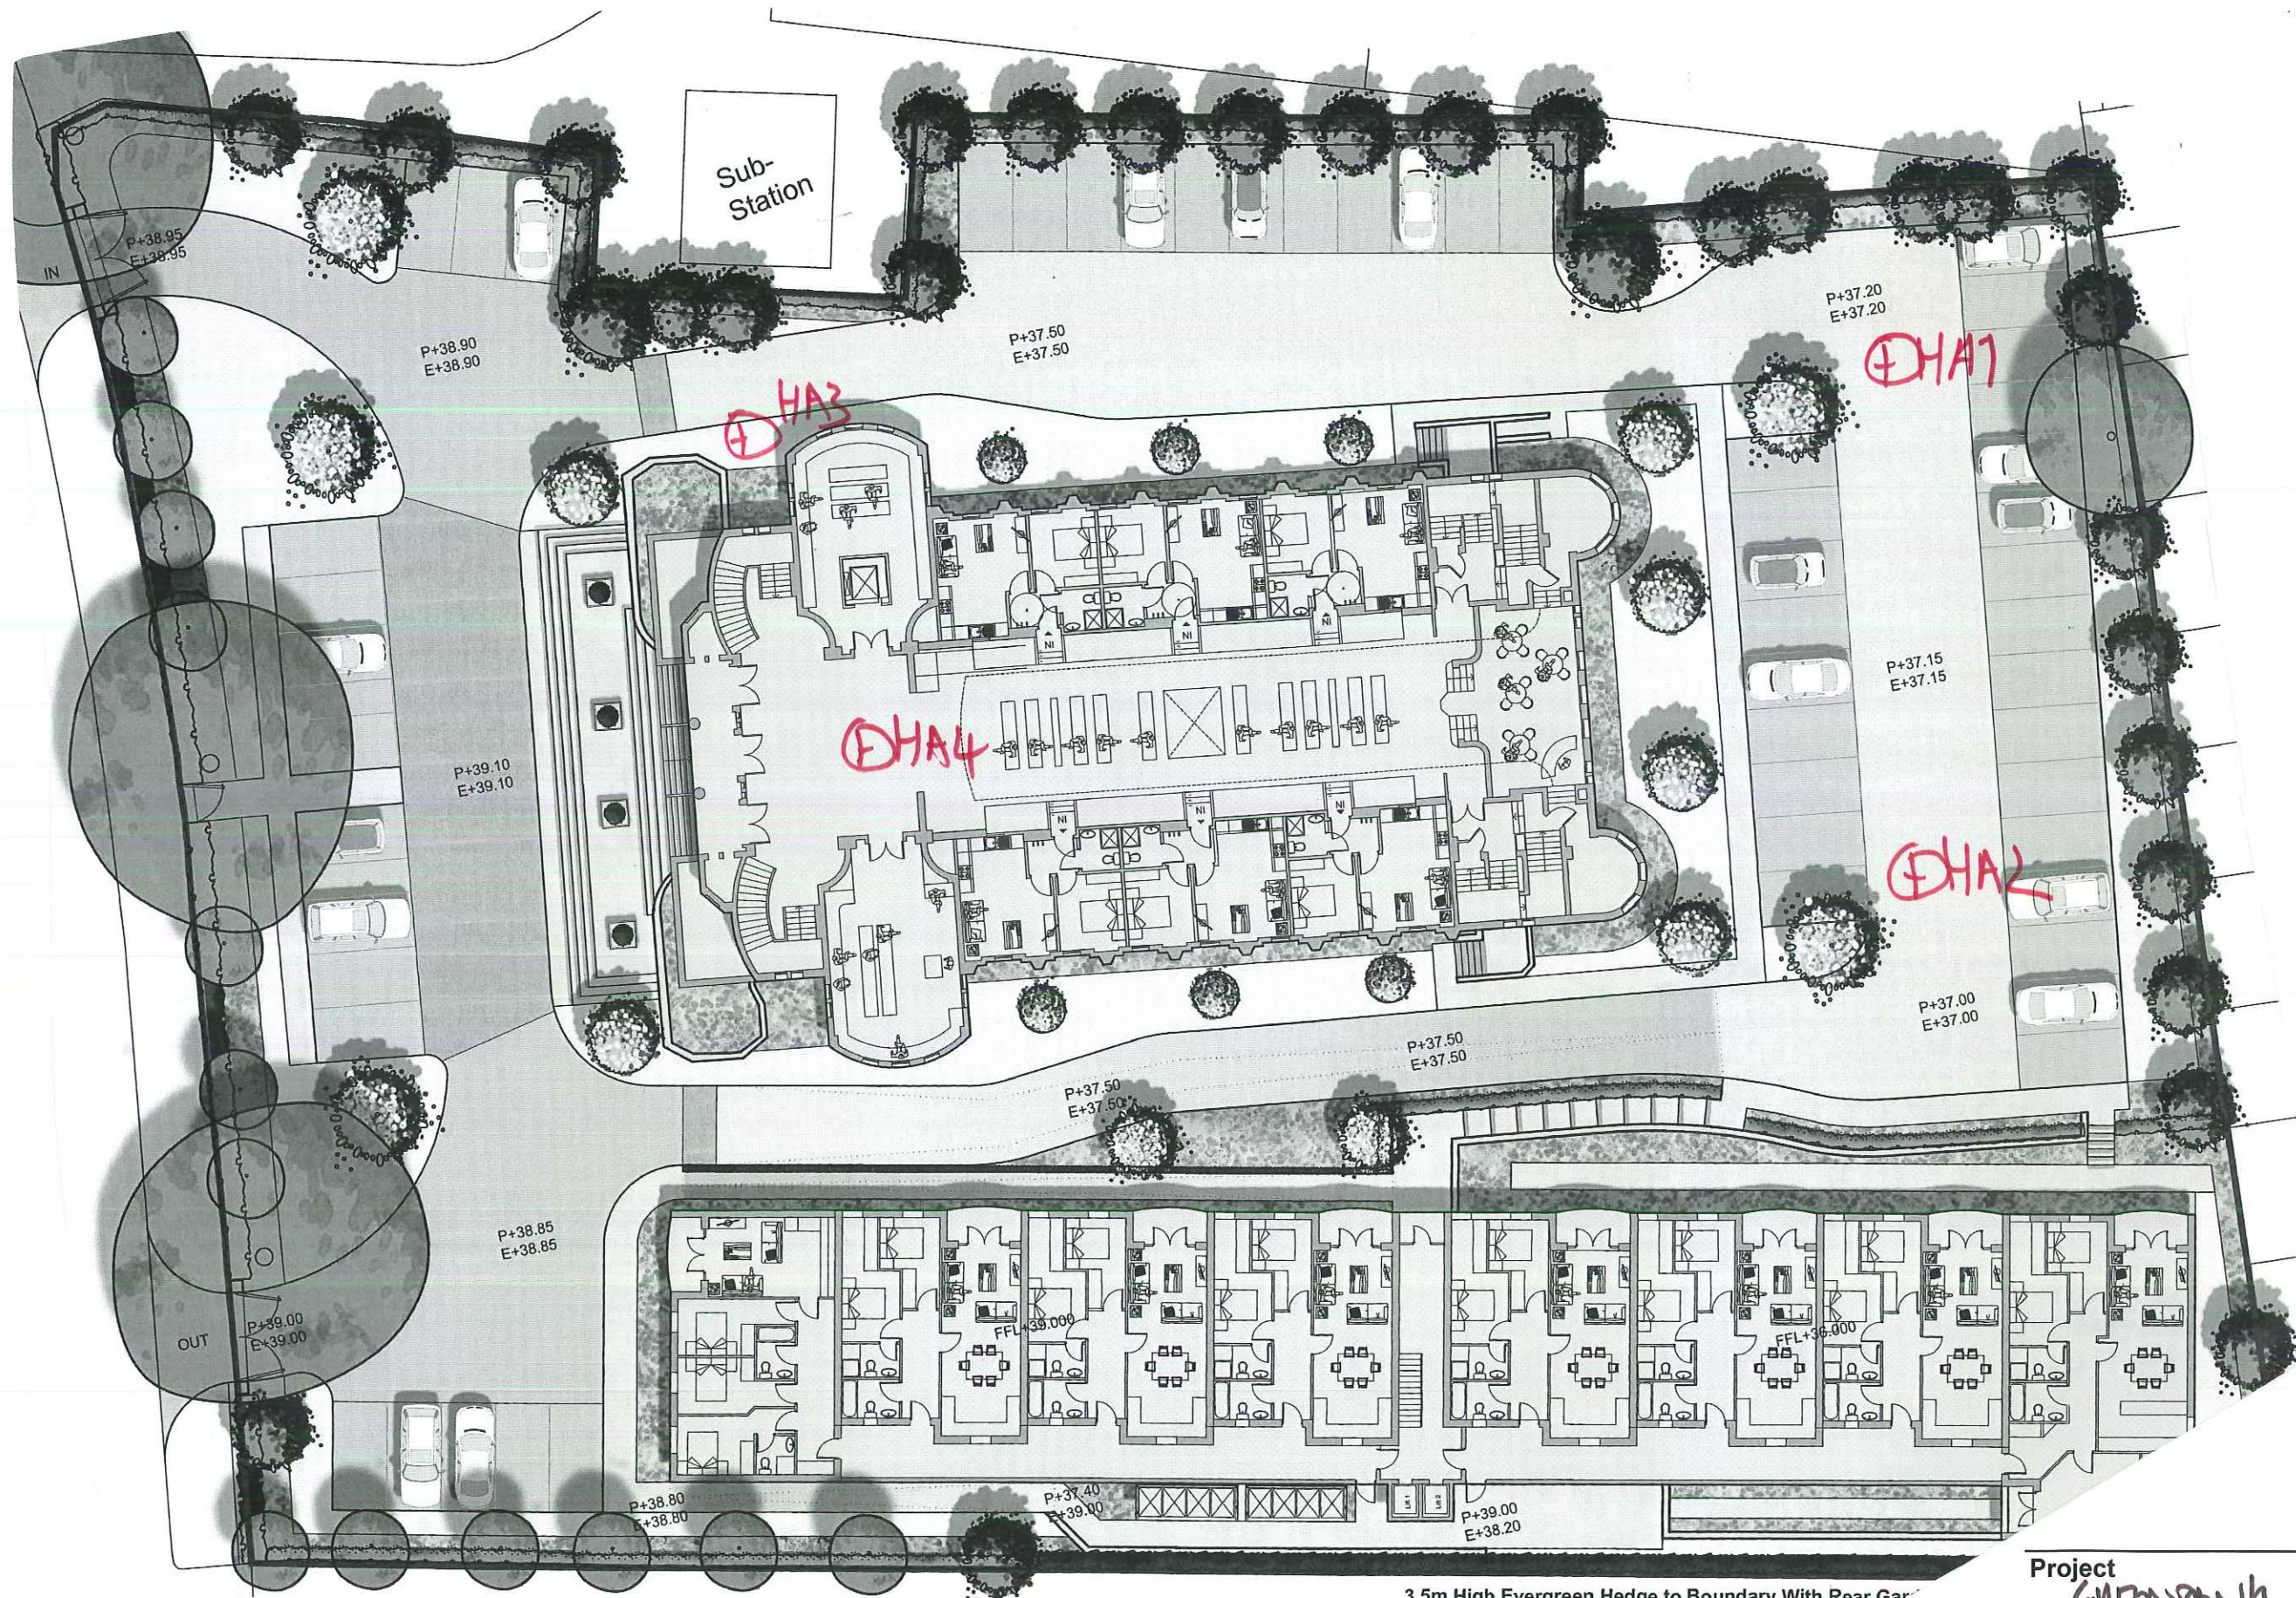
PLAN TH1

Trial Hole 1 indicated a strip footing. From inspection it appeared that the footing was integral with column pad foundations.

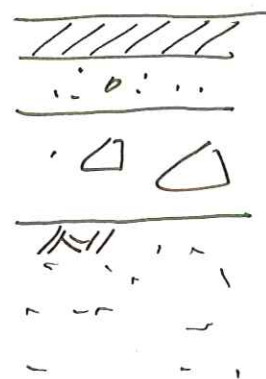
SECTION F3

20mm FINISHES
30mm CONCRETE
100mm CLINKER BRICK
CONCRETE
WET SAND
