Memorandum

ARUP

19 August 2010

Subject Korean House Site Condition Survey

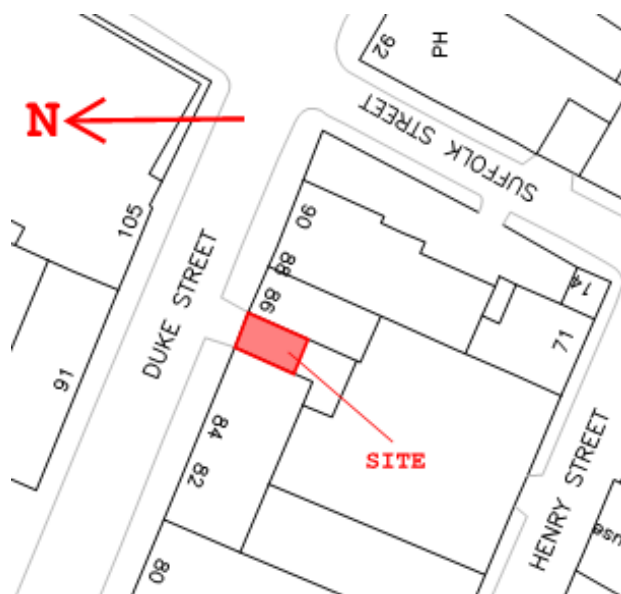
Figure 1 – DoHo Korean House Site

The site is defined as plot of land between Frensons Building and the EP Building off Duke Street, Liverpool. This is shown in figure 1 below, where the art work will be installed. The photographs in this report relate directly to any specific points of interest being discussed, a further full achieve set of photographs from the same site survey are available on request and will be retained by Arup for the duration of the artwork installation should they be required.
