# **HYDRAULIC TOWER CONDITION**

# Hydraulic Accumulation Tower at Bramley-Moore Dock Liverpool

## Stage 1 Visual Structural Condition Appraisal (2020 Update)

Curtins Ref: BMD01-CUR-Y0-ZZ-RP-S-000001

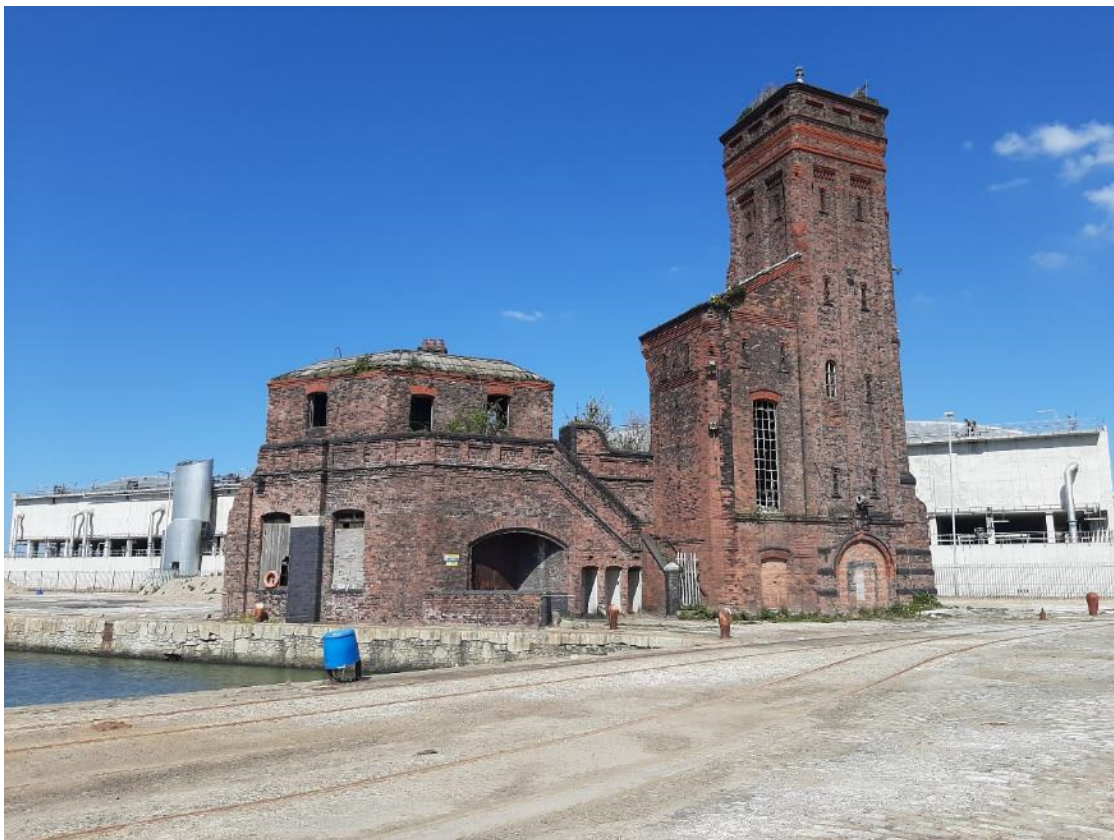
Figure 1: Hydraulic accumulator tower at Bramley-Moore Dock with integral boiler house (2020).

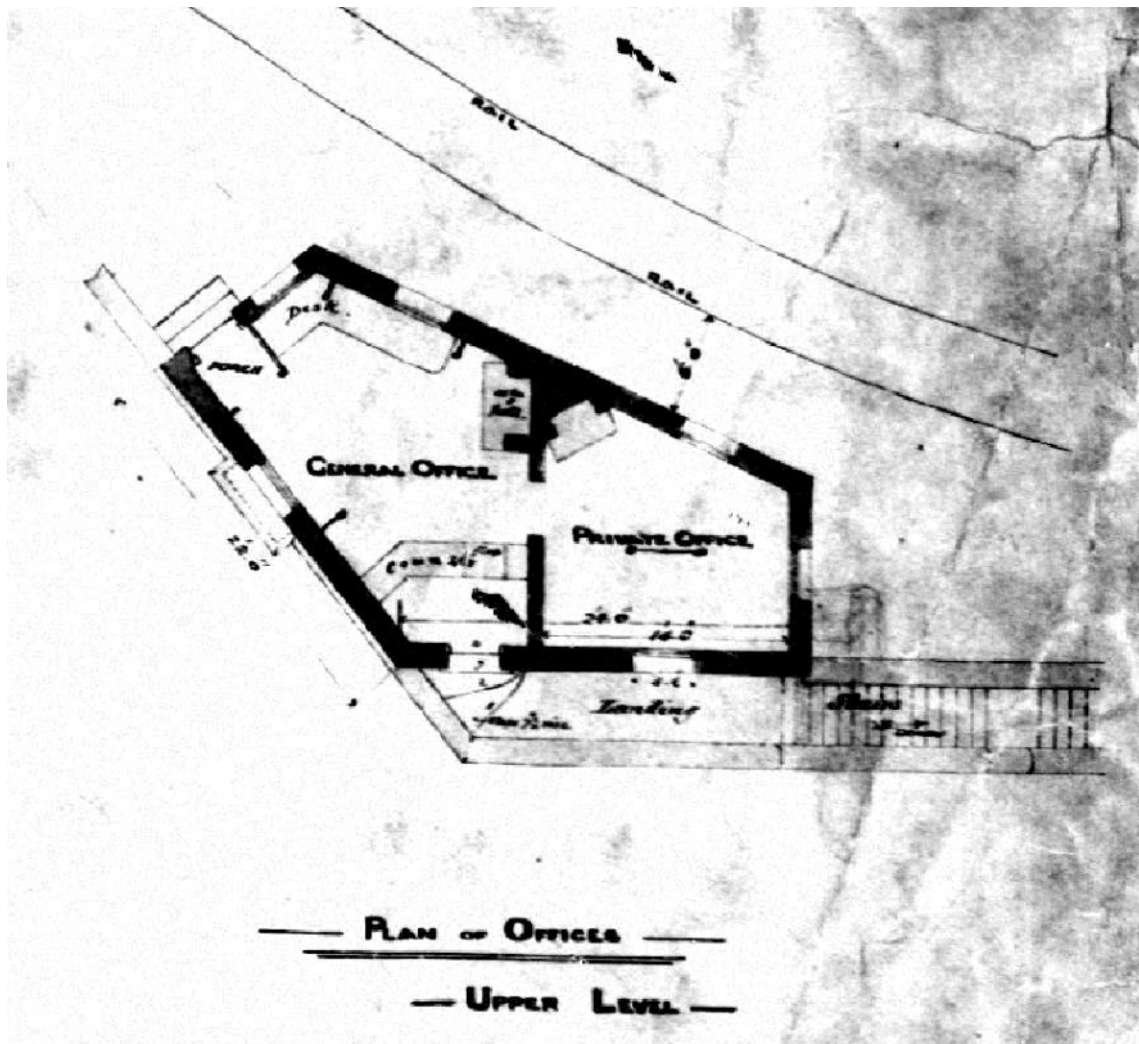
- 4.16 The pattern of movement observed to the walls of the Office Block points towards two likely scenarios:
- Deflection of the Boiler House roof deck, relative to the “fixed” (stiffer) foundation for the south and west walls of the Office Block (built off masonry walls below).
  - Roof thrust from the failing Office Block timber roof structure, compounding with thrust from the arches to push the north-east corner out.

Given our understanding of the overall structural assemblage, we believe the former to be more likely. This may be a past defect which could have arisen during the time of the high level elevated coal railway (loading/un-loading i.e. deflection-cycling of the roof deck relative to the stiff foundation of the outer walls, etc., initiating cracks which have then been exploited over time by decay processes). Either way it appears to be problematic and warrants further investigation and remedial work.

Figure 8: Record extract plan on office block showing coal railway adjacent on roof deck.
