**Bramley Moore Dock
Hydraulic Accumulation Tower
Visual Condition Appraisal - Update**
Drawing: 75808-CUR-00-XX-DR-S-103
Date Prepared: 15/05/2020

**Bramley Moore Dock
Hydraulic Accumulation Tower
Visual Condition Appraisal - Update**
Drawing: 75808-CUR-00-XX-DR-S-104
Date Prepared: 15/05/2020

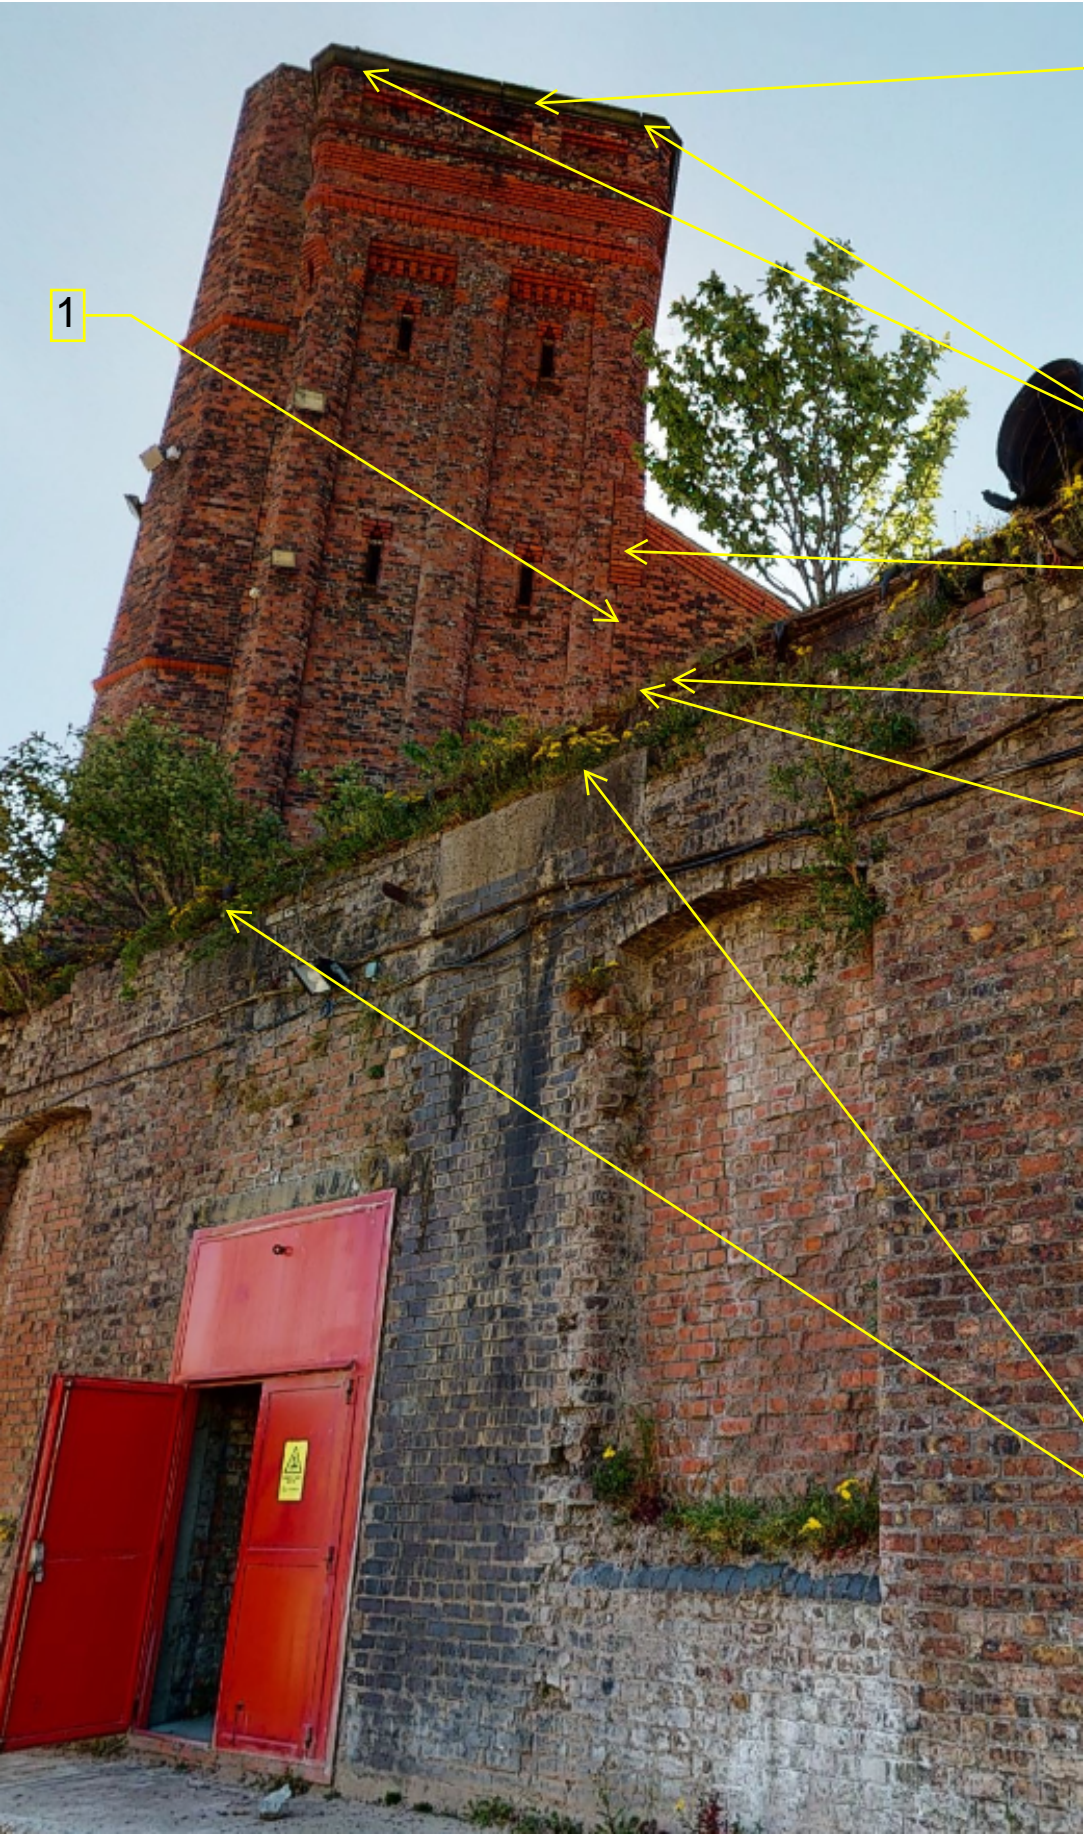
BRAMLEY-MOORE HYDRAULIC ACCUMULATION TOWER		
FACE	DEFECT #	DEFECT DESCRIPTION
NW	1	Butt-joint between low-rise retrospectively bonded tower and main core tower, joint visibly open as SE elev, again closing at point of cross-bonding with preload from superstructure of main core tower. Inspection this side limited owing to vantage points.
	2	Weathering of masonry & extensive opening of mortar joints (weathering-related) at corner corbeled piers.
	3	Mass coping stones exhibit minor movement as se elev, perpends visibly open.
	4	Extensive vegetation on roof at top of main core tower indicates failing roof.
	5	Weathering, exposed corroding girders of flat low-rise roof with extensive wallhead penetration, related vegetation and displacement to wall-head masonry.
	6	Skew course at verge exhibits open perpends indicating wallhead penetration.
	7	Coping stones at tower wallhead appear to have been displaced slightly since the April 2016 inspection. Suspected ratchet mechanism whereby vegetative growth is widening the perpends and debris accumulates in crack.

8	Verge terracotta detailing at wallhead, headers are loosened and several have dropped out. Progressed since the 2016 inspection.
	9	Verge terracotta detailing at wallhead, headers are loosened and several have dropped out. Progressed since the 2016 inspection.
