**A165 Chainage 800 to 805m**

**Figure A165 - Bramley Moore: Chainage 800 to 805m**

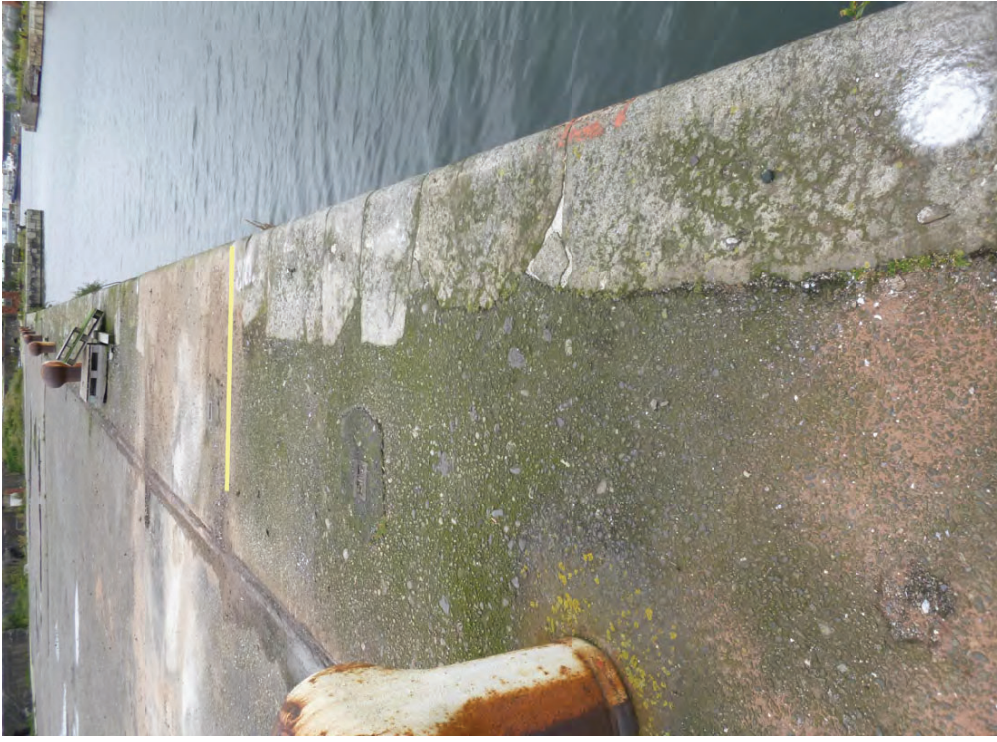
Figure A166a - Bramley Moore: Coping Chainage 805 to 810m

| Chainage (m) | Feature | Level (m from top) | Dimensions (m) | Description |
|---|---|---|---|---|
| 805 to 810 | Brickwork / Masonry | 0.5 to 1.8 | - | Good - Minor cracks created by minor movement. Surface defects in bricks or limited mortar loss from joints |
| 809 | Mooring Chain | 0.8 to 1.8 | - | Fixed within recess. Fair condition, extensive corrosion with minor thickness loss and/or minor damage to links |
| 805 to 810 | Concrete | 0 (coping) | - | Good - Structurally sound but with minor cracks and localised honeycombing/flaking with no significant defects |
| 806 | Mooring Bollard | 0 (coping) | H = 0.8m | T-shaped bollard embedded into coping. Good condition, localised surface corrosion |

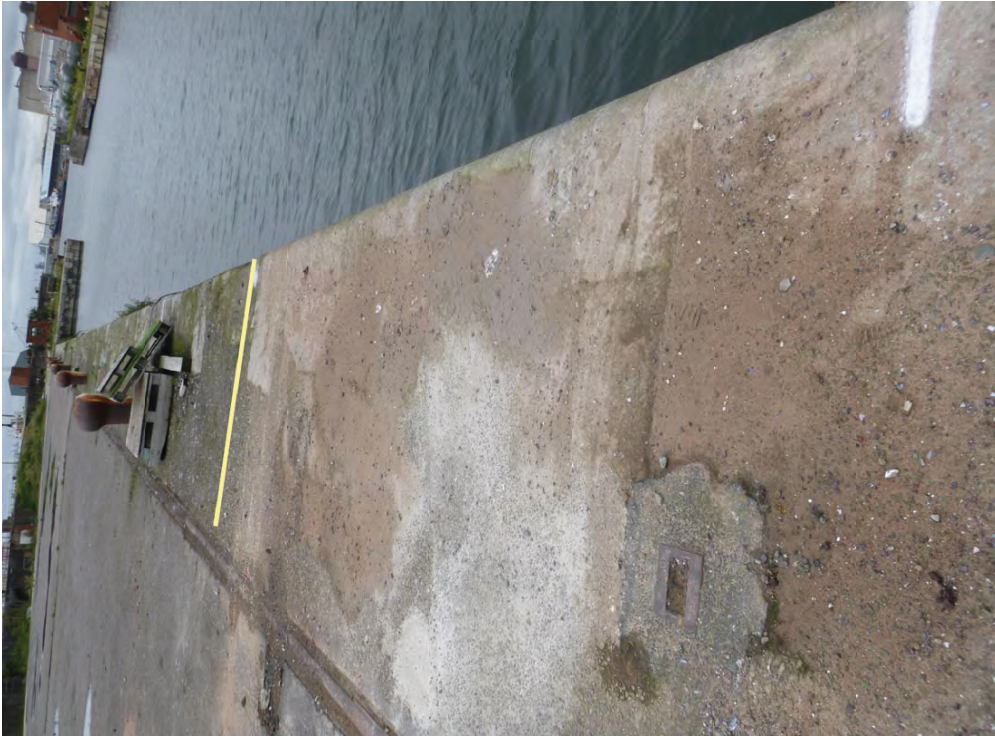
Figure A167a - Bramley Moore: Coping Chainage 810 to 815m

| Chainage (m) | Feature | Level (m from top) | Dimensions (m) | Description |
|---|---|---|---|---|
| 810 to 815 | Concrete | 0 (coping) | - | Good - Structurally sound but with minor cracks and localised honeycombing/flaking with no significant defects |
| 810.5 | Metalwork | 0 (coping) | 0.1 x 0.1m | Metal fixing. Good condition, localised surface corrosion |

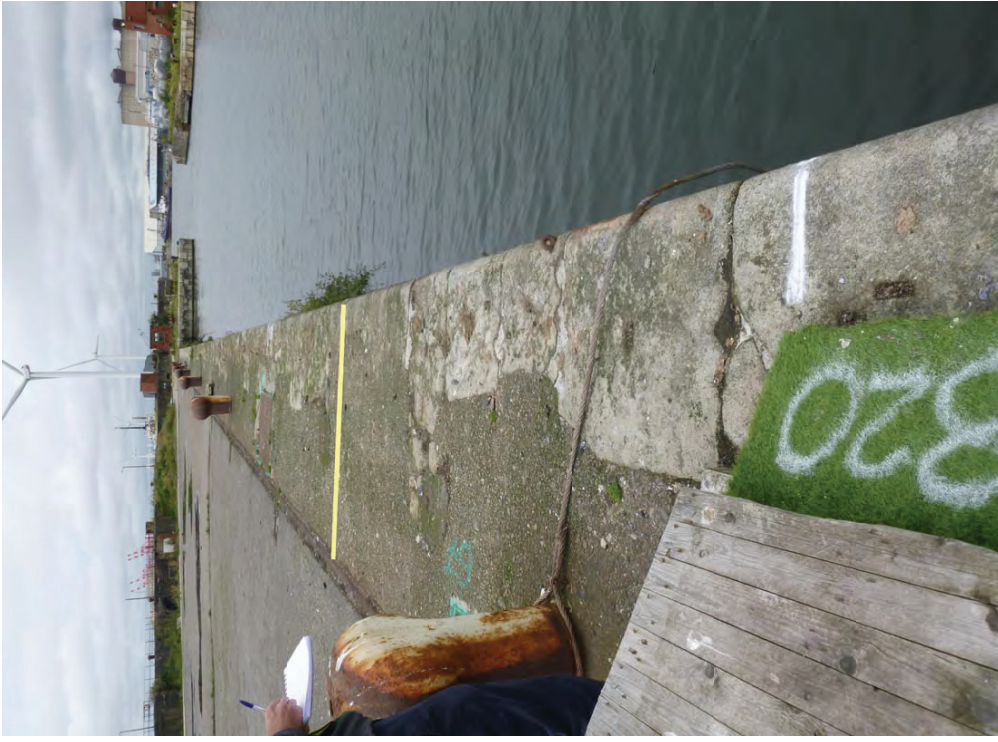
Figure A169a - Bramley Moore: Coping Chainage 820 to 825m

| Chainage (m) | Feature | Level (m from top) | Dimensions (m) | Description |
|---|---|---|---|---|
| 820 to 825 | Coping | 0 to 0.5 | - | Good - Minor cracks created by minor movement. Surface defects in coping or limited mortar loss from joints |
| 820 to 825 | Brickwork / Masonry | 0.5 to 1.8 | - | Good - Minor cracks created by minor movement. Surface defects in bricks or limited mortar loss from joints |
| 821 | Miscellaneous | 0 to 1.5 | - | Steel cable fixed to mooring bollard. Significant corrosion |
| 824.5 | Mooring Chain | 0.8 to 1.8 | - | Fixed within recess. Fair condition, extensive corrosion with minor thickness loss and/or minor damage to links |
| 820 to 825 | Concrete | 0 (coping) | - | Good - Structurally sound but with minor cracks and localised honeycombing/flaking with no significant defects |
| 821.5 | Mooring Bollard | 0 (coping) | H = 0.8m | T-Shaped bollard embedded into coping. Good condition, localised surface corrosion |

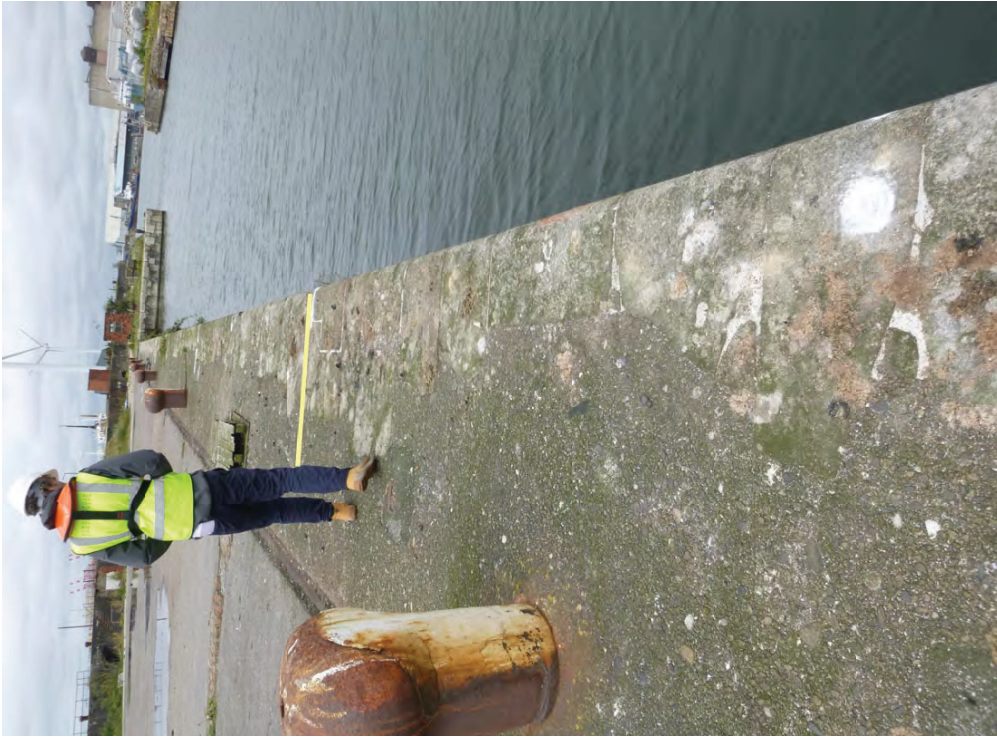
Figure A172a - Bramley Moore: Coping Chainage 835 to 840m

| Chainage (m) | Feature | Level (m from top) | Dimensions (m) | Description |
|---|---|---|---|---|
| 835 to 840 | Concrete | 0 (coping) | - | Good - Structurally sound but with minor cracks and localised honeycombing/flaking with no significant defects |
| 836.5 | Mooring Bollard | 0 (coping) | H = 0.8m | T-Shaped bollard embedded into coping. Good condition, localised surface corrosion |

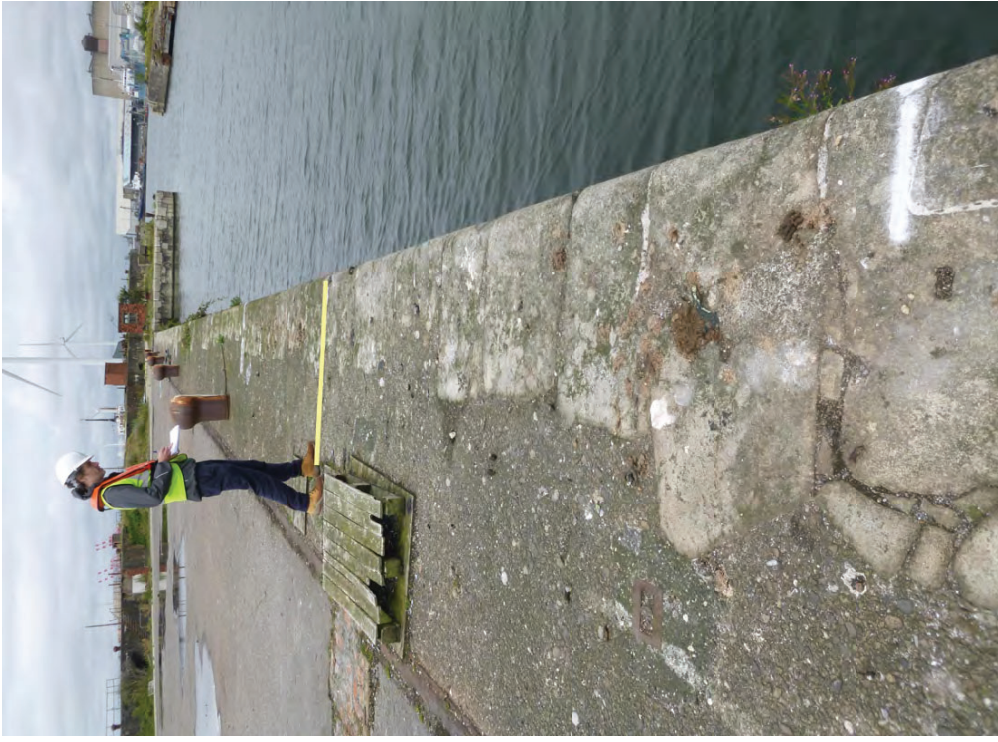
Figure A173a - Bramley Moore: Coping Chainage 840 to 845m

| Chainage (m) | Feature | Level (m from top) | Dimensions (m) | Description |
|---|---|---|---|---|
| 840 | Mooring Chain | 0.7 to 1.8 | - | Fixed within recess. Fair condition, extensive corrosion with minor thickness loss and/or minor damage to links |

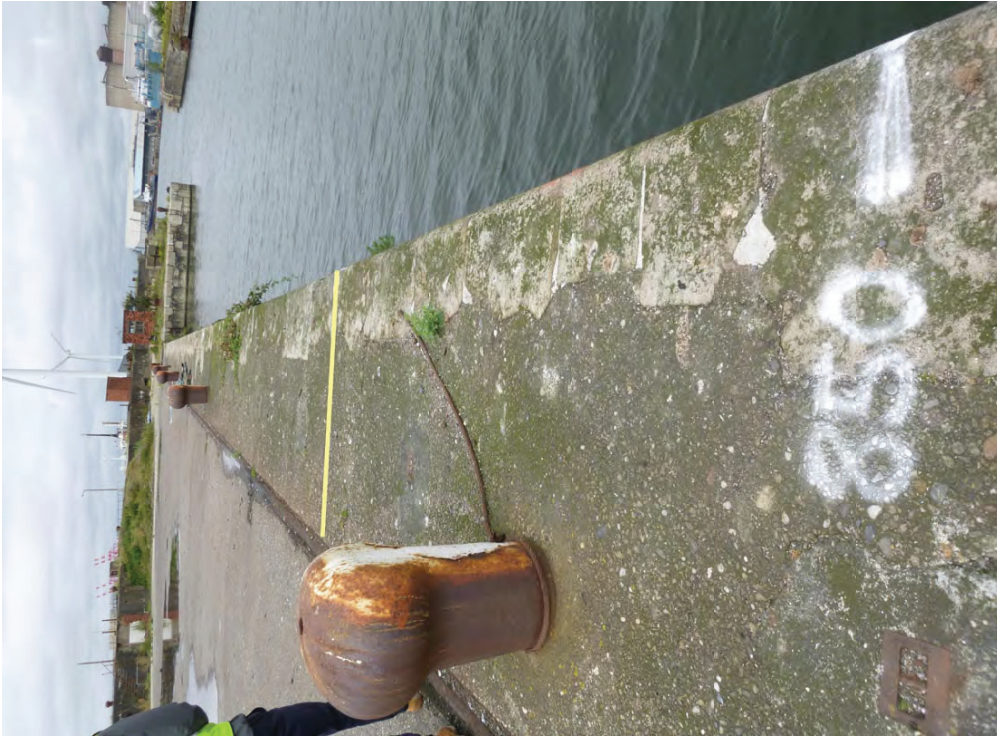
Figure A175a - Bramley Moore: Coping Chainage 850 to 855m

| Chainage (m) | Feature | Level (m from top) | Dimensions (m) | Description |
|---|---|---|---|---|
| 852 | Mooring Bollard | 0 (coping) | H = 0.8m | T-Shaped bollard embedded into coping. Good condition, localised surface corrosion |
