Figure A181a - Bramley Moore: Coping Chainage 880 to 885m

A182 Chainage 885 to 890m

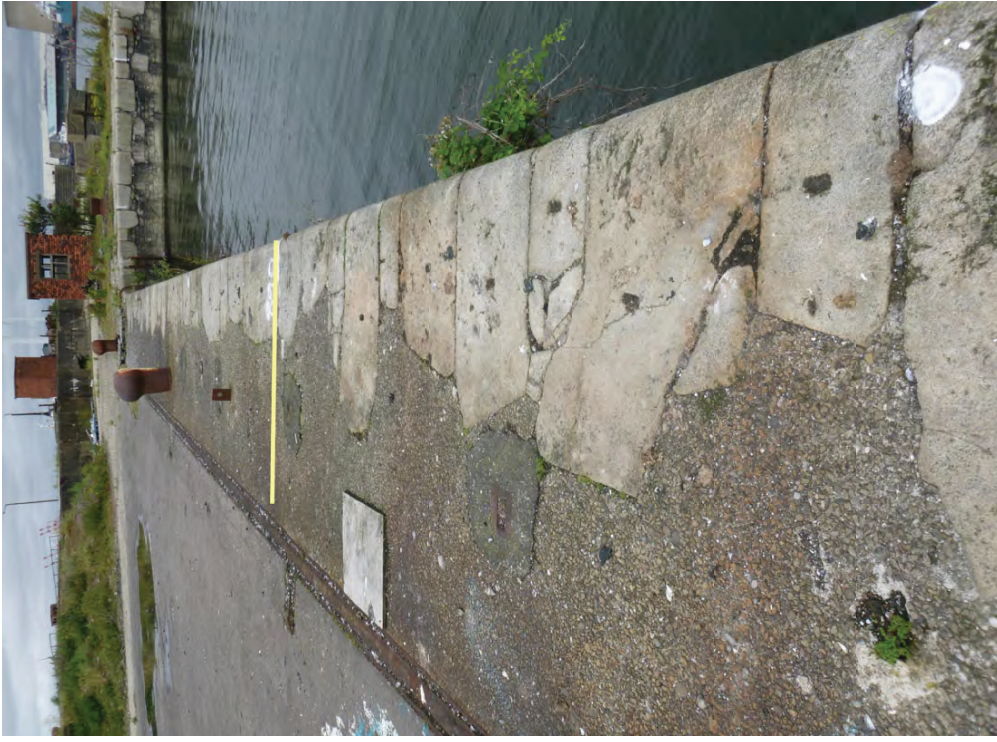
Figure A182a - Bramley Moore: Coping Chainage 885 to 890m

| Chainage (m) | Feature | Level (m from top) | Dimensions (m) | Description |
|---|---|---|---|---|
| 885 to 890 | Coping | 0 to 0.4 | - | Good - Minor cracks created by minor movement. Surface defects in coping or limited mortar loss from joints |
| 885 to 890 | Brickwork / Masonry | 0.4 to 1.8 | - | Very Good - No sign of movement. Joints are sound with no loss of mortar |
| 885 to 890 | Marine Growth | 1.5 to 1.8 | - | Minor growth. Features partially obscured |
| 885 to 888 | Vegetation | 0.2 to 0.5 | - | Minor growth. Features partially obscured. Onset of structural degradation by root growth |
| 886 | Mooring Chain | 0.5 to 1.8 | - | Fixed within recess. Fair condition, extensive corrosion with minor thickness loss and/or minor damage to links |
| 885 to 890 | Concrete | 0 (coping) | - | Good - Structurally sound but with minor cracks and localised honeycombing/flaking with no significant defects |
| 886 and 889 | Metalwork | 0 (coping) | 0.1 x 0.1m | Metal fixing. Good condition, localised surface corrosion |

| Chainage (m) | Feature | Defect | Level (m from top) | Description |
|---|---|---|---|---|
| 885 to 888 | Coping | Vegetation Damage | 0.2 | Small and shallow rooted vegetation resulting in surface cracks and the early onset of mortar degradation |
| 885 to 889 | Brickwork / Masonry | Staining / Calcification | 0.9 to 1.5 | White staining concentrated around mortar joints indicative of early sulphate attack. May lead to future spalling and deterioration of mortar |
| 887 to 888 | Brickwork / Masonry | Vegetation Damage | 0.2 to 0.5 | Established vegetation with deep roots. Roots have cracked mortar with the potential to displace bricks/blocks |
| 886 | Mooring Chain | Corrosion | 0.6 to 0.8 | Progressive corrosion has lead to deep pitting and loss of thickness weakening the metal |

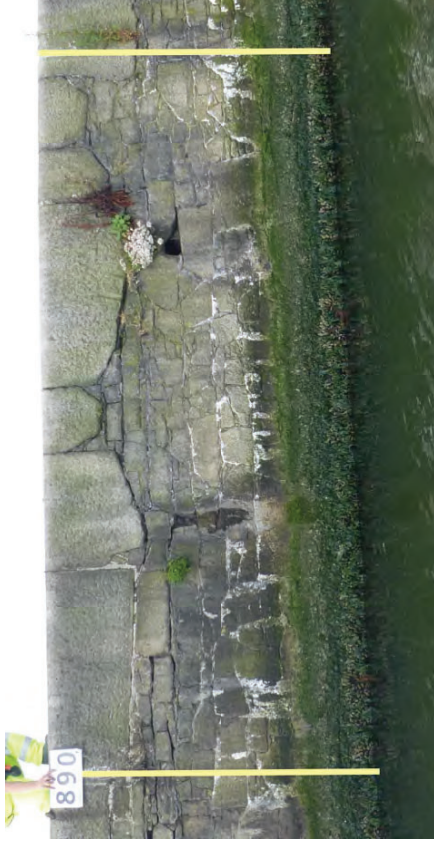
**Figure A183 - Bramley Moore: Chainage 890 to 895m**

| Overall Assessment | 2 | Good |

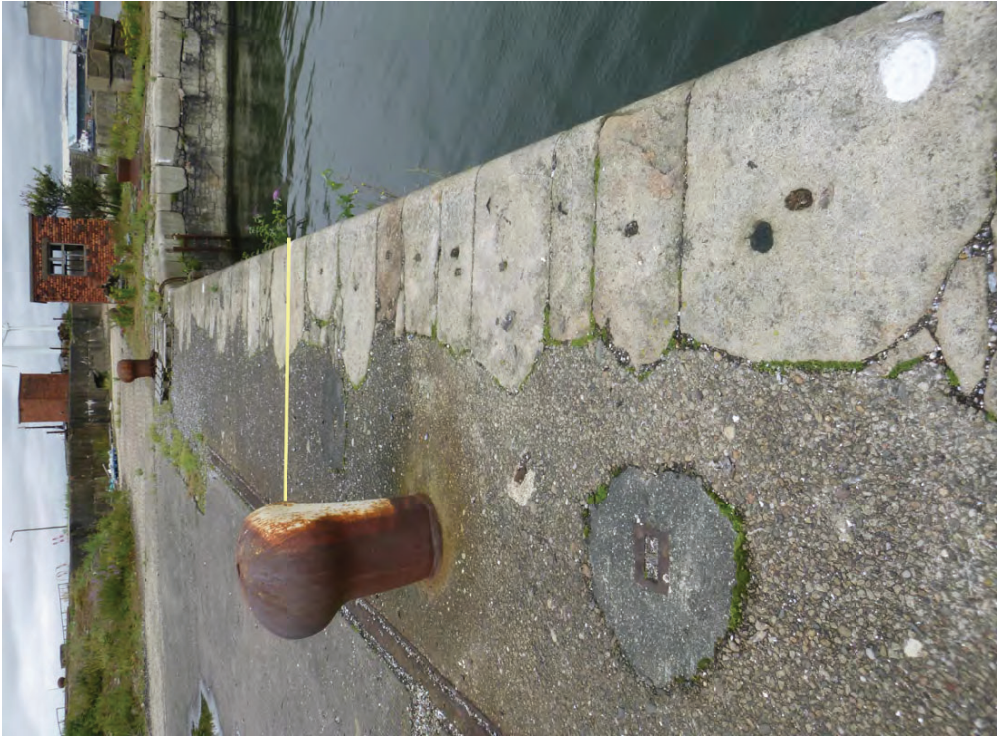
Figure A184a - Bramley Moore: Coping Chainage 895 to 900m

| Chainage (m) | Feature | Level (m from top) | Dimensions (m) | Description |
|---|---|---|---|---|
| 895 to 900 | Coping | 0 to 0.6 | - | Good - Minor cracks created by minor movement. Surface defects in coping or limited mortar loss from joints |
| 895 to 900 | Brickwork / Masonry | 0.6 to 1.8 | - | Good - Minor cracks created by minor movement. Surface defects in bricks or limited mortar loss from joints |
| 895 to 900 | Concrete | 0 (coping) | - | Good - Structurally sound but with minor cracks and localised honeycombing/flaking with no significant defects |
| 896 and 899 | Metalwork | 0 (coping) | 0.1 x 0.1m | Metal fixing. Good condition, localised surface corrosion |
| 897.5 | Mooring Bollard | 0 (coping) | H = 0.8m | T-Shaped bollard embedded into coping. Good condition, localised surface corrosion |

| Defects | | | | |
|---|---|---|---|---|
| 895 to 900 | Brickwork / Masonry | Staining / Calcification | 1 to 1.3 | White staining concentrated around mortar joints indicative of early sulphate attack. May lead to future spalling and deterioration of mortar |
| 897.5 | Coping | Loss of Mortar | 0.2 to 0.4 | Mortar loss to coping stone is limited to the surface. Defects are cosmetic only |
| 899 to 900 | Coping | Vegetation Damage | 0.3 | Small and shallow rooted vegetation resulting in surface cracks and the early onset of mortar degradation |

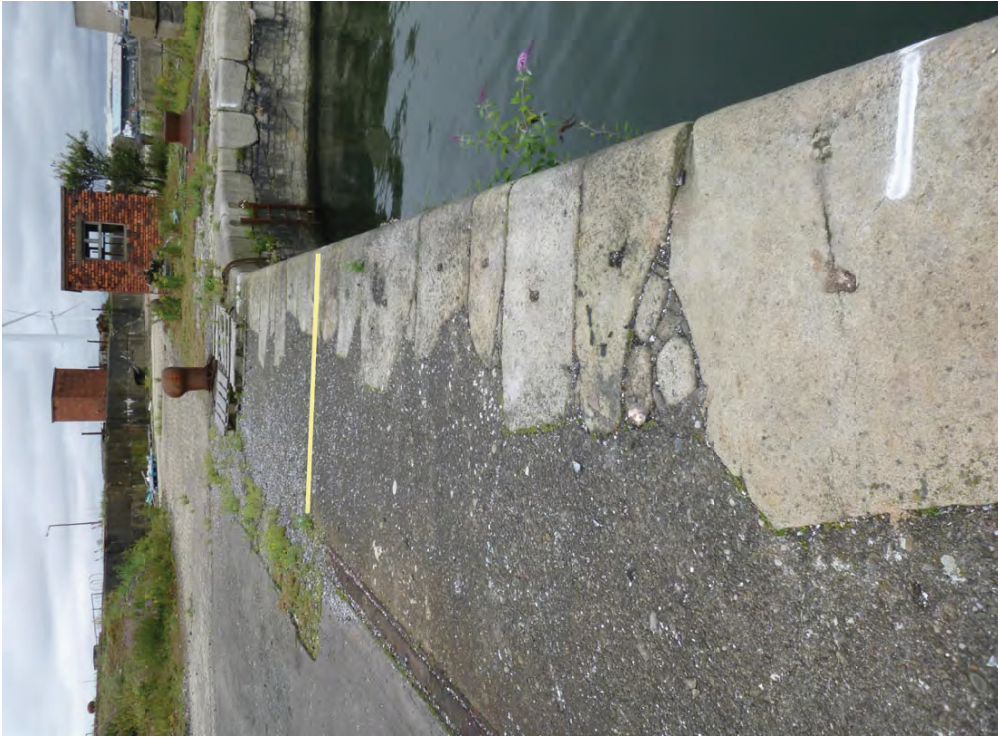
Figure A185a - Bramley Moore: Coping Chainage 900 to 905m

| Chainage (m) | Feature | Level (m from top) | Dimensions (m) | Description |
|---|---|---|---|---|
| 900 to 905 | Coping | 0 to 0.5 | - | Good - Minor cracks created by minor movement. Surface defects in coping or limited mortar loss from joints |
| 900 to 905 | Brickwork / Masonry | 0.5 to 1.8 | - | Good - Minor cracks created by minor movement. Surface defects in bricks or limited mortar loss from joints |
| 901 | Mooring Chain | 0.6 to 1.8 | - | Fixed within recess. Fair condition, extensive corrosion with minor thickness loss and/or minor damage to links |
| 900 to 905 | Concrete | 0 (coping) | - | Good - Structurally sound but with minor cracks and localised honeycombing/flaking with no significant defects |

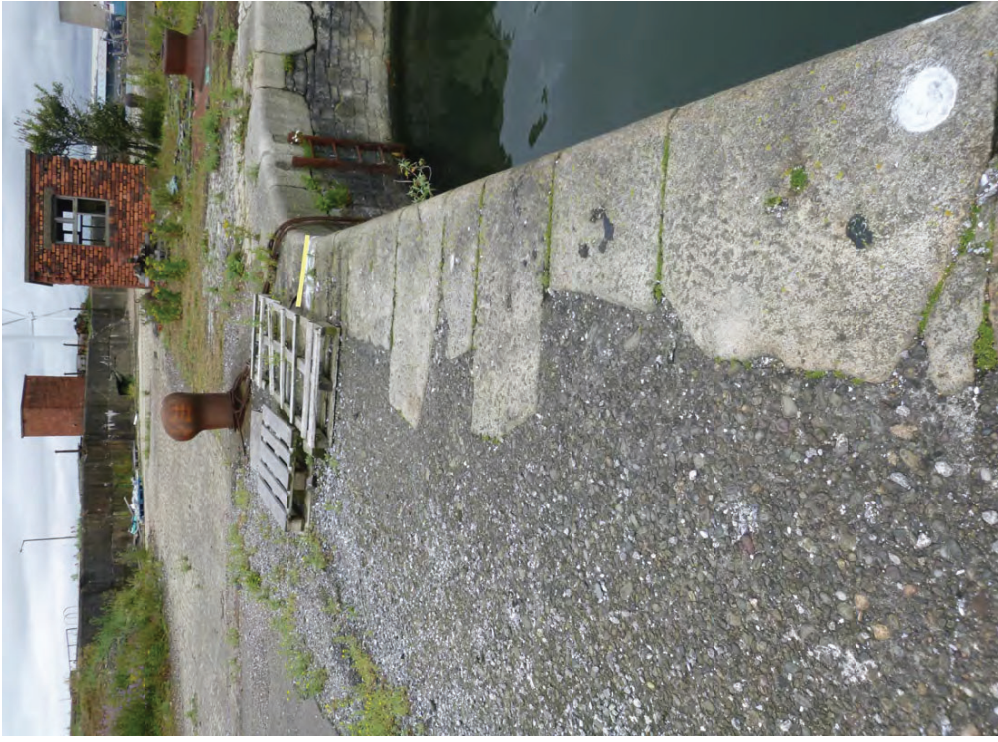
Figure A186a - Bramley Moore: Coping Chainage 905 to 910m

| Chainage (m) | Feature | Level (m from top) | Dimensions (m) | Description |
|---|---|---|---|---|
| 905 to 910 | Brickwork / Masonry | 0.3 to 1.8 | - | Good - Minor cracks created by minor movement. Surface defects in bricks or limited mortar loss from joints |
| 908 | Weephole / Outfall | 1.6 to 1.8 | D = 0.4m | Rectangular weephole/outfall. Good condition, some degradation but fully operable |

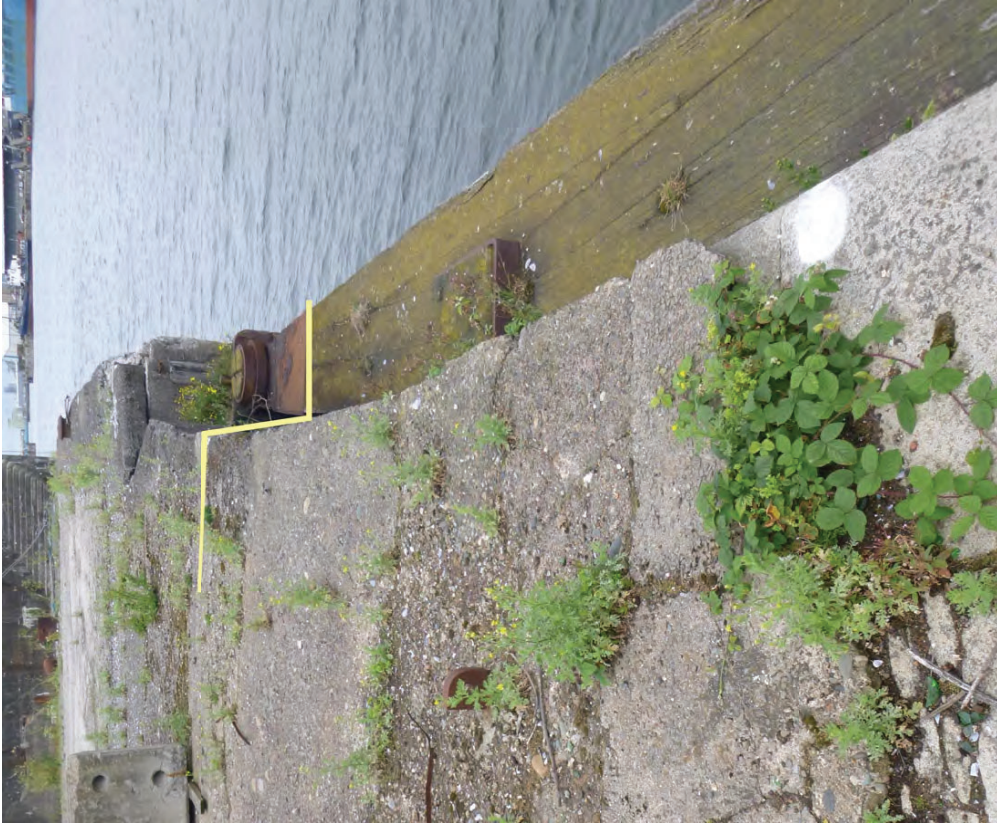
Figure A192a - Bramley Moore: Coping Chainage 935 to 940m

| Chainage (m) | Feature | Defect | Level (m from top) | Description |
|---|---|---|---|---|
| 935 to 940 | Concrete | Flaking / Spalling | 0 (coping) | Flaking of surface concrete. Flaking likely due to impact damage or freeze thaw action |
| 937 | Metalwork | Corrosion | 0 (coping) | Onset of corrosion to surface layers which may include pitting and/or flaking of the surface metal. Defects are cosmetic only |

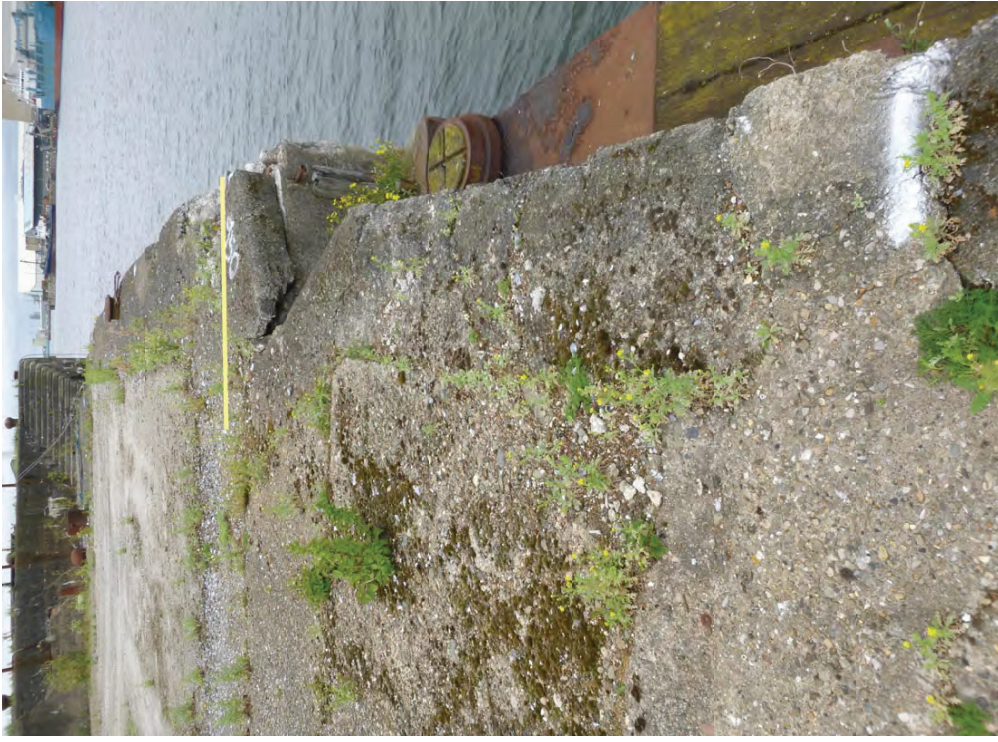
Figure A193a - Bramley Moore: Coping Chainage 940 to 945m

| Chainage (m) | Feature | Defect | Level (m from top) | Description |
|---|---|---|---|---|
| 940 to 945 | Brickwork / Masonry | Loss of Mortar | 0.3 to 2.1 | Mortar loss to bricks/blocks is limited to the surface. Defects are cosmetic only |
| 940 to 945 | Concrete | Cracking | 0 (coping) | Significant cracking of concrete surfacing. |

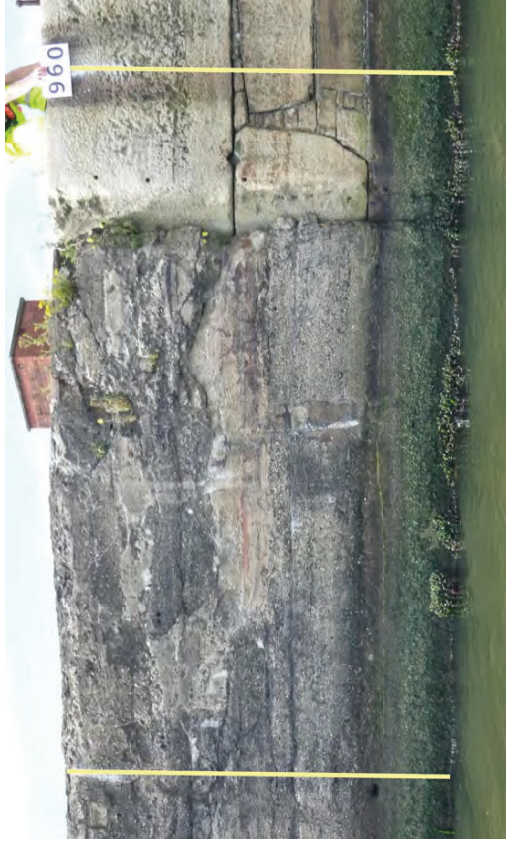
**Figure A196 - Bramley Moore: Chainage 955 to 960m**

| <b>Overall Condition Rating</b> | <b>2</b> | <b>Good</b> |
