Bramley-Moore Dock  
Bramley-Moore Dock Wall Visual  
Condition Report  
December 2019

**Bramley-Moore Dock Wall  
Visual Condition Report**

**Document Ref: 170701-01-200 - Rev. C**

**Bramley–Moore Dock Wall**

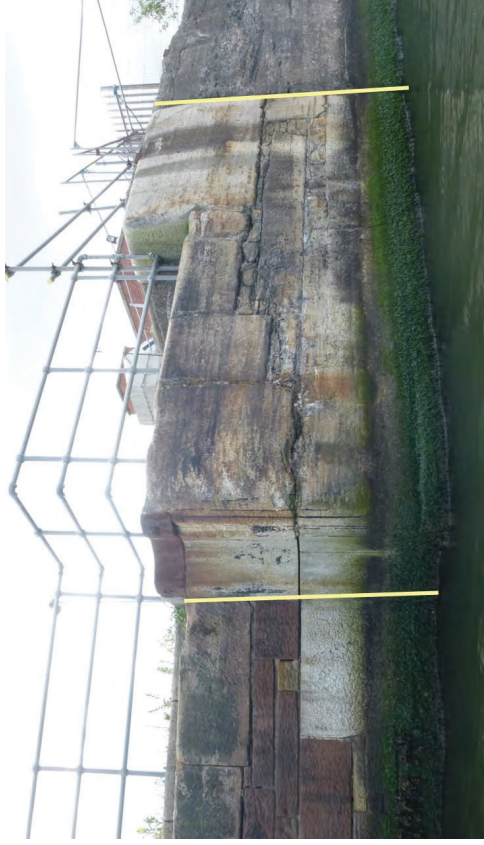
**Figure A3 - Bramley Moore: Chainage -13 to -8m**

Chainage (m)	Feature	Level (m from top)	Dimensions (m)	Description
-3 to 0	Vegetation	0 (coping)	-	Minor growth. Features partially obscured. Vegetation does not affect structural integrity
-1	Mooring Bollard	0 (coping)	-	Short pillar bollard. Good condition, localised surface corrosion
-8 to 0	Concrete	0 (coping)	-	Good - Structurally sound but with minor cracks and localised honeycombing/flaking with no significant defects
-8 to 0	Concrete	0 to 2.4	-	Good - Structurally sound but with minor cracks and localised honeycombing/flaking with no significant defects
-8 to 0	Marine Growth	1.9 to 2.4	-	Minor growth. Features partially obscured
-3	Chain Post / Fencing	0 (coping)	-	Temporary Heras fence restricting access

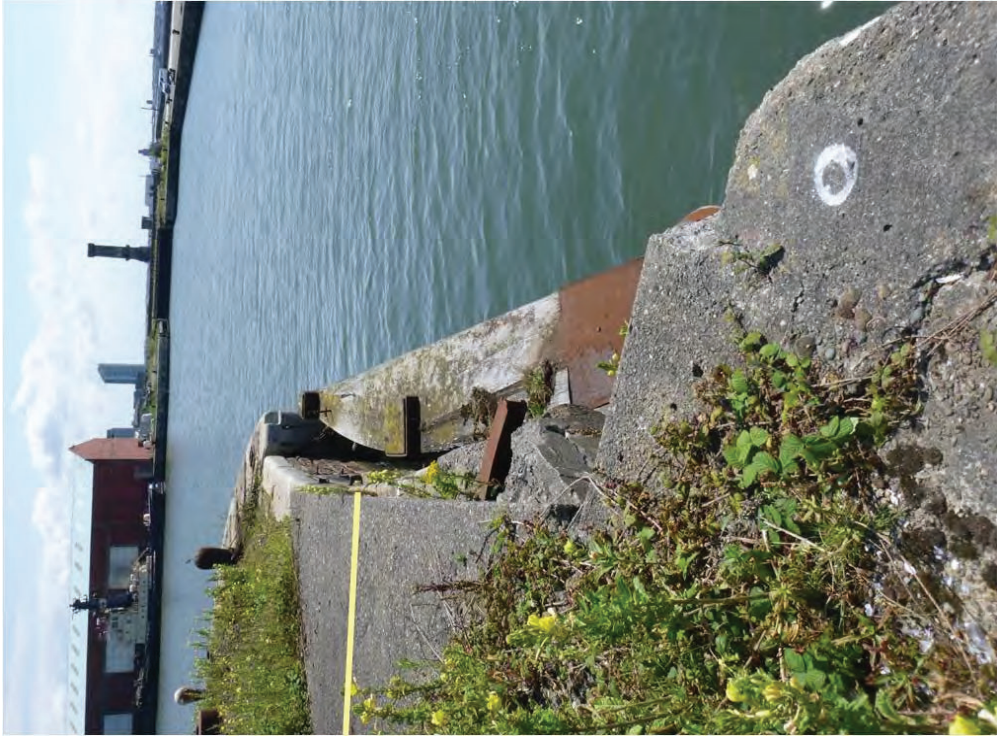
Figure A6a - Bramley Moore: Coping Chainage 5 to 10m

Chainage (m)	Feature	Defect	Level (m from top)	Description
5 to 5.5	Concrete	Impact Damage	0 to 1	Localised impact damage resulting in chipping/fragmentation of wall materials
5 to 8	Concrete	Cracking	0 to 1	Significant horizontal cracking of mortar joints and/or bricks/blocks. Indicates wall movement/settlement
5 to 10	Brickwork / Masonry	Loss of Mortar	0.7 to 2.2	Mortar loss to bricks/blocks extends below surface and has the potential to weaken/loosen surrounding bricks/blocks
7 to 10	Lock Gate	Decay	1 to 2.2	Decay is throughout intertidal zone leading to weakening of timber elements and localised section loss
7 to 10	Lock Gate	Corrosion	1 to 2.2	Progressive corrosion has lead to deep pitting and loss of thickness weakening the metal
