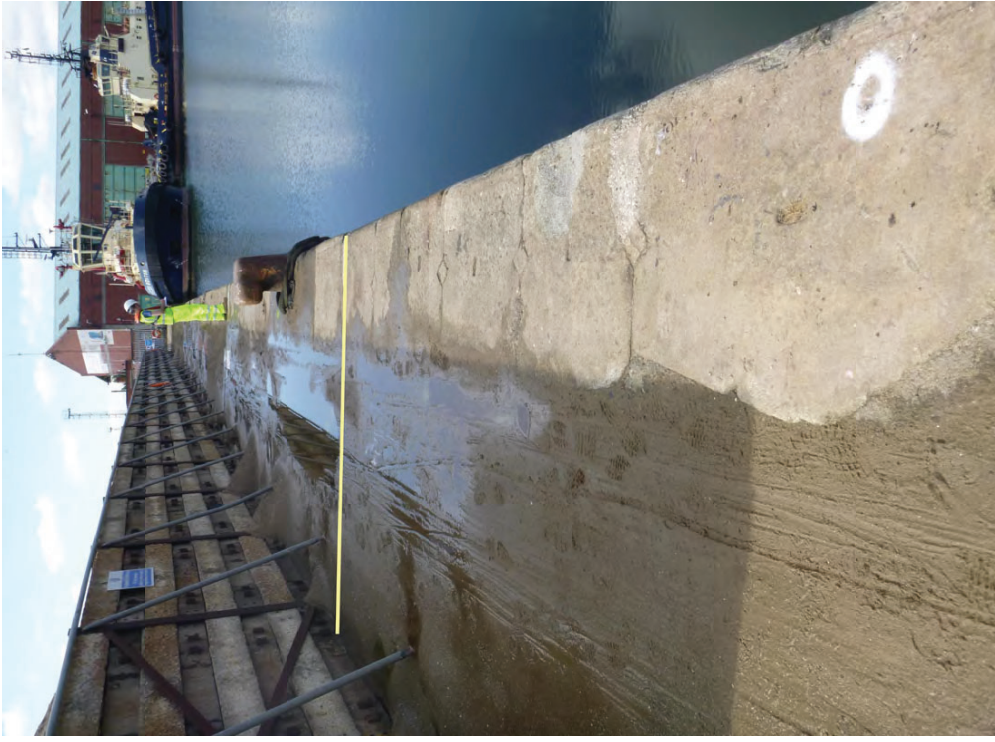
Figure A74a - Bramley Moore: Coping Chainage 345 to 350m

| Chainage (m) | Feature | Level (m from top) | Dimensions (m) | Description |
|---|---|---|---|---|
| 350 to 352, 353 to 355 | Coping | 0 to 0.5 | - | Good - Minor cracks created by minor movement. Surface defects in coping or limited mortar loss from joints |
| 350 to 355 | Brickwork / Masonry | 0.5 to 1.8 | - | Good - Minor cracks created by minor movement. Surface defects in bricks or limited mortar loss from joints |
| 352.5 | Mooring Bollard | 0 (coping) | H = 0.8m | T-Shaped bollard embedded into coping. Good condition, localised surface corrosion |

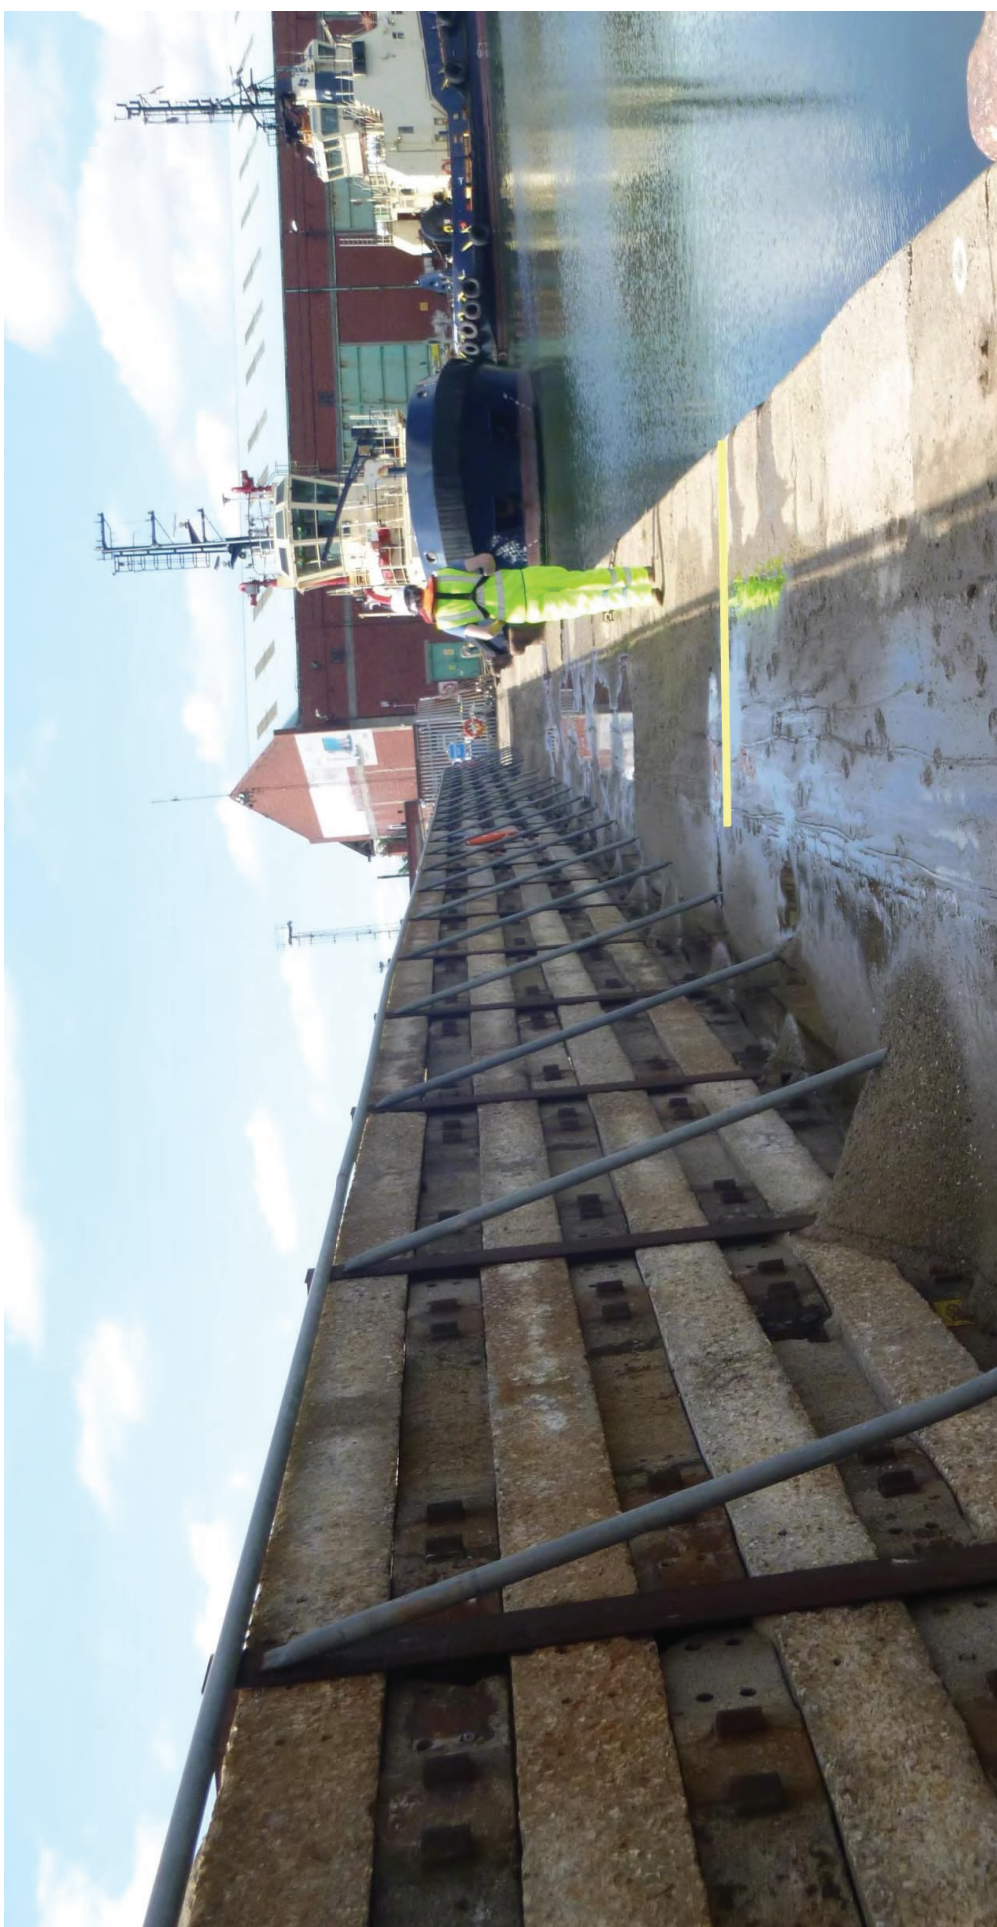
Figure A76a - Bramley Moore: Coping Chainage 355 to 360m

| Chainage (m) | Feature | Level (m from top) | Dimensions (m) | Description |
|---|---|---|---|---|
| 355 to 351, 353 to 355 | Coping | 0 to 0.5 | - | Good - Minor cracks created by minor movement. Surface defects in coping or limited mortar loss from joints |
| 351 to 353 | Repair | 0 to 0.5 | - | Concrete repair to coping |
| 355 to 360 | Brickwork / Masonry | 0.3 to 1.8 | - | Good - Minor cracks created by minor movement. Surface defects in bricks or limited mortar loss from joints |
| 351 | Weephole / Outfall | 1 | D = 0.2m | Rectangular weephole/outfall. Fair condition, some deterioration of material surrounding weephole/outfall. Any fixings have minor damage |
| 358.5 | Anchor | 0.1 to 0.4 | 0.3 x 0.3m | Good - Localised surface corrosion with slight loss of thickness. No physical deformation or movement of anchor ties/plates |

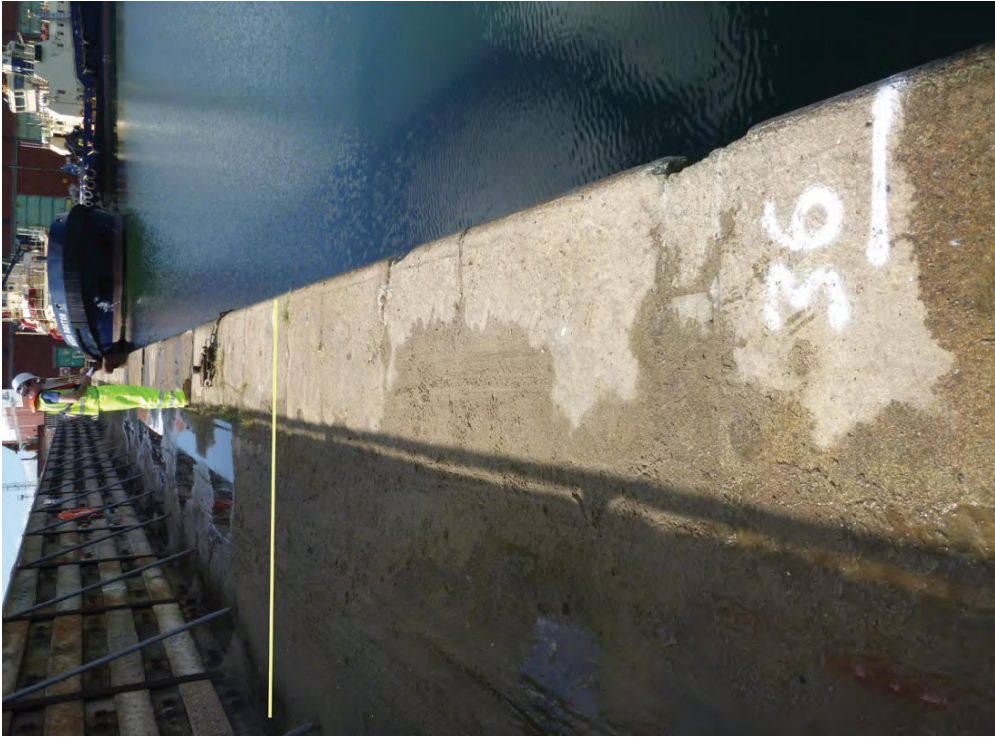
Figure A77a - Bramley Moore: Coping Chainage 360 to 365m

| Chainage (m) | Feature | Level (m from top) | Dimensions (m) | Description |
|---|---|---|---|---|
| 360 to 365 | Coping | 0 to 0.5 | - | Good - Minor cracks created by minor movement. Surface defects in coping or limited mortar loss from joints |
| 360 to 365 | Brickwork / Masonry | 0.5 to 1.8 | - | Good - Minor cracks created by minor movement. Surface defects in bricks or limited mortar loss from joints |
| 360.5 | Anchor | 0.1 to 0.4 | 0.3 x 0.3m | Good - Localised surface corrosion with slight loss of thickness. No physical deformation or movement of anchor ties/plates |
| 364 | Weephole / Outfall | 0.9 | D = 0.2m | Rectangular weephole/outfall. Fair condition, some deterioration of material surrounding weephole/outfall. Any fixings have minor damage |
| 360 to 361 | Metalwork | 0 (coping) | - | Rail track. Poor condition, extensive corrosion with major thickness loss |

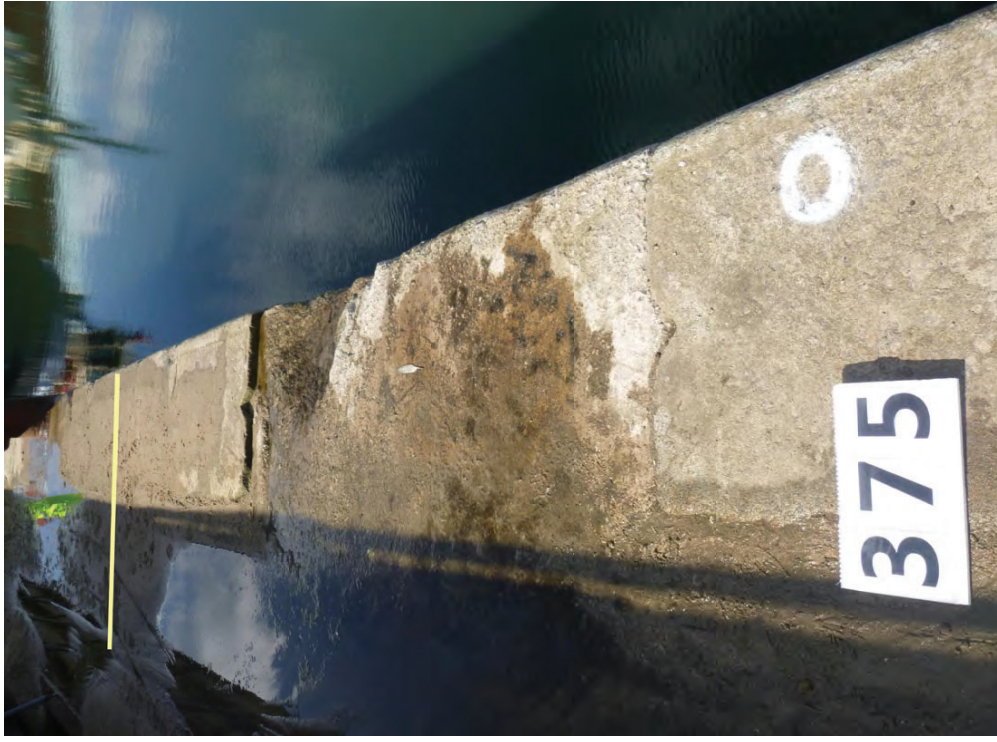
Figure A80a - Bramley Moore: Coping Chainage 375 to 380m

| Chainage (m) | Feature | Level (m from top) | Dimensions (m) | Description |
|---|---|---|---|---|
| 375 to 380 | Coping | 0 to 0.5 | - | Fair - Slight coping displacement created by movement. Mortar loss from joints and joints/coping cracking. Rounding/chipping of coping edges |
| 375 to 380 | Brickwork / Masonry | 0.5 to 1.8 | - | Good - Minor cracks created by minor movement. Surface defects in bricks or limited mortar loss from joints |
| 379 | Weephole / Outfall | 1.1 | D = 0.2m | Rectangular weephole/outfall. Good condition, some degradation but fully operable |
| 375 to 380 | Coping | 0 (coping) | - | Obscured due to large amounts of sand |

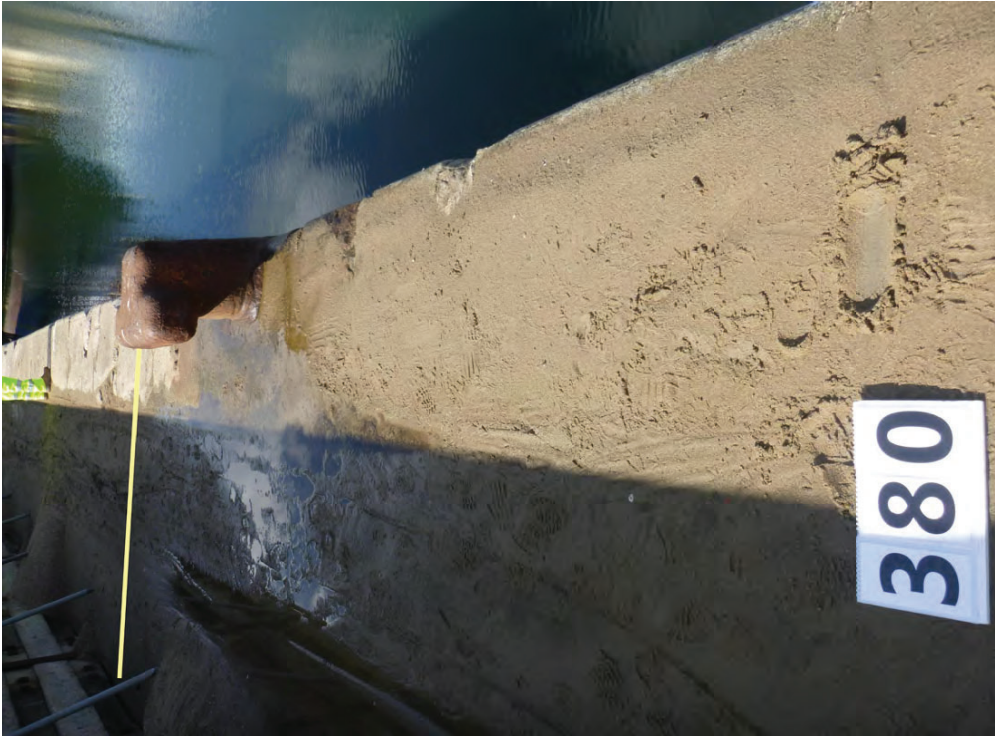
Figure A81a - Bramley Moore: Coping Chainage 380 to 385m

| Chainage (m) | Feature | Level (m from top) | Dimensions (m) | Description |
|---|---|---|---|---|
| 380 to 383, 384 to 385 | Coping | 0 to 0.5 | - | Good - Minor cracks created by minor movement. Surface defects in coping or limited mortar loss from joints |
| 380 to 383, 384 to 385 | Brickwork / Masonry | 0.5 to 1.8 | - | Good - Minor cracks created by minor movement. Surface defects in bricks or limited mortar loss from joints |
| 383 to 384 | Repair | 0 to 1.5 | - | Concrete repair to brickwork/blockwork |
| 383 | Mooring Bollard | 0 (coping) | H = 0.8m | T-Shaped bollard embedded into coping. Good condition, localised surface corrosion |

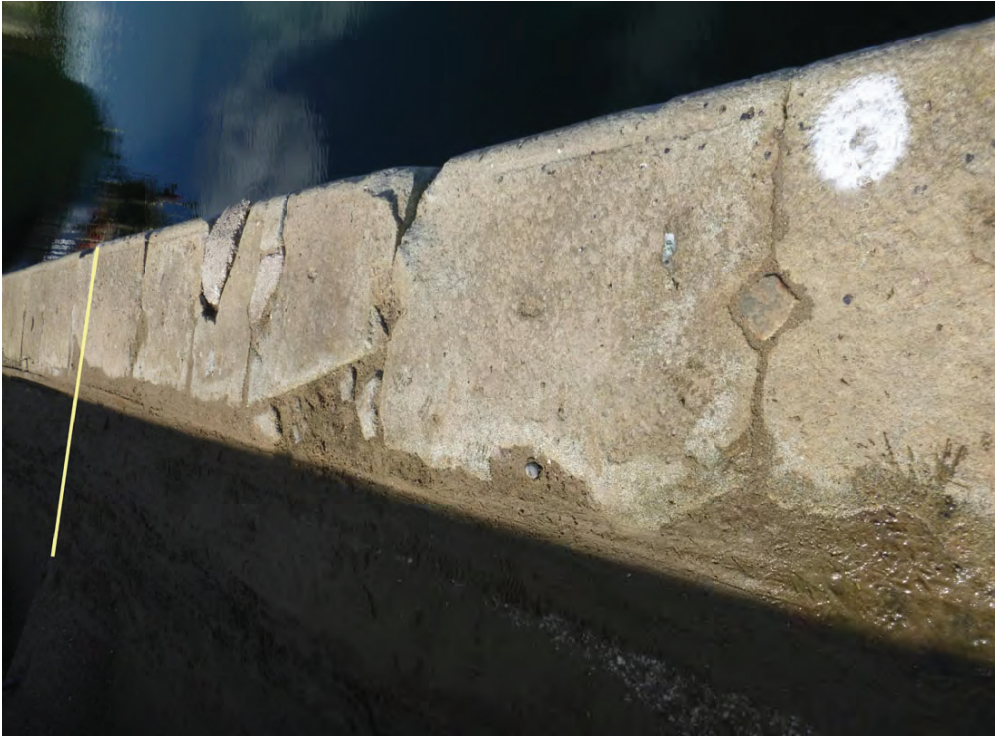
Figure A82a - Bramley Moore: Coping Chainage 385 to 390m

| Chainage (m) | Feature | Level (m from top) | Dimensions (m) | Description |
|---|---|---|---|---|
| 385 to 390 | Coping | 0 to 0.5 | - | Fair - Slight coping displacement created by movement. Mortar loss from joints and joints/coping cracking. Rounding/chipping of coping edges |
| 385 to 390 | Brickwork / Masonry | 0.3 to 1.8 | - | Fair - Slight brick displacement created by movement. Mortar loss from joints and joint/brick cracking |
| 387 | Weephole / Outfall | 0.9 | D = 0.2m | Piped outfall. Fair condition, some deterioration of material surrounding outfall. Significant corrosion to pipe |
| 385 to 390 | Concrete | 0 (coping) | - | Fair - Rust staining, localised spalling, lengthy cracking and some movement or extensive honeycombing |
| 385 to 390 | Metalwork | 0 (coping) | - | Rail track. Fair condition, extensive corrosion with minor thickness loss |

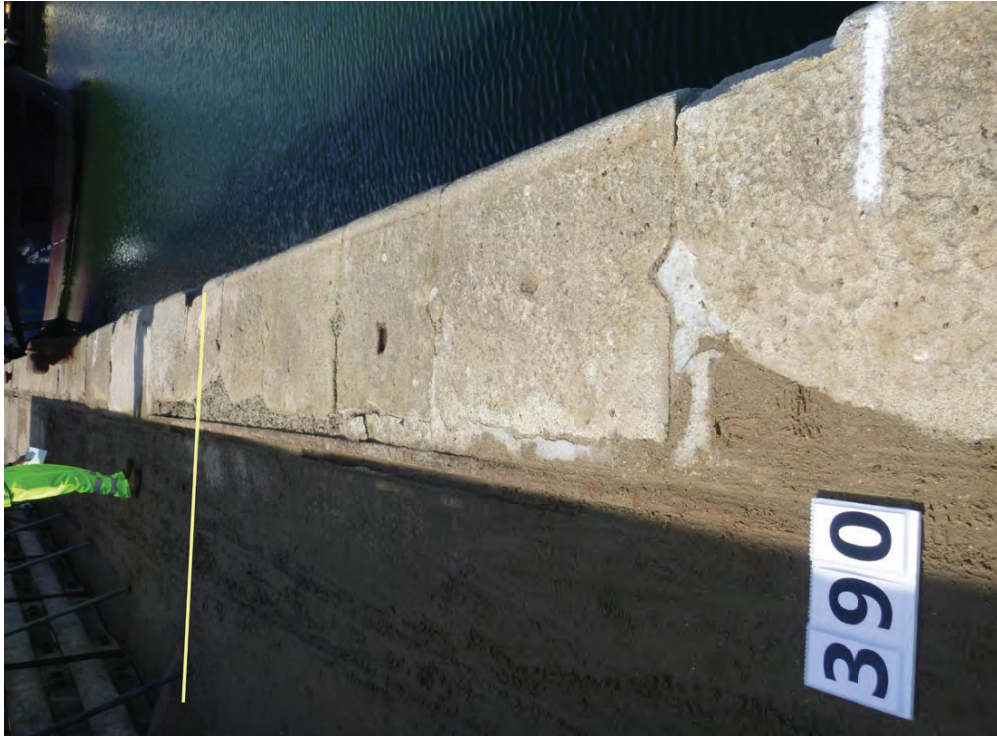
Figure A83a - Bramley Moore: Coping Chainage 390 to 395m

| Chainage (m) | Feature | Level (m from top) | Dimensions (m) | Description |
|---|---|---|---|---|
| 390 to 395 | Coping | 0 to 0.5 | - | Fair - Slight coping displacement created by movement. Mortar loss from joints and joints/coping cracking. Rounding/chipping of coping edges |
| 390 to 395 | Repair | 0.5 to 0.8 | - | Concrete repair to brickwork/blockwork |
| 390 to 395 | Brickwork / Masonry | 0.8 to 1.8 | - | Good - Minor cracks created by minor movement. Surface defects in bricks or limited mortar loss from joints |
| 390 to 395 | Concrete | 0 (coping) | - | Good - Structurally sound but with minor cracks and localised honeycombing/flaking with no significant defects |

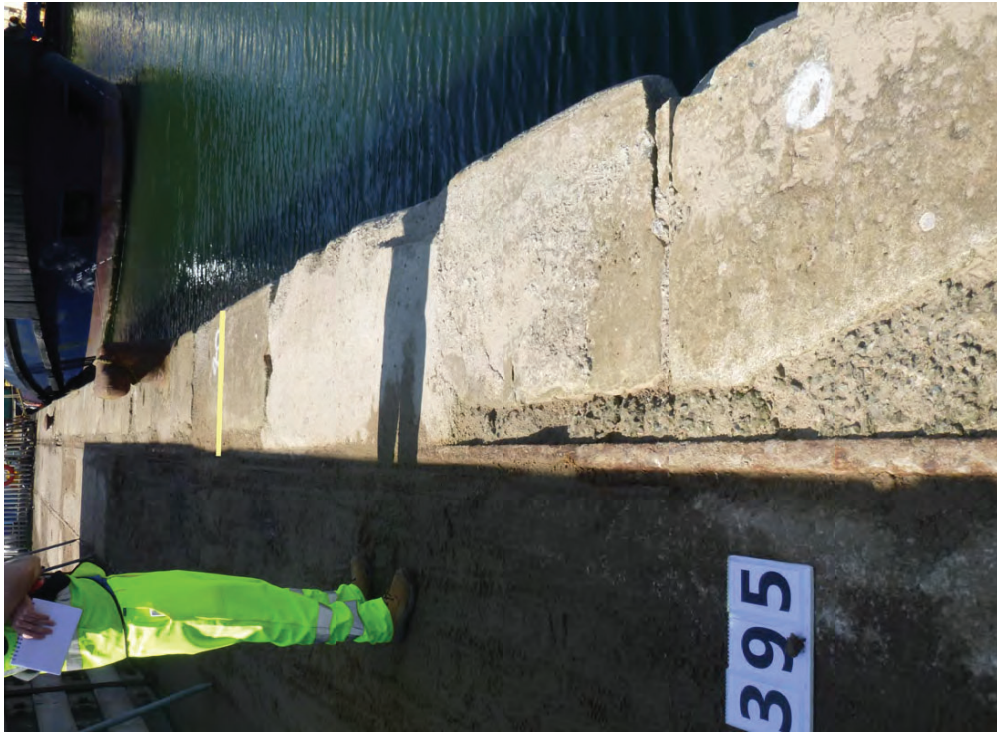
Figure A84a - Bramley Moore: Coping Chainage 395 to 400m

| Chainage (m) | Feature | Defect | Level (m from top) | Description |
|---|---|---|---|---|
| 395 to 400 | Brickwork / Masonry | Loss of Mortar | 0.2 to 1 | Mortar loss to bricks/blocks is significant resulting in loosening of bricks/blocks |
| 399 to 400 | Brickwork / Masonry | Loss of Bricks/Blocks | 0.3 to 1 | Loss of small group of bricks/blocks. Defects are cosmetic but have the potential to affect the walls integrity |

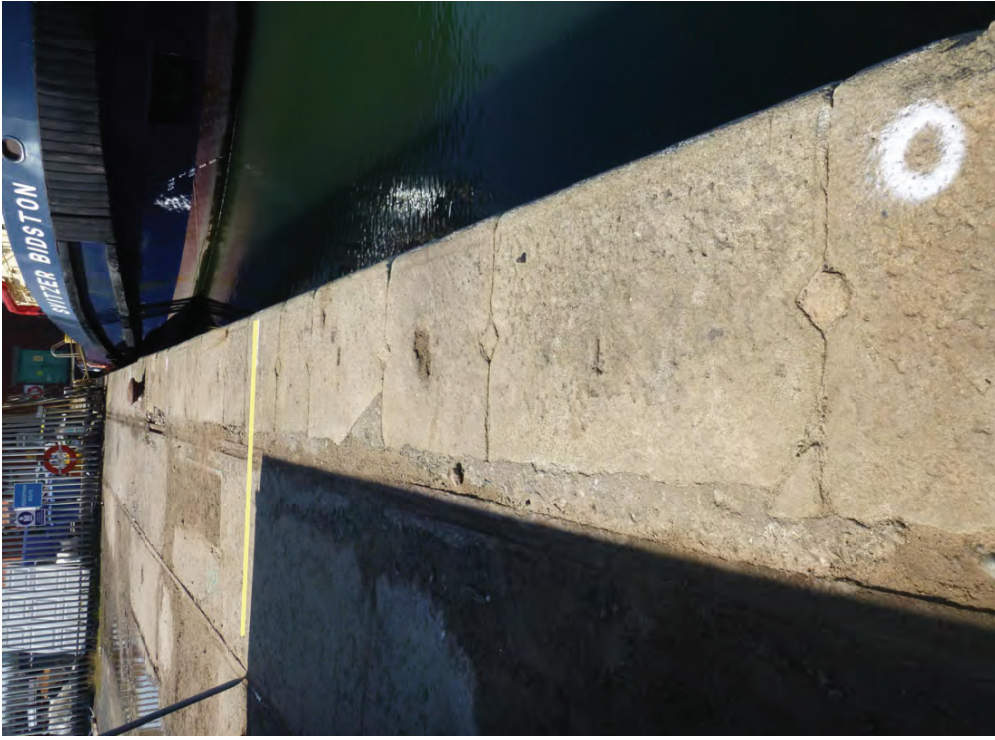
Figure A86a - Bramley Moore: Coping Chainage 405 to 410m

| Chainage (m) | Feature | Level (m from top) | Dimensions (m) | Description |
|---|---|---|---|---|
| 405 to 410 | Metalwork | 0 (coping) | - | Rail track. Fair condition, extensive corrosion with minor thickness loss |

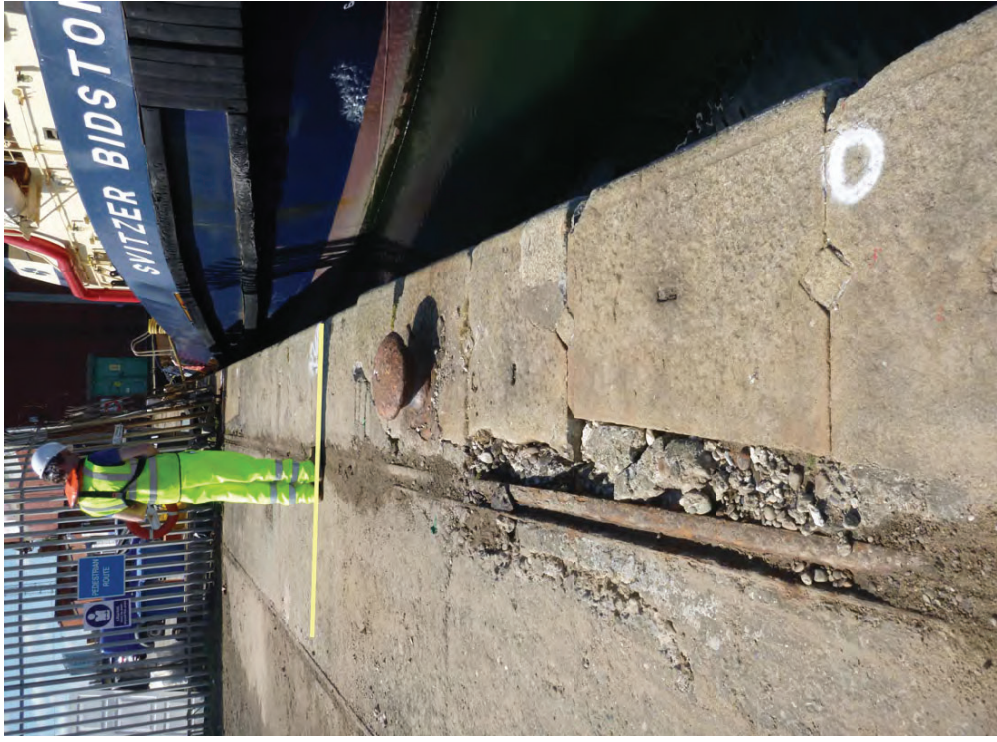
Figure A88a - Bramley Moore: Coping Chainage 415 to 420m

| Chainage (m) | Feature | Defect | Level (m from top) | Description |
|---|---|---|---|---|
| 415 to 417 | Concrete | Cracking | 0 (coping) | Significant cracking of concrete. Indicates wall movement/settlement |
| 416 to 418 | Concrete | Flaking / Spalling | 0 (coping) | Minor spalling or surface concrete most likely due to impact damage or early onset of reinforcement corrosion |

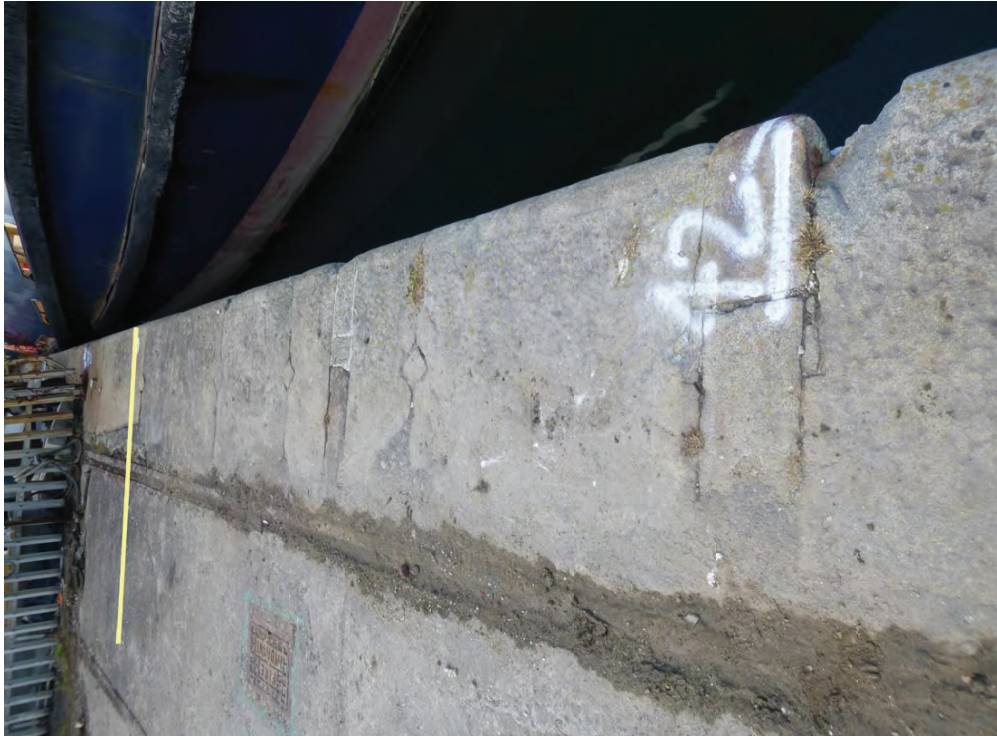
Figure A89a - Bramley Moore: Coping Chainage 420 to 425m

| Chainage (m) | Feature | Level (m from top) | Dimensions (m) | Description |
|---|---|---|---|---|
| 420 to 425 | Metalwork | 0 (coping) | - | Rail track. Fair condition, extensive corrosion with minor thickness loss |

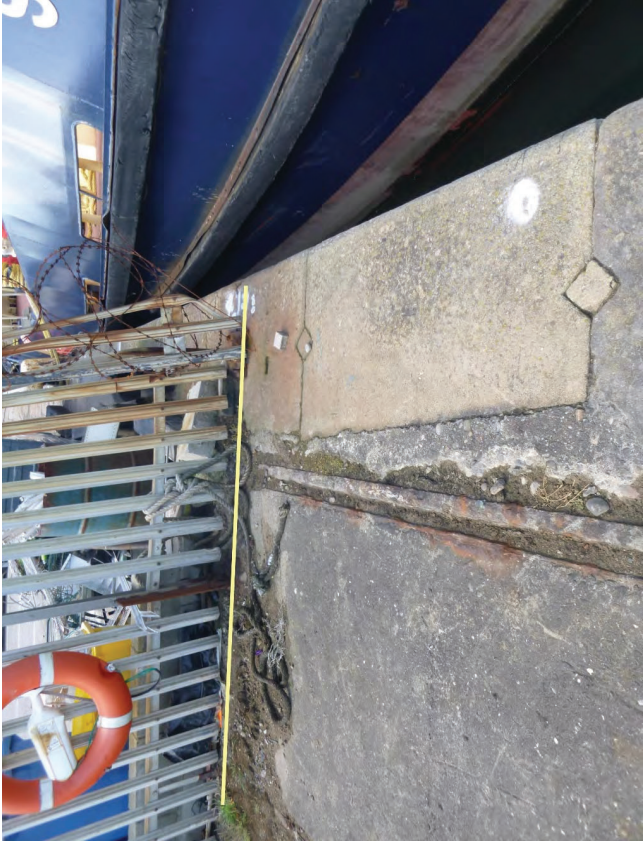
Figure A90a - Bramley Moore: Coping Chainage 425 to 430m

| <b>Chainage<br/>(m)</b> | <b>Feature</b> | <b>Defect</b> | <b>Level (m<br/>from top)</b> | <b>Description</b> |
|---|---|---|---|---|
| 427.5 | Brickwork /<br>Masonry | Loss of Bricks/BLOCKS | 0.5 to 1 | Loss of small group of bricks/blocks. Defects are cosmetic but have the potential to affect the walls integrity |
| 428.5 | Brickwork /<br>Masonry | Impact Damage | 0.5 to 1 | Localised impact damage resulting in chipping/fragmentation of wall materials |
