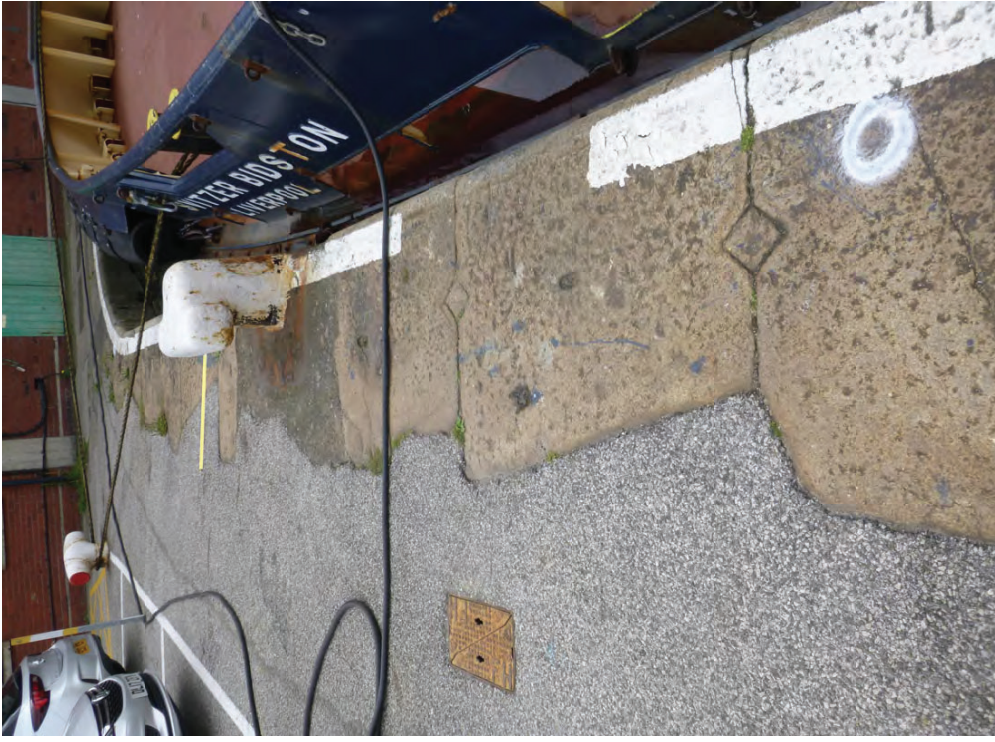
Figure A94a - Bramley Moore: Coping Chainage 445 to 450m

Chainage (m)	Feature	Level (m from top)	Dimensions (m)	Description
445 to 448, 449 to 450	Coping	0 to 0.5	-	Good - Minor cracks created by minor movement. Surface defects in coping or limited mortar loss from joints
445 to 448, 449 to 450	Brickwork / Masonry	0.5 to 1.8	-	Good - Minor cracks created by minor movement. Surface defects in bricks or limited mortar loss from joints
448 to 449	Repair	0 to 1.8	-	Concrete repair to brickwork/blockwork
445 to 450	Concrete	0 (coping)	-	Very Good - Hair-line cracks and small surface cavities may be apparent
448	Mooring Bollard	0 (coping)	H = 0.8m	T-Shaped bollard embedded into coping. Good condition, localised surface corrosion

Chamage (m)	Feature	Defect	Level (m from top)	Description
445 to 448, 449 to 450	Coping	Loss of Mortar	0.3 to 0.5	Mortar loss to coping stone is limited to the surface. Defects are cosmetic only
445 to 448, 449 to 450	Brickwork / Masonry	Loss of Mortar	0.3 to 1.2	Mortar loss to bricks/blocks extends below surface and has the potential to weaken/loosen surrounding bricks/blocks
447 and 449	Coping	Loss of Bricks/Blocks	0.2	Holes in blockwork, likely left by historic fixings. Defects are cosmetic but have the potential to affect the walls integrity.
447	Brickwork / Masonry	Loss of Bricks/Blocks	0.9	Loss of small group of bricks/blocks. Defects are cosmetic but have the potential to affect the walls integrity

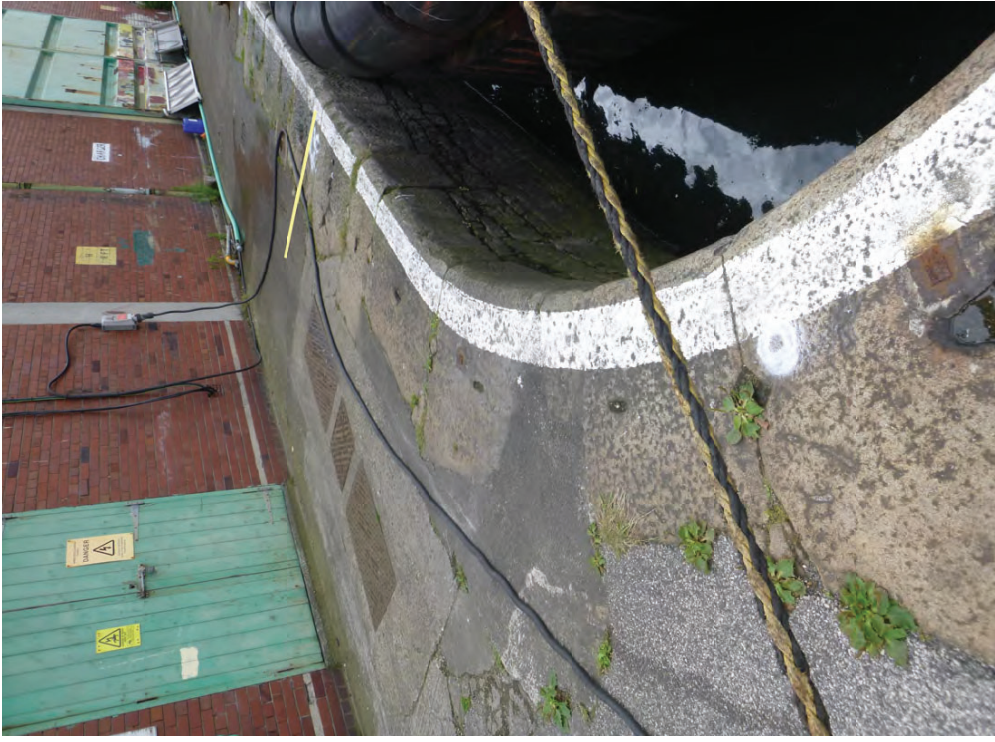
Figure A96a - Bramley Moore: Coping Chainage 455 to 460m

Chainage (m)	Feature	Level (m from top)	Dimensions (m)	Description
455 to 460	Coping	0 to 0.5	-	Good - Minor cracks created by minor movement. Surface defects in coping or limited mortar loss from joints
455 to 460	Brickwork / Masonry	0.5 to 1.8	-	Good - Minor cracks created by minor movement. Surface defects in bricks or limited mortar loss from joints
455 to 460	Marine Growth	1.5 to 1.8	-	Significant growth. Features obscured. Condition cannot be assessed

455.5	Mooring Chain	1 to 1.3	-	Fixed to wall. Fair condition, extensive corrosion with minor thickness loss and/or minor damage to links
456	Weephole / Outfall	0.5	D = 0.15m	Circular weephole/outfall. Fair condition, some deterioration of material surrounding weephole/outfall. Any fixings have minor damage
457	Weephole / Outfall	1.8	D = 0.25m	Rectangular weephole/outfall. Good condition, some degradation but fully operable
455 to 460	Concrete	0 (coping)	-	Good - Structurally sound but with minor cracks and localised honeycombing/flaking with no significant defects

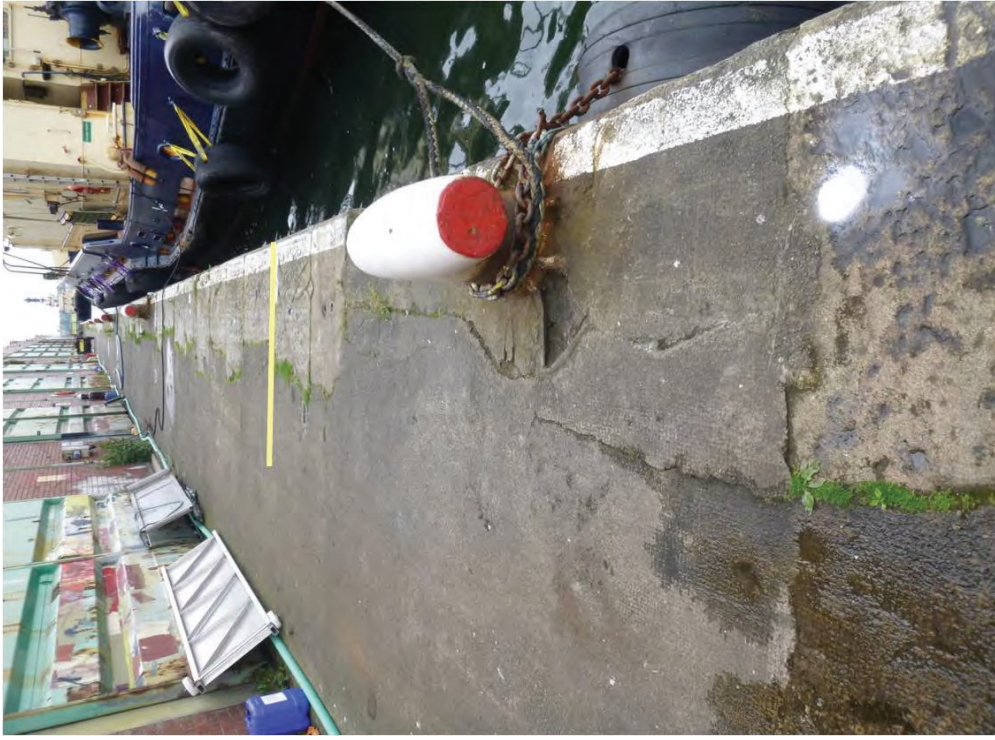
Figure A98a - Bramley Moore: Coping Chainage 465 to 470m

Chainage (m)	Feature	Level (m from top)	Dimensions (m)	Description
465 to 468	Repair	0 to 1.5	-	Concrete repair to brickwork/blockwork
467 to 470	Coping	0 to 0.5	-	Good - Minor cracks created by minor movement. Surface defects in coping or limited mortar loss from joints
467 to 470	Brickwork / Masonry	0.5 to 1.8	-	Good - Minor cracks created by minor movement. Surface defects in bricks or limited mortar loss from joints
465 to 470	Marine Growth	1.5 to 1.8	-	Minor growth. Features partially obscured
465	Weephole / Outfall	1.5	D = 0.15m	Circular weephole/outfall. Good condition, some degradation but fully operable

466.5	Fender	0 to 1.6	-	Tyre Fender. Good condition, fixed to bollard/coping with chain/rope
465 to 470	Concrete	0 (coping)	-	Good - Structurally sound but with minor cracks and localised honeycombing/flaking with no significant defects

466.5	Mooring Bollard	0 (coping)	H = 0.8m	T-Shaped bollard embedded into coping. Good condition, localised surface corrosion

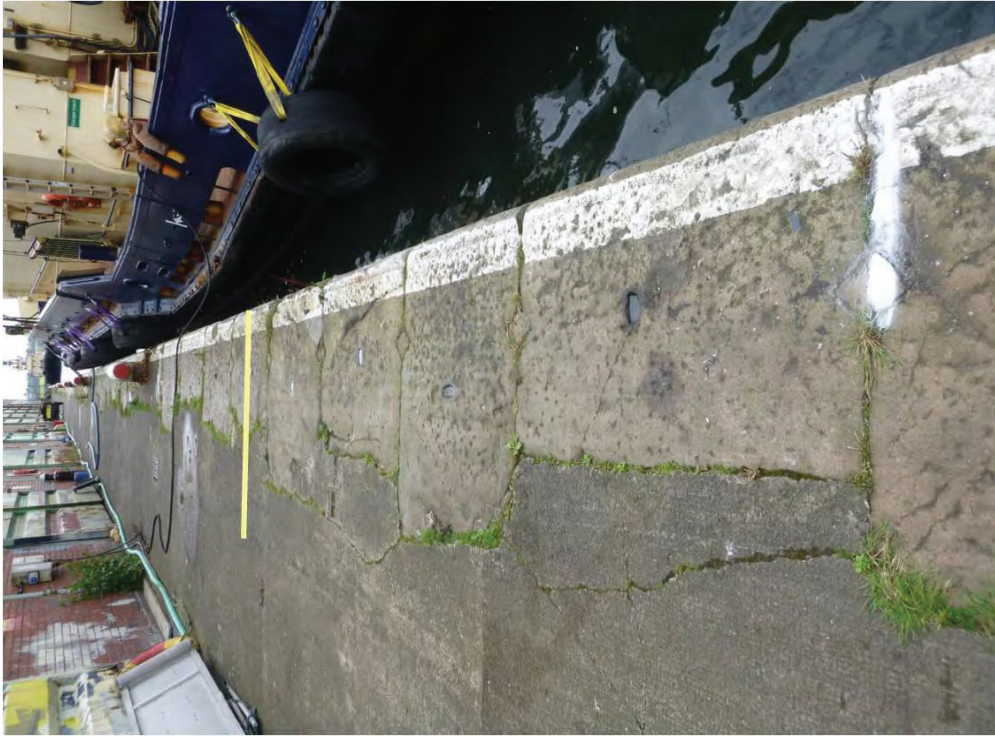
Figure A99a - Bramley Moore: Coping Chainage 470 to 475m

Chainage (m)	Feature	Level (m from top)	Dimensions (m)	Description
470 to 475	Coping	0 to 0.5	-	Good - Minor cracks created by minor movement. Surface defects in coping or limited mortar loss from joints
470 to 475	Brickwork / Masonry	0.5 to 1.8	-	Good - Minor cracks created by minor movement. Surface defects in bricks or limited mortar loss from joints
470 to 475	Marine Growth	1.5 to 1.8	-	Minor growth. Features partially obscured
470 to 475	Concrete	0 (coping)	-	Good - Structurally sound but with minor cracks and localised honeycombing/flaking with no significant defects
470 to 475	Vegetation	0 (coping)	-	Minor growth. Features partially obscured. Vegetation does not affect structural integrity
473.5	Metalwork	0 (coping)	0.1 x 0.1m	Metal fixing. Good condition, localised surface corrosion

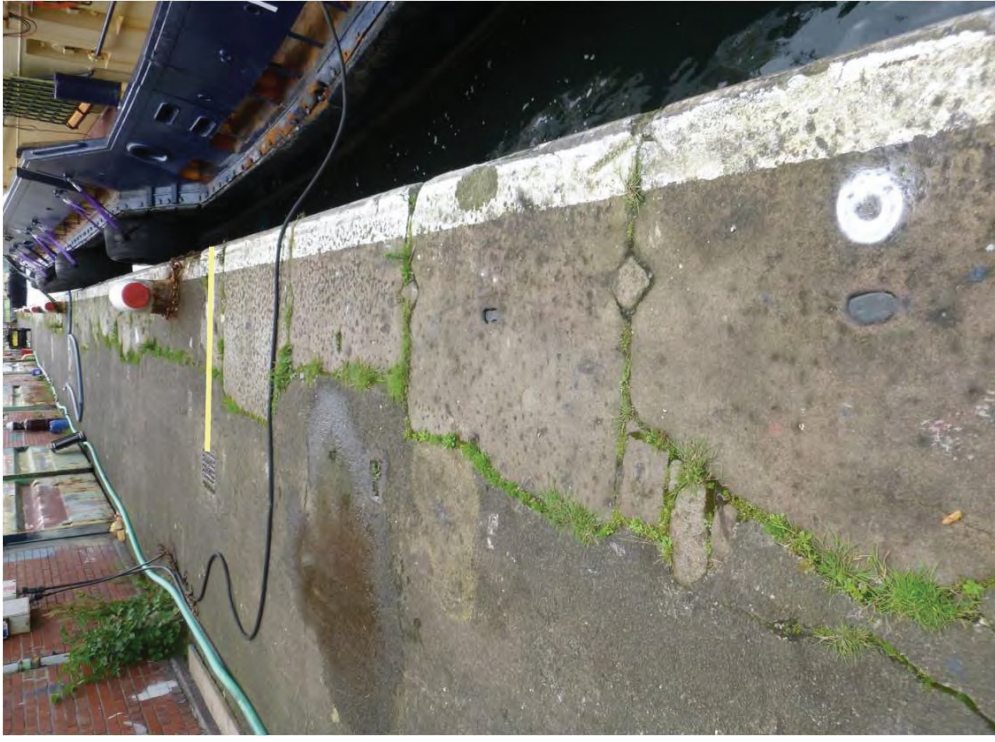
Figure A100a - Bramley Moore: Coping Chainage 475 to 480m

Features / Condition				
Chainage (m)	Feature	Level (m from top)	Dimensions (m)	Description
475 to 480	Coping	0 to 0.5	-	Good - Minor cracks created by minor movement. Surface defects in coping or limited mortar loss from joints
475 to 480	Brickwork / Masonry	0.5 to 1.8	-	Good - Minor cracks created by minor movement. Surface defects in blocks or limited mortar loss from joints
475 to 480	Marine Growth	1.5 to 1.8	-	Minimal growth. Features remain visible
475 to 480	Concrete	0 (coping)	-	Minimal growth. Features remain visible. Vegetation does not affect structural integrity
475 to 480	Vegetation	0 (coping)	-	Minimal growth. Features remain visible. Vegetation does not affect structural integrity
477.5	Metalwork	0 (coping)	0.1 x 0.1m	Metal fixing. Good condition, localised surface corrosion

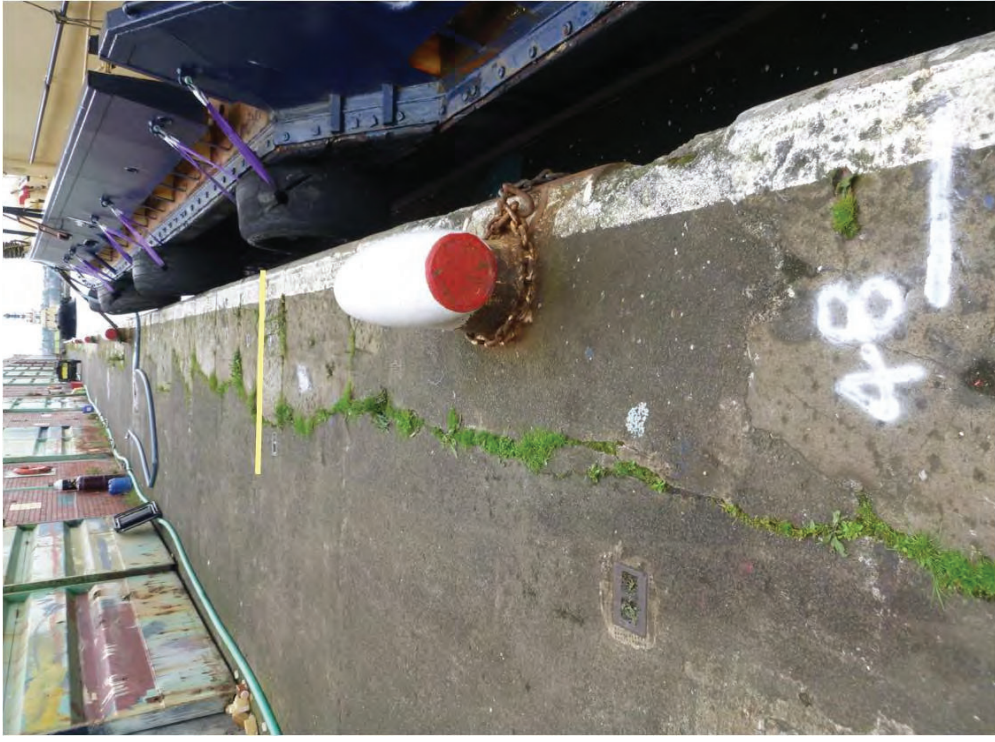
Figure A101a - Bramley Moore: Coping Chainage 480 to 485m

Chainage (m)	Feature	Level (m from top)	Dimensions (m)	Description
480 to 481, 483 to 485	Coping	0 to 0.5	-	Good - Minor cracks created by minor movement. Surface defects in coping or limited mortar loss from joints
480 to 485	Brickwork / Masonry	0.5 to 1.8	-	Good - Minor cracks created by minor movement. Surface defects in bricks or limited mortar loss from joints
481 to 483	Repair	0 to 1.5	-	Concrete repair to brickwork/blockwork
480 to 485	Marine Growth	1.5 to 1.8	-	Minimal growth. Features remain visible

482.5	Weephole / Outfall	1.2	D = 0.2m	Circular weephole/outfall. Good condition, some degradation but fully operable
480 to 485	Concrete	0 (coping)	-	Good - Structurally sound but with minor cracks and localised honeycombing/flaking with no significant defects
480 to 485	Vegetation	0 (coping)	-	Minimal growth. Features remain visible. Vegetation does not affect structural integrity
481 and 484.5	Metalwork	0 (coping)	0.1 x 0.1m	Metal fixing. Good condition, localised surface corrosion
482	Mooring Bollard	0 (coping)	H = 0.8m	T-Shaped bollard embedded into coping. Good condition, localised surface corrosion

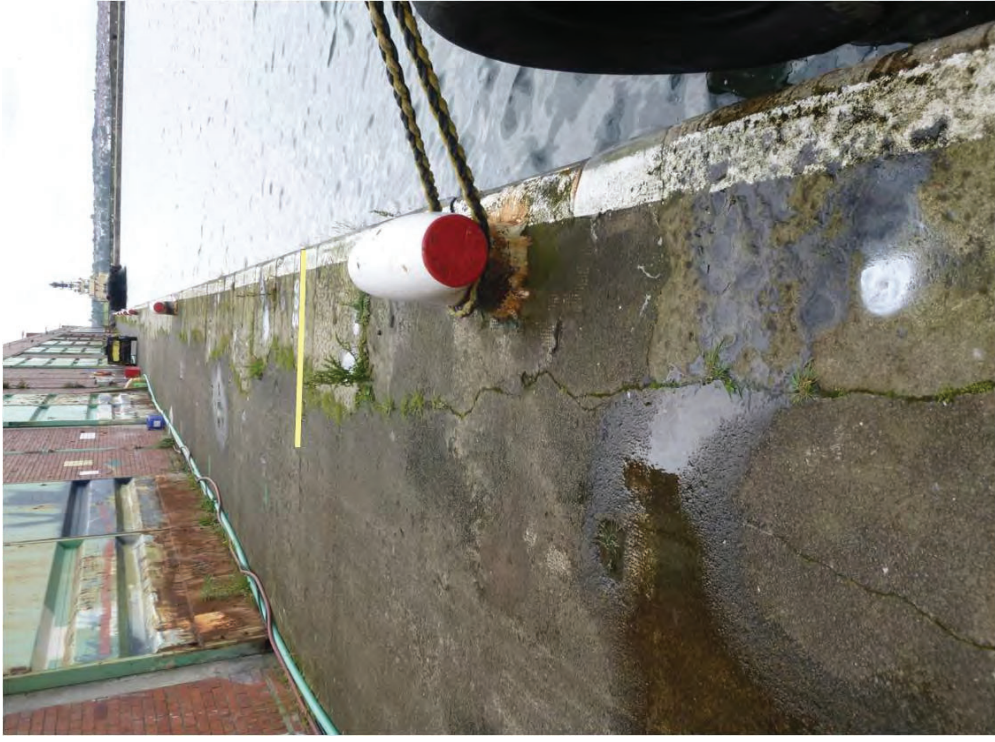
Figure A104a - Bramley Moore: Coping Chainage 495 to 500m

Chainage (m)	Feature	Defect	Level (m from top)	Description
498 to 500	Coping	Loss of Mortar	0.2 to 0.5	Mortar loss to coping stone is limited to the surface. Defects are cosmetic only
498 to 500	Brickwork / Masonry	Loss of Mortar	0.2 to 0.7	Mortar loss to bricks/blocks is limited to the surface. Defects are cosmetic only
495	Brickwork / Masonry	Loss of Bricks/Blocks	1 to 2	Holes in blockwork, likely left by historic fixings. Defects are cosmetic but have the potential to affect the walls integrity.
497 to 498	Repair	Loss of Mortar	1.4 to 1.5	Mortar loss to bricks/blocks extends below surface and has the potential to weaken/loosen surrounding bricks/blocks
495 to 497	Concrete	Cracking	0 (coping)	Minor cracking of concrete typical of shrinkage or thermal expansion. Cracks are non structural
