A112 Chainage 535 to 540m

Figure A112 - Bramley Moore: Chainage 535 to 540m

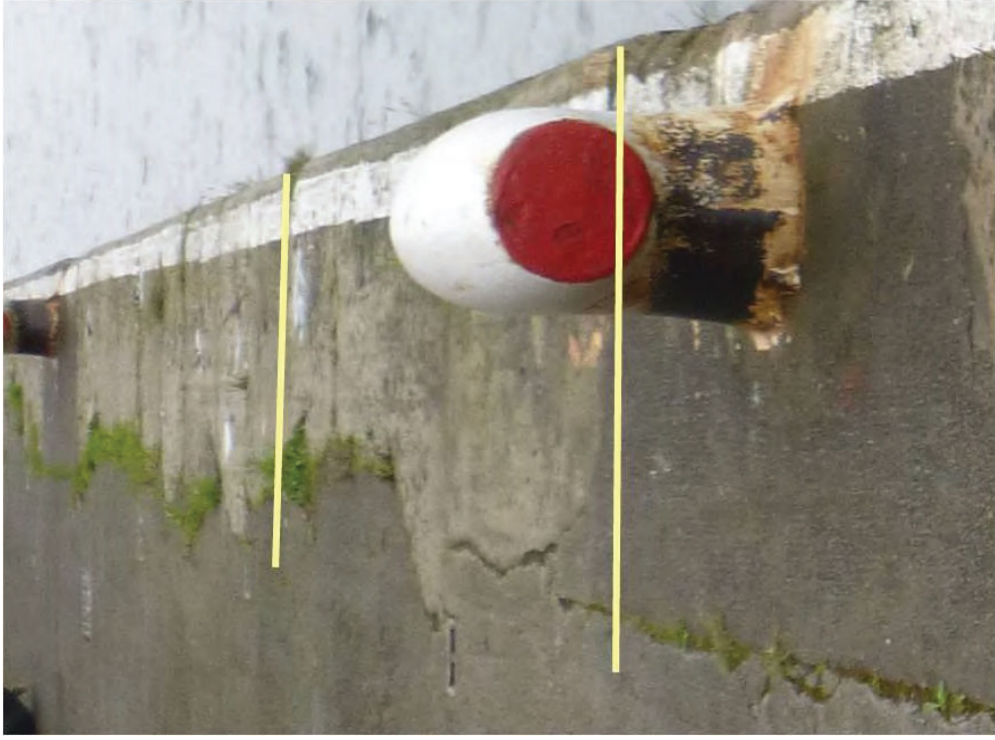
Figure A112a - Bramley Moore: Coping Chainage 535 to 540m

| Chainage (m) | Feature | Level (m from top) | Dimensions (m) | Description |
|---|---|---|---|---|
| 537 | Metalwork | 0 (coping) | 0.1 x 0.1m | Metal fixing. Good condition, localised surface corrosion |

| Chainage (m) | Feature | Defect | Level (m from top) | Description |
|---|---|---|---|---|
| 535 to 540 | Coping | Loss of Mortar | 0.4 to 0.5 | Mortar loss to coping stone is limited to the surface. Defects are cosmetic only |
| 535 to 537 | Concrete | Cracking | 0 (coping) | Minor cracking of concrete typical of shrinkage or thermal expansion. Cracks are non-structural |

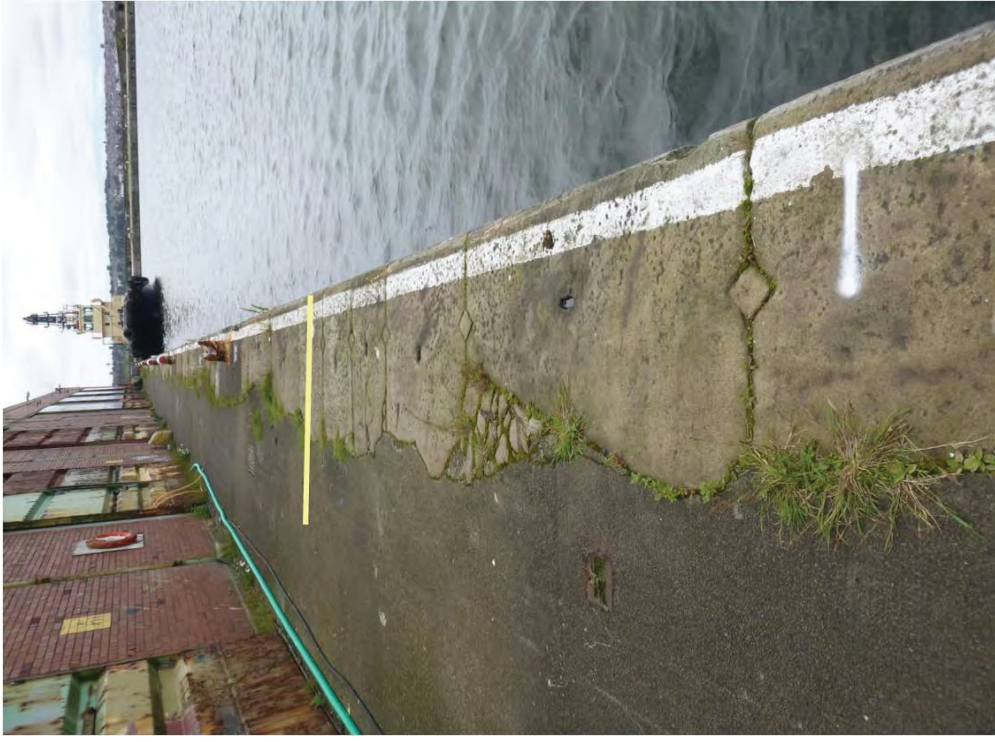
Figure A119a - Bramley Moore: Coping Chainage 570 to 575m

| Chainage (m) | Feature | Level (m from top) | Dimensions (m) | Description |
|---|---|---|---|---|
| 570 to 575 | Coping | 0 to 0.4 | - | Good - Minor cracks created by minor movement. Surface defects in coping or limited mortar loss from joints |
| 570 to 575 | Concrete | 0 (coping) | - | Good - Structurally sound but with minor cracks and localised honeycombing/flaking with no significant defects |
| 571 | Metalwork | 0 (coping) | 0.1 x 0.1m | Metal fixing. Good condition, localised surface corrosion |

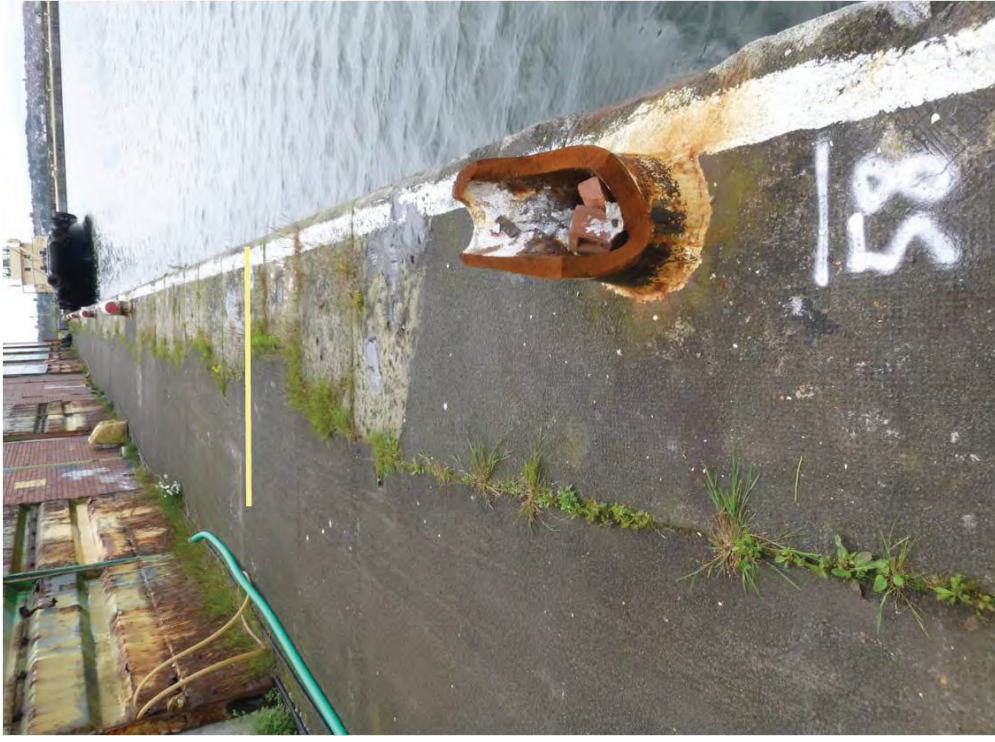
Figure A121a - Bramley Moore: Coping Chainage 580 to 585m

| Chainage (m) | Feature | Level (m from top) | Dimensions (m) | Description |
|---|---|---|---|---|
| 581 | Mooring Bollard | 0 (coping) | H = 0.4m | Mooring bollard broken, derelict and beyond repair |

| Chainage (m) | Feature | Defect | Level (m from top) | Description |
|---|---|---|---|---|
| 582 to 583 | Coping | Loss of Mortar | 0.3 to 0.5 | Mortar loss to coping stone is limited to the surface. Defects are cosmetic only |
| 581 | Mooring Bollard | Collapse / Failure | 0 (coping) | Mooring bollard has broken in two following impact or overloading. Remains are corroded |

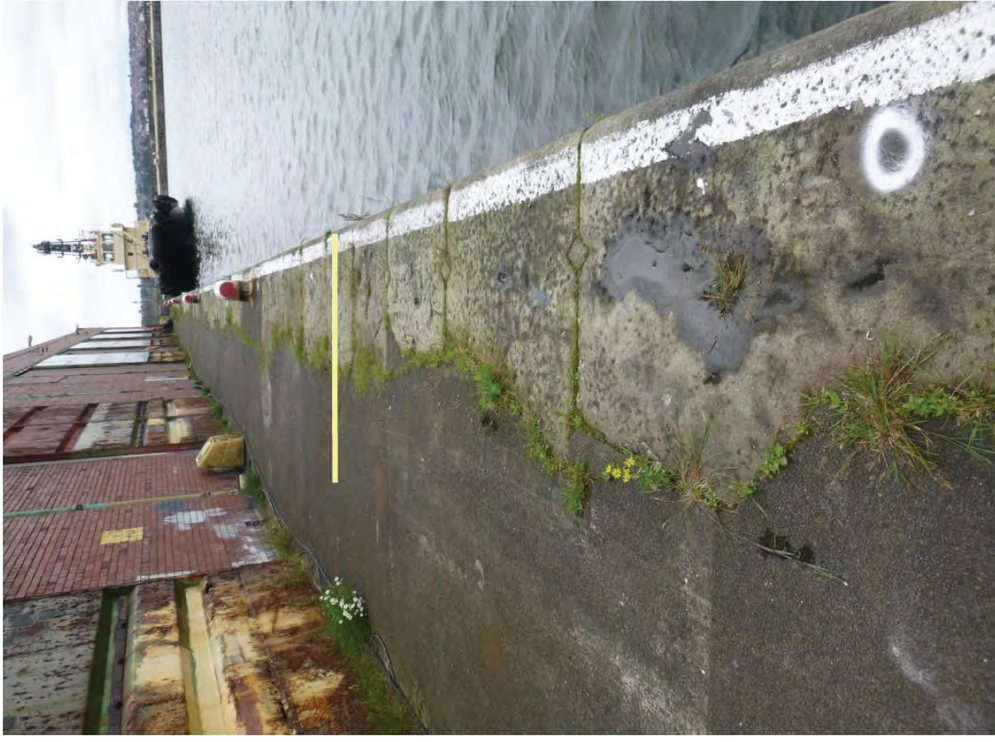
Figure A122a - Bramley Moore: Coping Chainage 585 to 590m

| Chainage (m) | Feature | Level (m from top) | Dimensions (m) | Description |
|---|---|---|---|---|
| 585 to 590 | Coping | 0 to 0.5 | - | Good - Minor cracks created by minor movement. Surface defects in coping or limited mortar loss from joints |
