**A128 Chainage 615 to 620m**

**Figure A128 - Bramley Moore: Chainage 615 to 620m**

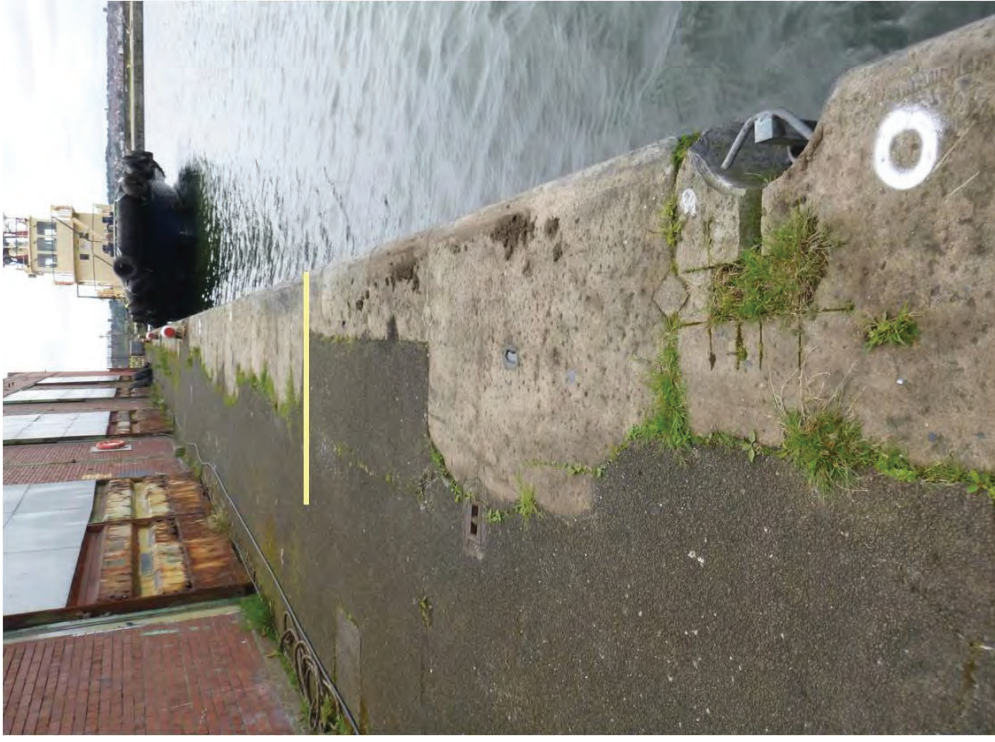
Figure A128a - Bramley Moore: Coping Chainage 615 to 620m

| Features / Condition | | | | |
|---|---|---|---|---|
| 615 to 620 | Coping | 0 to 0.5 | - | Good - Minor cracks created by minor movement. Surface defects in coping or limited mortar loss from joints |
| 615 to 620 | Brickwork / Masonry | 0.5 to 1.8 | - | Good - Minor cracks created by minor movement. Surface defects in blocks or limited mortar loss from joints |
| 615 to 620 | Marine Growth | 1.5 to 1.8 | - | Minimal growth. Features remain visible |
| 615.5 | Ladder | 0 to 1.8 | - | Ladder within recess. Good condition, some corrosion in intertidal zone |
| 618.5 | Weephole / Outfall | 1.3 | D = 0.15m | Circular weephole/outfall. Good condition, some degradation but fully operable |
| 615 to 620 | Concrete | 0 (coping) | - | Fair - Rust staining, localised spalling, lengthy cracking and some movement or extensive honeycombing |
| 615 to 618 | Vegetation | 0 (coping) | - | Minimal growth. Features remain visible. Vegetation does not affect structural integrity |
| 618 | Metalwork | 0 (coping) | 0.1 x 0.1m | Metal fixing. Good condition, localised surface corrosion |

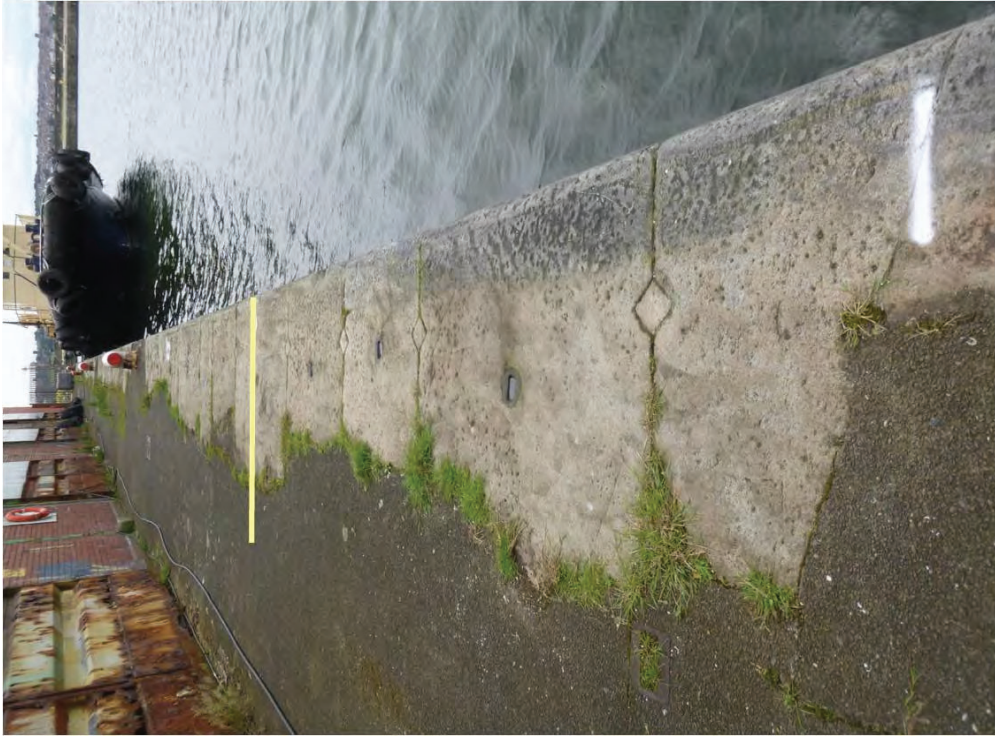
Figure A129a - Bramley Moore: Coping Chainage 620 to 625m

| Chainage (m) | Feature | Defect | Level (m from top) | Description |
|---|---|---|---|---|
| 620 to 625 | Coping | Loss of Mortar | 0.4 to 0.5 | Mortar loss to coping stone is limited to the surface. Defects are cosmetic only |
| 620 to 625 | Brickwork / Masonry | Loss of Mortar | 0.5 to 0.8 | Mortar loss to bricks/blocks is limited to the surface. Defects are cosmetic only |
| 620 to 625 | Brickwork / Masonry | Staining / Calcification | 1.2 to 1.5 | White staining concentrated around mortar joints indicative of early sulphate attack. May lead to future spalling and deterioration of mortar |
| 620 to 625 | Coping | Vegetation Damage | 0 (coping) | Small and shallow rooted vegetation resulting in surface cracks and the early onset of mortar degradation |

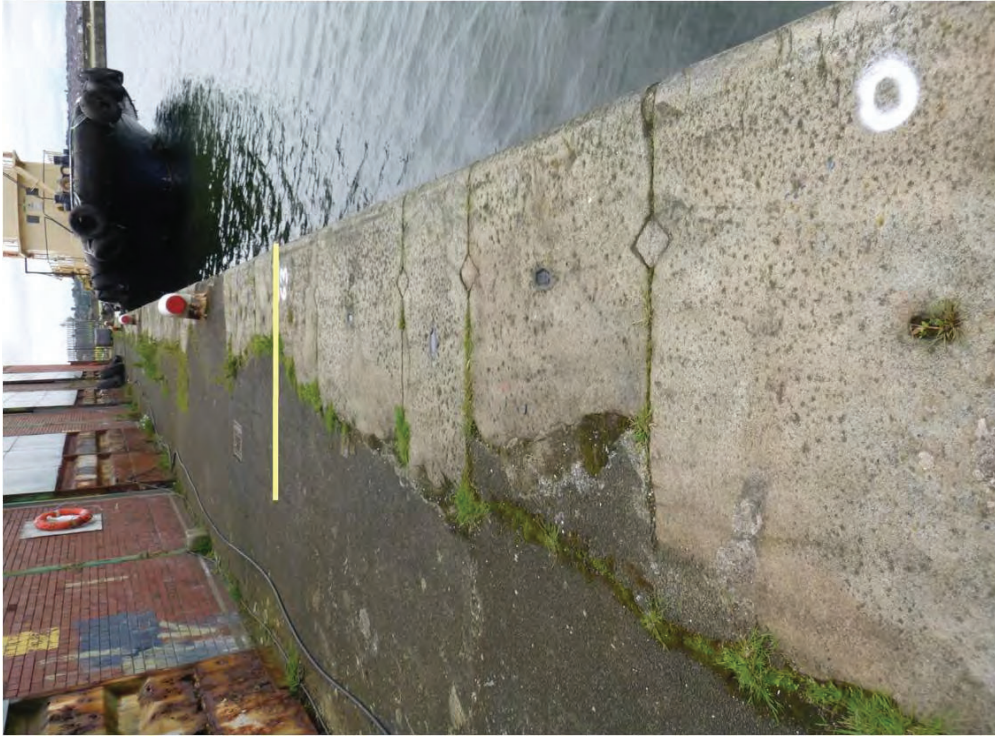
Figure A130a - Bramley Moore: Coping Chainage 625 to 630m

| Chainage (m) | Feature | Defect | Level (m from top) | Description |
|---|---|---|---|---|
| 628 to 629 | Coping | Loss of Mortar | 0.3 to 0.5 | Mortar loss to coping stone is limited to the surface. Defects are cosmetic only |
| 628 | Brickwork / Masonry | Loss of Mortar | 0.5 to 0.7 | Mortar loss to bricks/blocks extends below surface and has the potential to weaken/loosen surrounding bricks/blocks |
| 625 to 630 | Brickwork / Masonry | Staining / Calcification | 1 to 1.5 | White staining concentrated around mortar joints indicative of early sulphate attack. May lead to future spalling and deterioration of mortar |
| 625 to 630 | Coping | Vegetation Damage | 0 (coping) | Small and shallow rooted vegetation resulting in surface cracks and the early onset of mortar degradation |
| 625 to 630 | Concrete | Cracking | 0 (coping) | Minor cracking of concrete typical of shrinkage or thermal expansion. Cracks are non-structural |

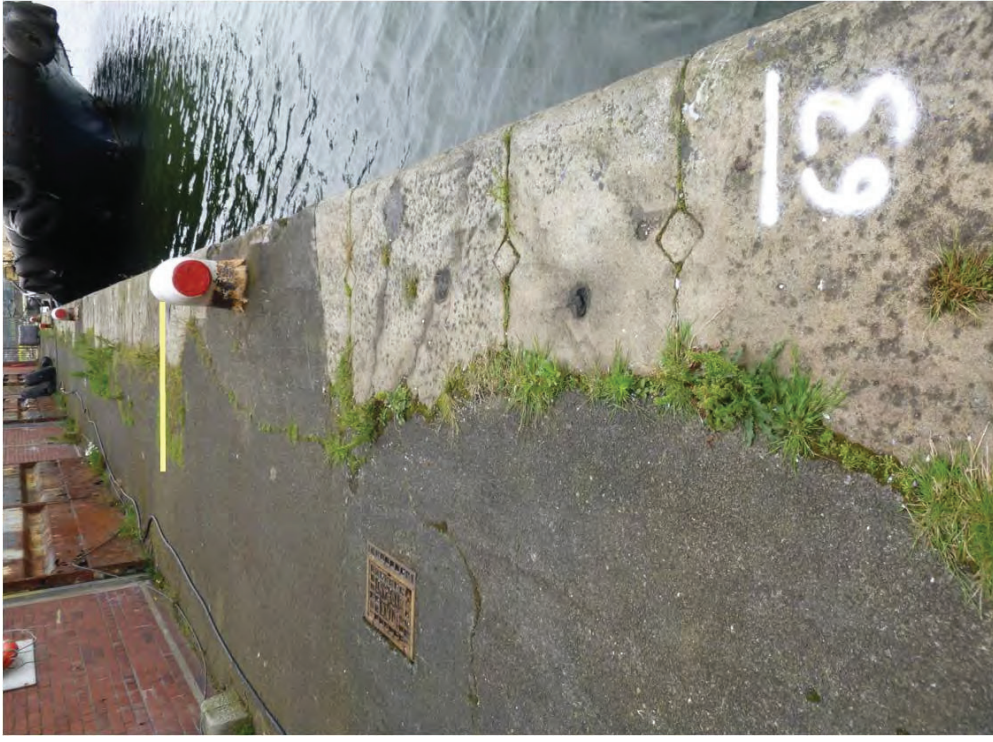
Figure A131a - Bramley Moore: Coping Chainage 630 to 635m

| Chainage (m) | Feature | Defect | Level (m from top) | Description |
|---|---|---|---|---|
| 630 to 633 | Coping | Loss of Mortar | 0.3 to 0.5 | Mortar loss to coping stone is limited to the surface. Defects are cosmetic only |
| 630 to 633 | Brickwork / Masonry | Loss of Mortar | 0.5 to 0.6 | Mortar loss to bricks/blocks extends below surface and has the potential to weaken/loosen surrounding bricks/blocks |
| 633 | Brickwork / Masonry | Loss of Bricks/Blocks | 1 to 1.8 | Holes in blockwork, likely left by historic fixings. Defects are cosmetic but have the potential to affect the walls integrity. |
| 630 to 633 | Coping | Vegetation Damage | 0 (coping) | Small and shallow rooted vegetation resulting in surface cracks and the early onset of mortar degradation |
| 630 to 635 | Concrete | Cracking | 0 (coping) | Minor cracking of concrete typical of shrinkage or thermal expansion. Cracks are non-structural |

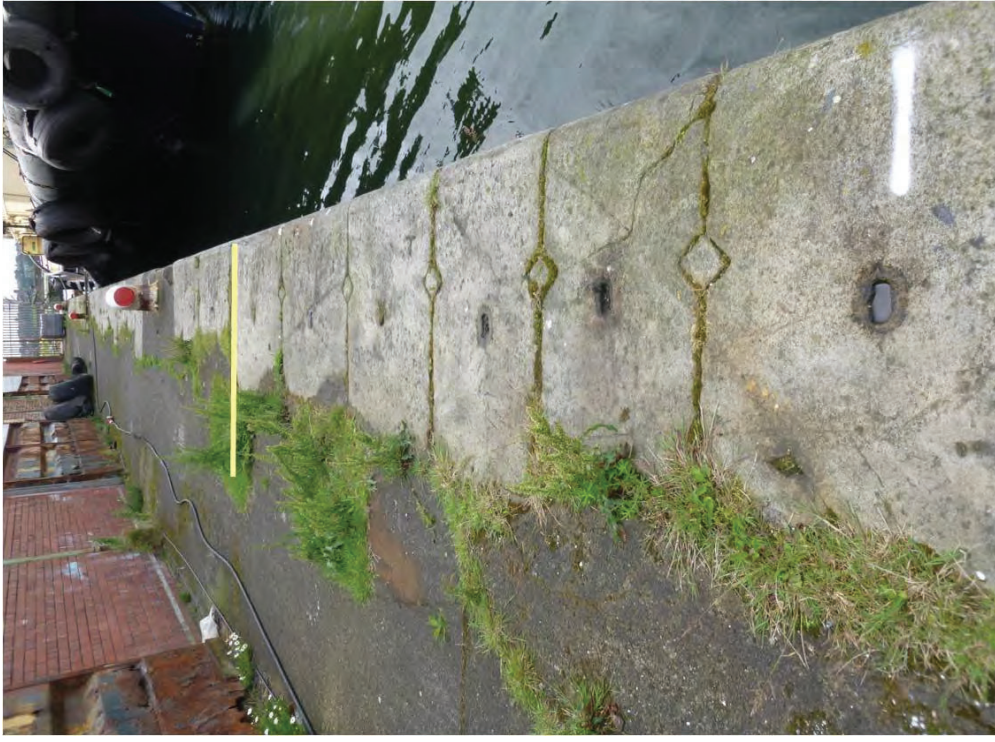
Figure A133a - Bramley Moore: Coping Chainage 640 to 645m

| Chainage (m) | Feature | Defect | Level (m from top) | Description |
|---|---|---|---|---|
| 640 to 645 | Concrete | Cracking | 0 (coping) | Minor cracking of concrete typical of shrinkage or thermal expansion. Cracks are non-structural |
| 640 to 645 | Coping | Vegetation Damage | 0 (coping) | Small and shallow rooted vegetation resulting in surface cracks and the early onset of mortar degradation |

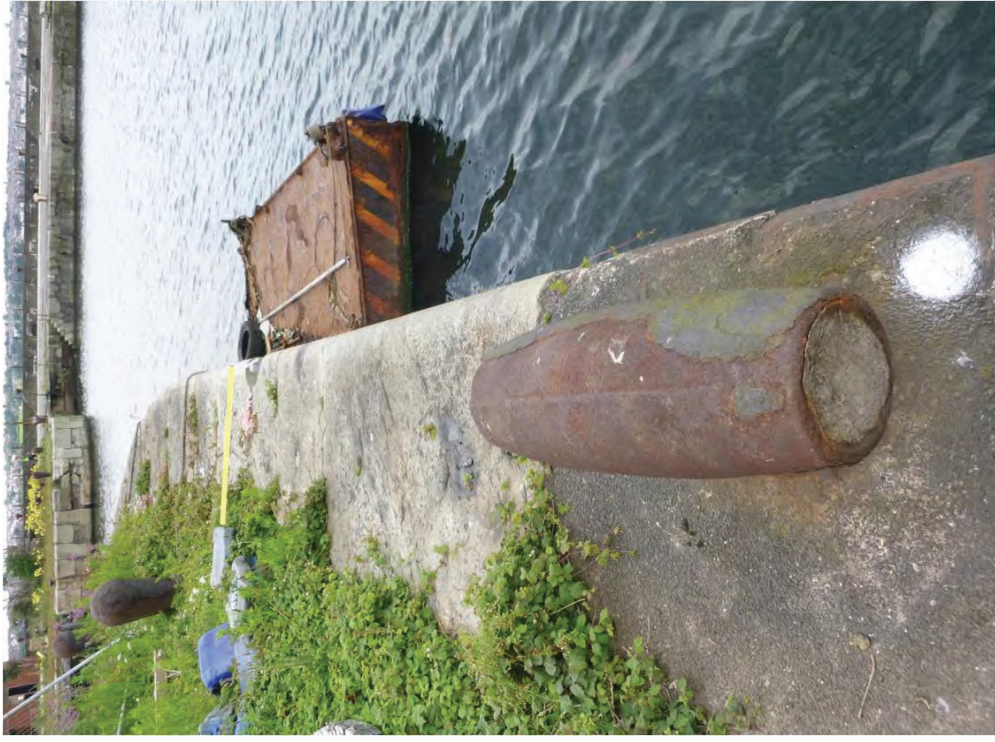
Figure A144a - Bramley Moore: Coping Chainage 695 to 700m

| Chainage (m) | Feature | Defect | Level (m from top) | Description |
|---|---|---|---|---|
| 692 | Brickwork / Masonry | Loss of Bricks/Blocks | 0.5 to 1.5 | Holes in blockwork, likely left by historic fixings. Defects are cosmetic but have the potential to affect the walls integrity. |
| 699.5 | Ladder | Corrosion | 0 to 1.8 | Onset of corrosion to surface layers which may include pitting and/or flaking of the surface metal. Defects are cosmetic only |
