Former Holly Lodge Girls' College, Queens Drive

Protected Species Survey Report (Bats).

February 2015

Updated May 2016

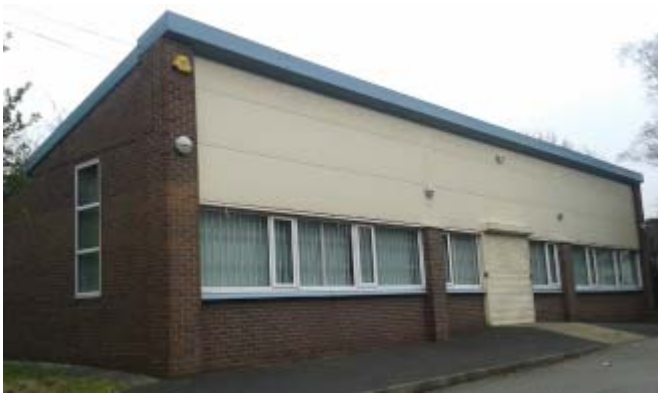
- 6.5 Building F was found to contain **negligible** bat roost potential and no further activity surveys are required.
- 6.6 For Buildings listed above in Sections 6.1 to 6.3, there may be implications with regard to bats and the proposed development and further activity surveys are required to establish if bats are using these buildings.

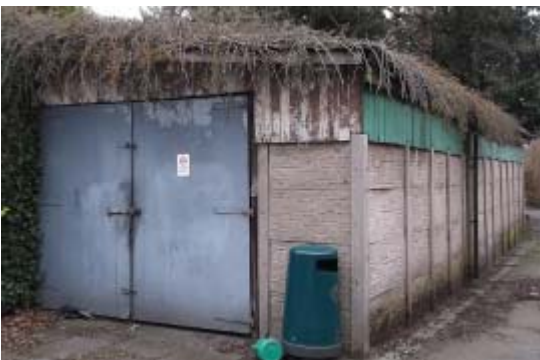
- 6.4 Building I was found to contain **negligible to low** bat roost potential. It is recommended that areas of potential are subject to soft demolition under the supervisor of a licensed Ecologist.

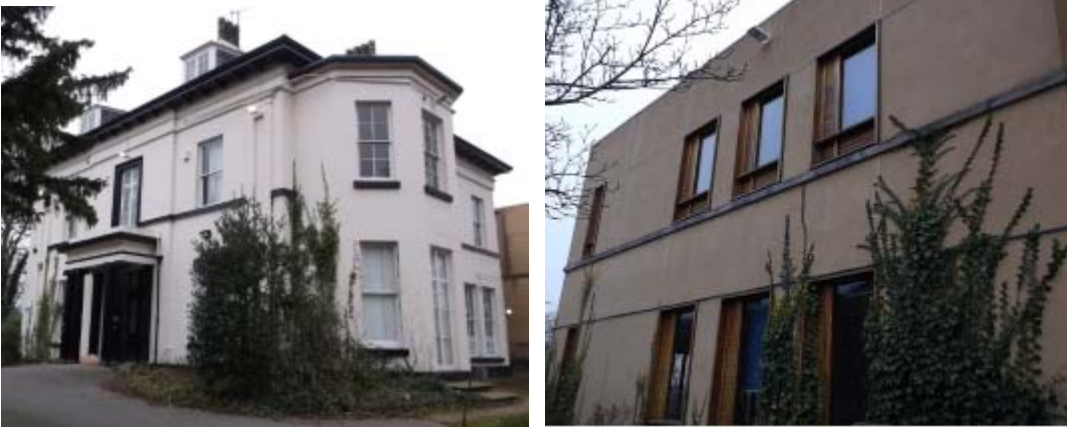
Building L – Viewed from south with adjoining modern building to the north
