File Note: LEL_CRN_L156TF_PRA_001_REV A

Discipline: Preliminary Ecological Appraisal for Bats and Preliminary Roost Assessment

Site: Church Road North, Wavertree L15 6TF (Structure Grid Ref: SJ 3928 8936).

Site Visit Date: Thursday 18th June 2020

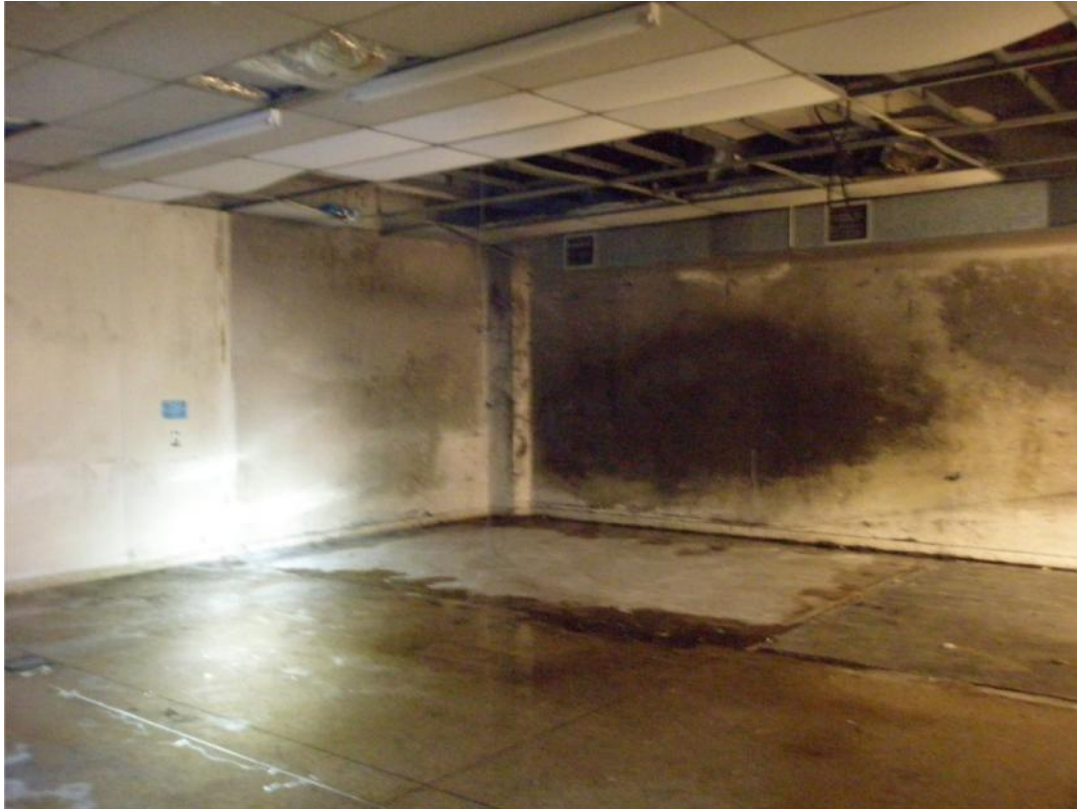
Figure 4d: Image 4 – another section of the warehouse showing clean floors.

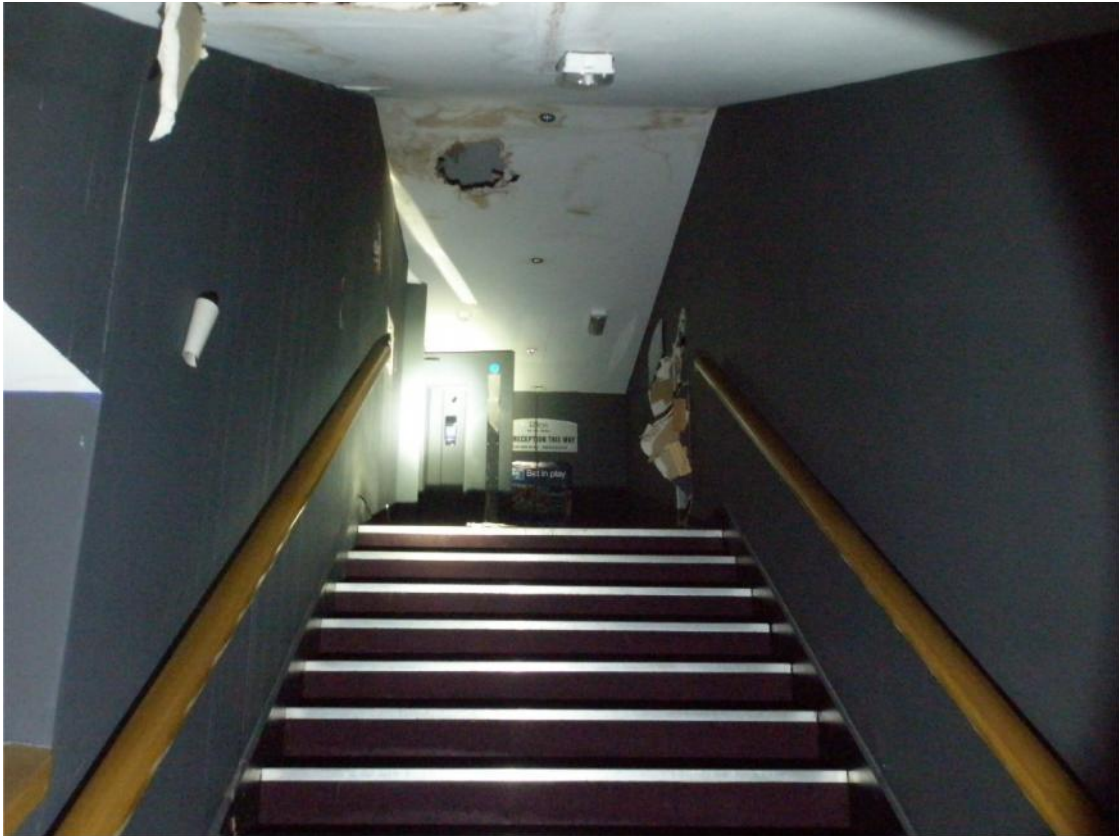
Figure 5a: Image 1 – access to the former Riley's snooker club from the ground floor level is via some stairs.

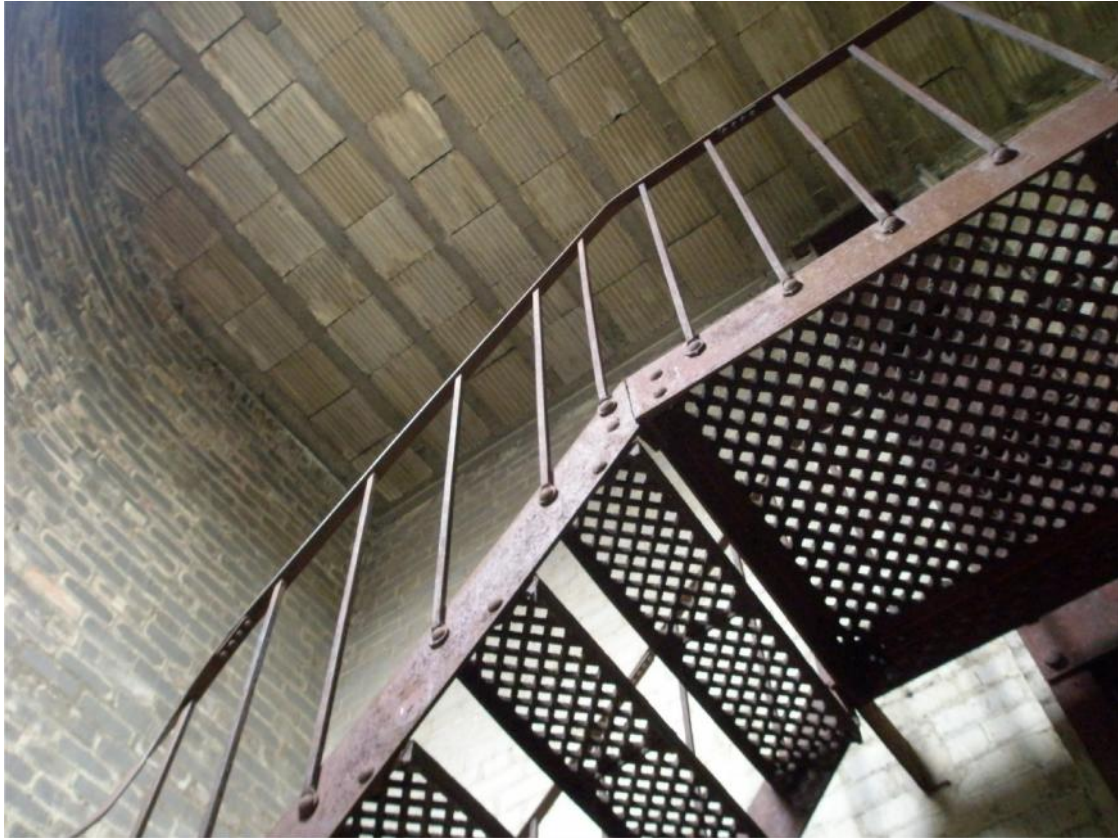
Figure 6c: Image 3 – a view of the roof of the structure from below the stairwell – it's unclear what the material is made from.

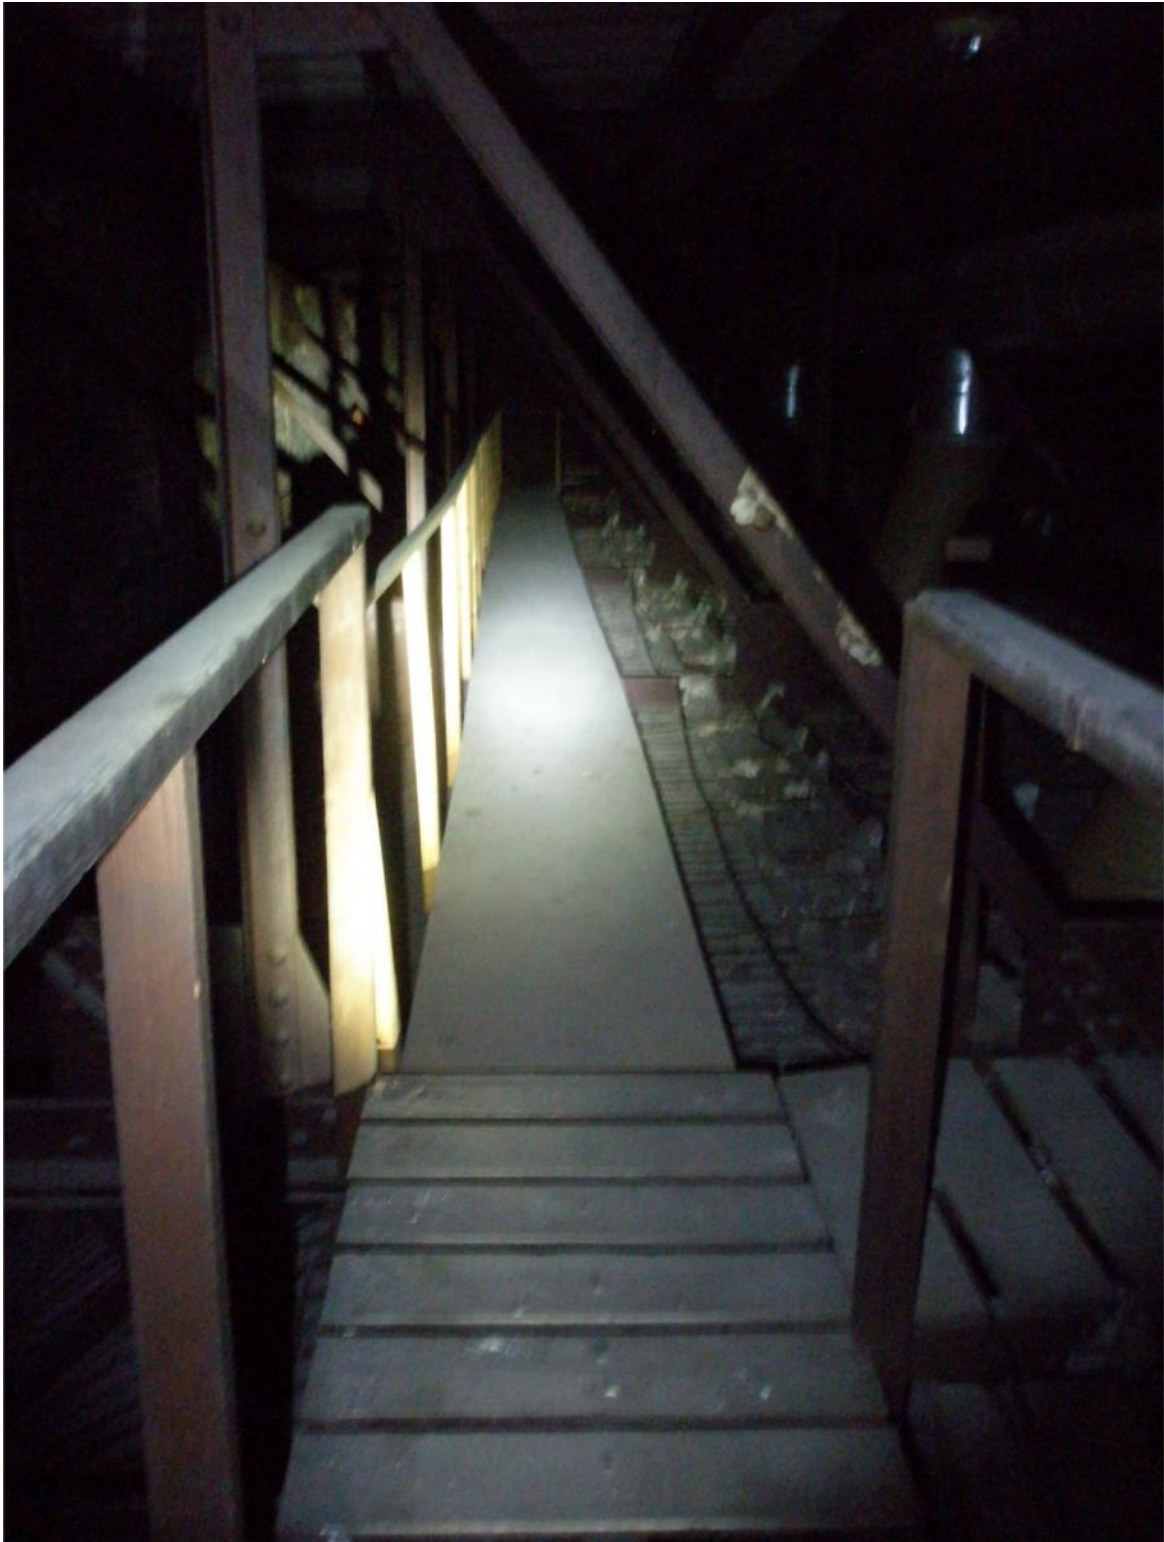
Figure 6h: Image 8 – a small opening from one of the rooms off the corridor leads into a substantial roof void where, access permitting, checks for use by bats were made.

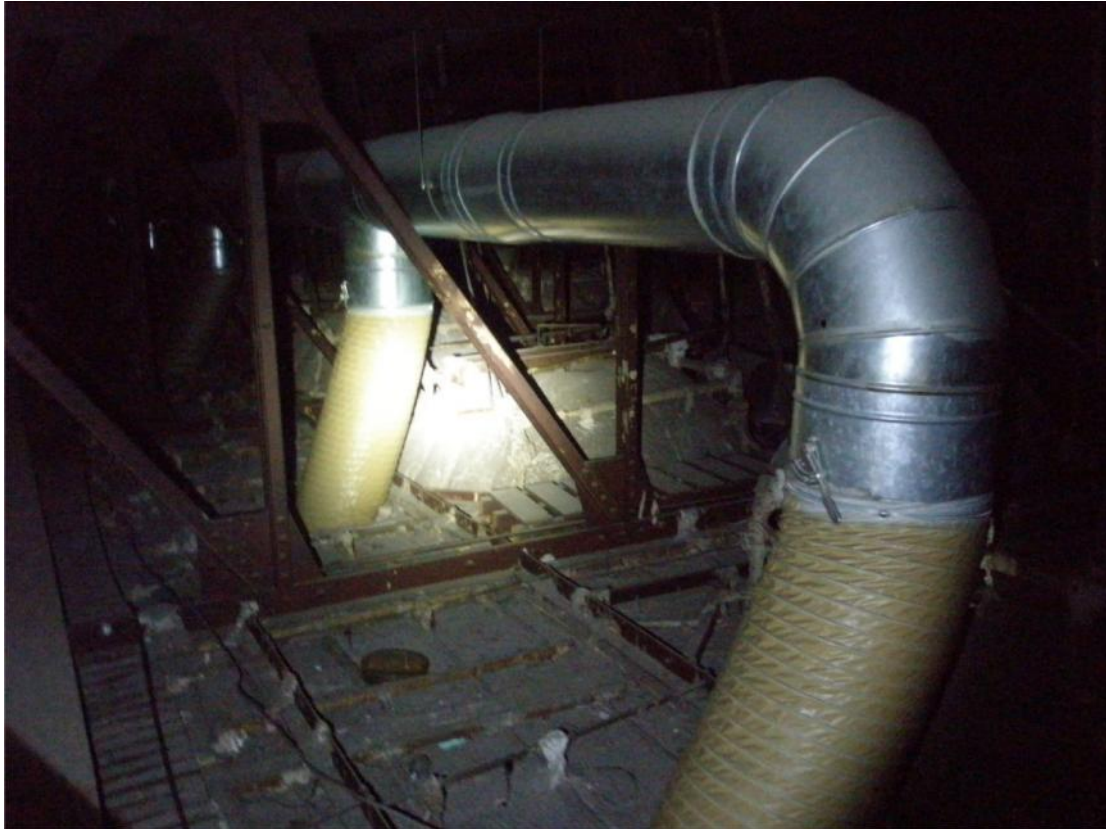
Figure 6i: Image 9 – a view inside the roof void shows ventilation shafts and the outline of the former cinema auditorium roof.
