8.2 Design Option 02

Galkoff Extension Design Options

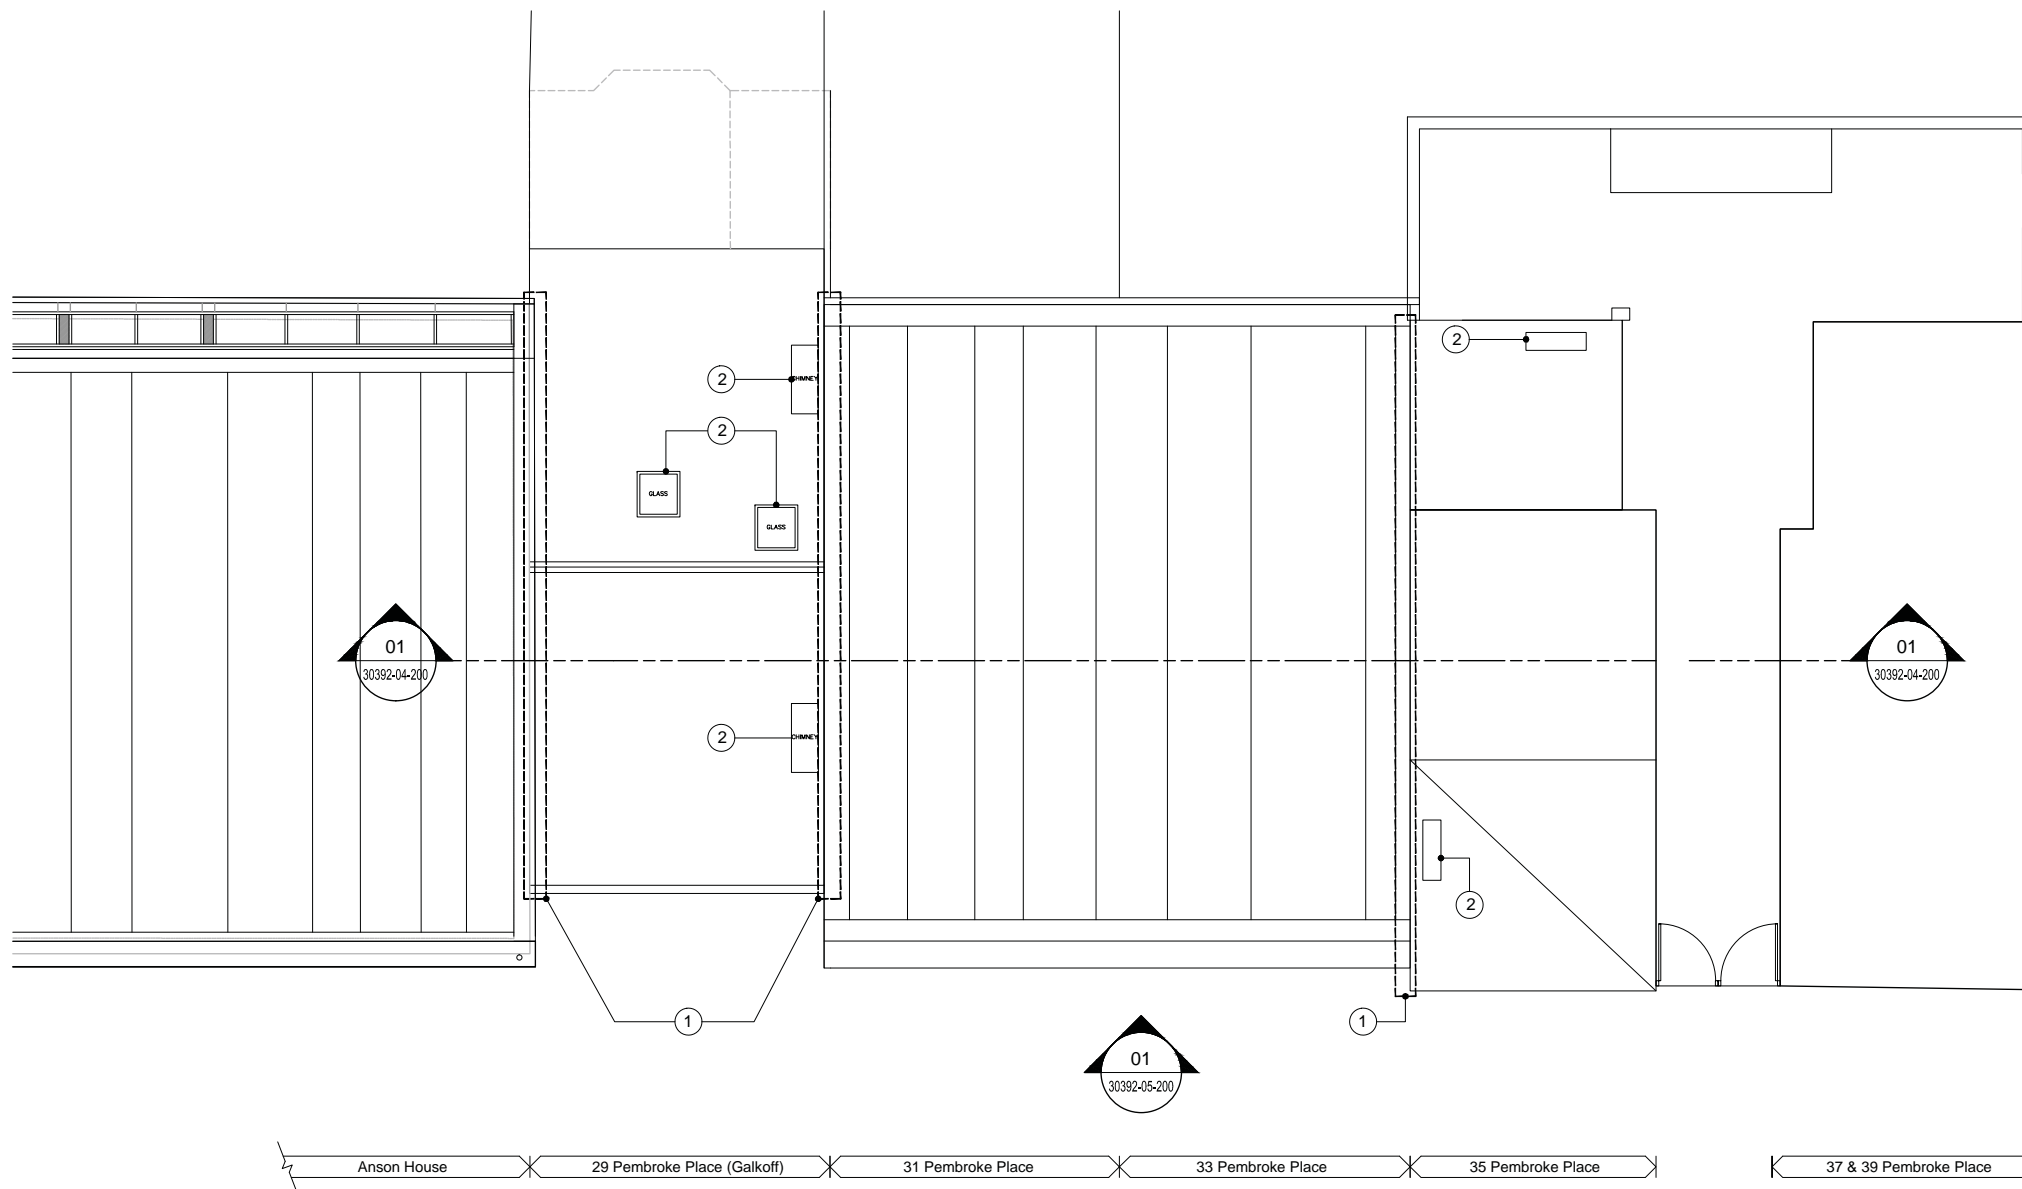
Option 02 Roof Plan 1:100

1. Roof alteration required to allow for flashing junction
2. Existing features to be made good.

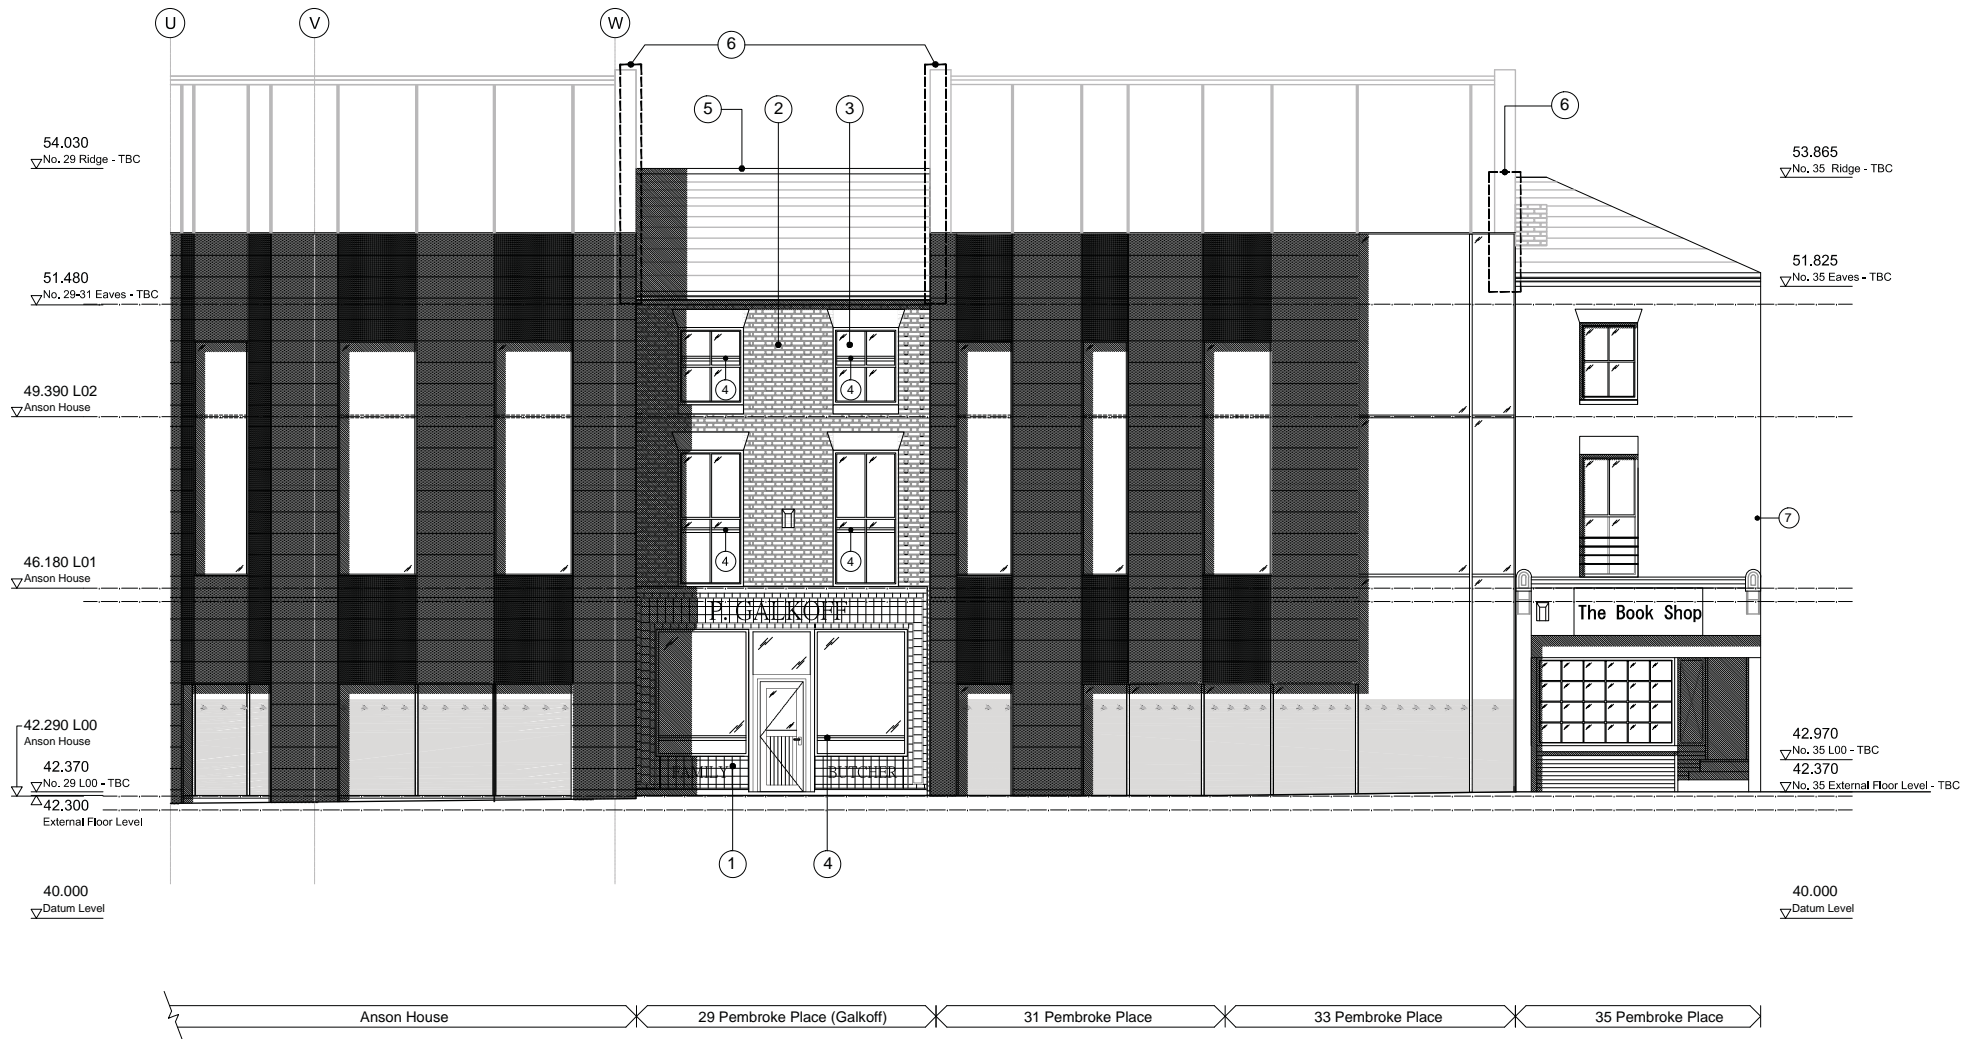
Option 02 South Elevation 1:100

1. Tiled facade of special interest. Reinstall and restore.
2. Existing brickwork - clean and re-point mortar.
3. Existing Windows - restore
4. Balustrade required for safety due to low cill height.
5. Existing Roof - Refer to Structural report. Renovate.
6. Roof Alteration for flashing junction.

7. No. 35 will be fully refurbished for future use and its history interpreted through further consultation with Liverpool City Council and English Heritage.
