Heron Eccles Playing Fields

Arboricultural Method Statement

June 2016

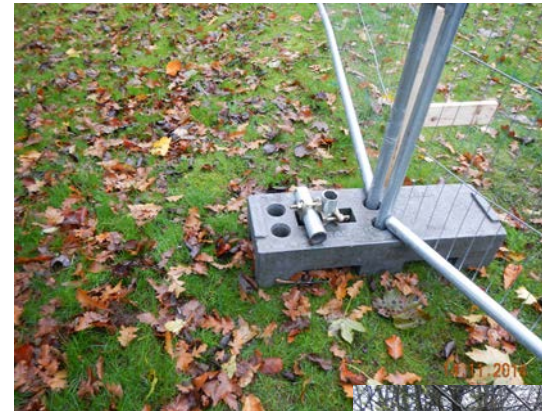
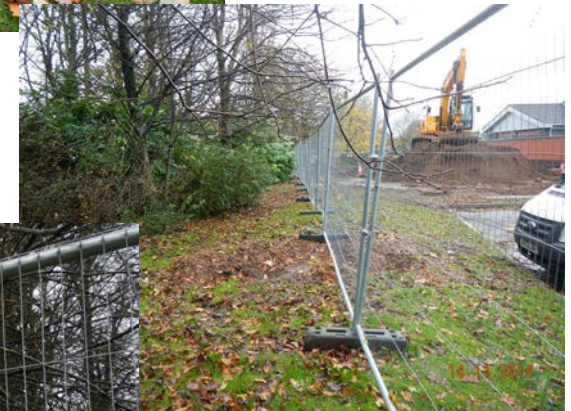
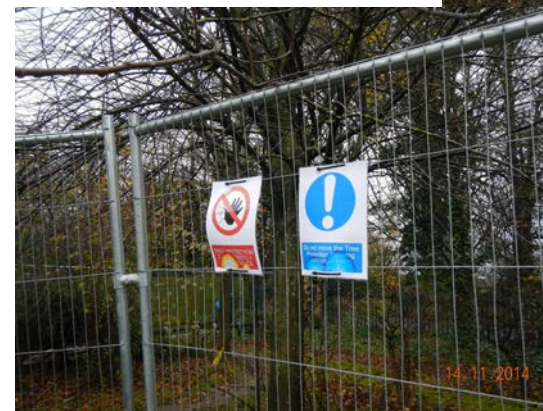
- Type B Heras fencing erected as indicated on the Plan 3283/200.
- Fencing installed at locations shown on the plan and marked on site.
- Location and adequacy signed off by Arboricultural Consultant and LPA advised.
- Tool Box Talk – make construction staff aware of the importance of areas by site manager.
- Signs to be erected advising of the area's importance.
