# **Brunswick Quay, Liverpool**

## **Proposed Residential Development**

### **Phase 1 Geo-Environmental Investigation**

For: Maro Developments Ltd.

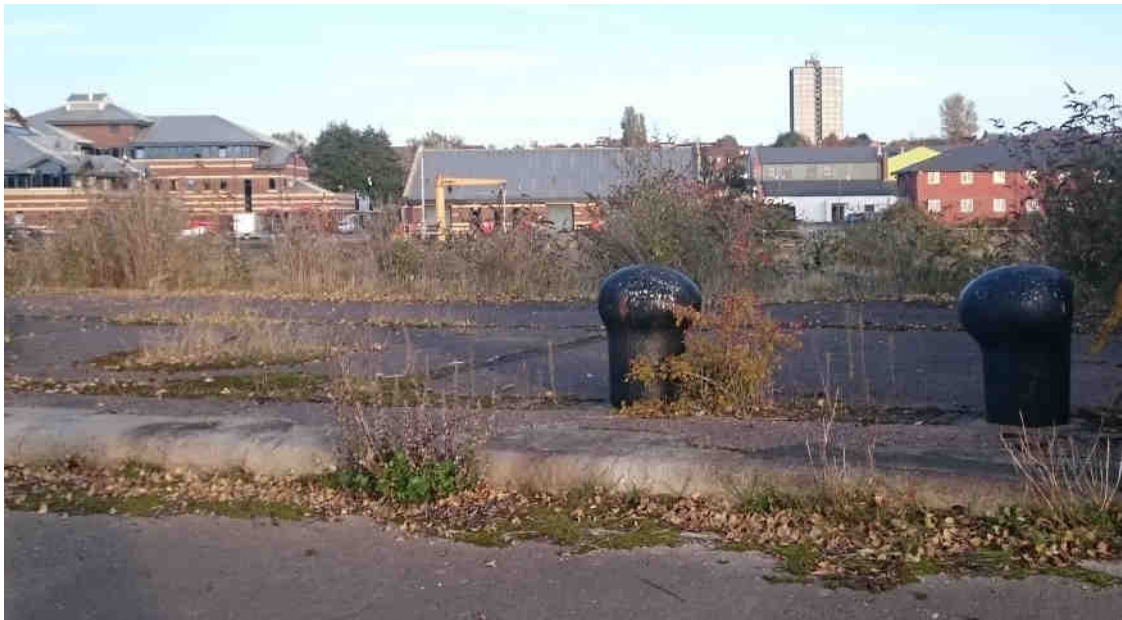
*Figure 2 - Looking east from the centre of the site. The historic 100 Foot Lock wall can be seen in the foreground and associated mooring posts remain in-situ.*

The top of the historic 100 Foot Lock walls are evident along the centre of the site and the western boundary (see figure 2 below), both suspected to be constructed of concrete with granite, on the basis of historic plans. Looking at the off-site adjacent 80 Foot Lock (see figure 3 below), the entire lock wall appears to be constructed of concrete with granite, presumably to the dock sill. On this basis, it is likely that on-site buried walls of the 100 Foot Lock are of the same construction.

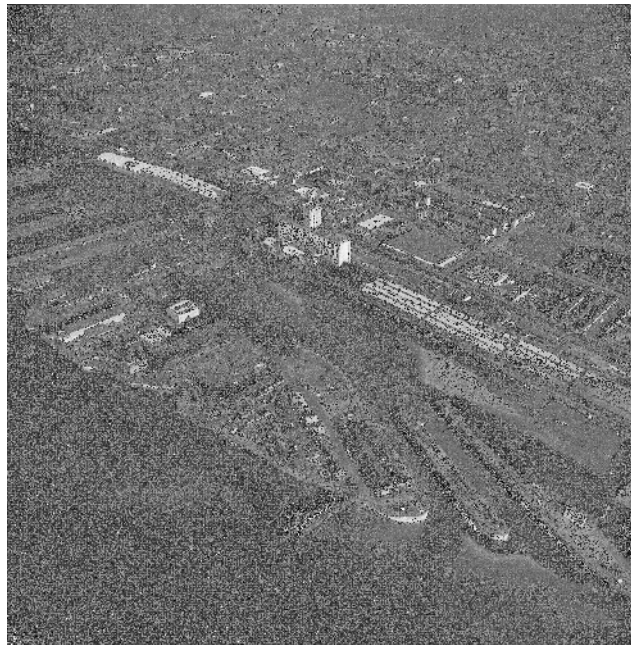
Figure 7 - C. 1980 aerial image of Brunswick Dock and Locks silted up (obtained from Britain From Above, under license).
