## **APPENDIX 13**

### **GEOTECHNICS LTD. DESK STUDY AND GROUND INVESTIGATION REPORTS**

# Detailed Unexploded Ordnance (UXO) Threat & Risk Assessment

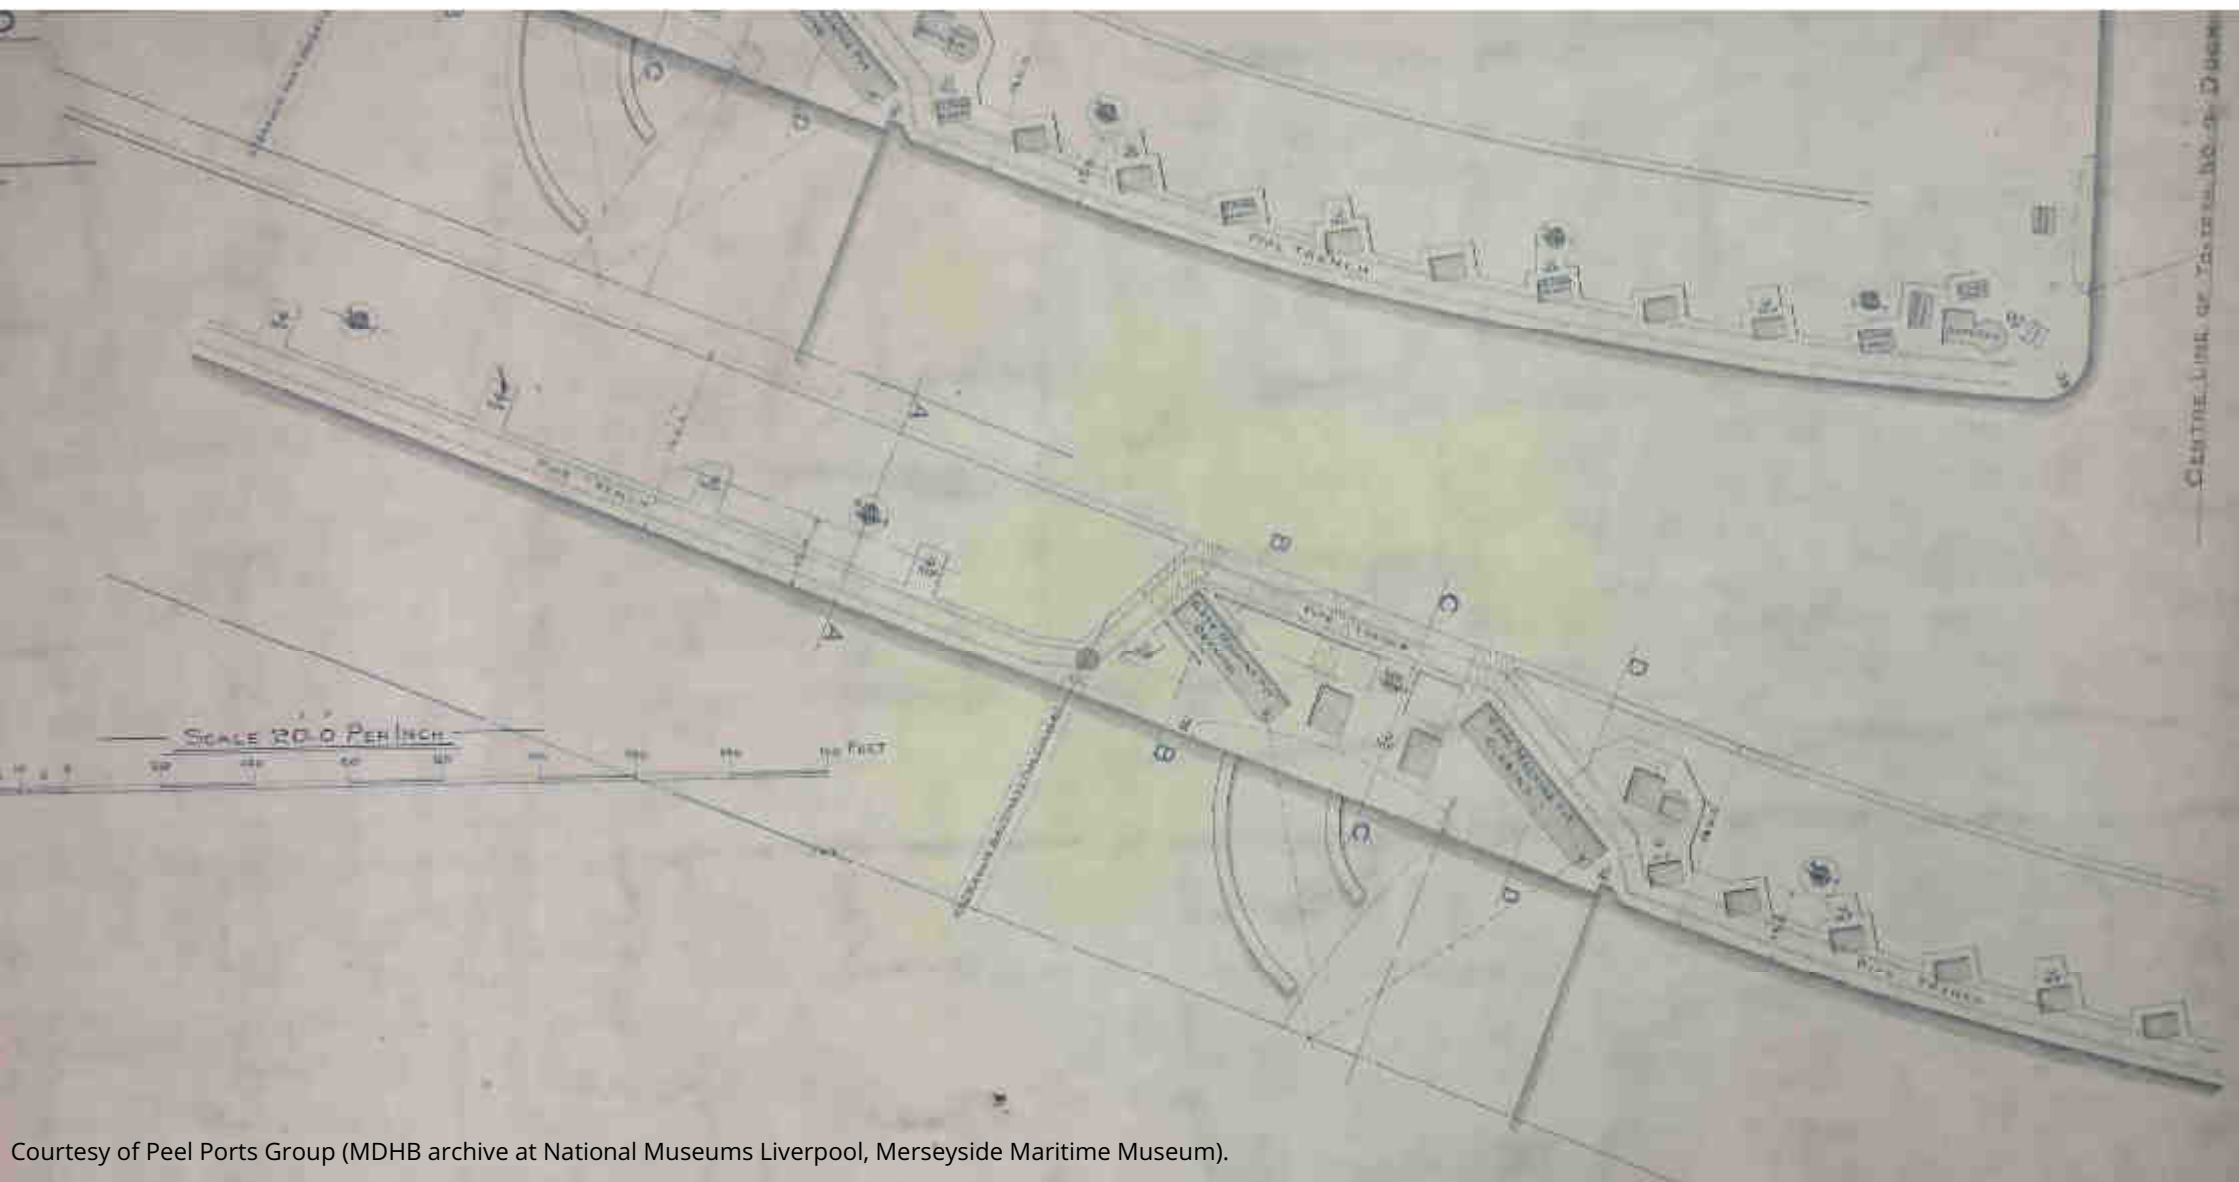
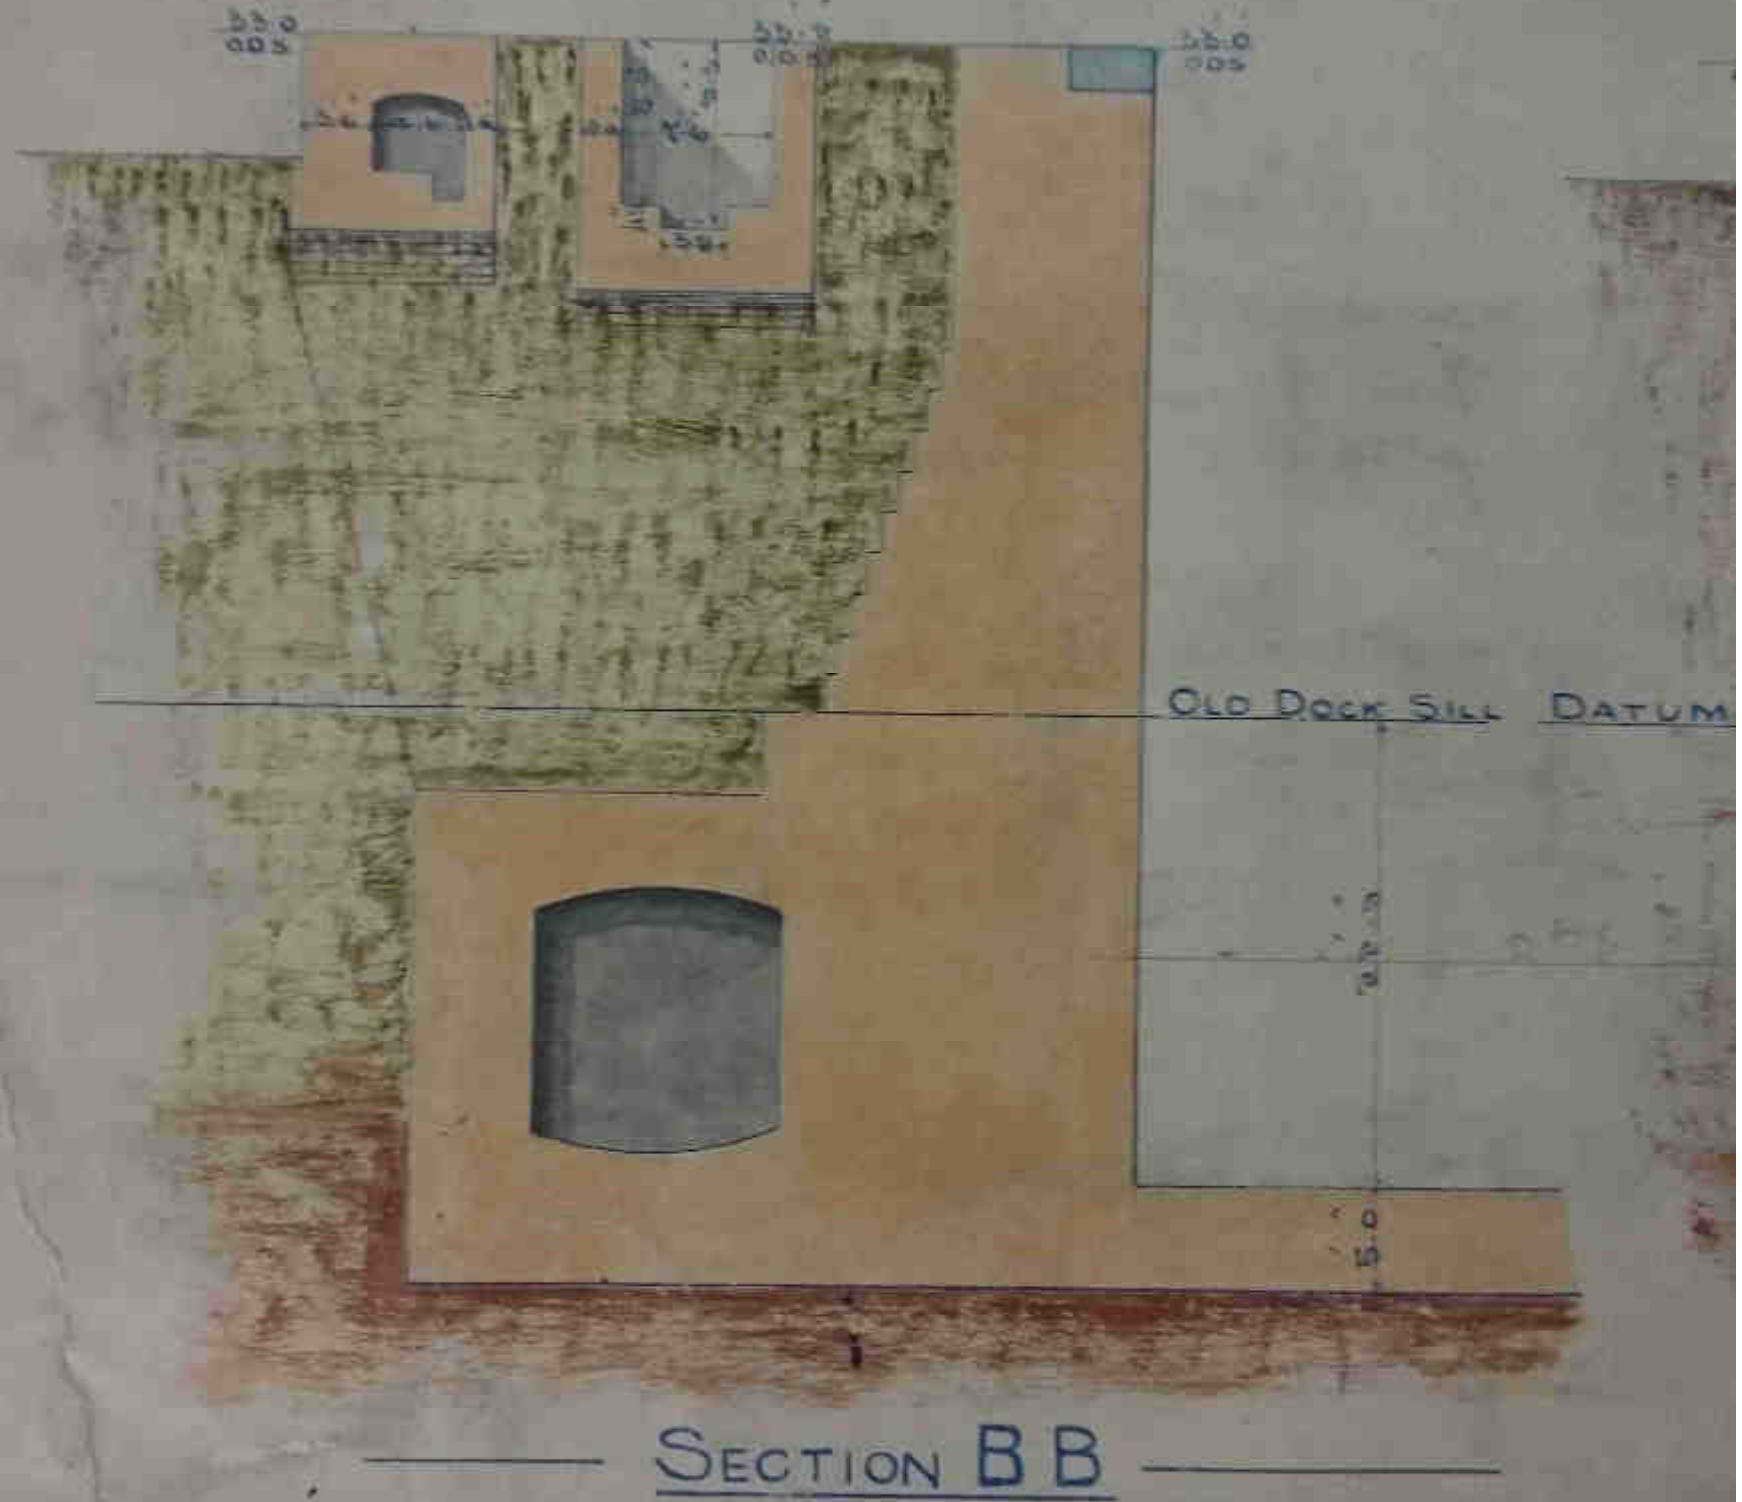
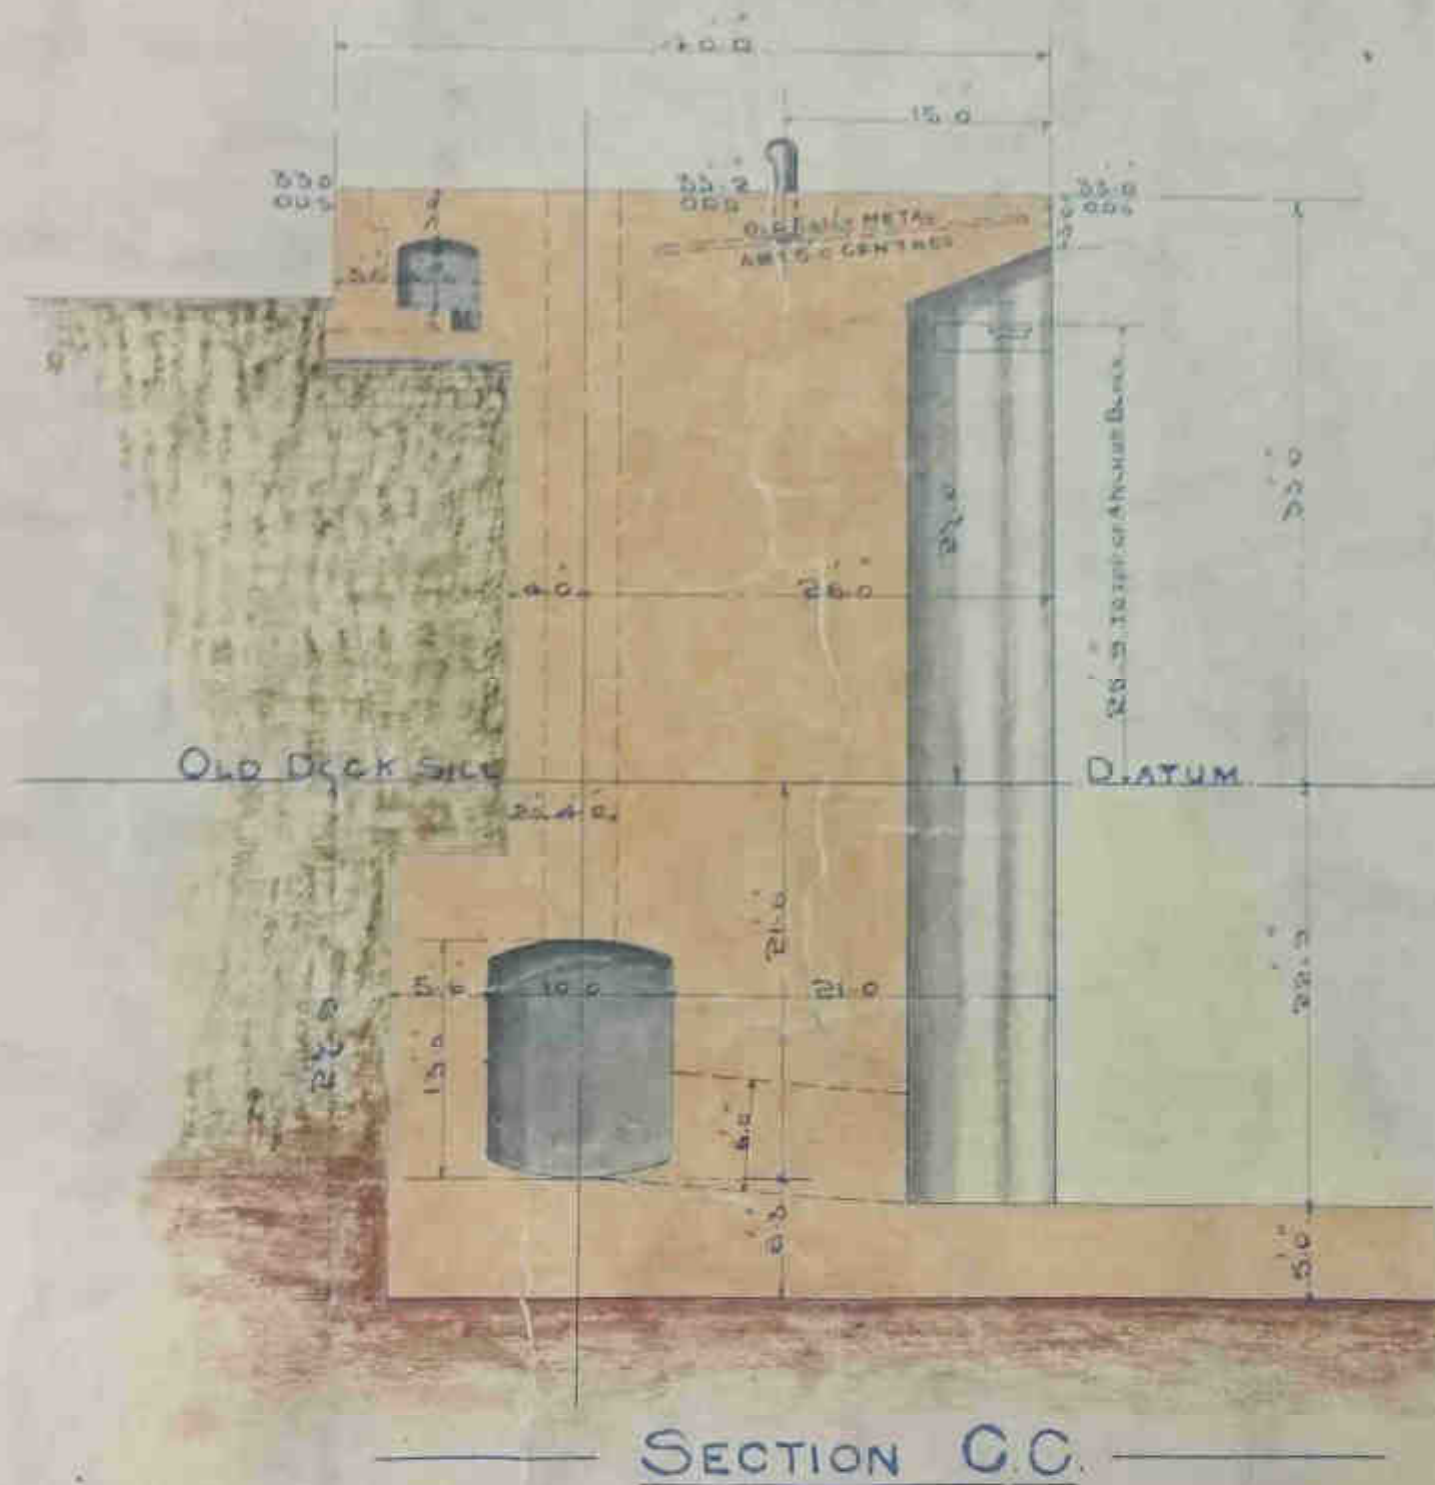
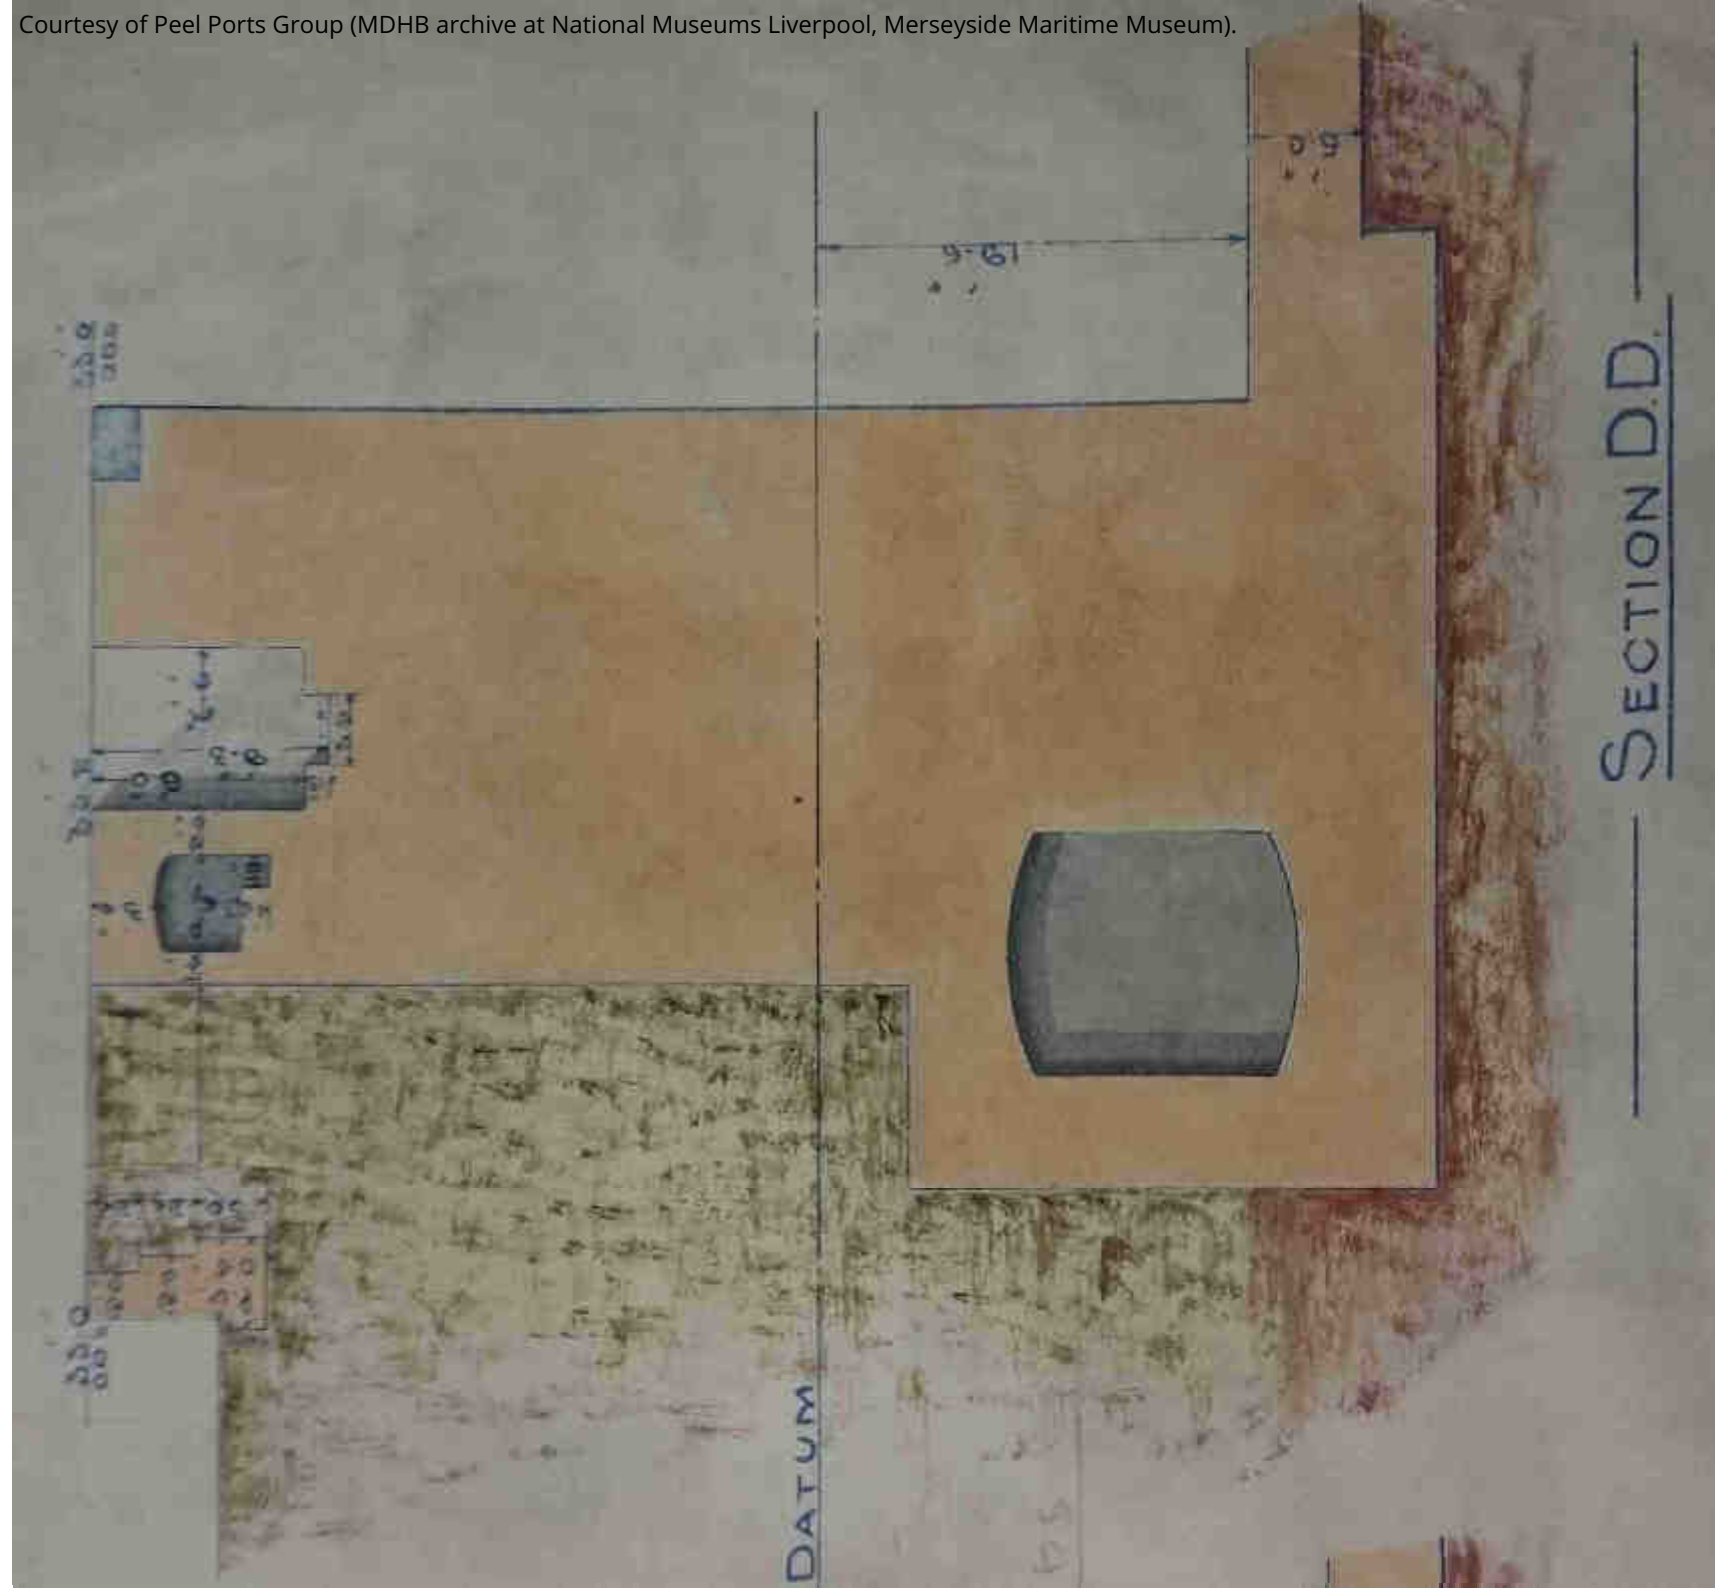
Plan shows plan view of east wall of 100ft lock and 4 No. sections through wall. All sections show extents of concrete (present in significant thickness), location of shallow pipe trench and deep culvert. Section AA shows section through air shaft showing depth and connection to underground culvert. Section BB shows section through gate opening machine pit (2.82m depth x 1.98m width). Section CC shows section through lock gate and top of wall overhang. Also shows 'old raily [railway] metal' at approx. 1.5m centres between ground level and 0.91m depth. Section DD shows section through gate closing machine pit (2.82m depth x 1.98m width).

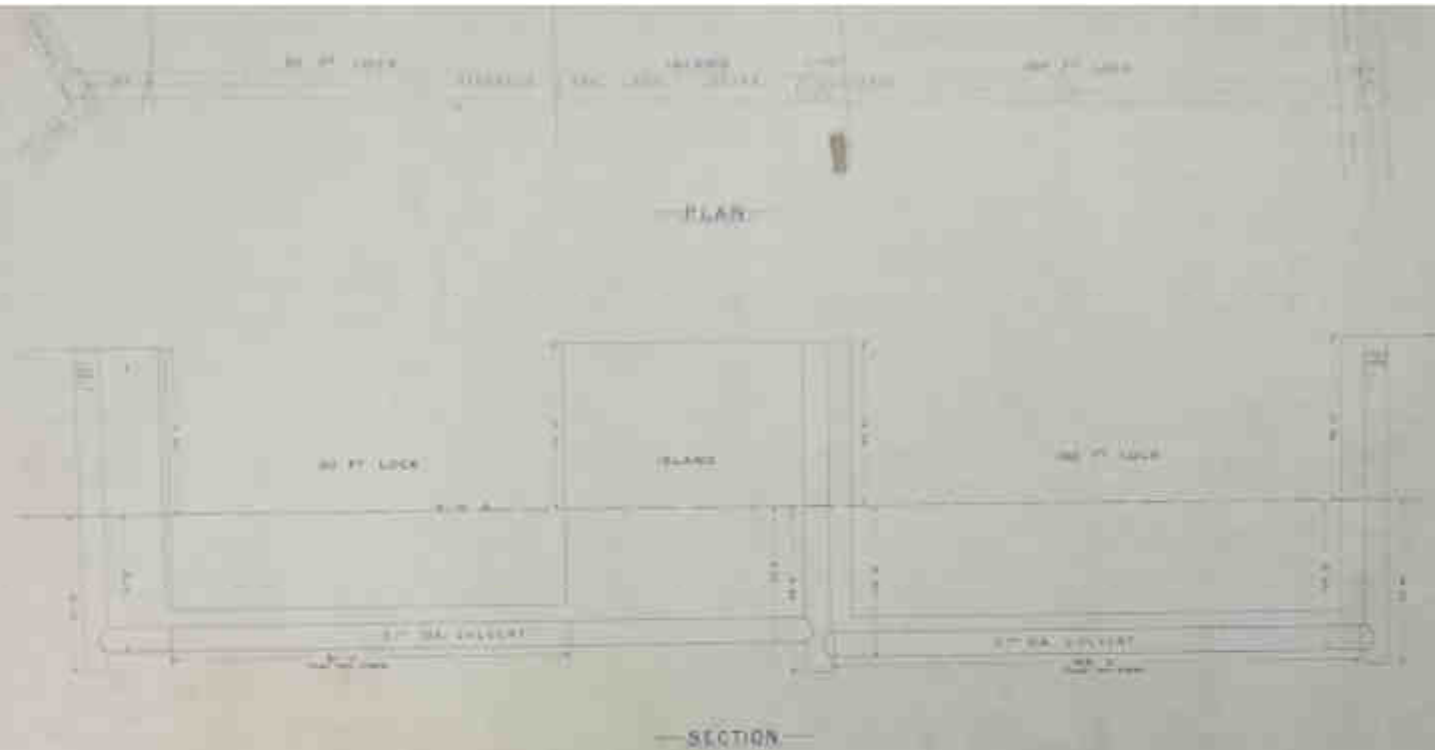
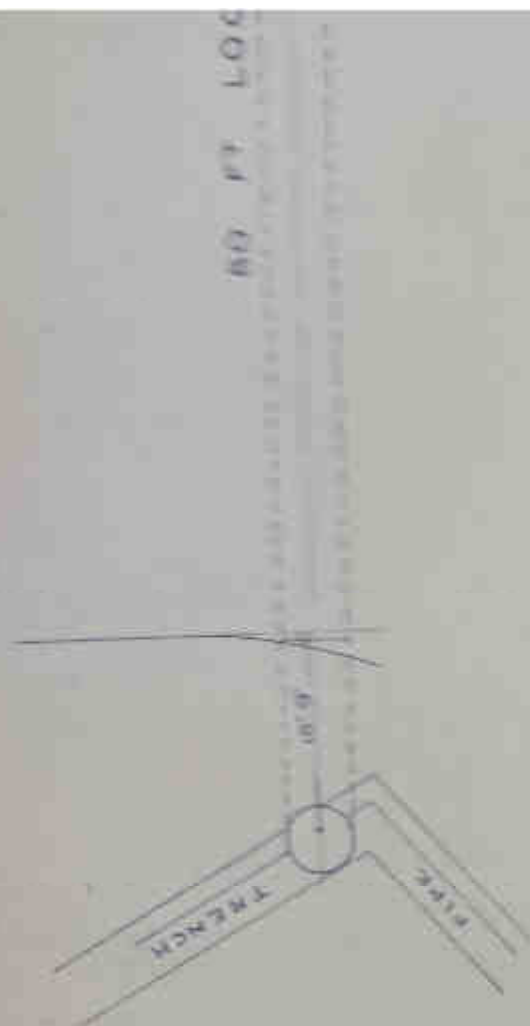
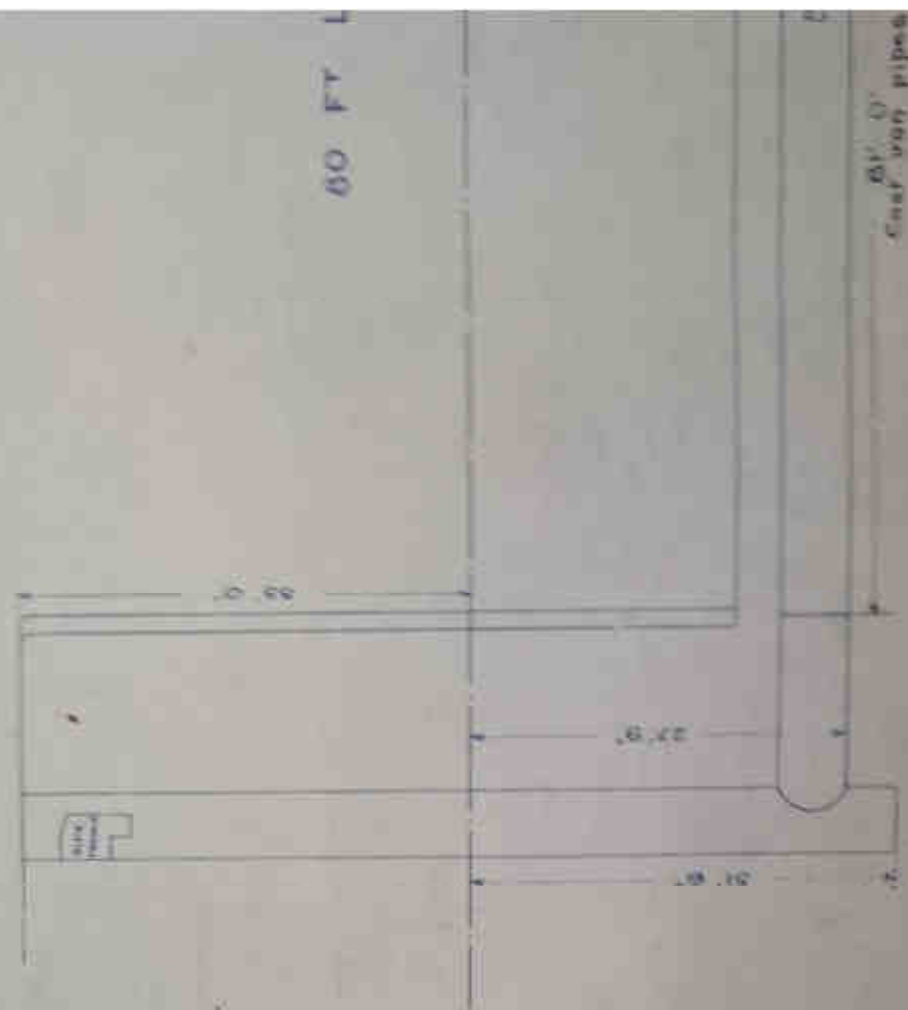
#### 'Plan And Section Of Hydraulic, Gas & Water Culvert'

Plan view shows location of a 1.52m diameter cast iron culvert passing from west side of 80ft lock to east side of 100ft lock and 3 No. connections to surface: 1 in the western wall of the 80ft lock, 1 in the central island and 1 in the east wall of the 100ft lock. Cross section shows depths of culvert beneath locks and approximate locations of connections to surface from lock walls where they intersect with the shallow pipe trench.

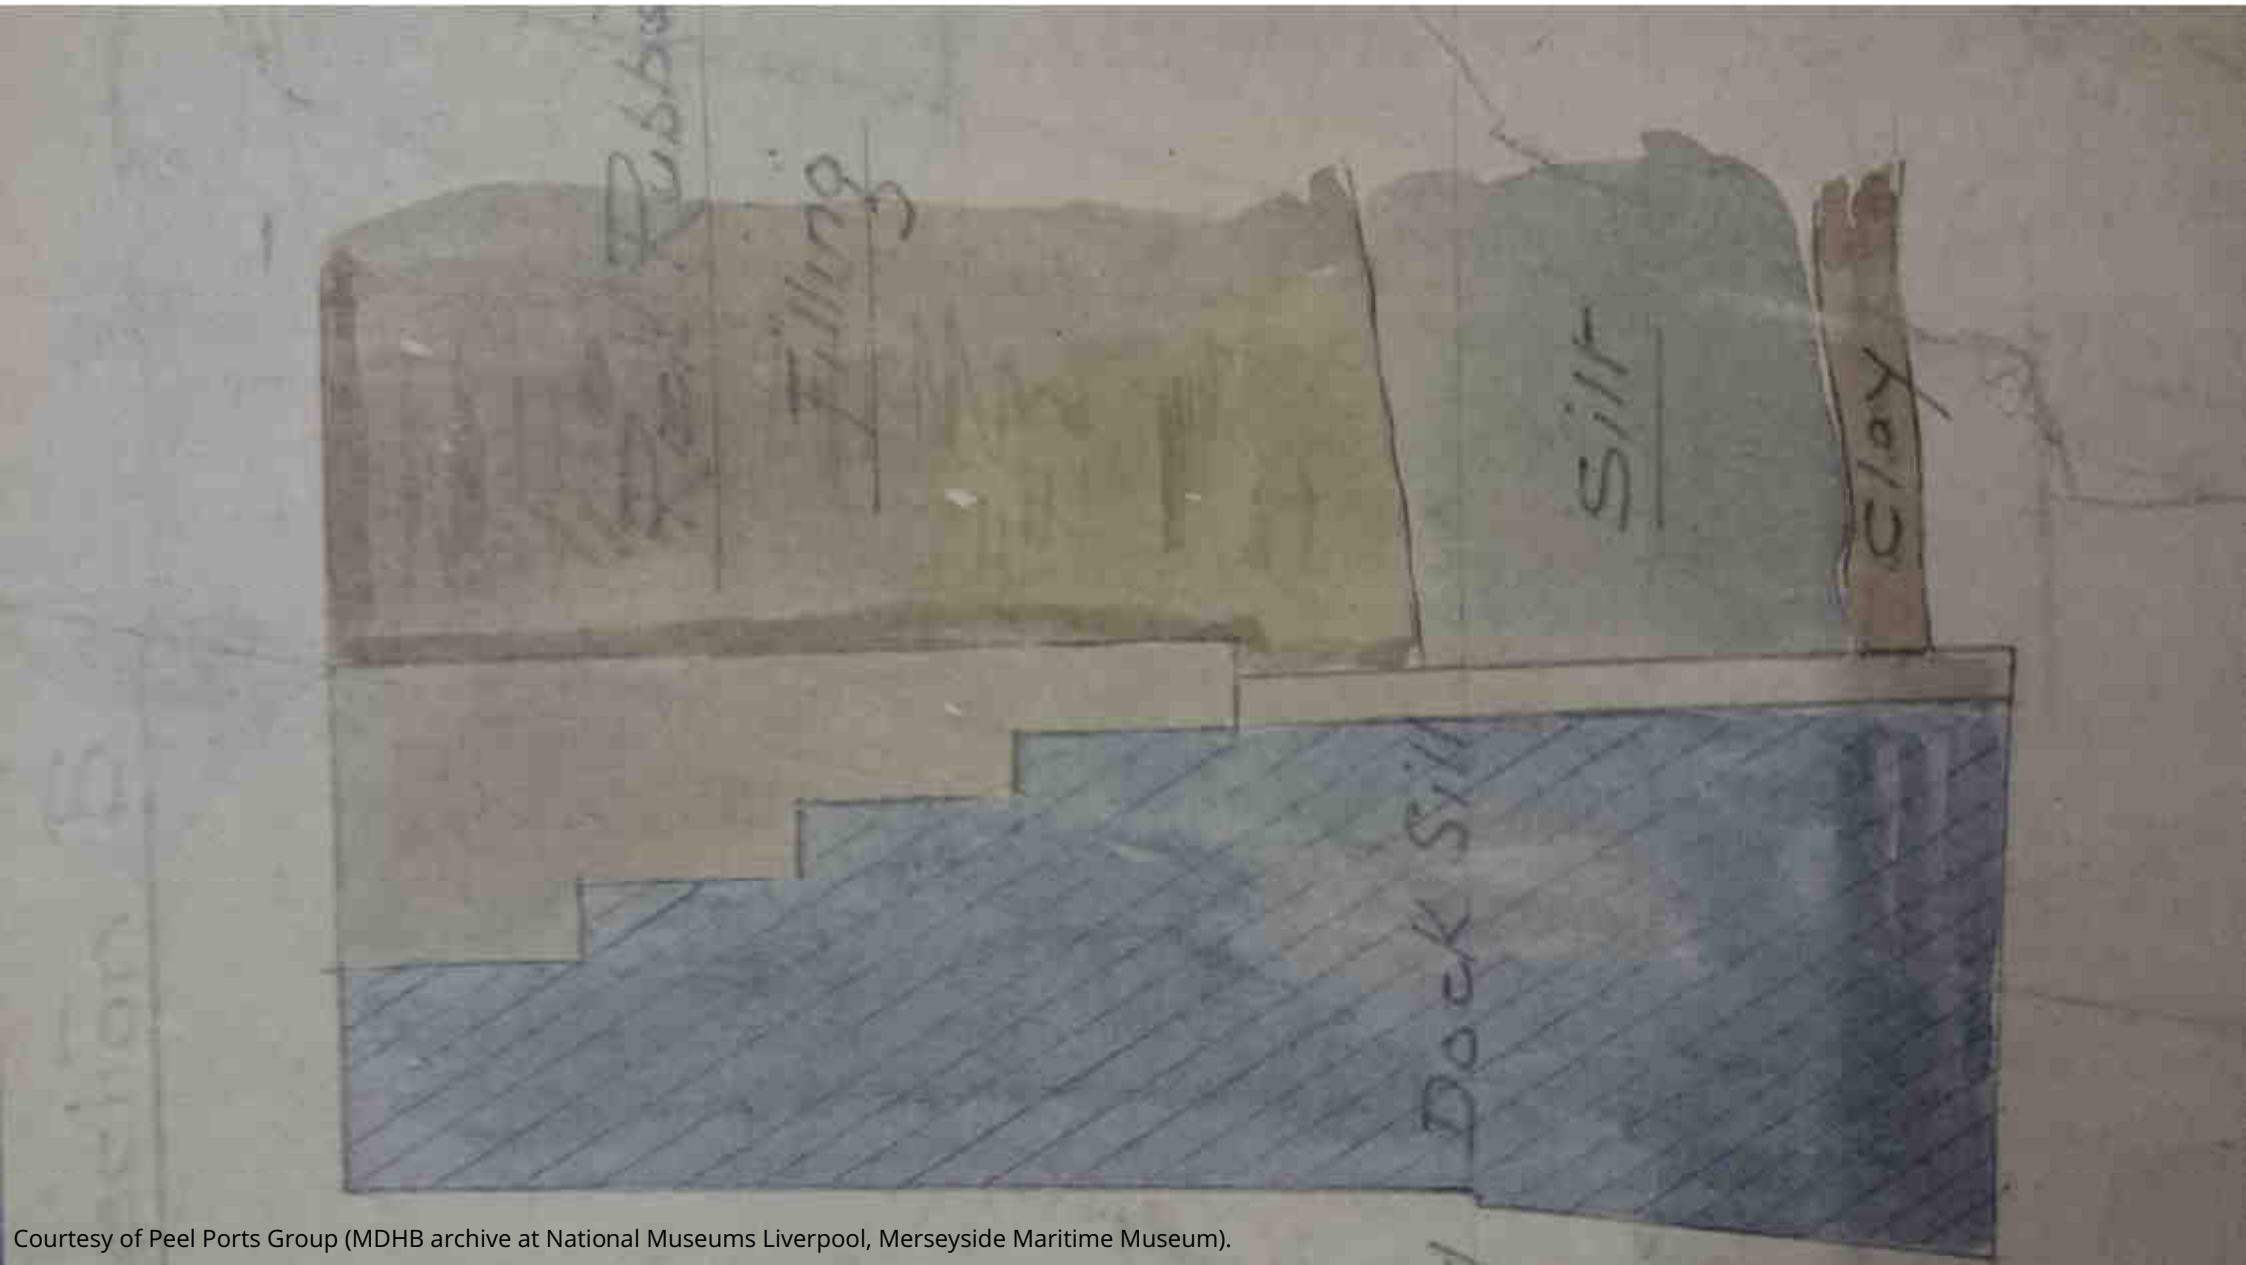
Toxteth Lock was located approximately 21m south of the site. The River Wall to the south of this is shown on a cross sectional sketch. The (presumably concrete) wall widens towards the top. Behind it is 'rock rubble filling' almost to old dock sill (ODS = 10.06m bgl). This is underlain by 'silt', underlain by a relatively thin layer of 'clay', underlain by 'rock' at roughly 14.6m bgl.

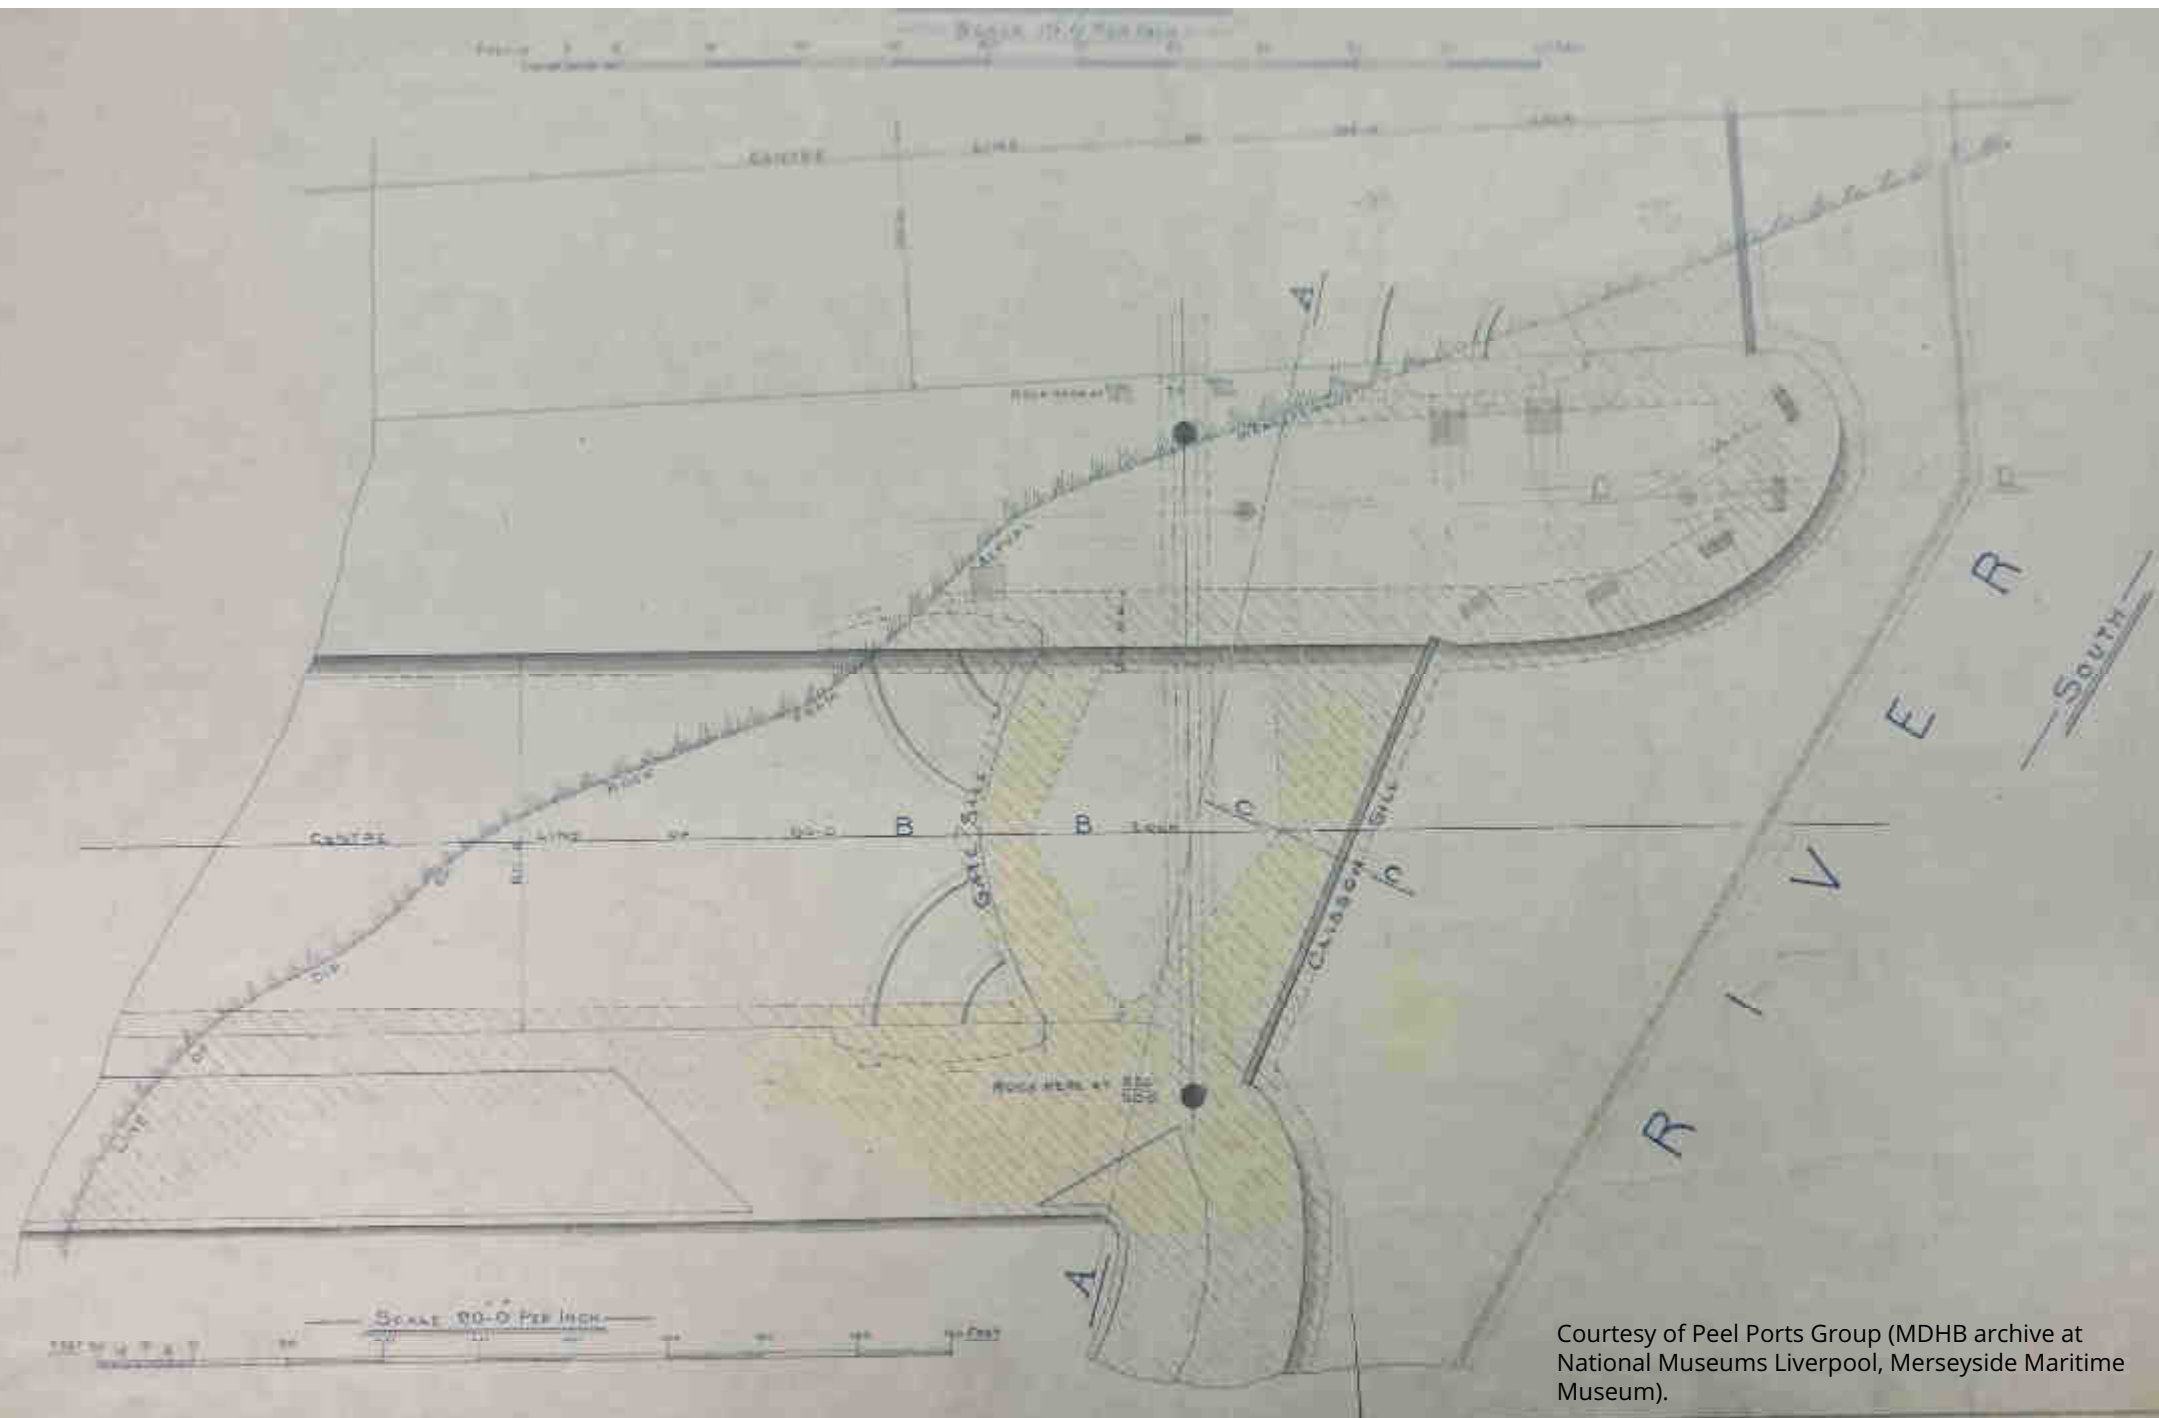
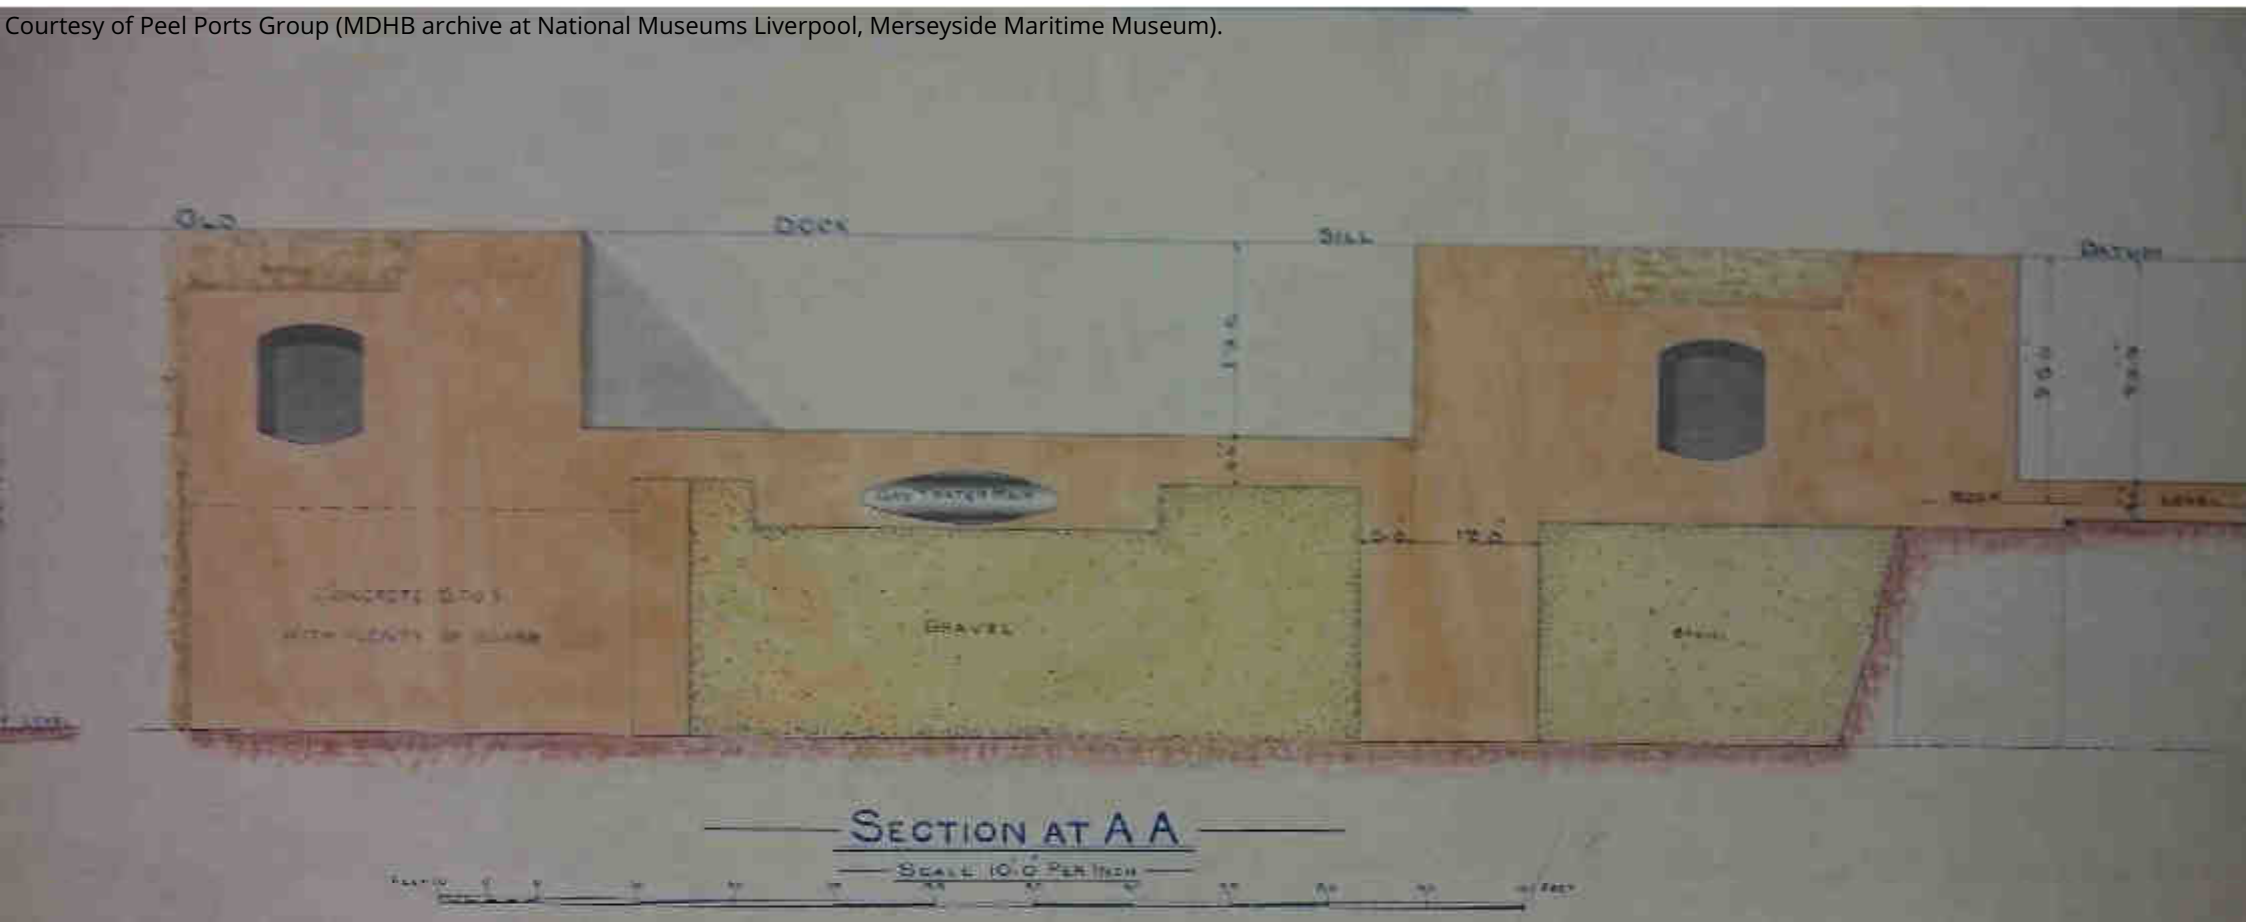
Plan view shows 80ft lock and half of 100ft lock and rock levels at end of cast iron culvert where it crosses 80ft lock. Also shows the underwater section which extends into the river to the south of the locks and the location of the timber piles which secure it. Section AA shows cross sectional view across 80ft lock and apparent rock cut beneath it to include the gas and water main, with lock construction materials including gravel and '8 to 1 concrete with plenty of burrs'. Section BB shows a cross section through the gate sill with rock level and base construction. Section CC shows a cross section through the caisson sill with rock level and base construction. Section DD shows a cross section through the river-facing end of the island between the locks. This shows the concrete extending past the end of the island beneath the water, which is secured to rock with 0.30m x 0.30m timber piles. Also shows culver outlet and wall construction including '8 to 1 concrete with plenty of burrs'.
