## **APPENDIX 13**

### **GEOTECHNICS LTD. DESK STUDY AND GROUND INVESTIGATION REPORTS**

# Detailed Unexploded Ordnance (UXO) Threat & Risk Assessment

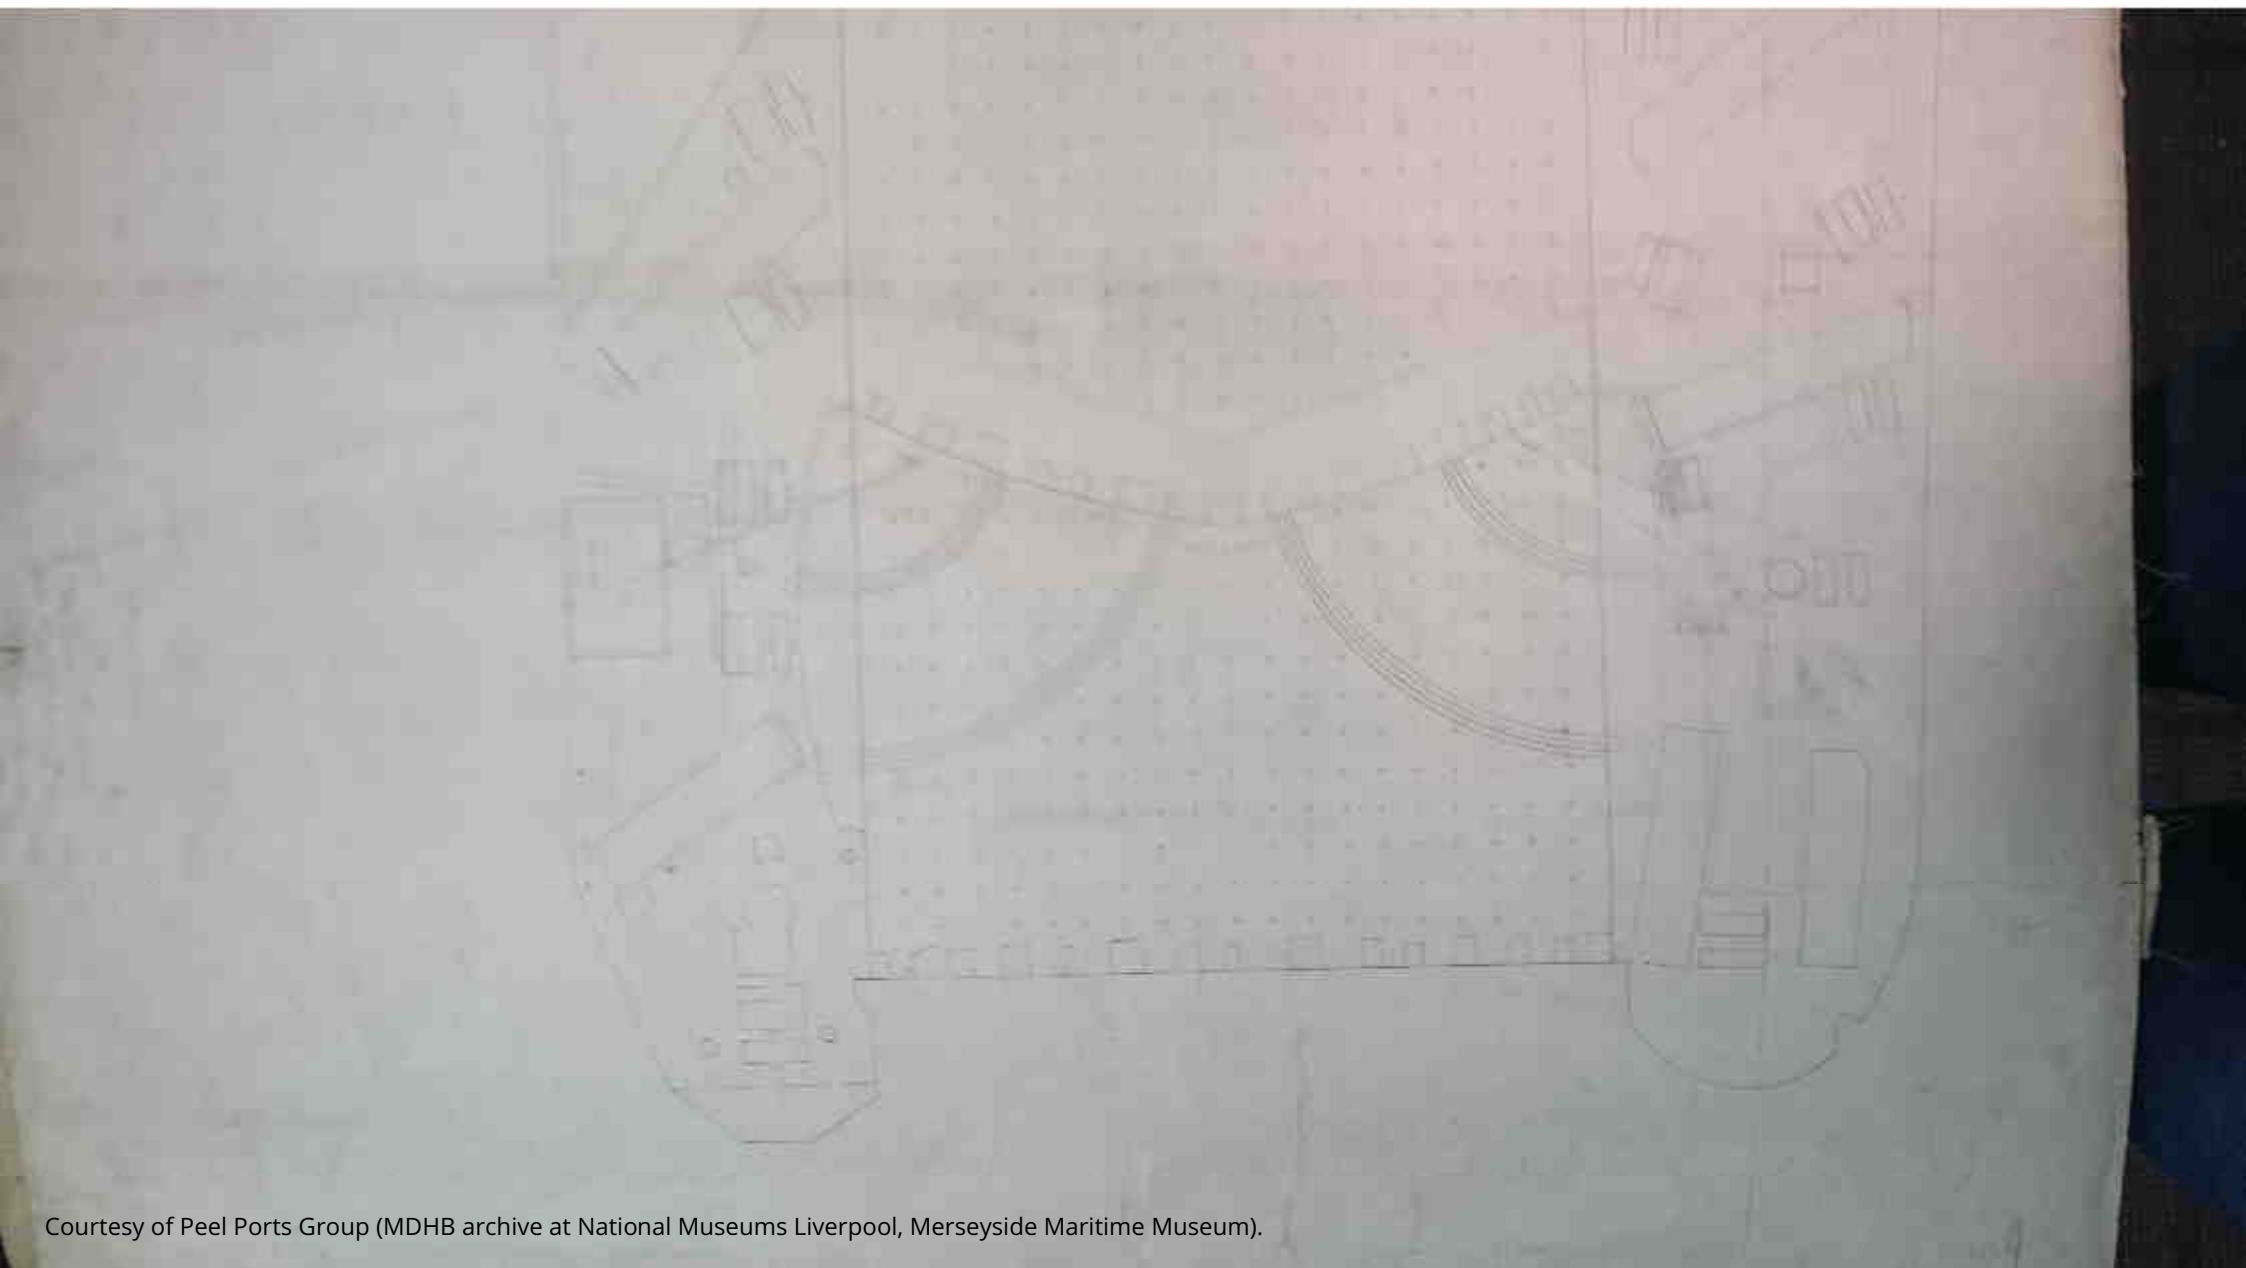
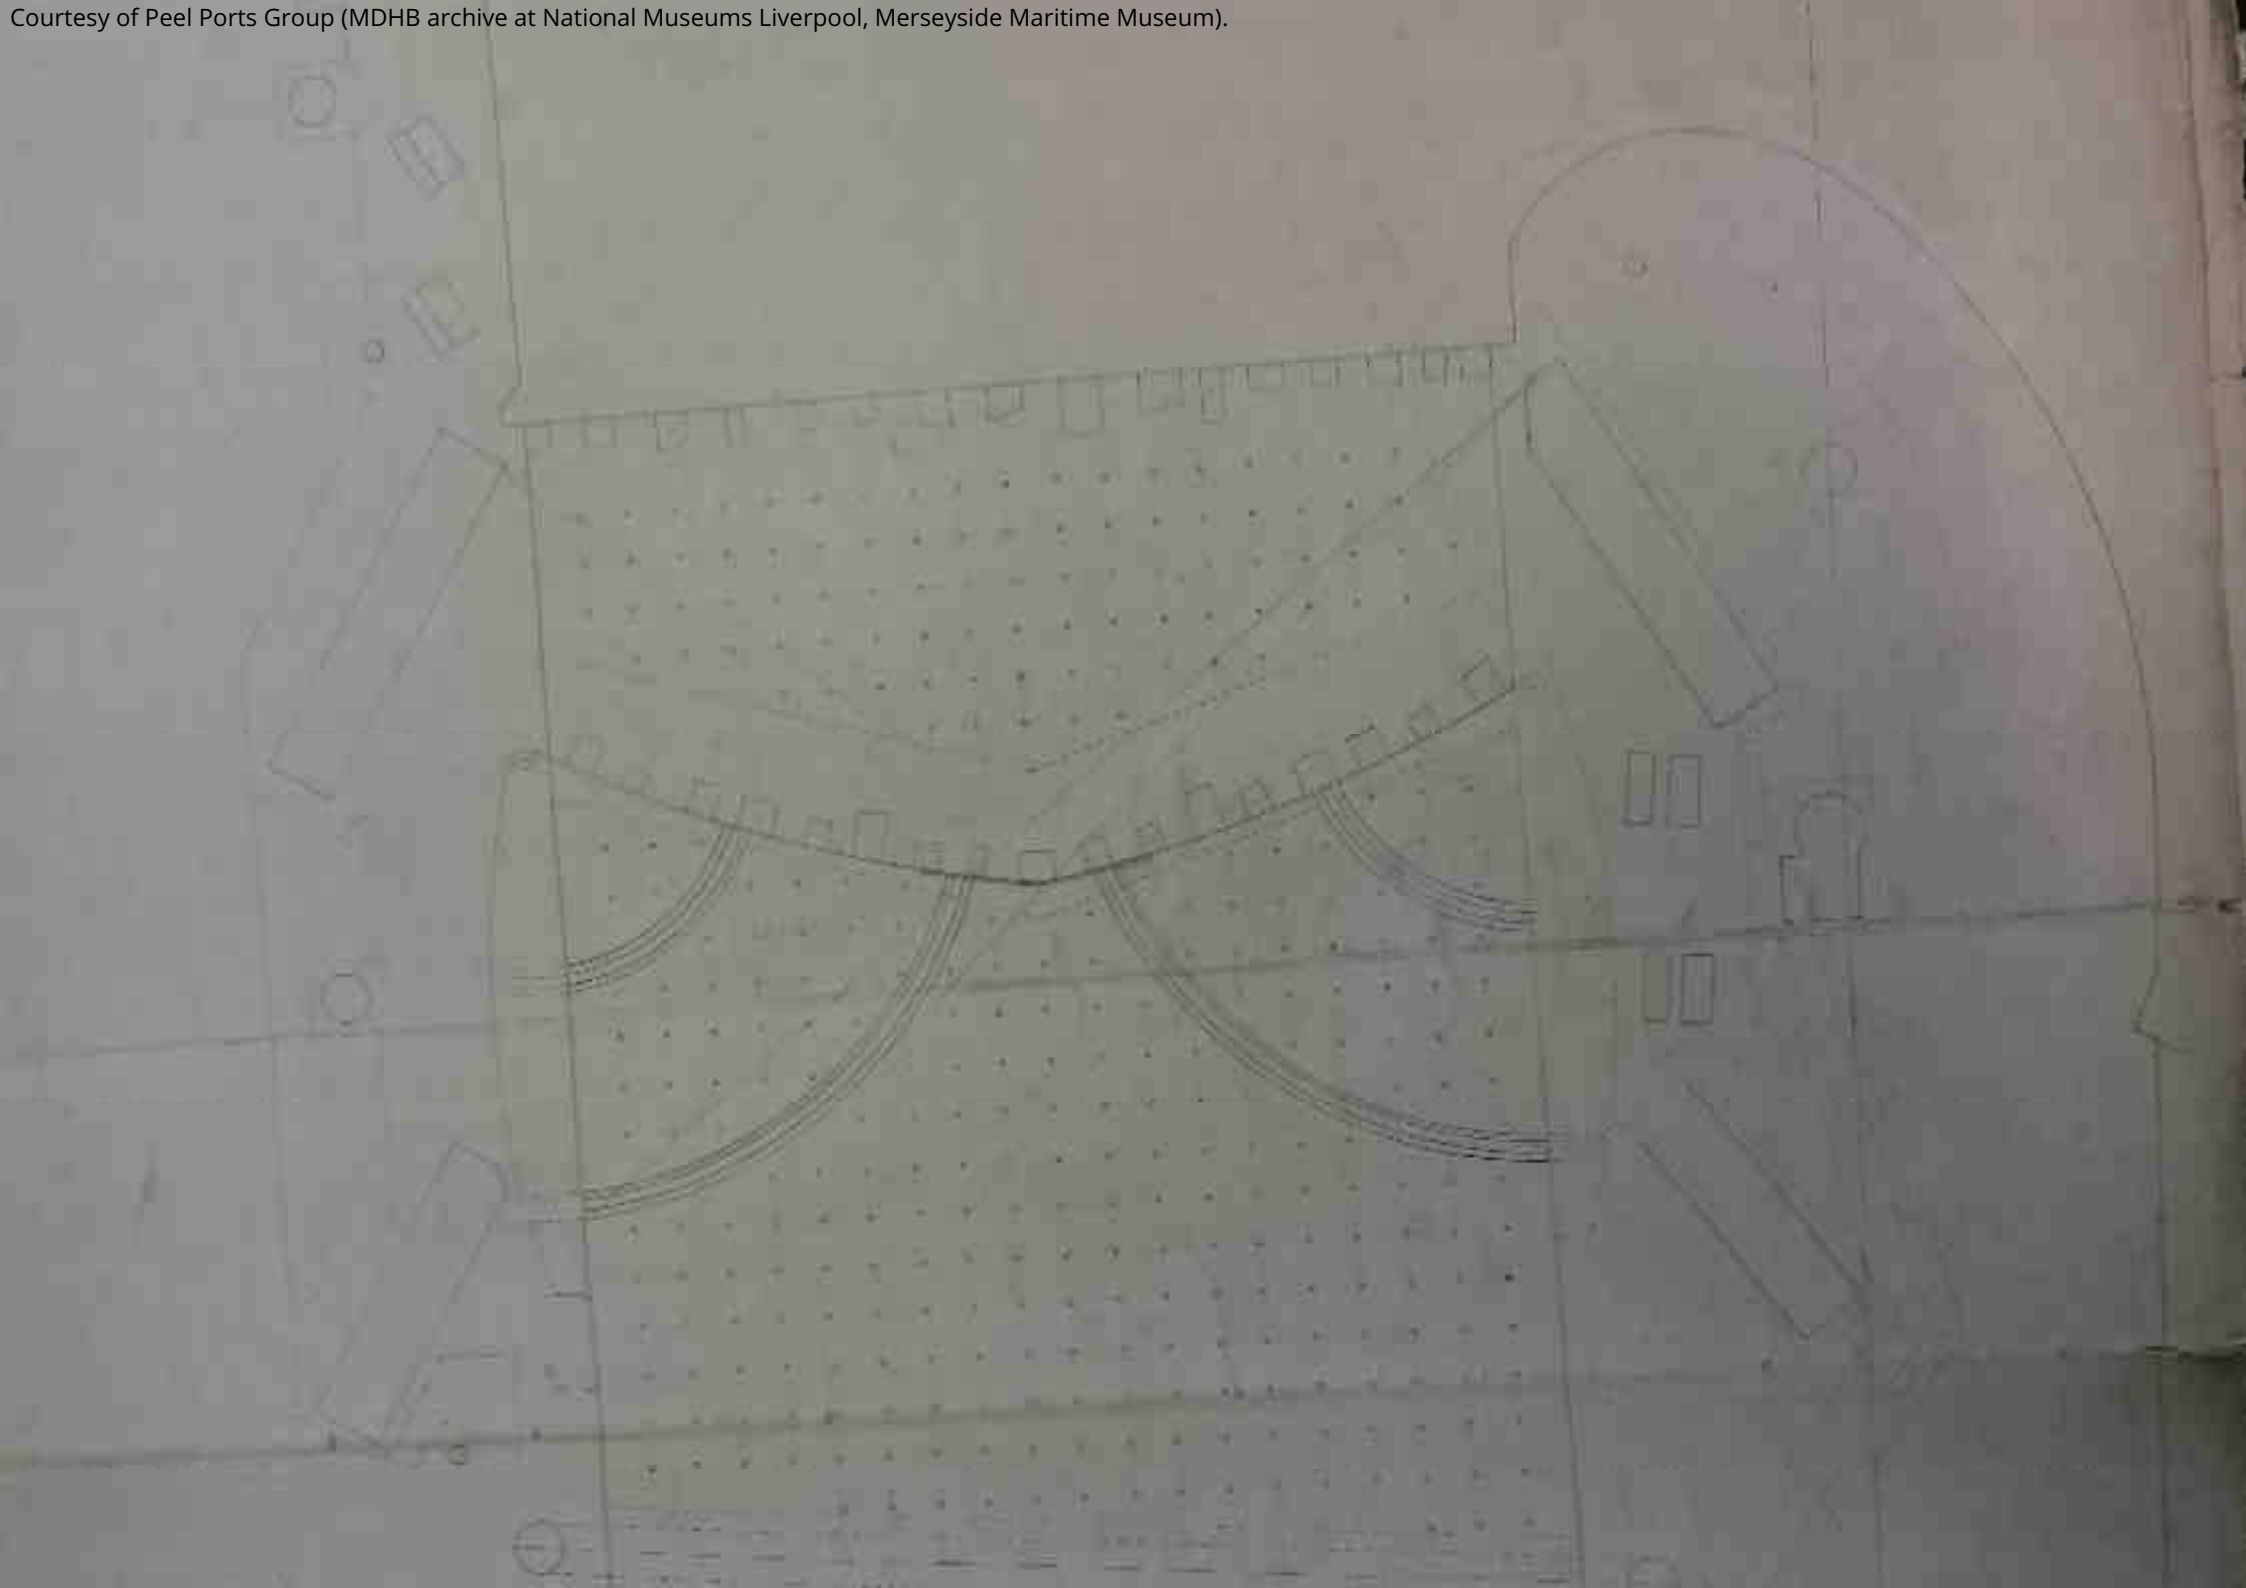
A long plan shows the 100ft lock in detail. Many small, evenly spaced dots are present along its length – these are conjectured to be the locations of timber piled foundations.

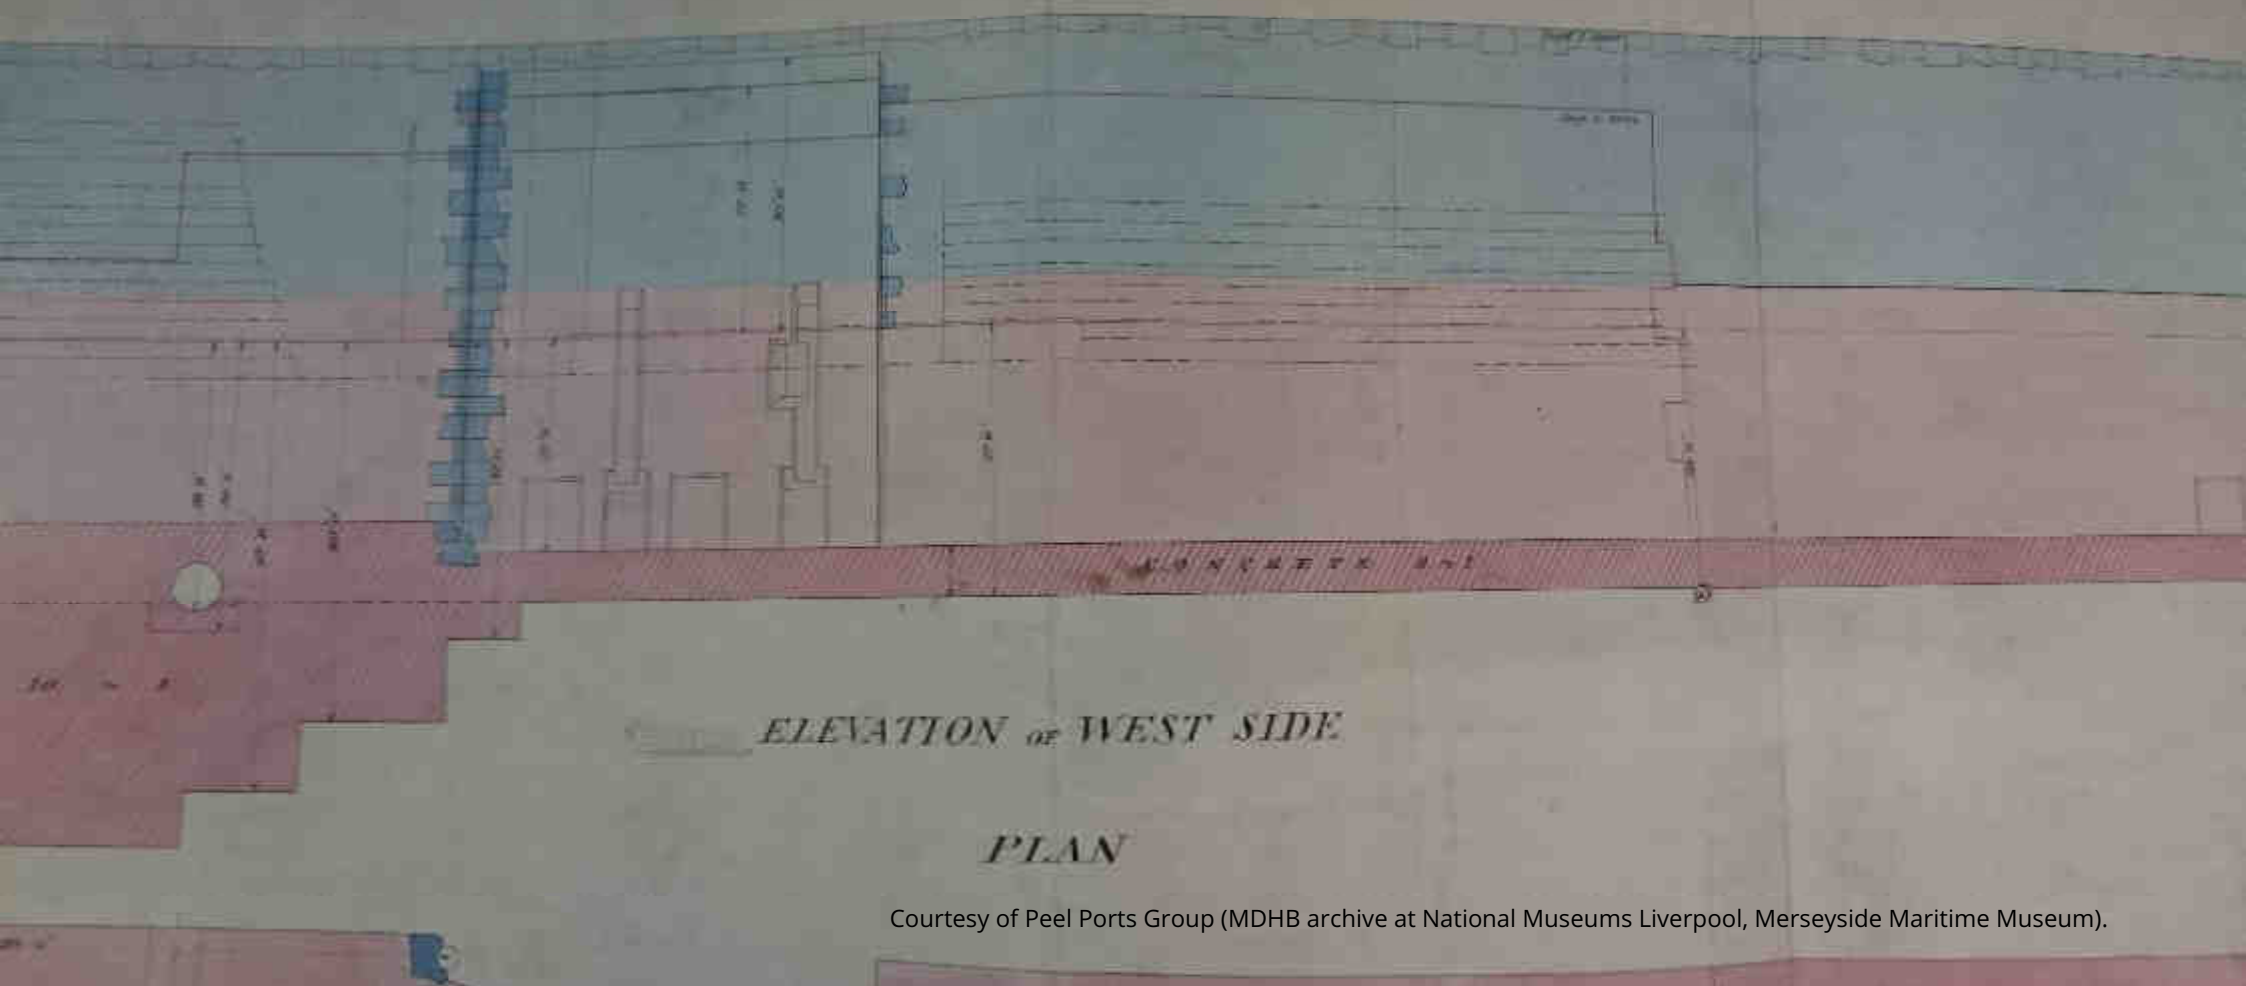
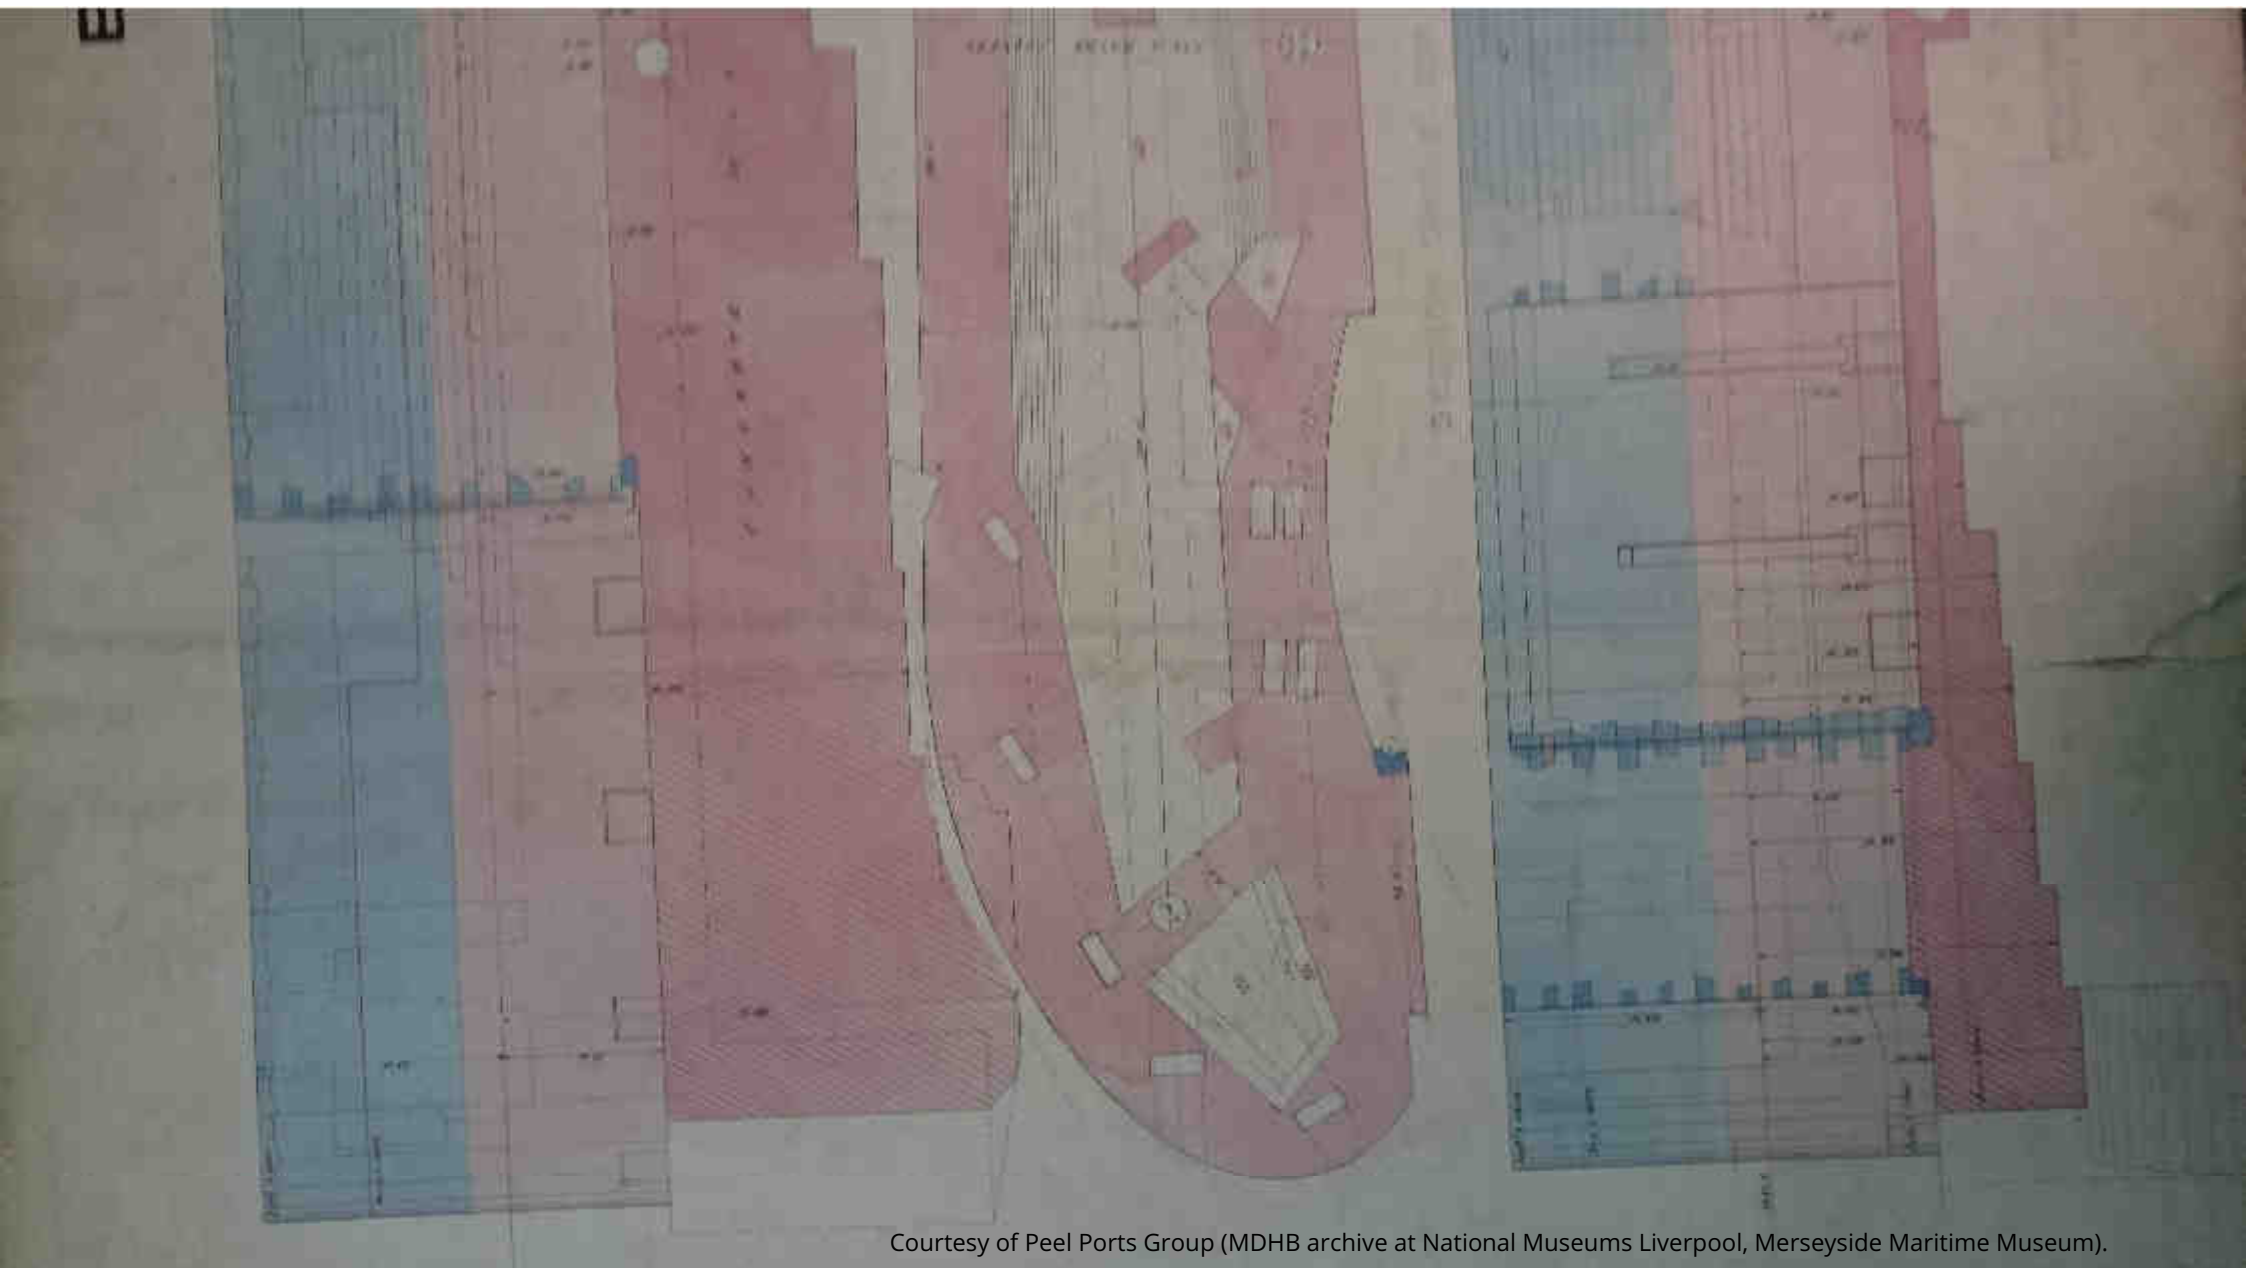
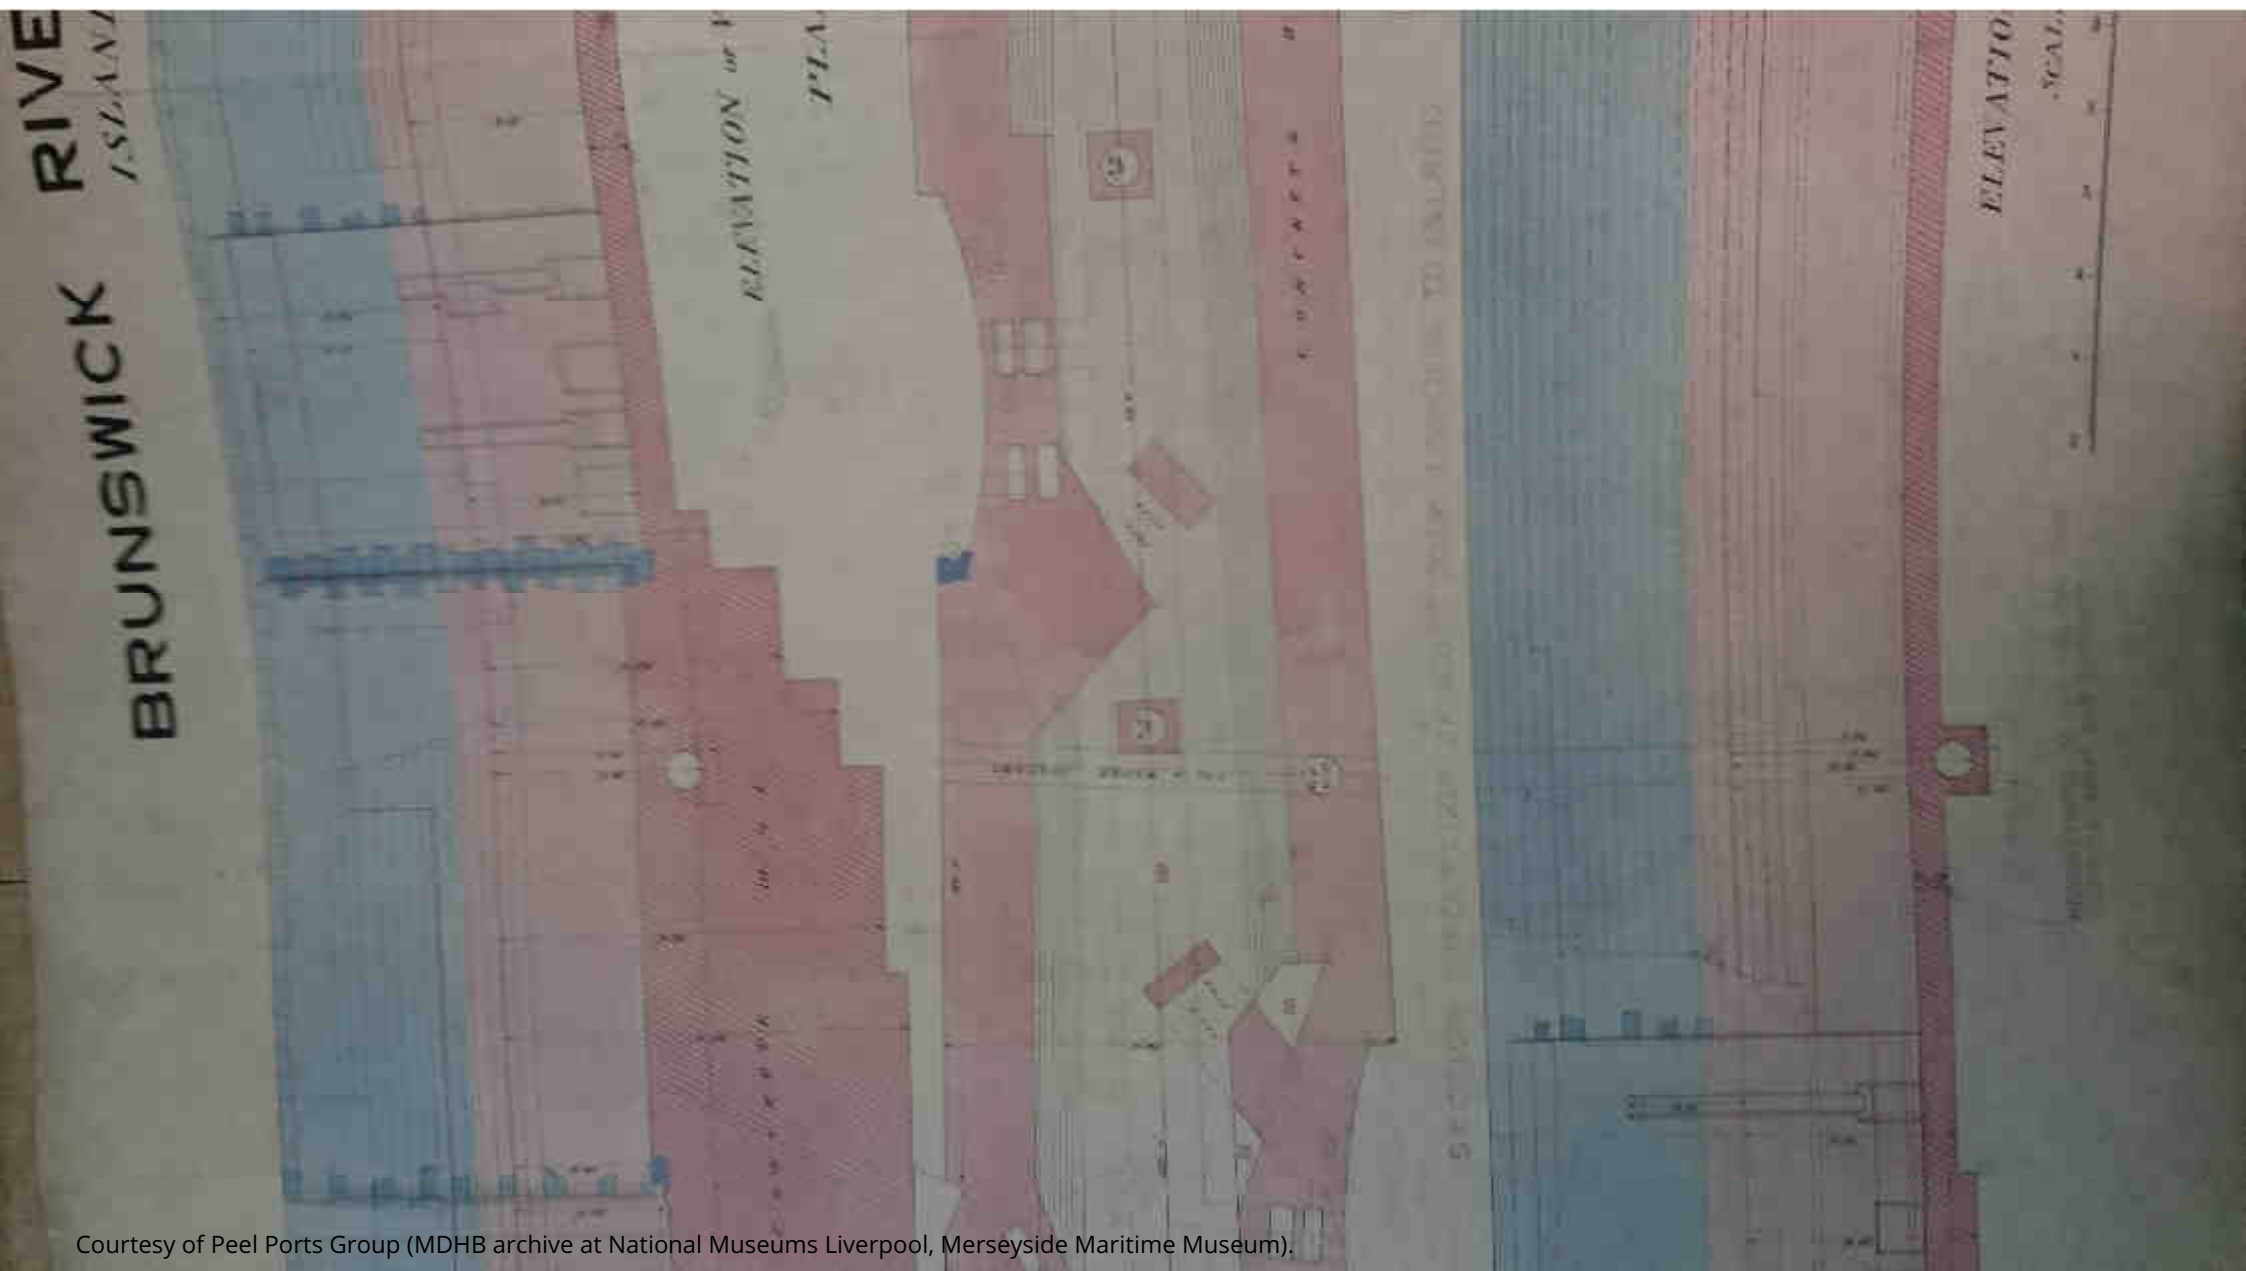
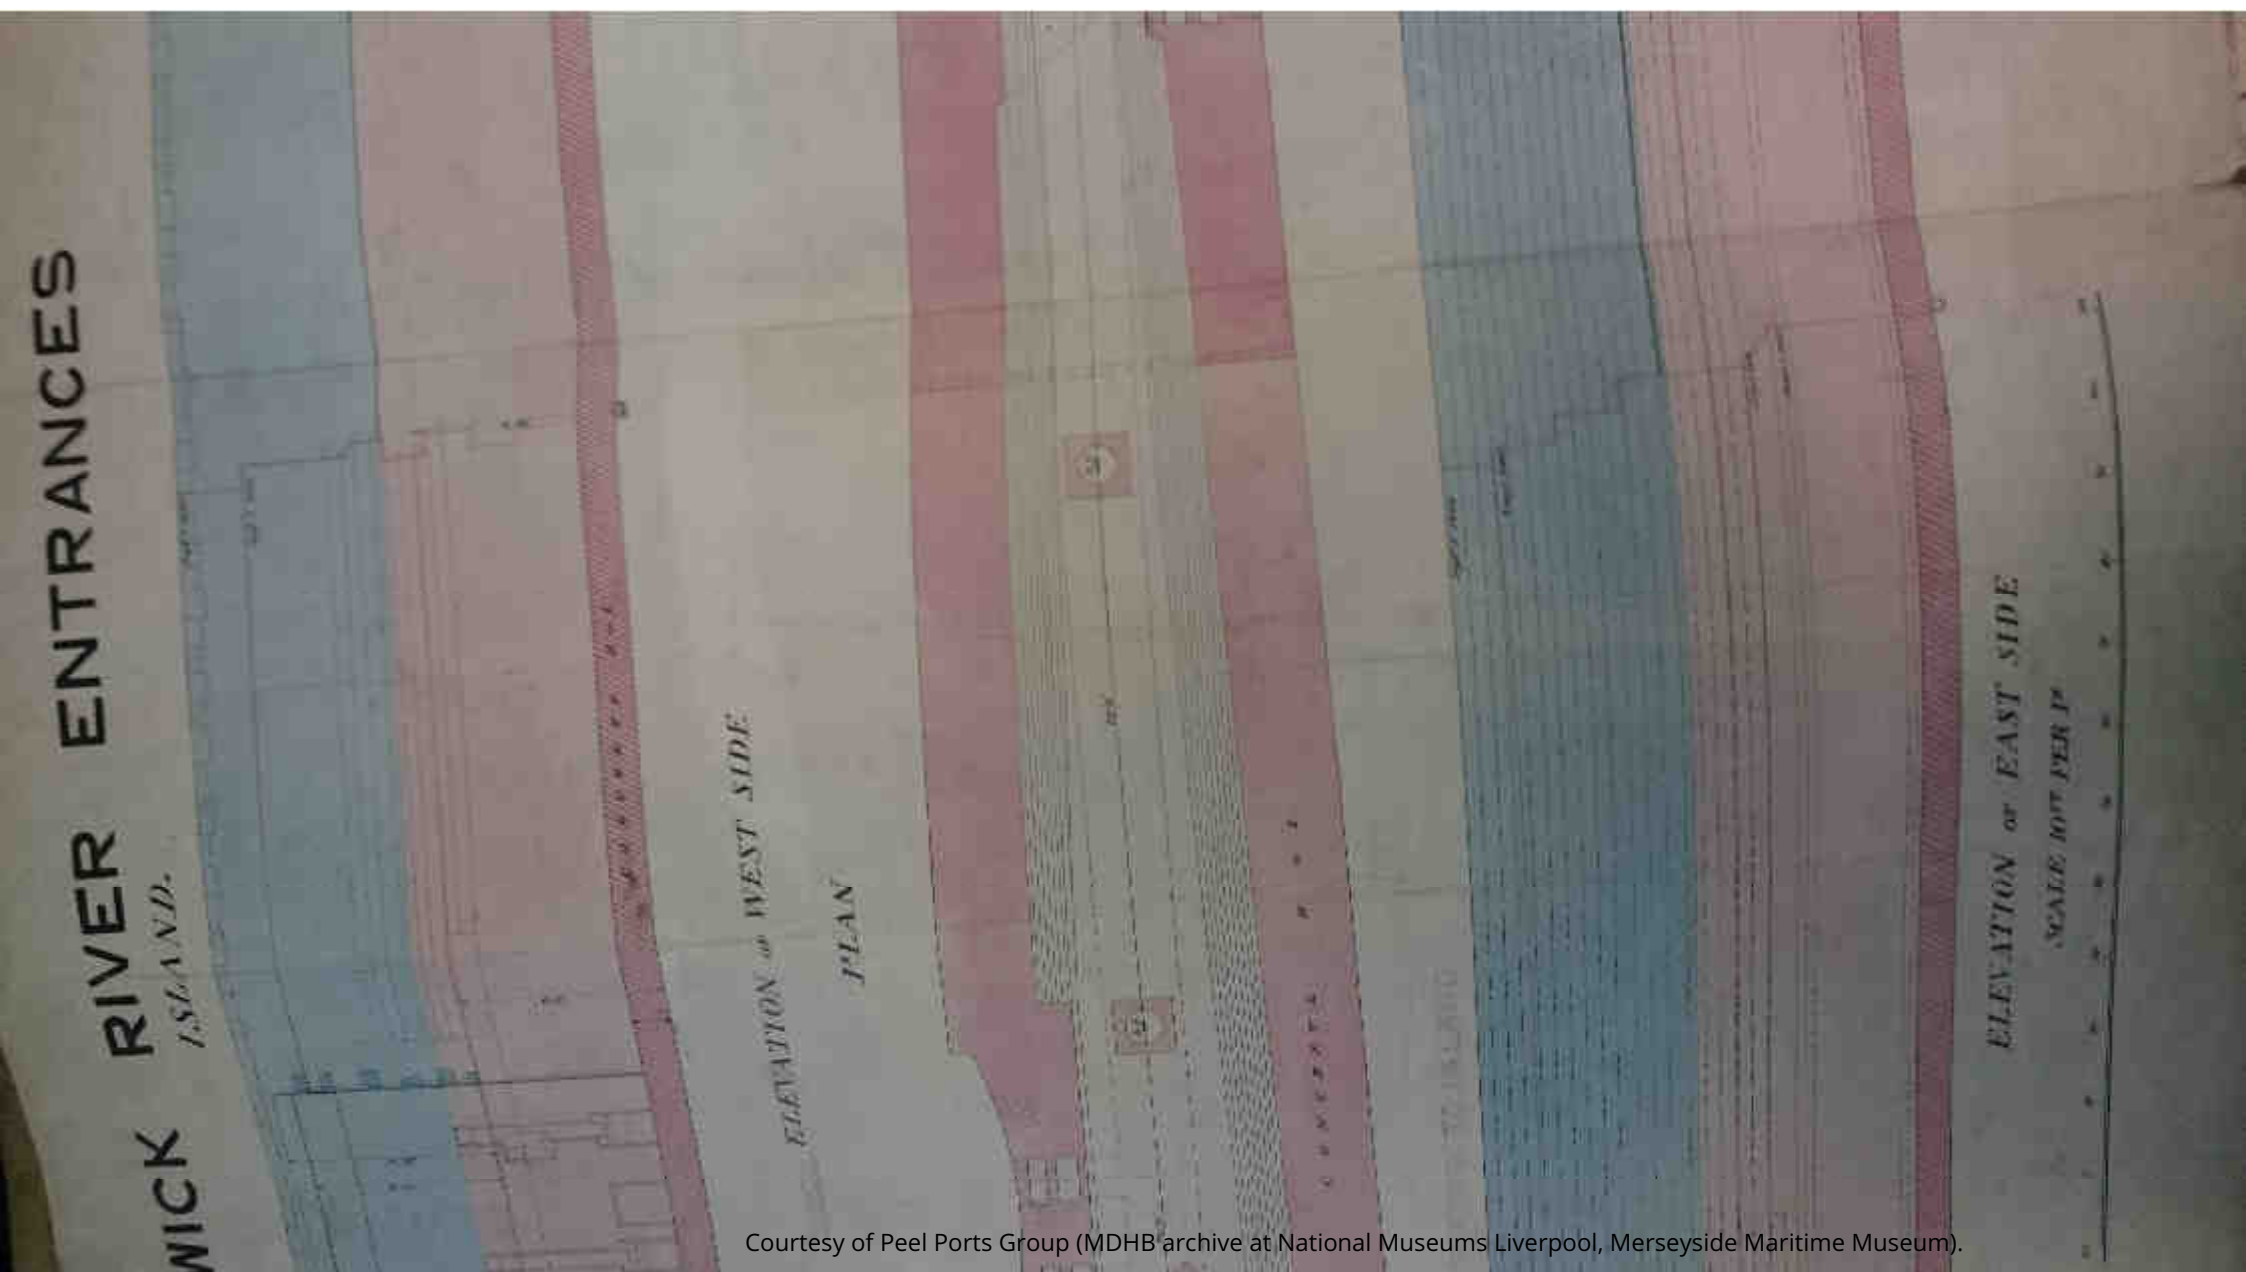
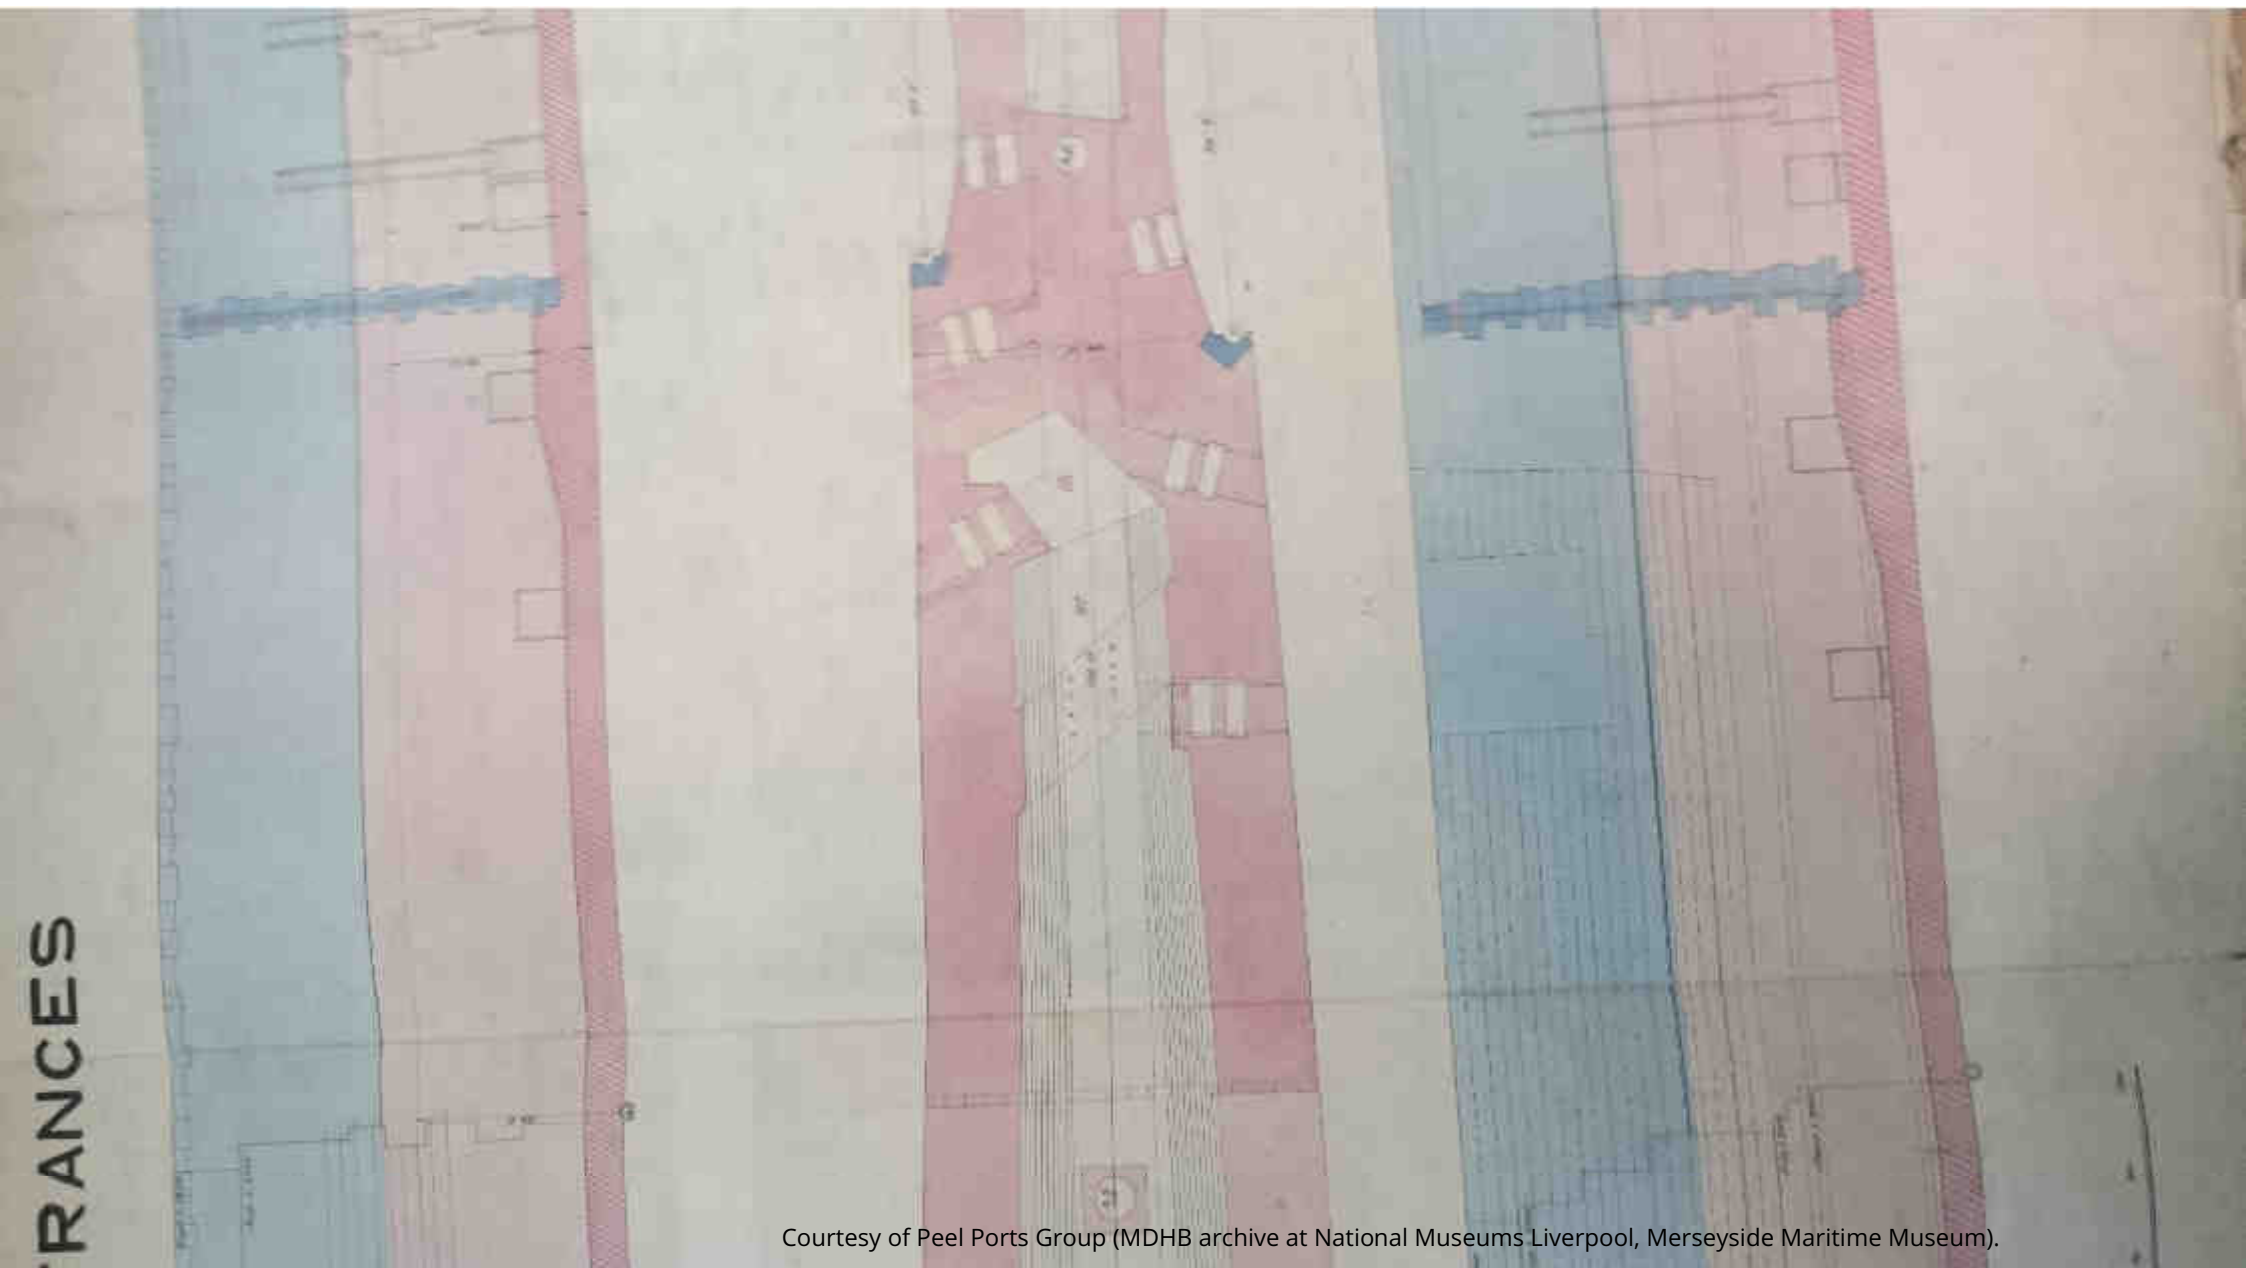
### 'Brunswick River Entrances: Island' plan and cross sections

Cross sections show the west side and east side walls of the island between the Brunswick Locks. Plan view shows island construction. The river-facing end of the island has a significant thickness of concrete beneath it, presumably to act as a breaker for the head of river water. The concrete is either 10 to 1 or 8 to 1 and various sub surface features are founded upon it.

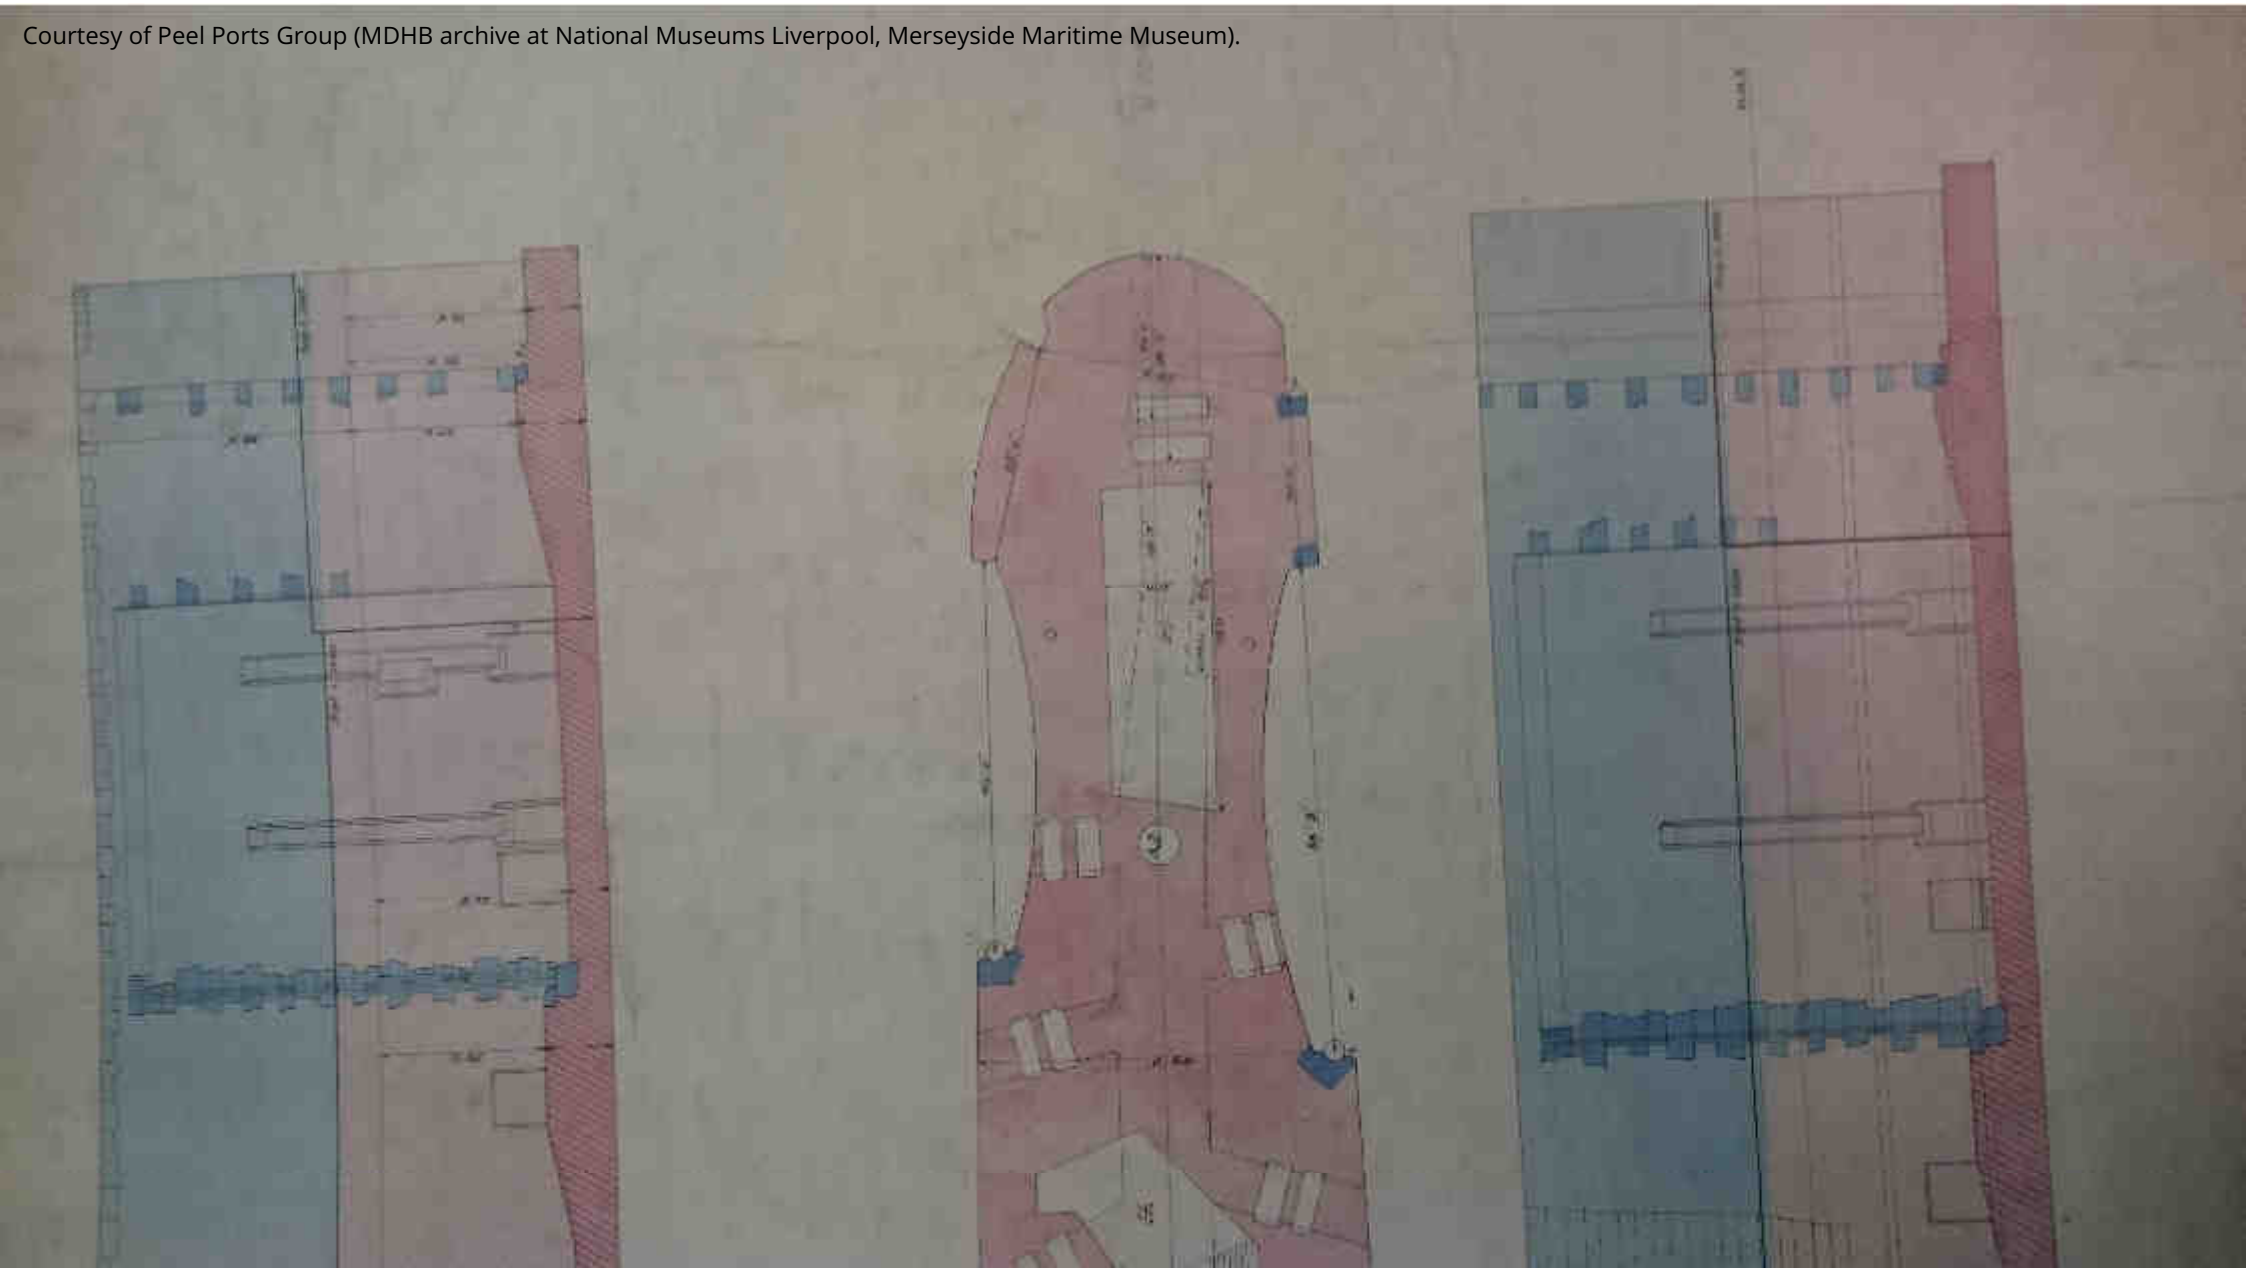
### 'Brunswick River Entrances Foundation Plan'

Plan view shows the depths of foundations of the 100ft lock, its walls, the 80ft lock, its walls and the island between them. The depths are given in feet below ODS (Old Dock Sill, 10.06m bgl). Most parts are formed on rock (pink), except the southern-most part of the island and roughly the southern half of the 80ft lock are founded on gravel. Some parts are labelled with the date they were constructed.
