## **APPENDIX 13**

### **GEOTECHNICS LTD. DESK STUDY AND GROUND INVESTIGATION REPORTS**

# Detailed Unexploded Ordnance (UXO) Threat & Risk Assessment

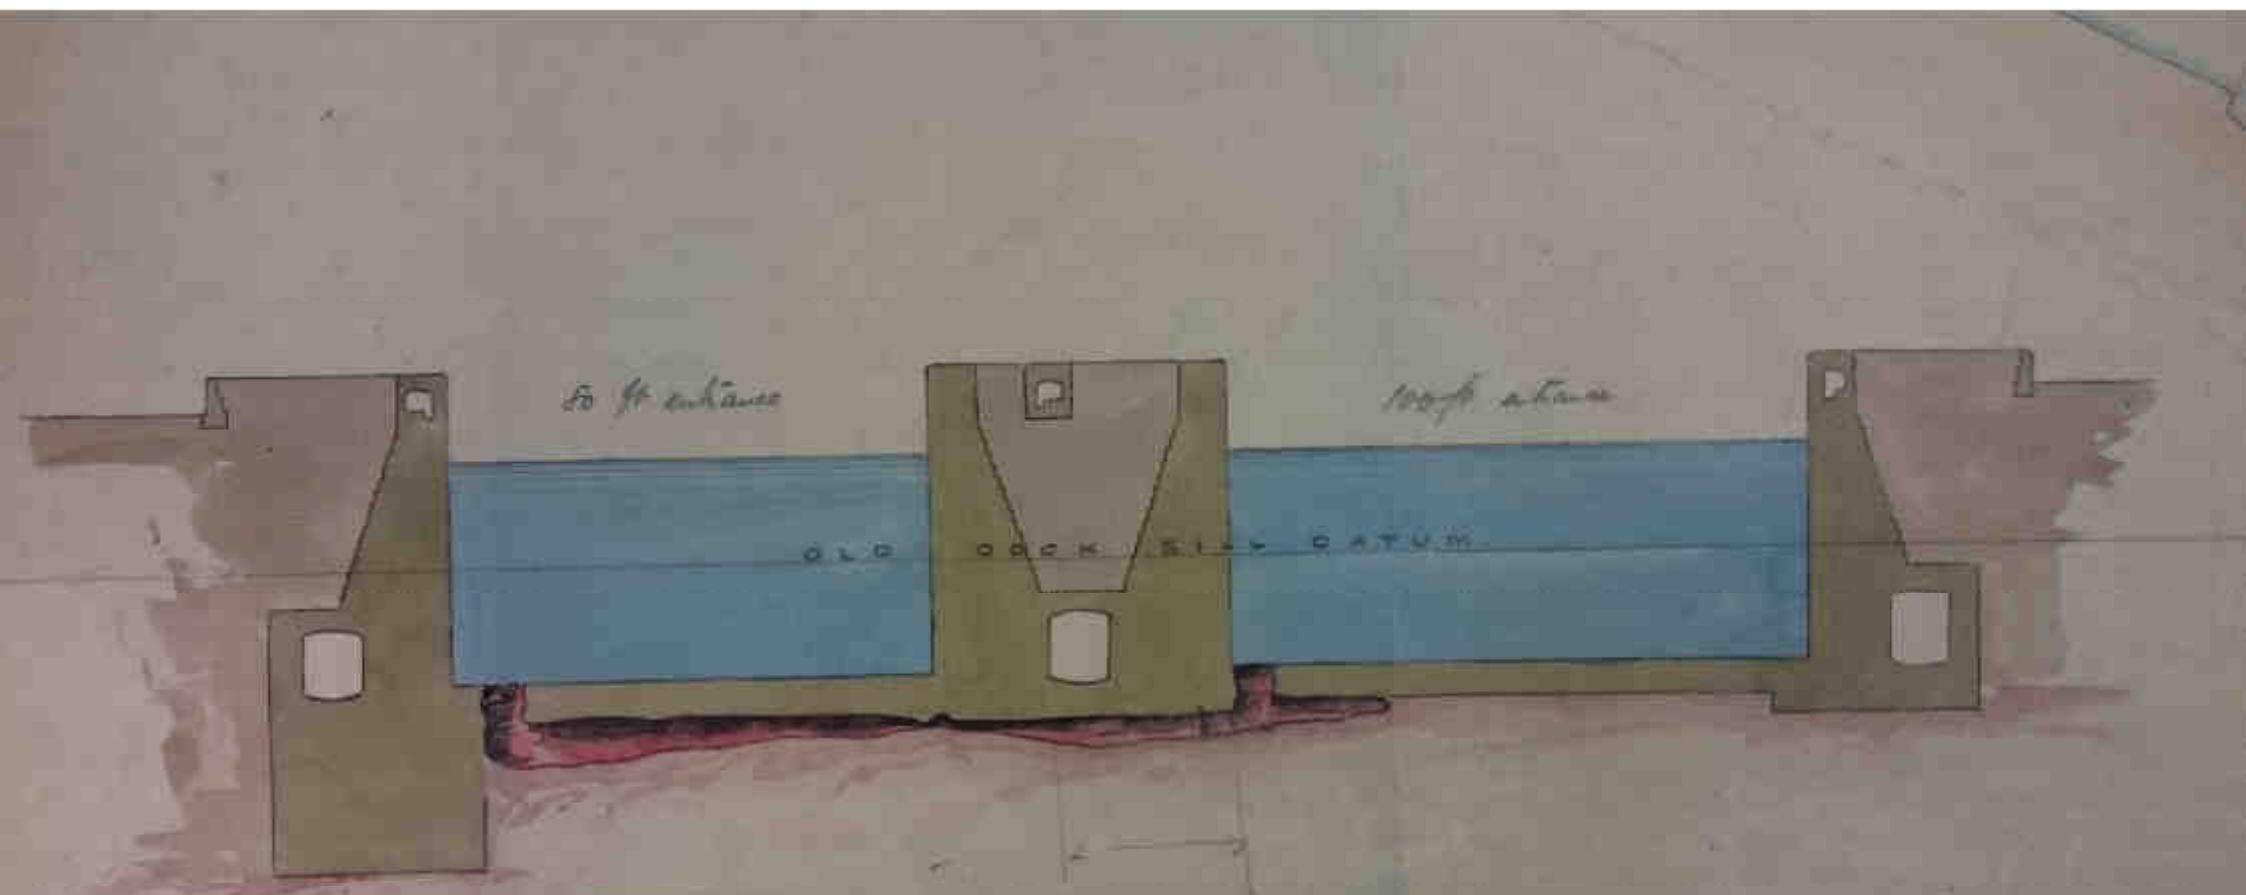
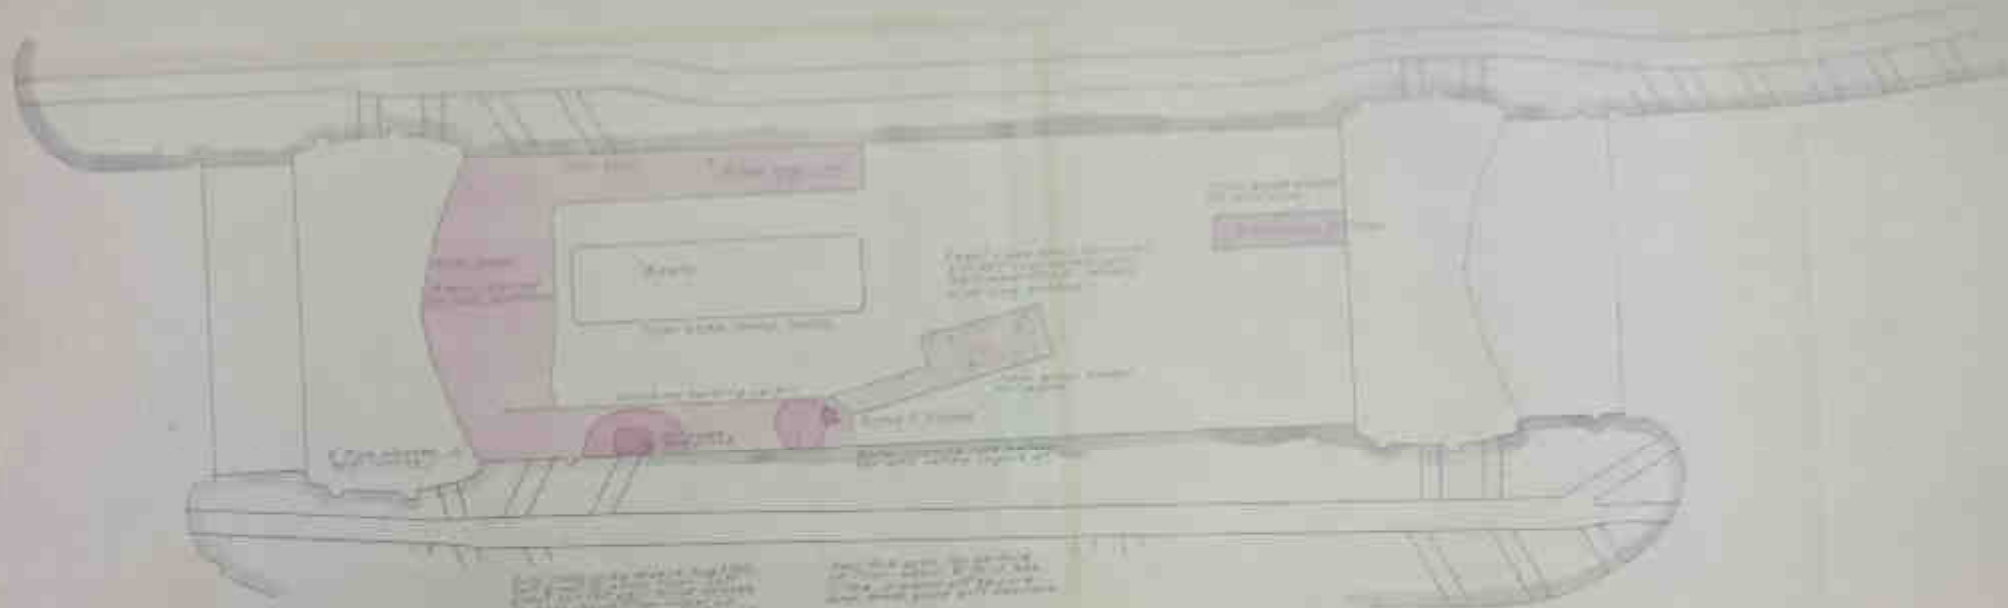
'Brunswick 100ft River Entrance: Examination of floor of lock March 1926' plan, plan of damage to underside of 100ft and 80ft locks and section AB.

Plan details damage to lock floor as reported by divers. Some of the concrete was reported as damaged and was repaired, indicating that the thickness of the concrete lock floor may be of variable thickness and quality. Another plan shows damage to the underside of both locks; this is unlabelled but is possibly water ingress where the locks are not completely watertight. This plan is also shown in section.

Cross section on line A-B.

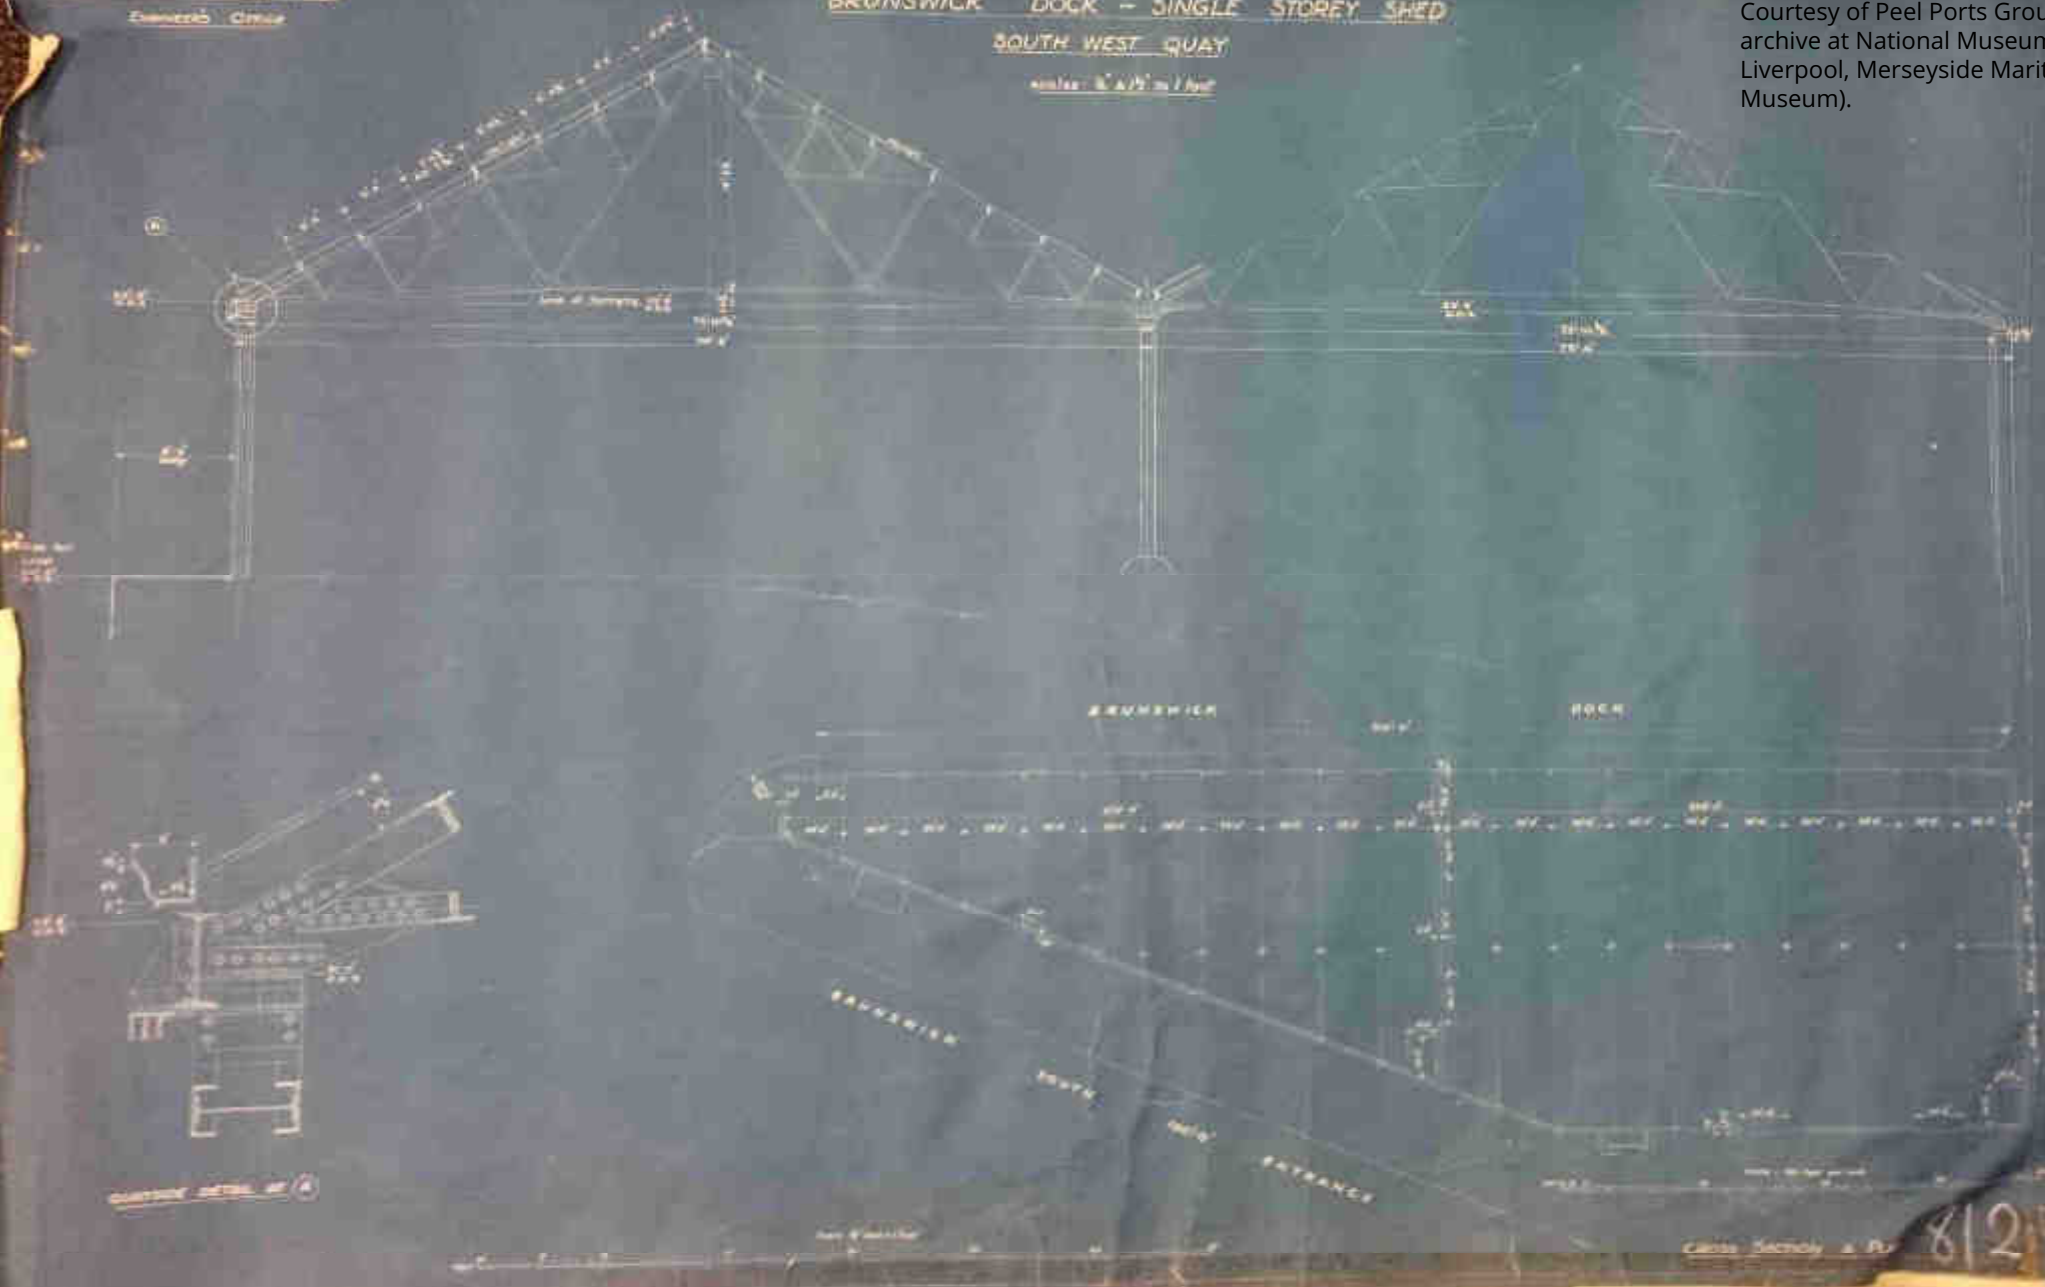
BRUNSWICK DOCK - SINGLE STOREY SHED  
SOUTH WEST QUAY

Scale: 1/4" = 1' 0"

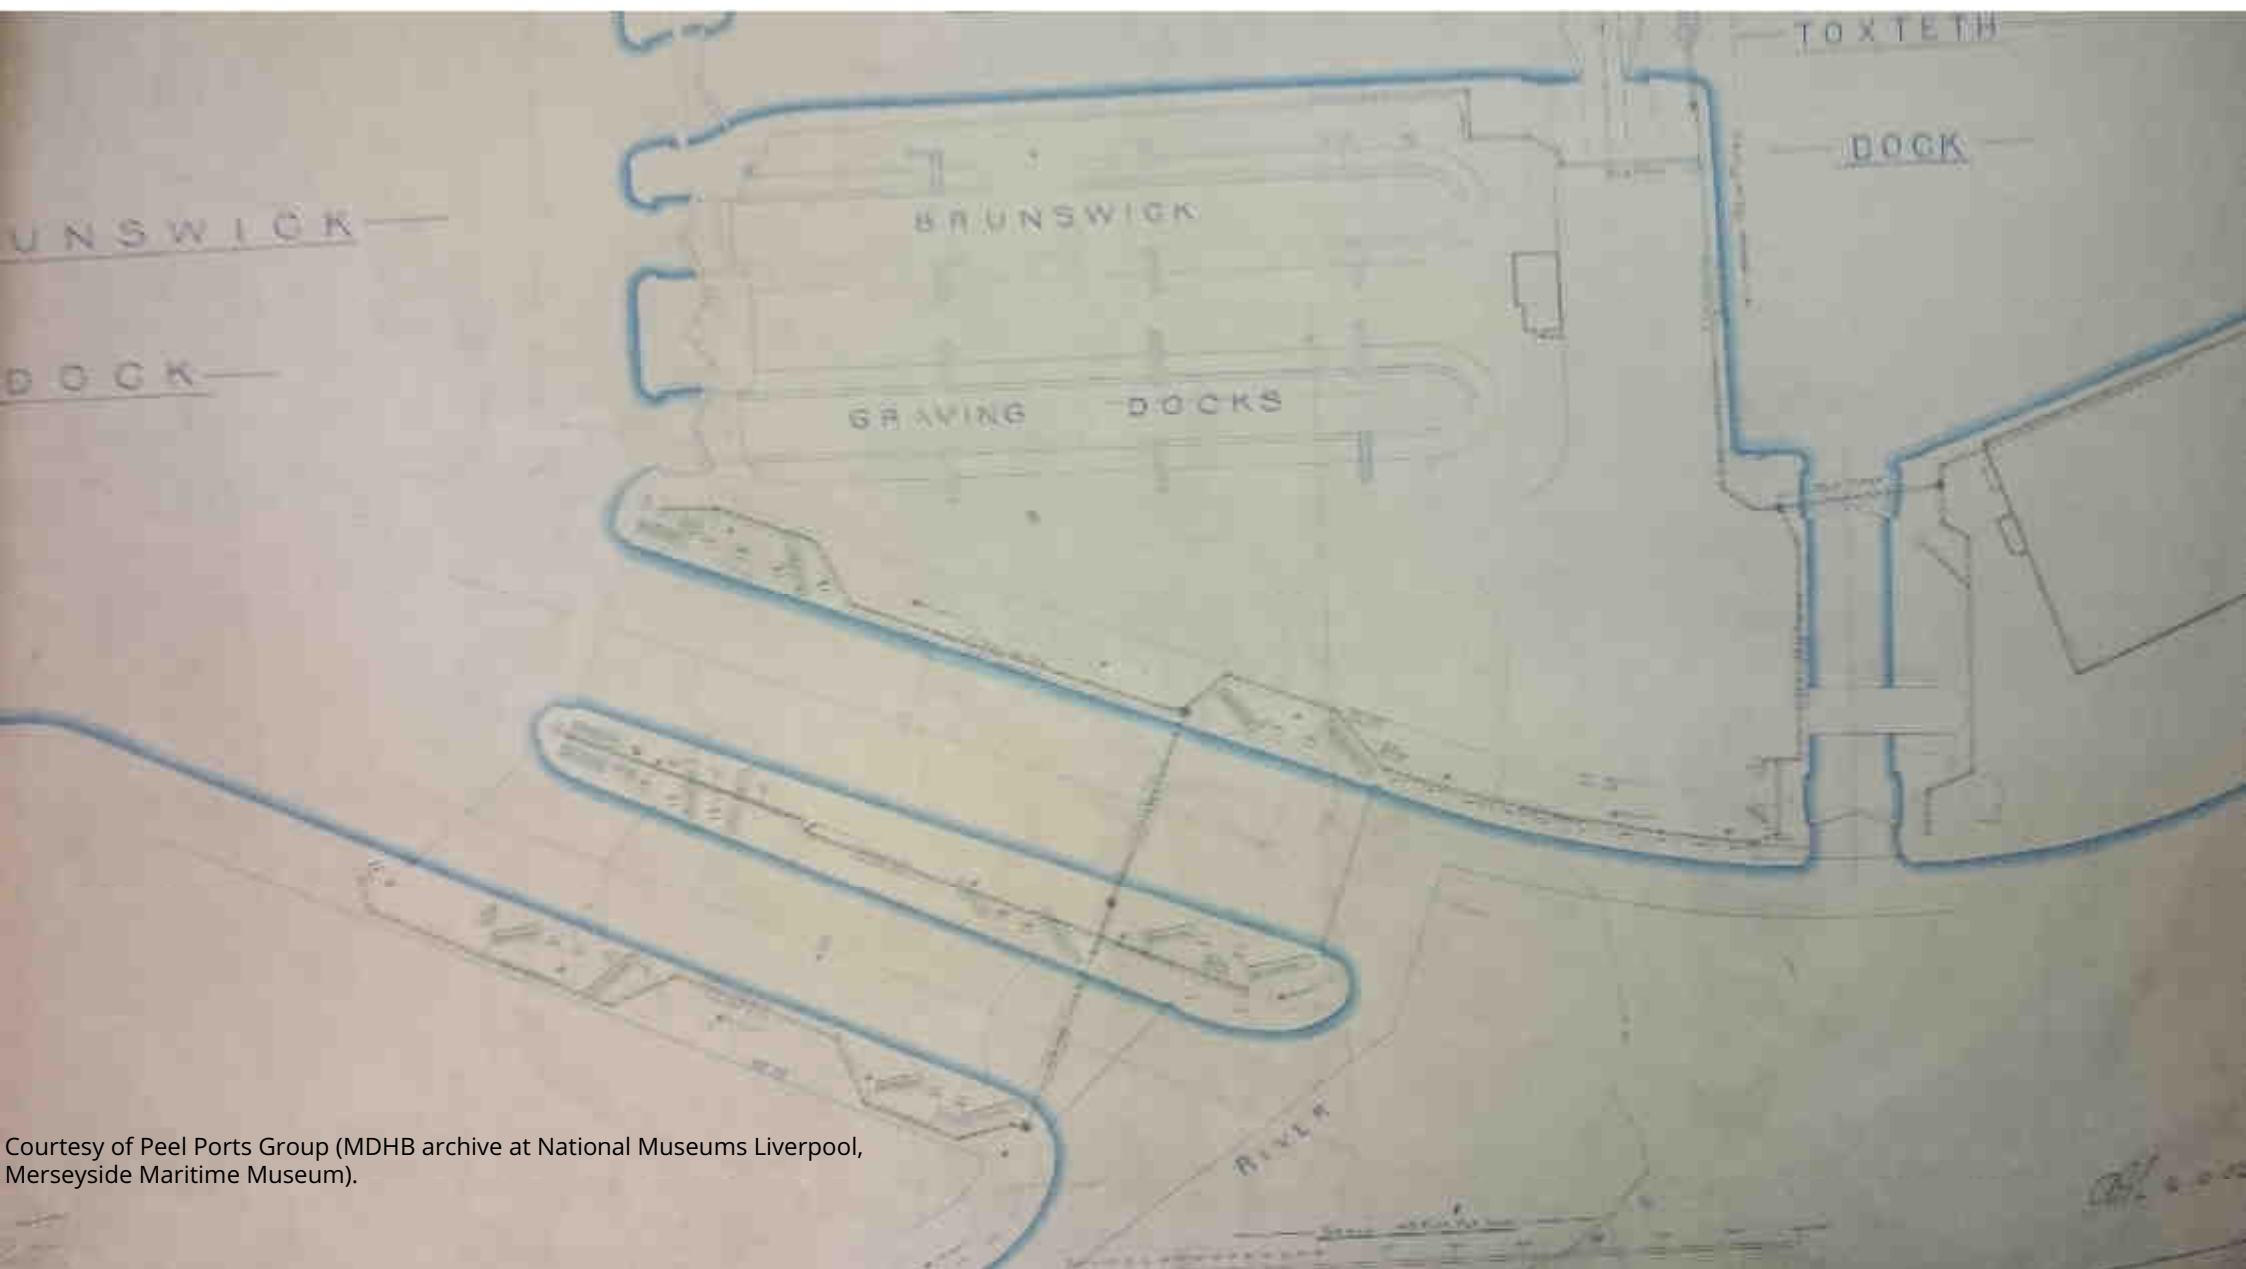
‘Plan Shewing Arrangement of Hydraulic Pipes’

Plan view shows locations of hydraulic pipes within the deep culvert that passes below both locks and the shallow pipe trenches along the lock walls. Due to the age of these plans and that the 100ft lock has been infilled, it is anticipated that these pipes are no longer present, however, this cannot be discounted completely.

Section AA on this drawing shows a **cross section through the site**. This shows the 100ft lock wall construction. The site (does not show strata or subsurface features) contains 4 No. ‘centre line of column’ markers – it is unclear what these pertain to, possibly the historic warehouse, although it was not constructed at the time of drawing of the plan. The cross section shows the location of the historic ‘Brunswick No. 2 Graving Dock’ and a small part of the off-site Brunswick No. 1 Graving Dock. The old ground level at either side of them is shown to be uneven. The construction of the Brunswick Dock wall (approximately 16m deep) is right through the centre of the Brunswick No. 2 Graving dock (the base of which is at ODS, 9.45m bgl) and appears to be entirely constructed of concrete with a shallow pipe trench running along its length, not noted on any other plans. The depth to the bottom of the dock is given to be 16m bgl. A possibly paved area appears to extend past the dock wall, however, it is unclear what this pertains to as the cross section appears to show Brunswick Dock post construction of the extension to the south (due to the placement of the dock wall), therefore the area shown as land is expected to be water.

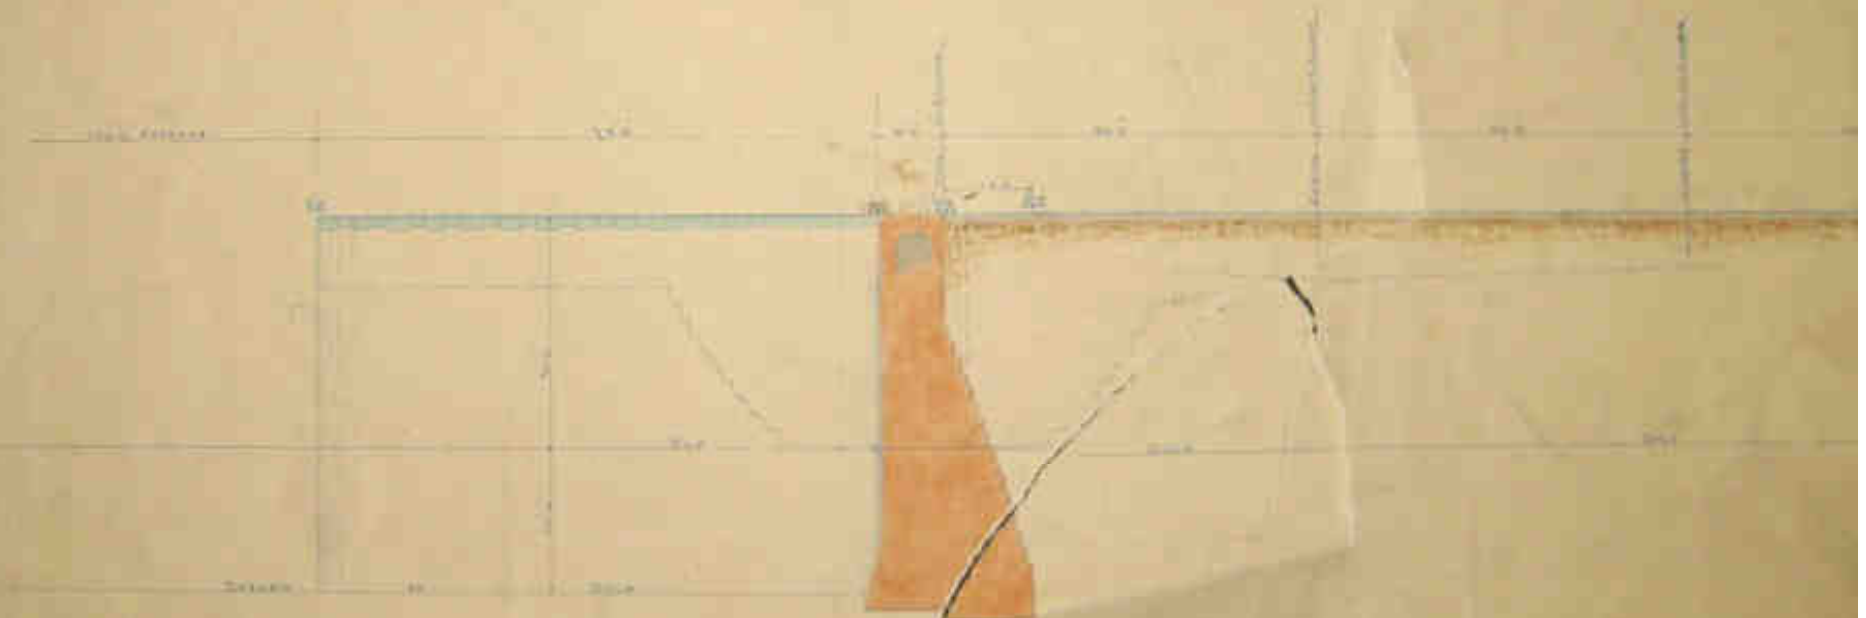
BRUNSWICK NEW RIVER ENTRANCES  
SOUTHERN WORKS ACT 1898  
WORK Q

SECTION AT A-A ON PLAN

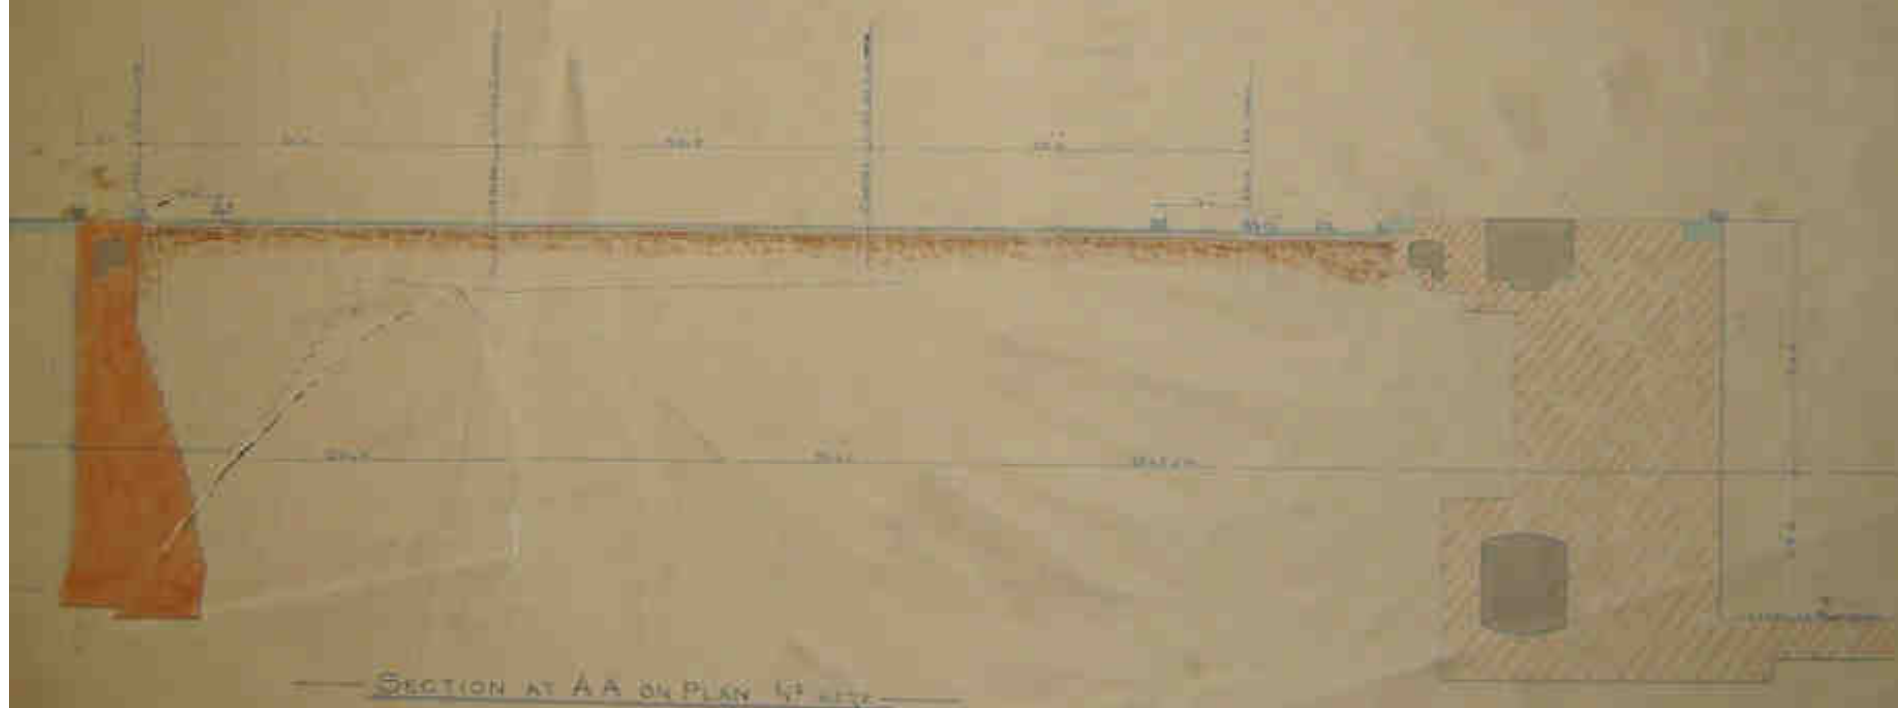
WORK O

SECTION AT AA ON PLAN OF RIVER

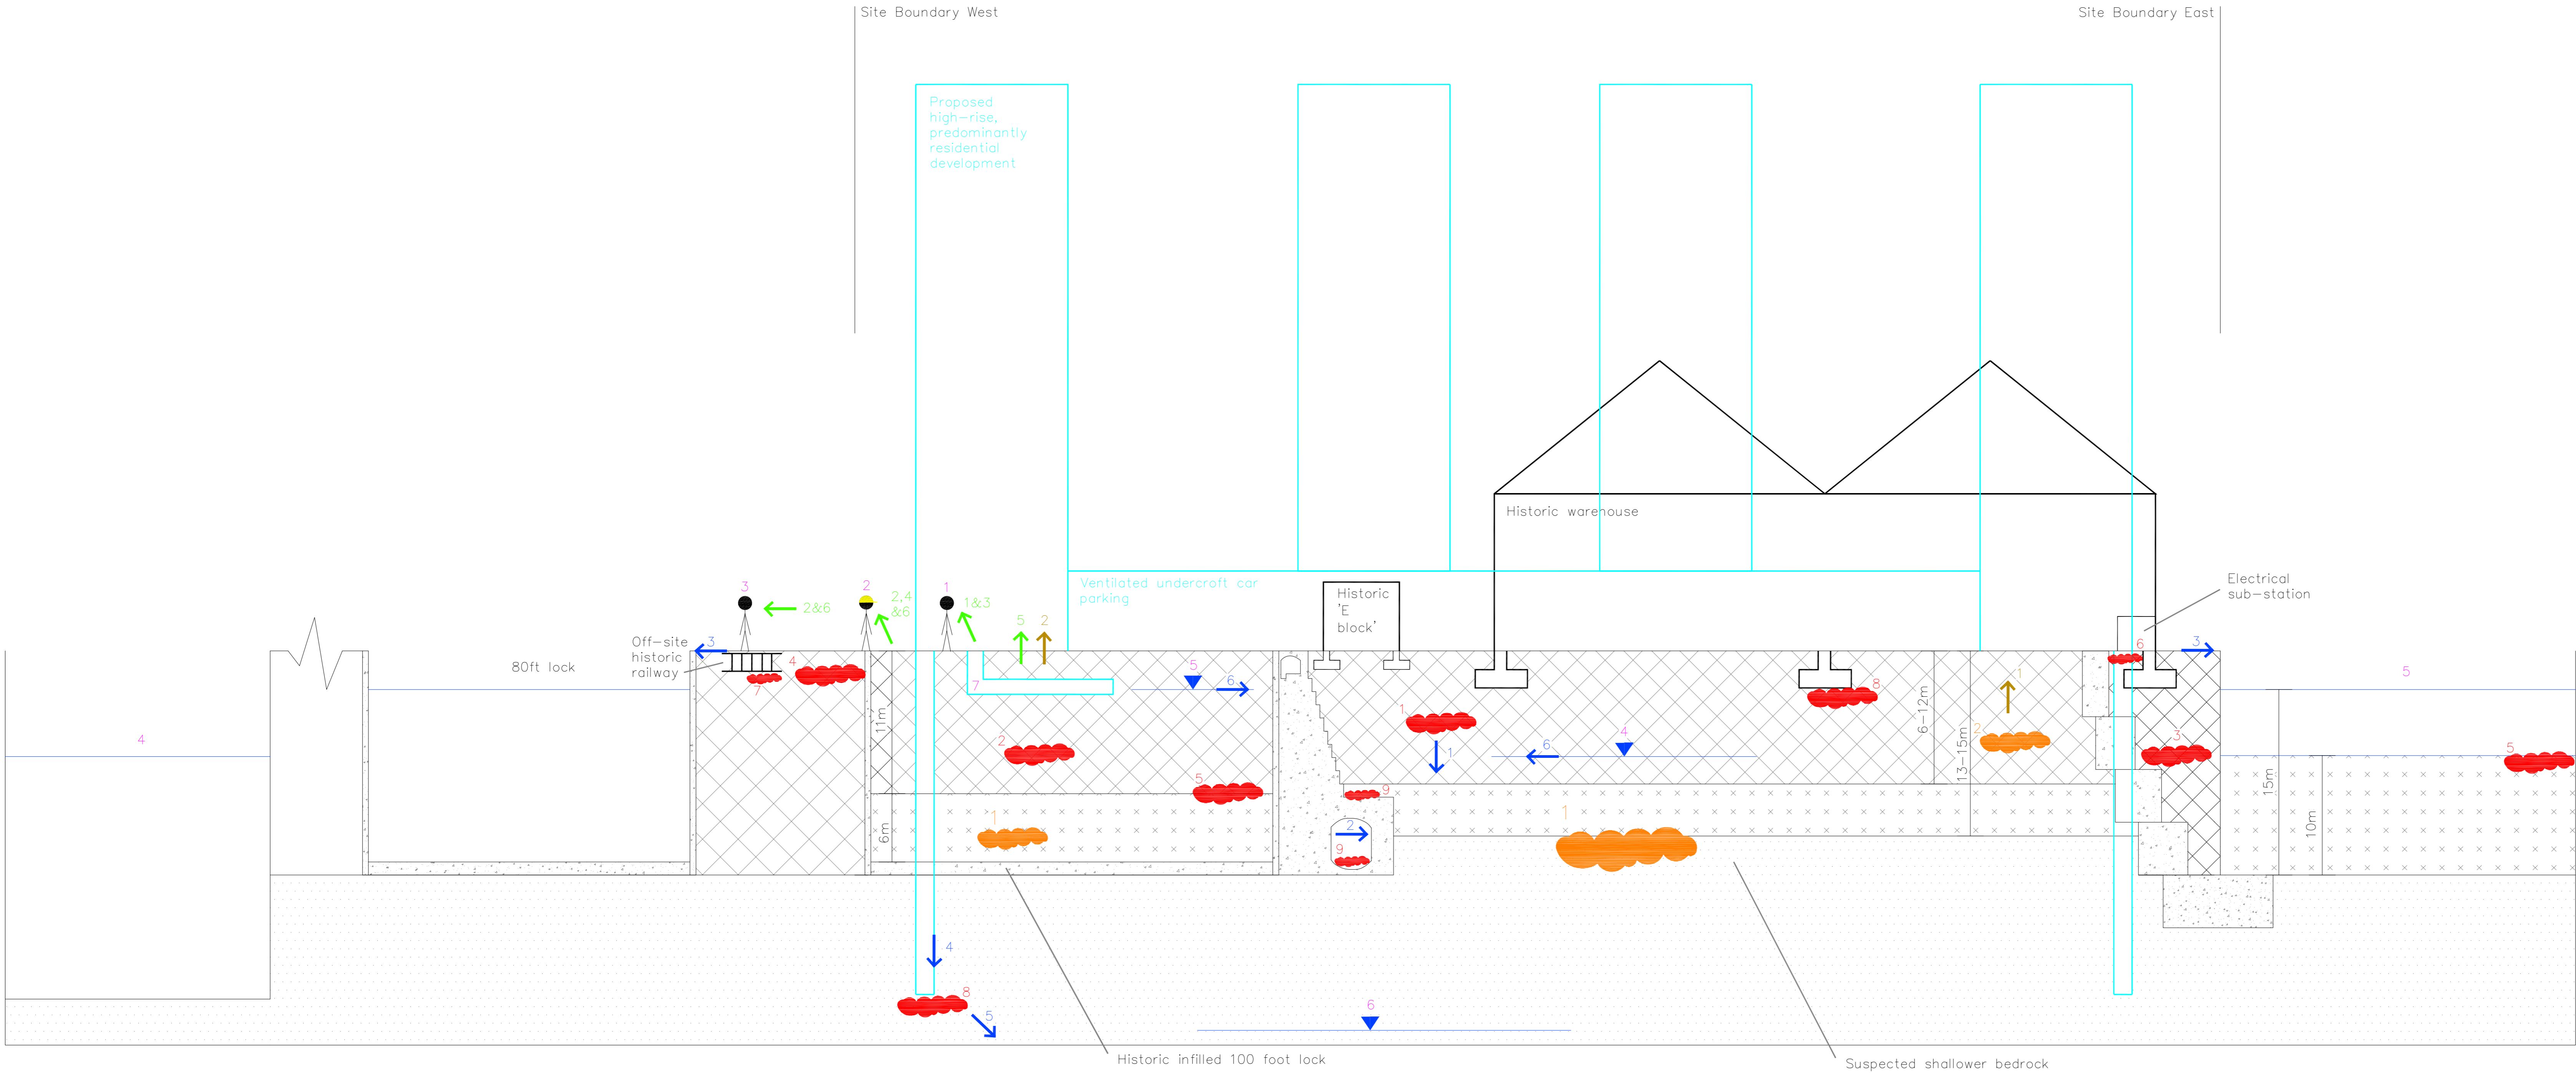
**APPENDIX 12**  
**DIAGRAM OF CONCEPTUAL MODEL**

- Made Ground  
Concrete  
Alluvium  
Sandstone

1. On and off site dockyards and dockland
2. Infilling of historic Brunswick 100ft Lock
3. Infilling of historic Graving Dock
4. On and off site historic ship building industry
5. Possible microbiological (e.g. anthrax) contaminated silt
6. Current electrical sub-station
7. Off-site historic railway

8. Pooling beneath historic and future foundations
9. Pooling within conduits and around obstructions

1. Ingestion of contaminated soil and dust, indoors (end users only)
2. Ingestion of contaminated soil and dust, outdoors
3. Dermal contact with contaminated soil, indoors (end users only)
4. Dermal contact with contaminated soil, outdoors (construction workers only)
5. Soil vapour ingress through cracks and subfloor voids, accumulation in buildings and inhalation
6. Possible asbestos-containing material in made ground – inhalation risk during earthworks and material movement

1. Vertical migration of surface contamination into unsaturated zone
2. Lateral migration along historic conduits
3. Surface runoff
4. Vertical migration along foundations
5. Vertical and lateral migration through porous / high permeability sandstone and along fractures in the bedrock
6. Lateral migration along groundwater flow towards surface water

1. Vertical migration through granular made ground deposits.
2. Ground gas ingress through cracks and subfloor voids and accumulation in buildings.
