Plots 08 & 12 • Detail Drawings

> **NEW HALLNo. 04** Next Big Thing Estates 045_03_P020 • No. 04 - Window Detail 1:10 @ A3, 1:5 @ A1 Planning awing. All dimensions are to be checked on site prior to commencing works on site. Any discrepancy found betwe drawing and that given elsewhere or recorded on site shall be notified immediately to the Client architect in writing

NEW HALL No. 04

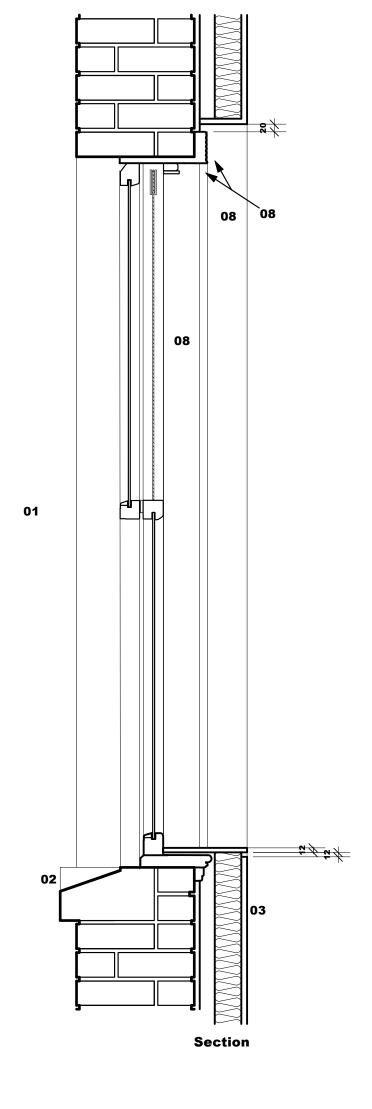
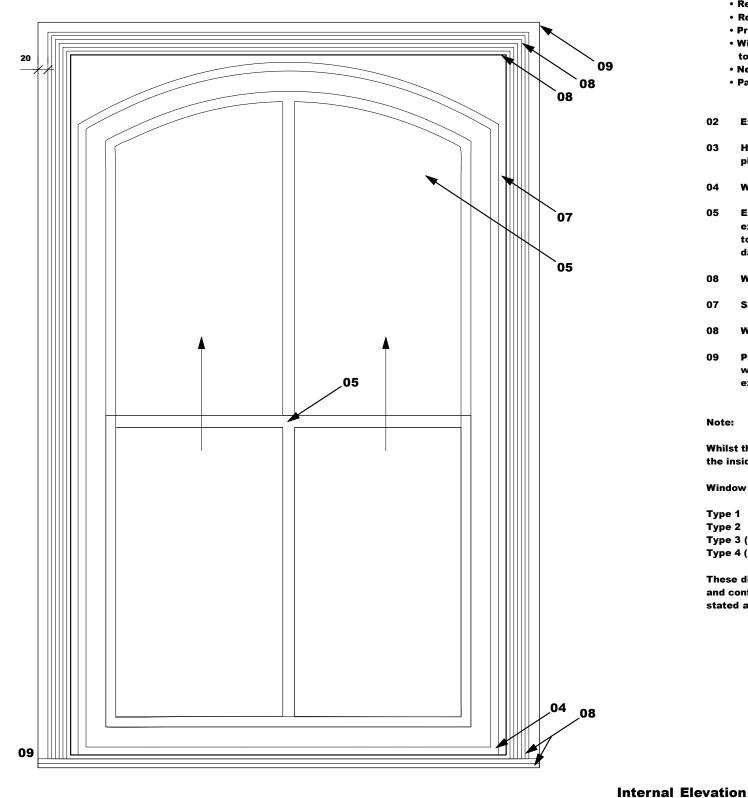
Plan Detail

- 01 Original Sash Windows Restored:
 - Remove excess paint from frame and effect repairs if necessary
 - Replace sash cords and service pulleys if necessary

- Renovate top and bottom sash if necessary, planing off excess paint
 - Prime all exposed woodwork and chalk beading
 - Window restrictors will be necessary (to allow bottom and top sash to slide only 100mm open for safety)

- New Centre catch lock stainless steel, NOT GOLD!
 - Painted using 2 coats of satin matte white external paint
- Existing stone sills remain unaltered
- 03 Hardwood sill to inside to cover new insulated plasterboard zone, plasterboard bead below to form shadow gap

- Window frame restored and expose
- Existing glass to be replaced with slimline double glazing with the exception of any original Victorian glass panels if any remain. Due to severe vandalism on site, many of the original glass panes are damaged.

- Window frame exposed
- Sash cords and pulleys repaired
- Window reveal sill 12mm painted hardwood
- Plasterboard drylining to return 20mm outside of the existing window architrave- or best dimension to avoid meeting the existing sill- see internal section, bottom corners

Whilst the windows have arched panes to the top section, the reveal to the inside is rectangular as drawn.

Window No.	Replacement	Proposed Restoration Works	Window Surrounds Present	Dry Lining Detail
W01	No	As per drawing 045 03 P020	Yes	As per drawing 045 03 P020 (Original Window Surrounds Left On Show)
W02	No	As per drawing 045 03 P020	Yes	As per drawing 045 03 P020 (Original Window Surrounds Left On Show)
V03	No	As per drawing 045_03_P020	Yes	As per drawing 045_03_P020 (Original Window Surrounds Left On Show)
V04	No	As per drawing 045 03 P020	Yes	As per drawing 045 03 P020 (Original Window Surrounds Left On Show)
V05	No	As per drawing 045 03 P020	No	As per drawing 045 03 P020 (Original Window Surrounds Left On Show)
V08	No	As per drawing 045 03 P020	No	As per drawing 045 03 P020 (Original Window Surrounds Left On Show)
V07	No	As per drawing 045 03 P020	No	As per drawing 045 03 P020 (Original Window Surrounds Left On Show)
V08	No	As per drawing 045 03 P020	No	As per drawing 045_03_P020 (Original Window Surrounds Left On Show)

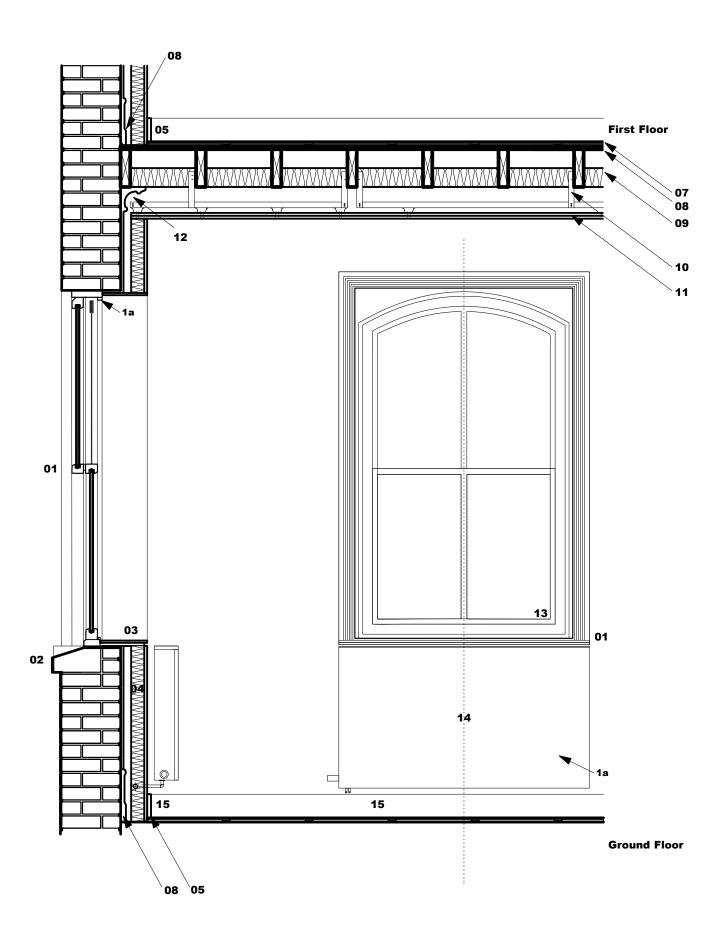
Drawing No. Scale 045_03_P022 • Plots 08 & 12 • Ground Floor Section Detail

- Please refer to window details
- 2 Existing stone sills to remain
- 03 20mm painted hardwood sill to inside, plasterboard bead return under
- 04 Dry-lining to external walls:

- 70mm insulated plasterboard with vapor barrier
 - Fixed on carrier rails to create a cavity (prevention of damp)
 - All sockets to be recessed, not surface mounted

- Skim and painted white
 - 150mm square edge skirting (NO TAURUS CURVES)
- O5 Plasterboard returns to window, if possible a thin insulated pb or insulated DPC to be used to reduce cold bridging

- 08 Original (albeit badly damaged and previously crudely infilled) skirting to remain in place
- 7 22mm allowance for both a new oak floor to living areas and carpet to bedrooms

- 08 Original joists & floor boards remain, carpet tiles removed
- RS60 100mm mineral wood insulation friction fitted between joists
- Acoustic hangers screw fixed at 1200 centres (every fourth joist)

- 2 layers of Knauf 'Soundsheild' to create a 60 minute fire barrier Board layout to be staggered, FR beading to perimeter and skimmed. To avoid doubt, no so called 'magic tape' or skimless finished.

- 12 Original architrave (again, badly damaged, chopped and infilled previously) to remain in place with the new ceiling hangers to avoid the perimeter

- 13 Please refer to window details
- 4 Radiators (white convectors)
- All water feeds to be concealed as much as possible to avoid potential burns

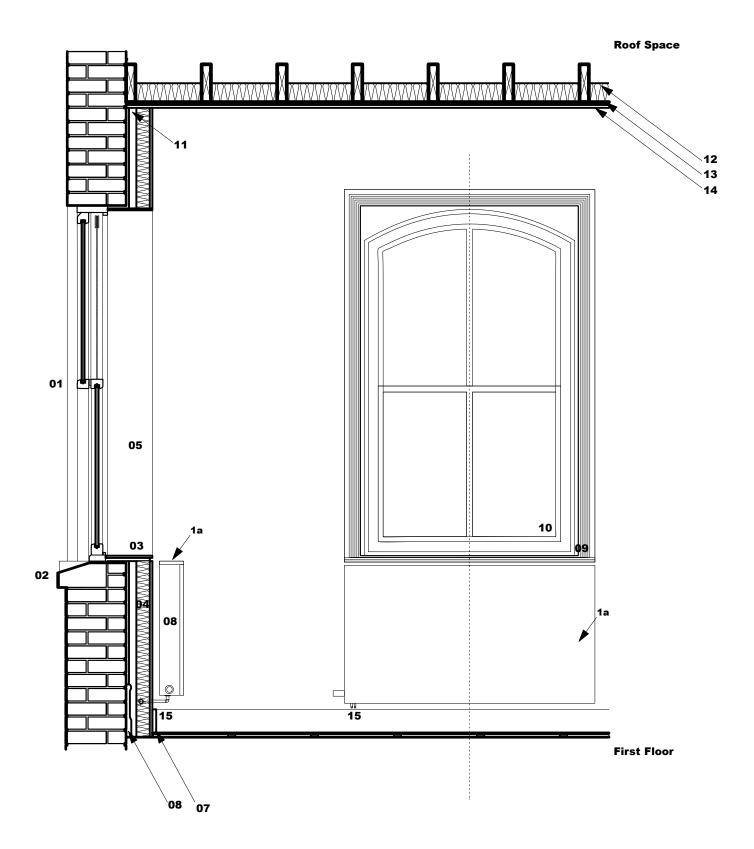
045_03_P022 • Plots 08 & 12 • First Floor Section Details

- Please refer to window details
- Existing stone sills to remain
- 20mm painted hardwood sill to inside, plasterboard bead return under
- **Dry-lining to external walls:**

- 70mm insulated plasterboard with vapor barrier
 - Fixed on carrier rails to create a cavity (prevention of damp)
 - All sockets to be recessed, not surface mounted

- Skim and painted white
 - 150mm square edge skirting (NO TAURUS CURVES)
- Plasterboard returns to window, if possible a thin insulated pb or insulated DPC to be used to reduce cold bridging

- Original (albeit badly damaged and previously crudely infilled) skirting to remain in place
- 22mm allowance for both a new oak floor to living areas and carpet to 07 bedrooms

- New white convector radiators
- Windows restored as per window details
- Any damaged glass repaired.
- No architrave is present within the rooms on first floor however, they are present and made visible in the hallway- see drawing P047

- 12 RS60 100mm mineral wood insulation friction fitted between joists
- Damaged ceilings replaced (water ingress in places)
- New plasterboard, skim and paint finish to ceiling

- All water feeds to be concealed as much as possible to avoid potential burns

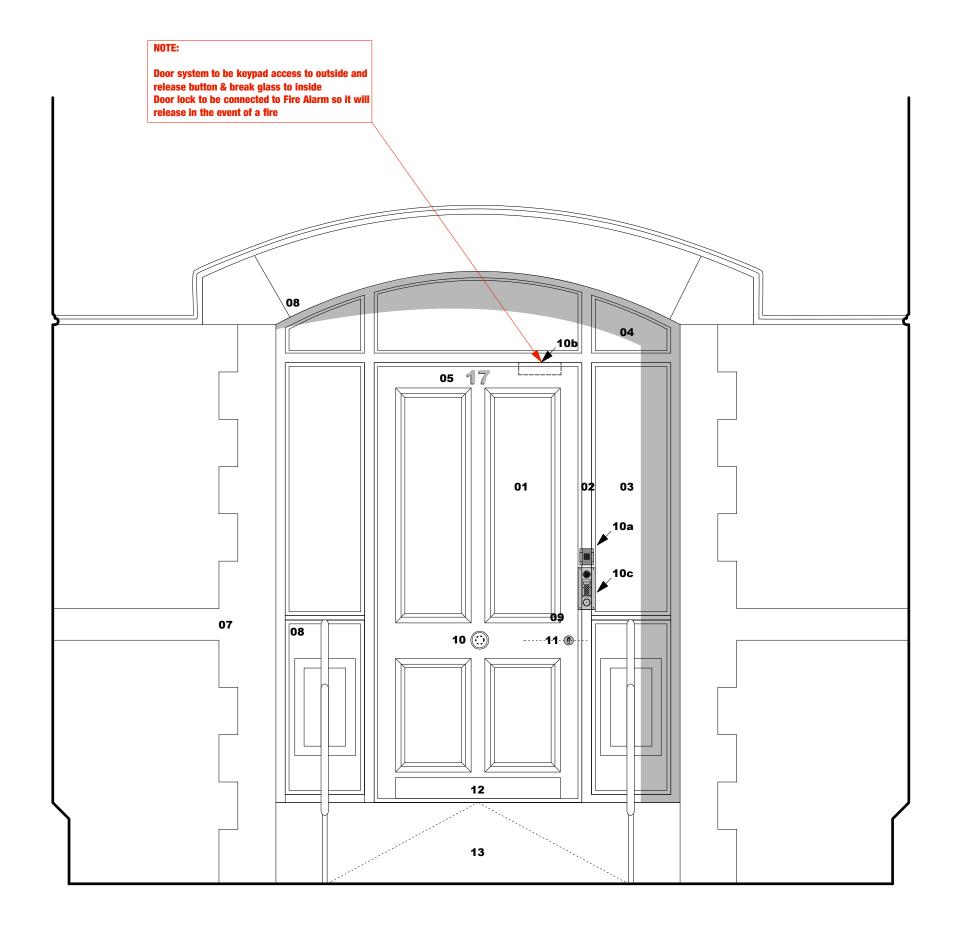
NEW HALL No. 04
Client Next Big Thing Next Big Thing Estates 045_03_P023 • Front Door Details

- 01 Existing Door Repaired, painted anthracite grey- see spec.
- 02 Door surround and frame repaired, painted gloss white as existing
- 03 New slimline double glazing installed, clear glass throughout
- 04 New slimline double glazing installed, clear glass throughout
- 05 New brush steel lettering for door numbers- as per Item 3
- 08 Door arch maintained
- 07 All brickwork maintained
- 08 Timber infill panels repaired and painted gloss white as existing
- 09 New D-Line pull handle brushed stainless steel, as per Item 2
- 10 Digital Lock Access (Item 2):
 - 10A GSD 1 Door Digital Keypad, 50 user (MAS Alarm Systems)
 - Keypad to both sides (no door release to inside)
 - 10B Magnetic Security Lock System GL-1800F 10TB
 - 10C Videx 10 button intercom panel, stainless steel

Note: Magnetic lock to be connected to Fire Alarm System so the lock releases when fire alarm sounds

- 11 New brushed stainless steel locks with thumb turns items 5 & 6
- 12 Protective brushed stainless steel kick-plate as per item 4
- 13 Existing access ramp and handrails remain handrails painted black

Door No.	Replacement	Proposed Works		
D01	No	As per drawing 045_03_P023 (original door restored, glass pane restored)		
D02	No	Original Door- To be Maintained		
D03	No	Original Door- To be Maintained		
D04	No	Original Door- To be Maintained		
D05	Yes	Not original fire door- glass infill present		
D05a	Yes	Not original fire door- glass infill present		
D08	Yes	Not original fire door- glass infill present		
D07	Yes	Not original fire door- glass infill present		
D08	Yes	Not original fire door- glass infill present		
D09	Yes	Not original fire door- glass infill present		
D10	Yes	Not original fire door- glass infill present		
D11	Yes	Not original fire door- glass infill present		
D12	Yes	Not original fire door- glass infill present		
D12a	Yes	Not original fire door- glass infill present		
D13	No	Original door restored, painted gloss black		
D13a	No	Original door restored, painted gloss black		
D14	No	Original Door- To be Maintained

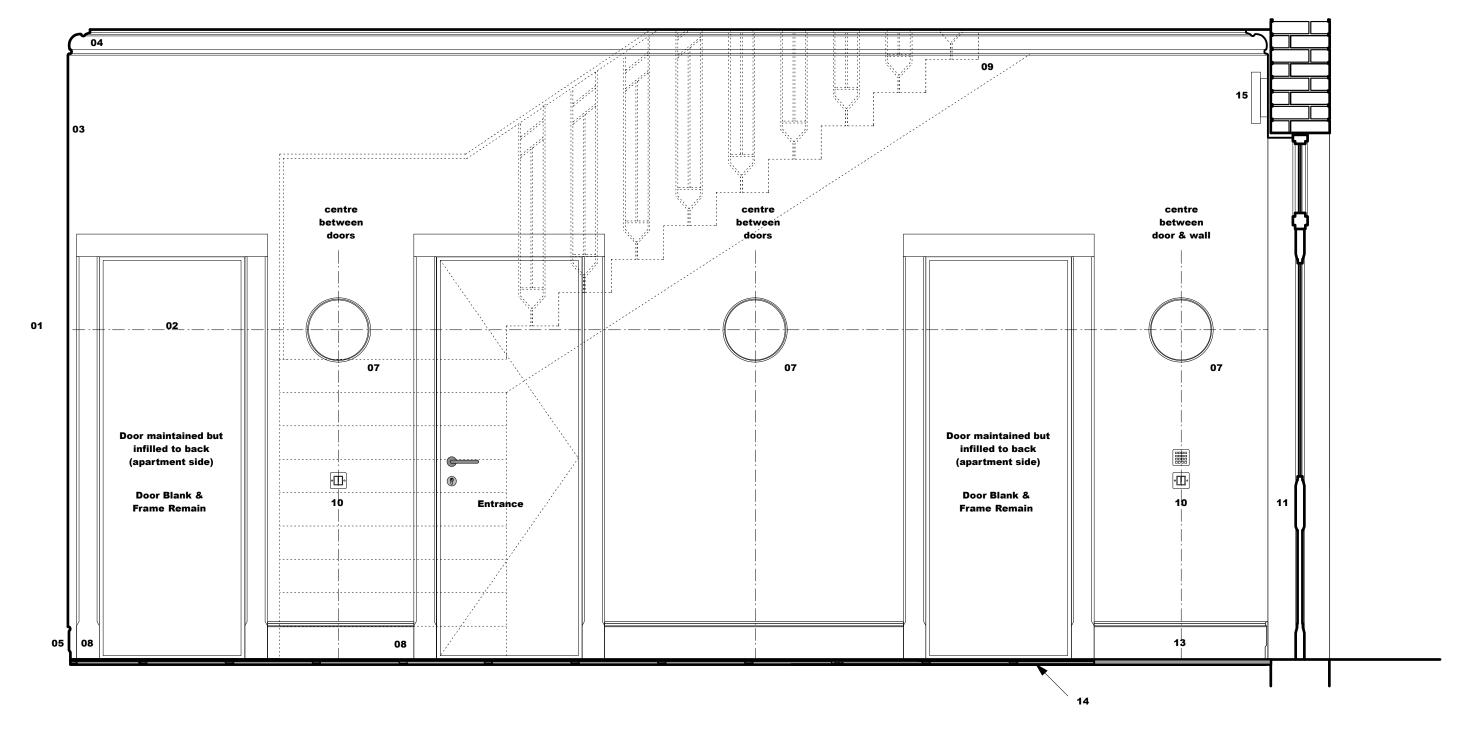
Orawing 045_03_P024 • Ground Floor Hallway Details

- 01 Bathroom & Laundry Room to other side
- 02 Door removed and kept to allow for access to rooms
- 03 Walls patch repaired and painted
- 04 Architrave patch repaired and painted
- 05 Skirting boards patch repaired and painted
- 08 Door frames unaltered and painted
- 07 Wall mounted emergency rated lights Item 3 (60 minute battery)
- 08 Skirting boards patch repaired and painted
- 09 Outline of existing stair no alterations required
- 10 All switches and keypads mounted centre to lights and doors
- 11 Front door maintained and repaired as per details on P046
- 12 Doors maintained if possible, new ironmongery used- items 1 & 2
- 13 New mat utilising existing mat-well
- 14 New timber floor to replace existing carpet tiles
- 15 Zumtobel square emergency light, centre over door item 4

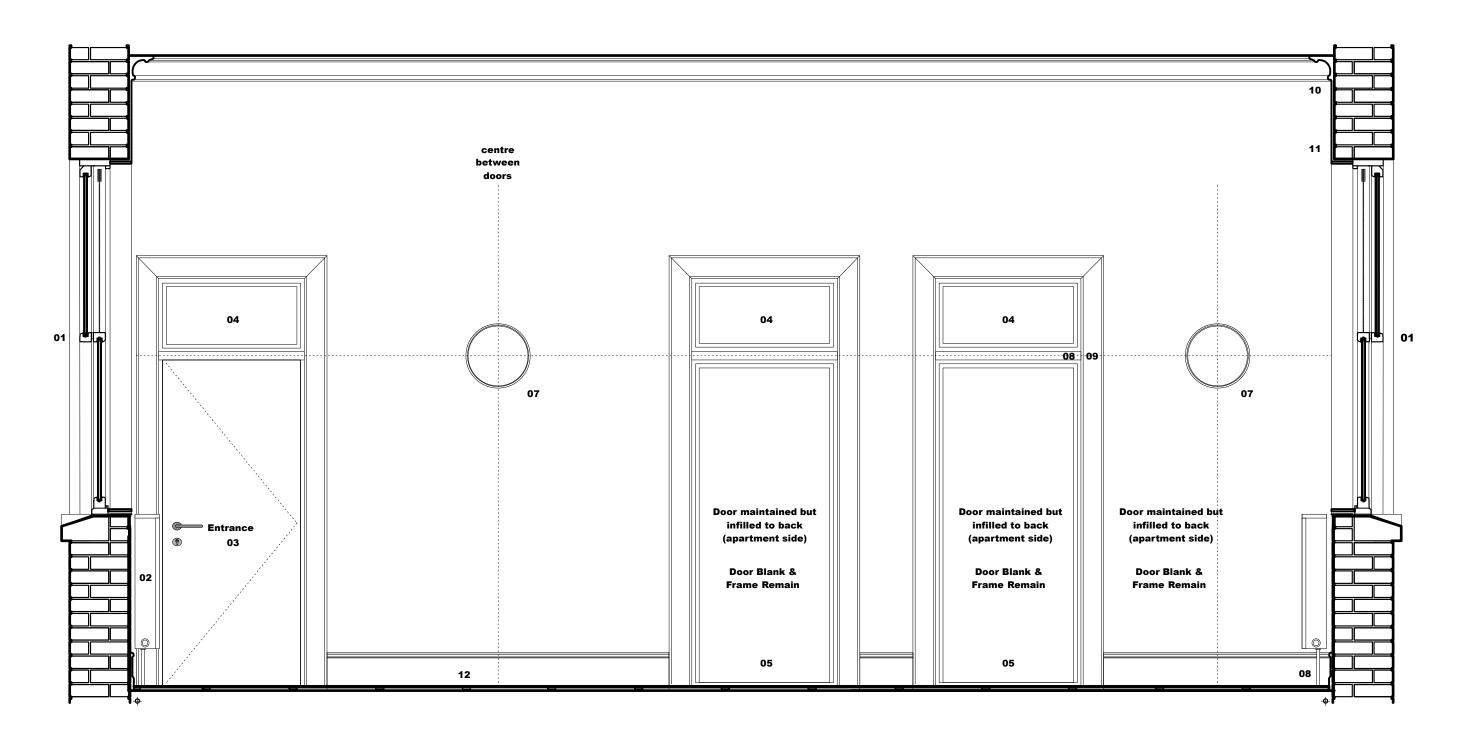
045_03_P025 • First Floor Hallway Details 1:20 @ A3

- 01 Windows restored please refer to drawing P44
- 02 Low surface temperature radiators
- 03 Apartment Entrance
- 04 Fan Light remains, painted panel in front with 20mm offset to all edges
- 05 Door opening remain, painted panel infill with 20mm offset to all edges
- 08 Skirting boards remain, paint finish
- 07 Emergency lights as per item 01-60 min battery needed
- 08 Fan light frame remains
- 09 Door frame remains
- 10 Architrave remains, ceiling to be patch repaired and painted.
- 11 Walls to be made good (patch repair) and painted.
- 12 Timber floor to replace carpet tiles

Item 2: Zumtobel square illuminated emergency exit lights where required

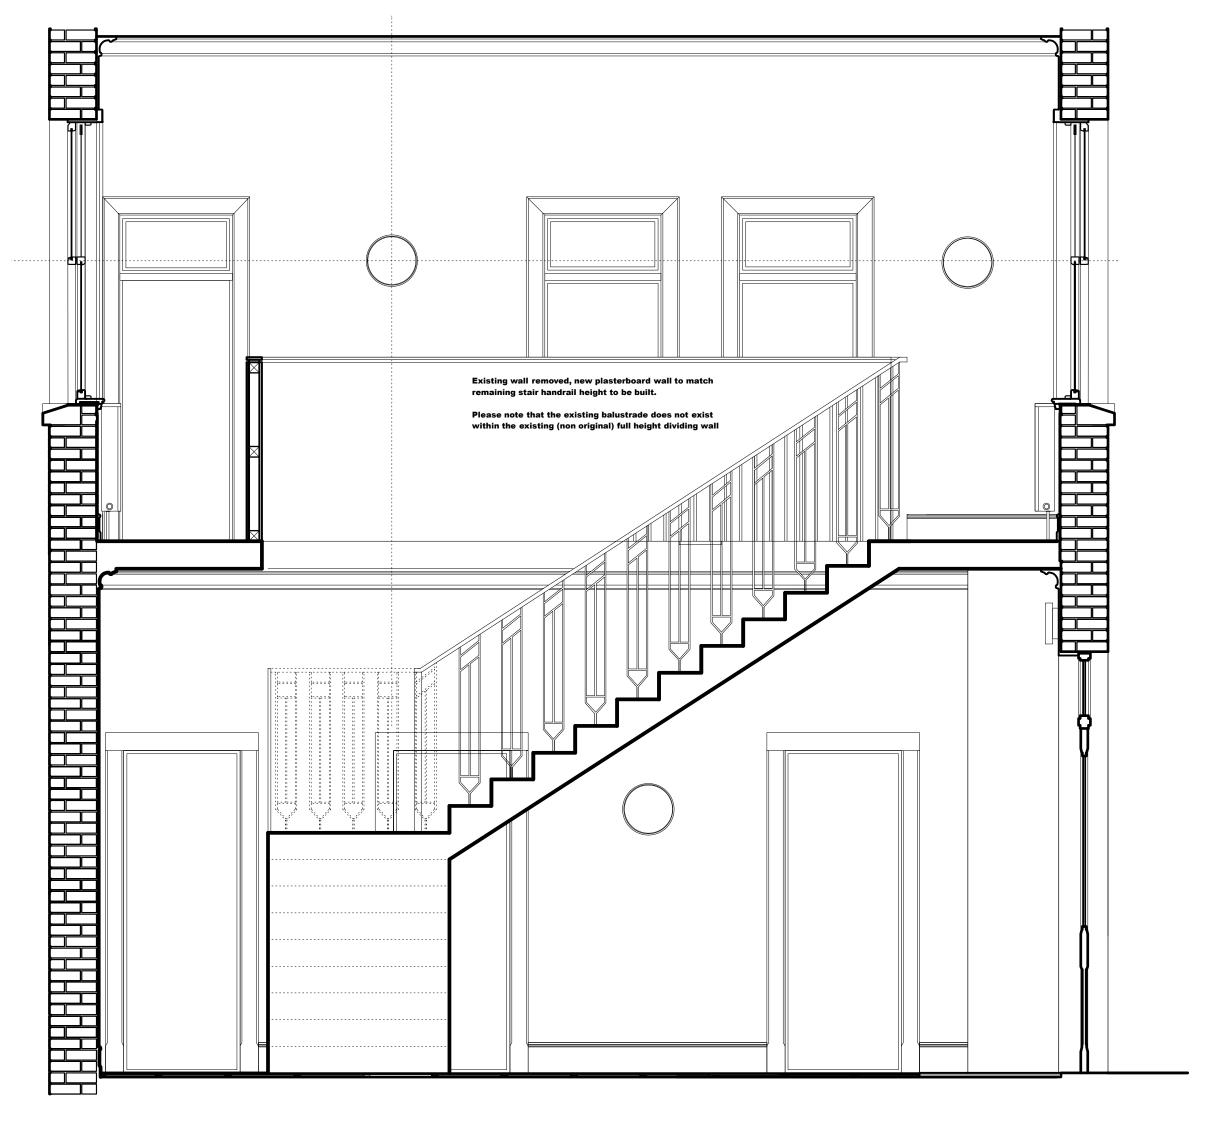
NEW HALL	NO. U4
Client	Next Big Thing Estates
Drawing	045_03_P026 • Hallway: New Stair Wall
Seale	1:25 @ A3
Status	Design Development

This new wall is a client requirement to prevent occupant's self harm, or worse, by climbing over the existing balustrade. The existing balustrade will be maintained with a new 120mm stud wall built around it, using the return angle for stability.

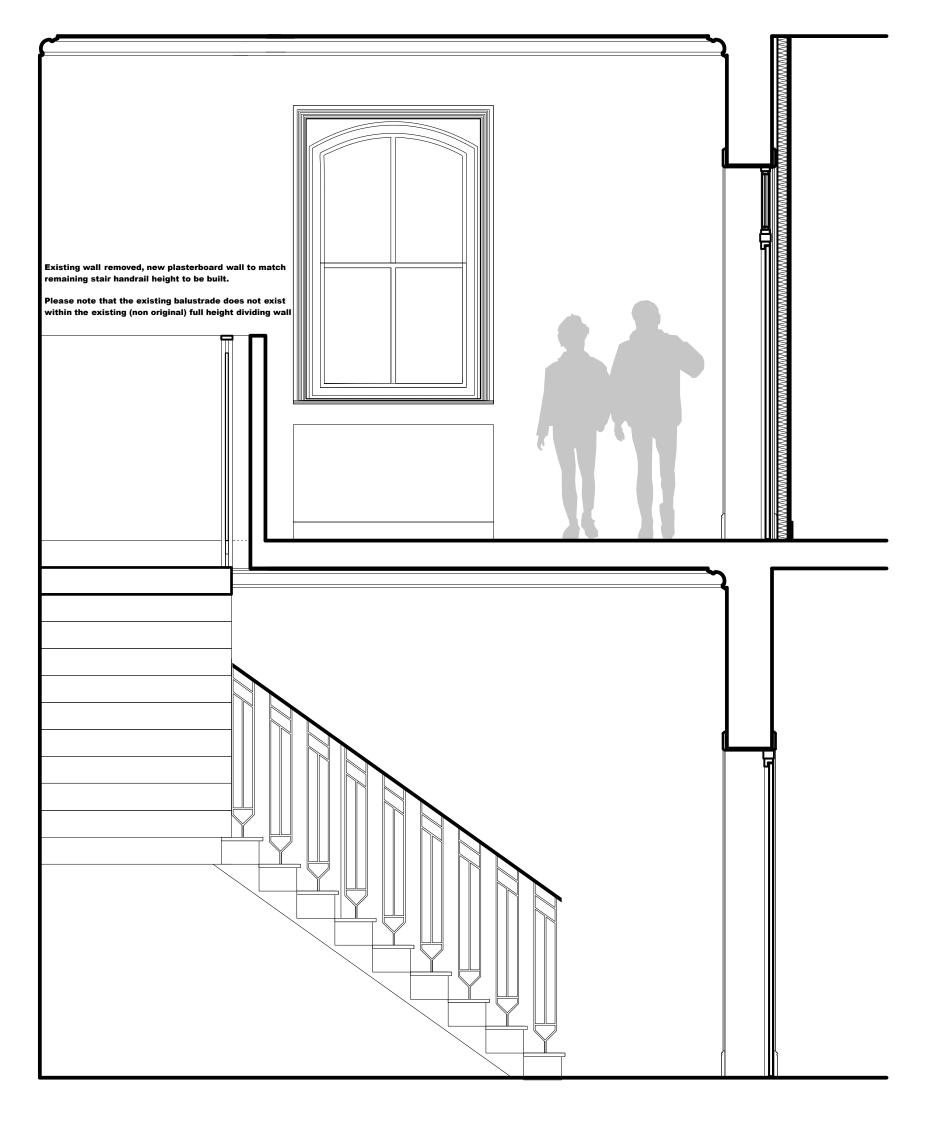
Client	Next Big Thing Estates
Drawing No.	045_03_P027 • Plots 08 & 12 • Hallway Stair Wall

This new wall is a client requirement to prevent occupant's self harm, or worse, by climbing over the existing balustrade. The existing balustrade will be maintained with a new 120mm stud wall built around it, using the return angle for stability.

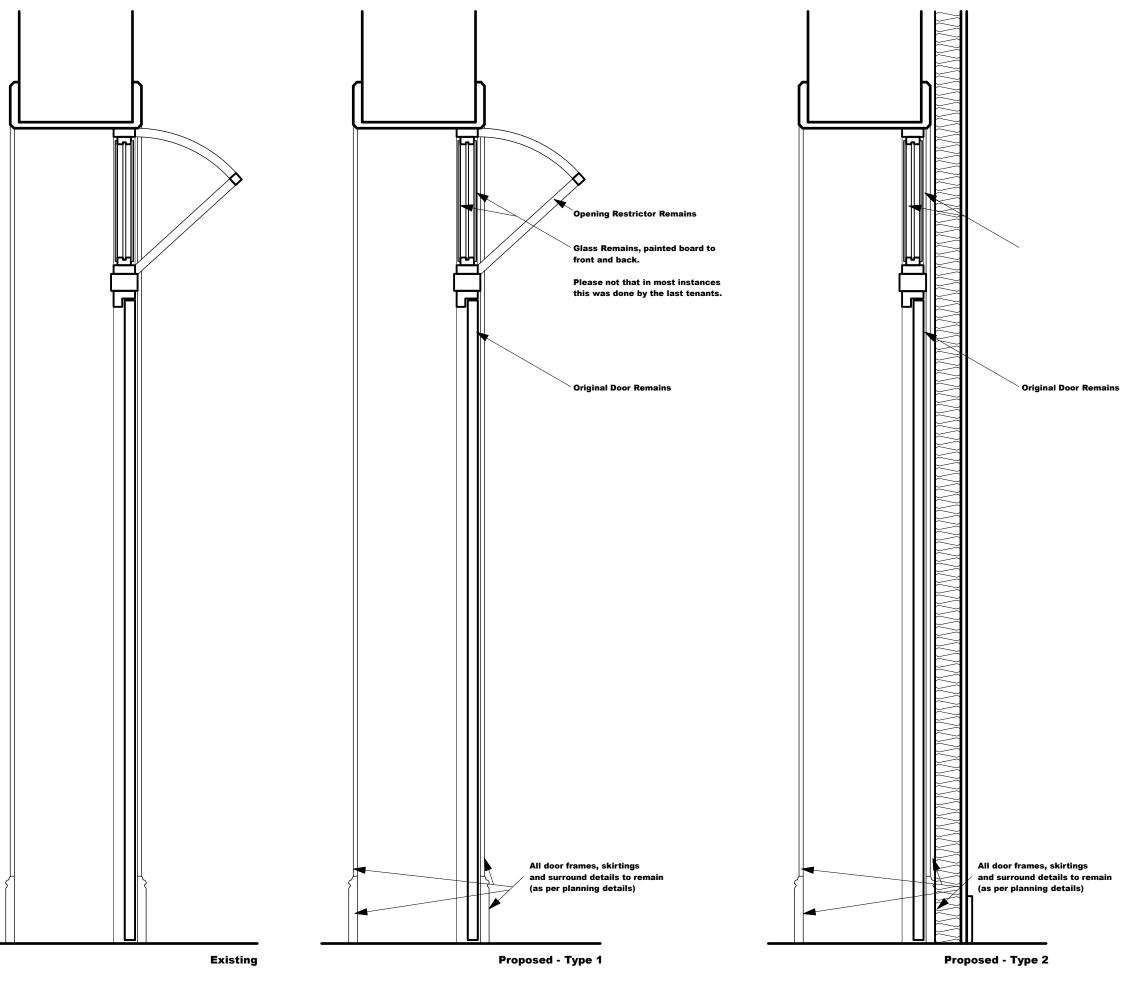
Type 1 is is relevant to all the doors with fanlights where they are maintained on the door schedule. The exception to this is: Note:

- D14 The door & fanlight remain but the fanlight restictor is removed- see type 2 D15 The door & fanlight remain but the fanlight restictor is removed- see type 2 D16 The door is not required due to the proposed layouts and will be stored and fixed

Note: Type 2 is when the doors must be fixed shut with acoustic separation behind it. The doors will not be damaged or have any studwork fixed to them, just shut and locked. We also need to do this for the necessary fire compartmentation to the apartments.
