# GeoEnvironmental Investigation

Hardman House

Liverpool

Report Ref: A1530/16

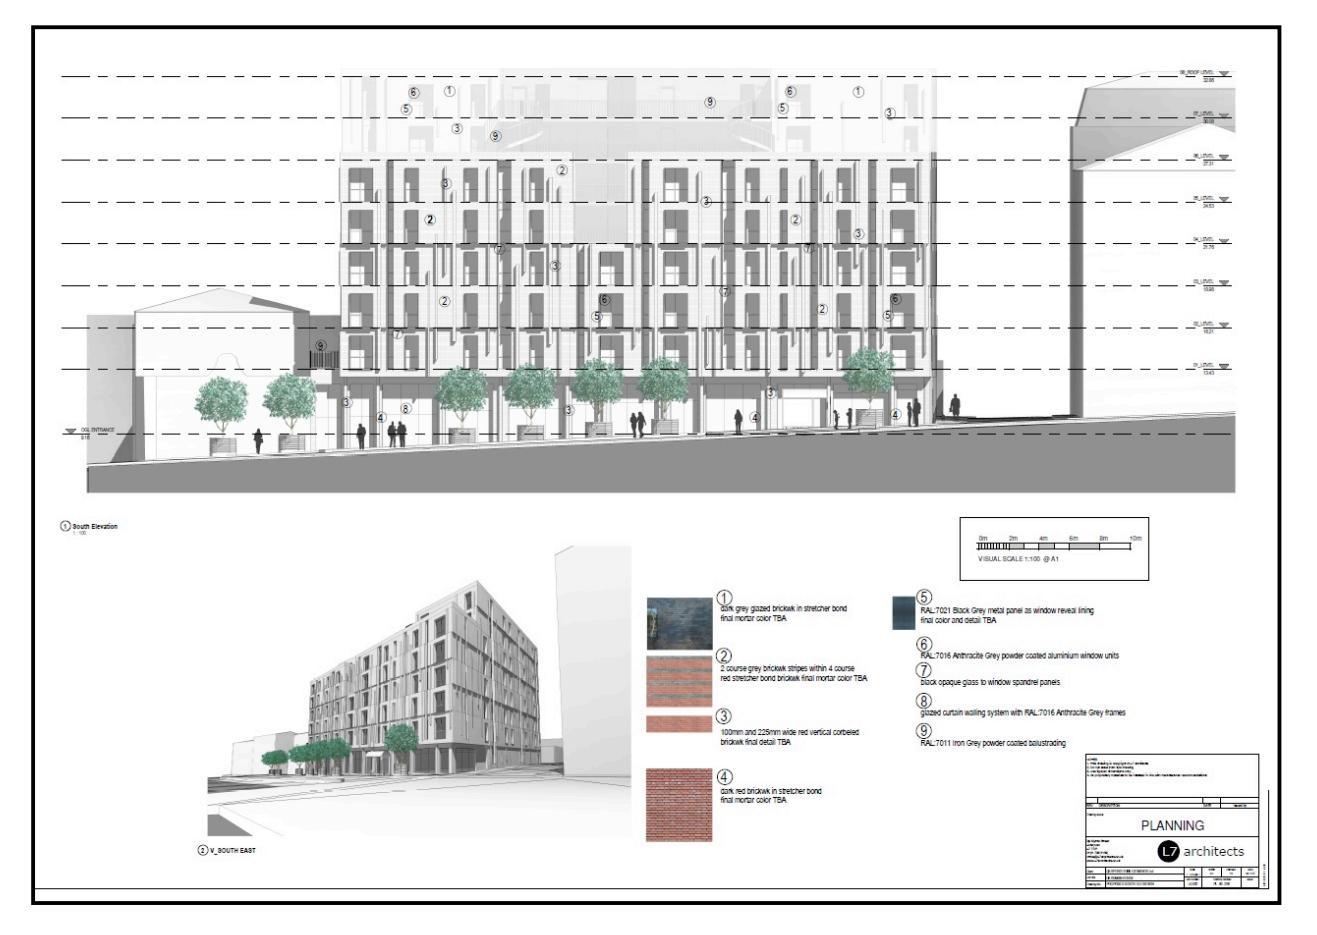
## Figure 2 Development Layout Plan

The proposed development consists of the demolition of the building currently on site and the construction of a seven-storey residential complex.

See Figure 2 below for the proposed development layout plan provided by the client.

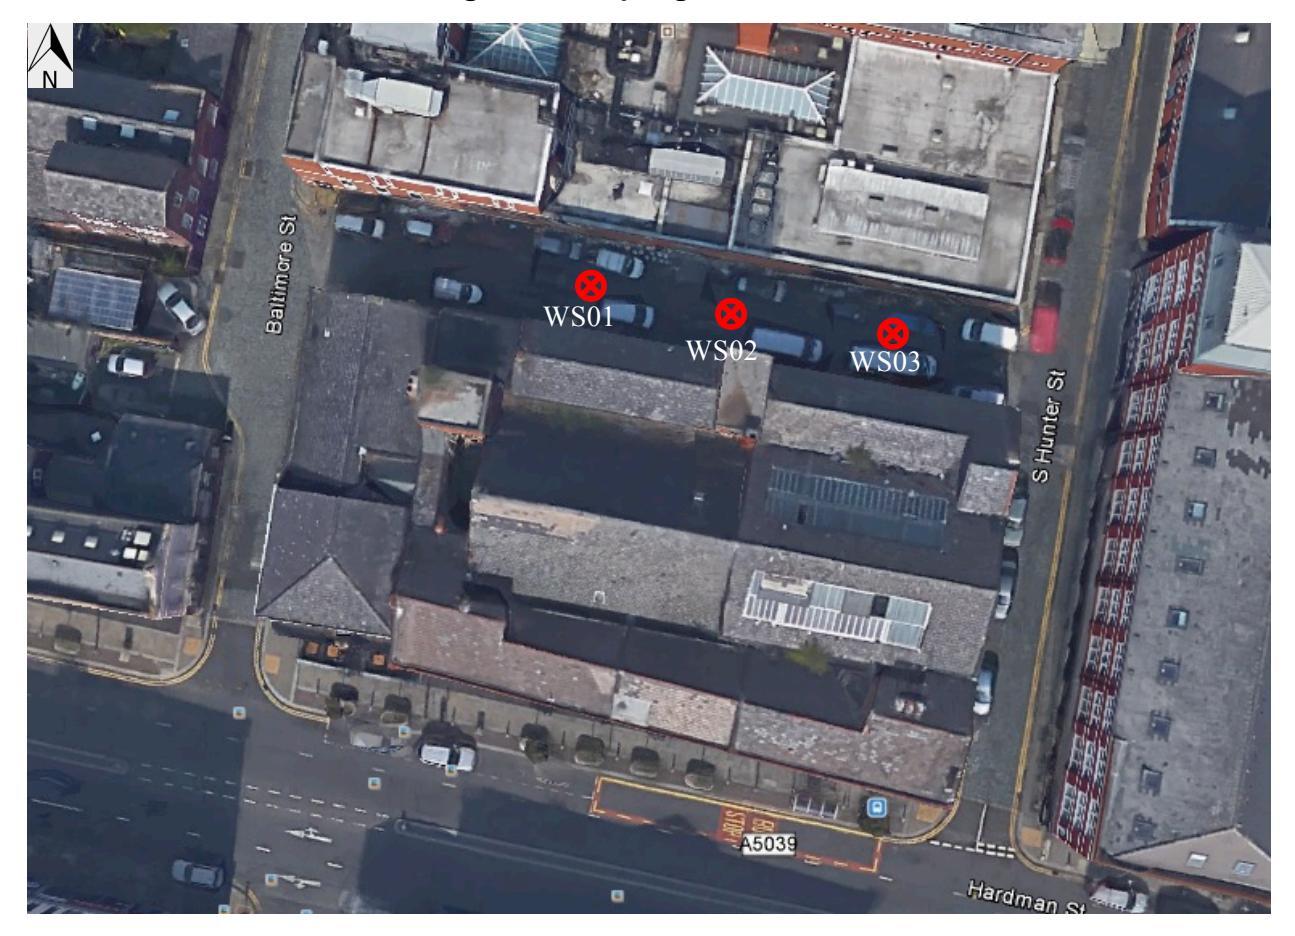
## Figure 3 Sampling Location Plan

The ground investigation works took place on the 27<sup>th</sup> January 2017 and comprised of the drilling of three probeholes (WS01 to WS03) by use of a windowless sampling technique to a nominal depth of 3.9m bgl.

The sampling locations are illustrated in Figure 3 (below).
