ARBORICULTURAL SURVEY AND IMPLICATION ASSESSMENT

THE BRIDGE INN CHILDWALL VALLEY ROAD CHILDWALL

Ref: 15/00007

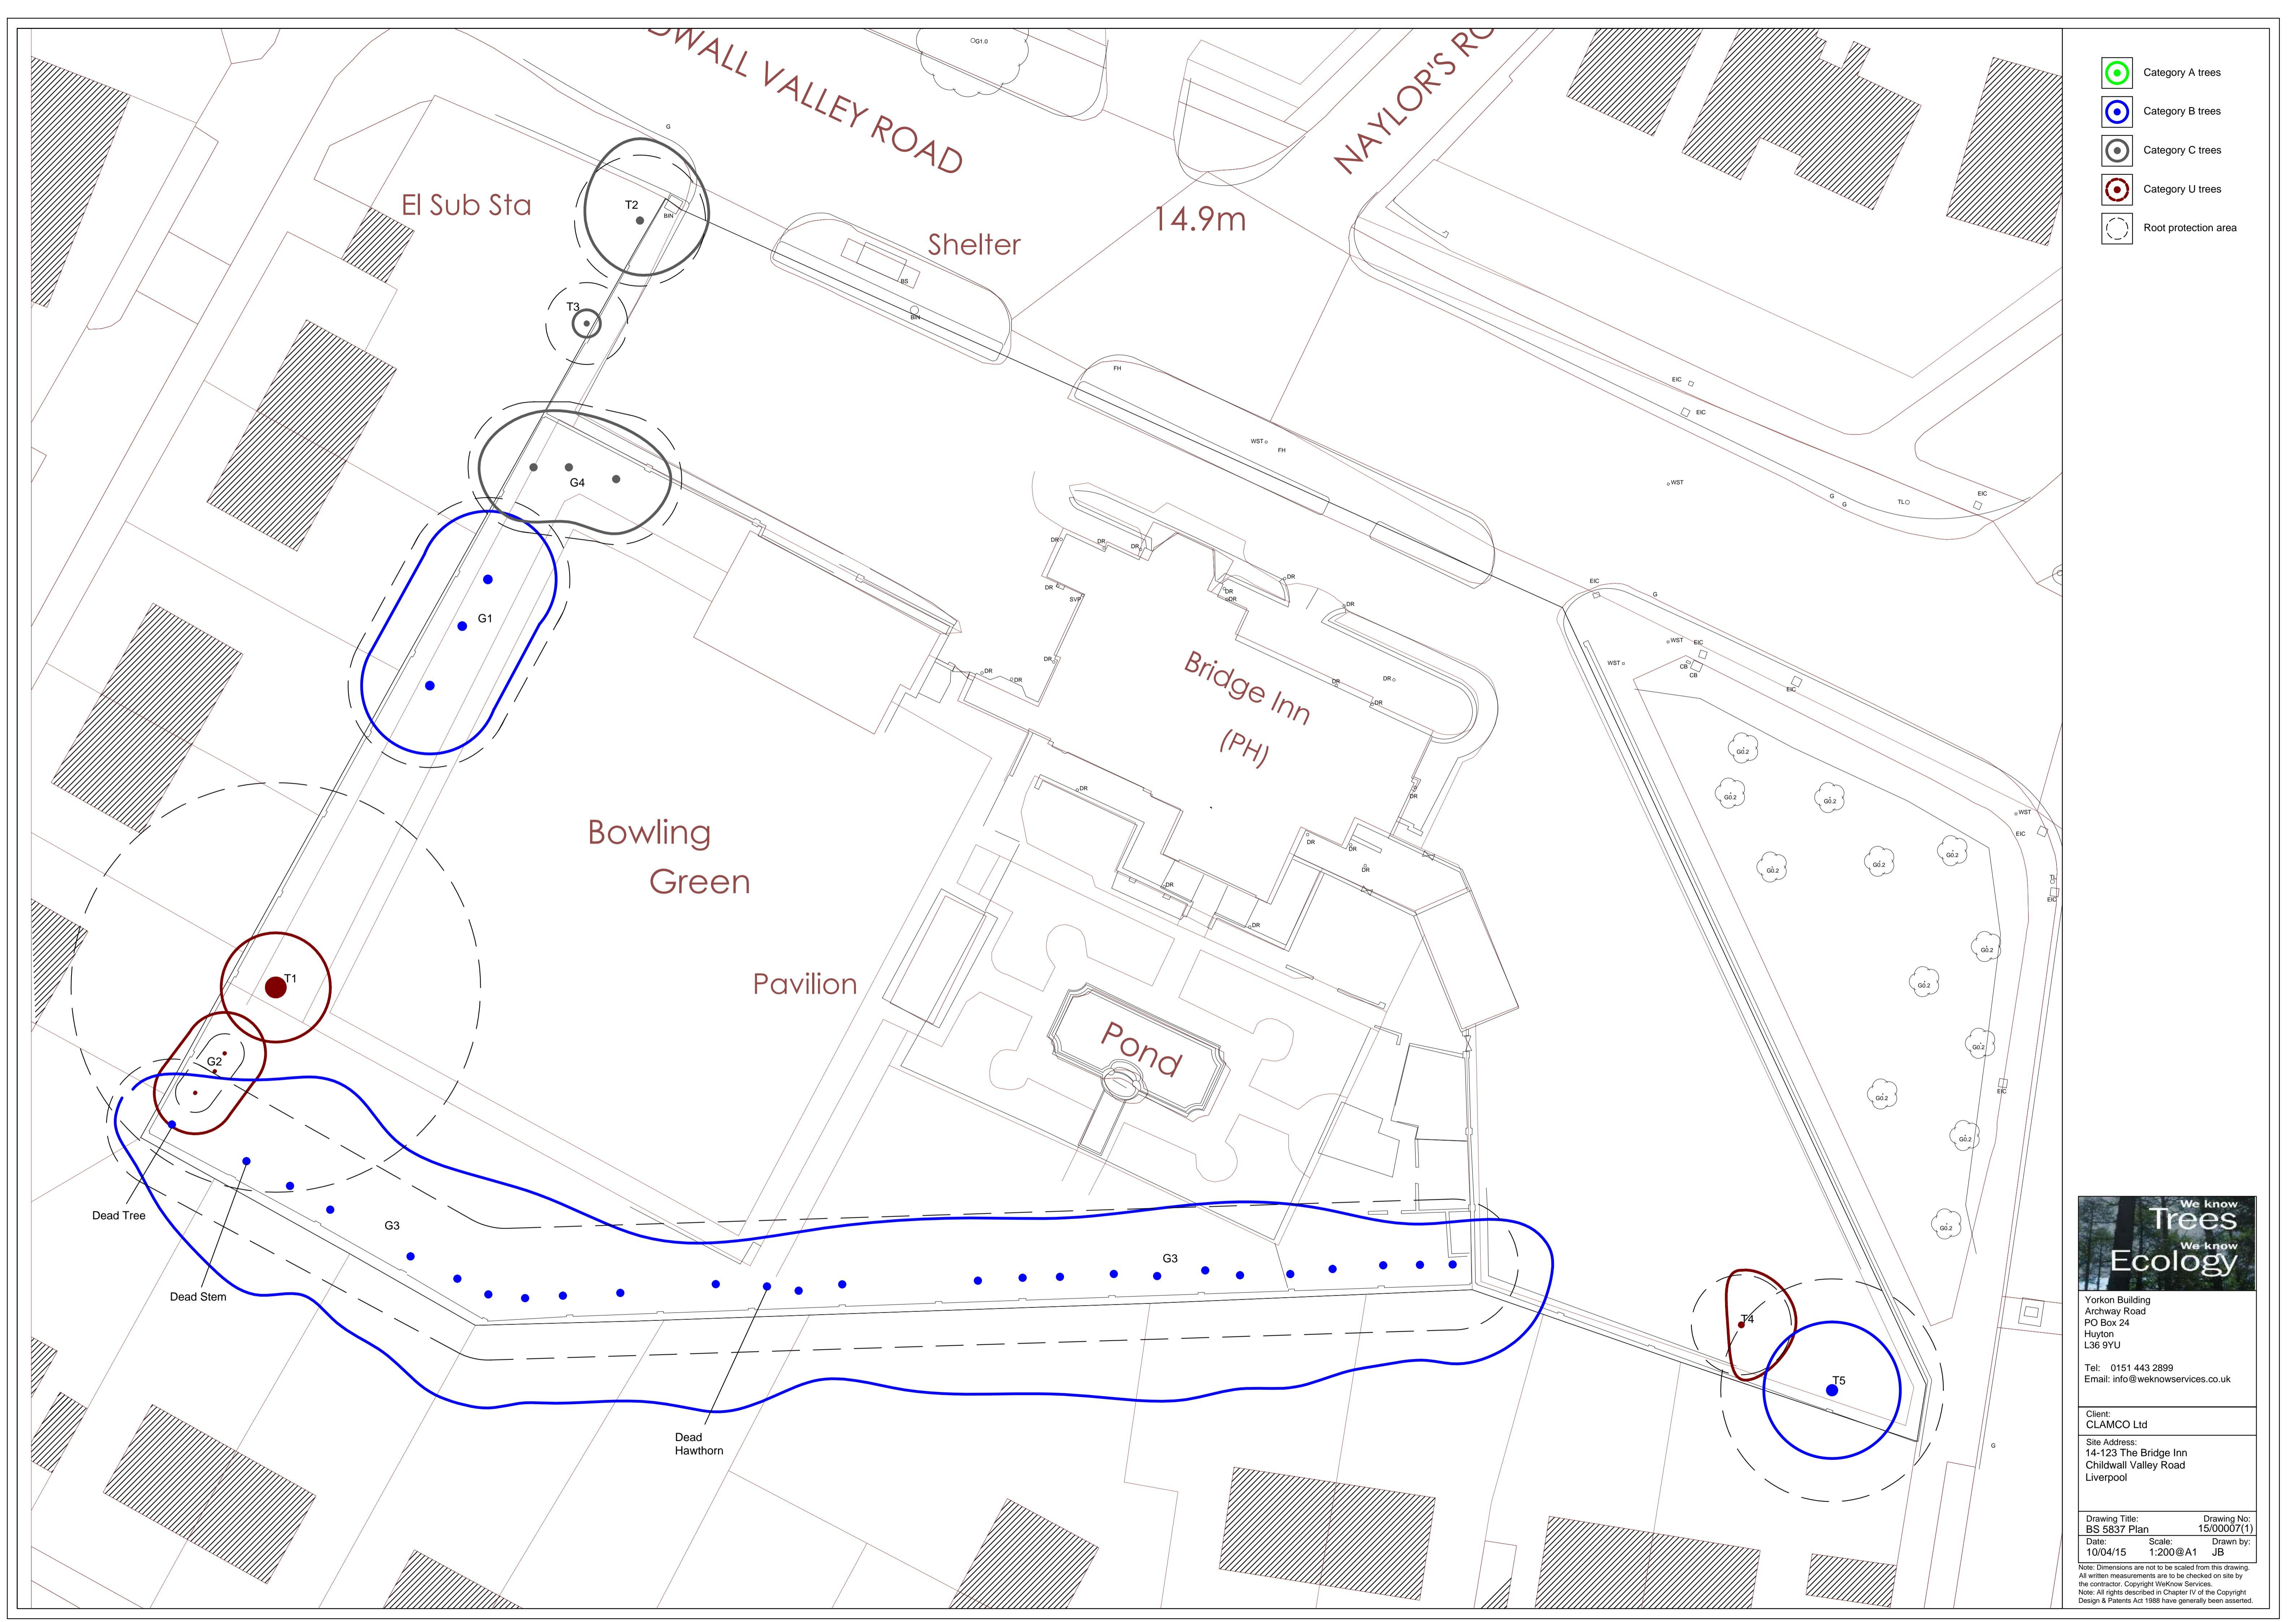
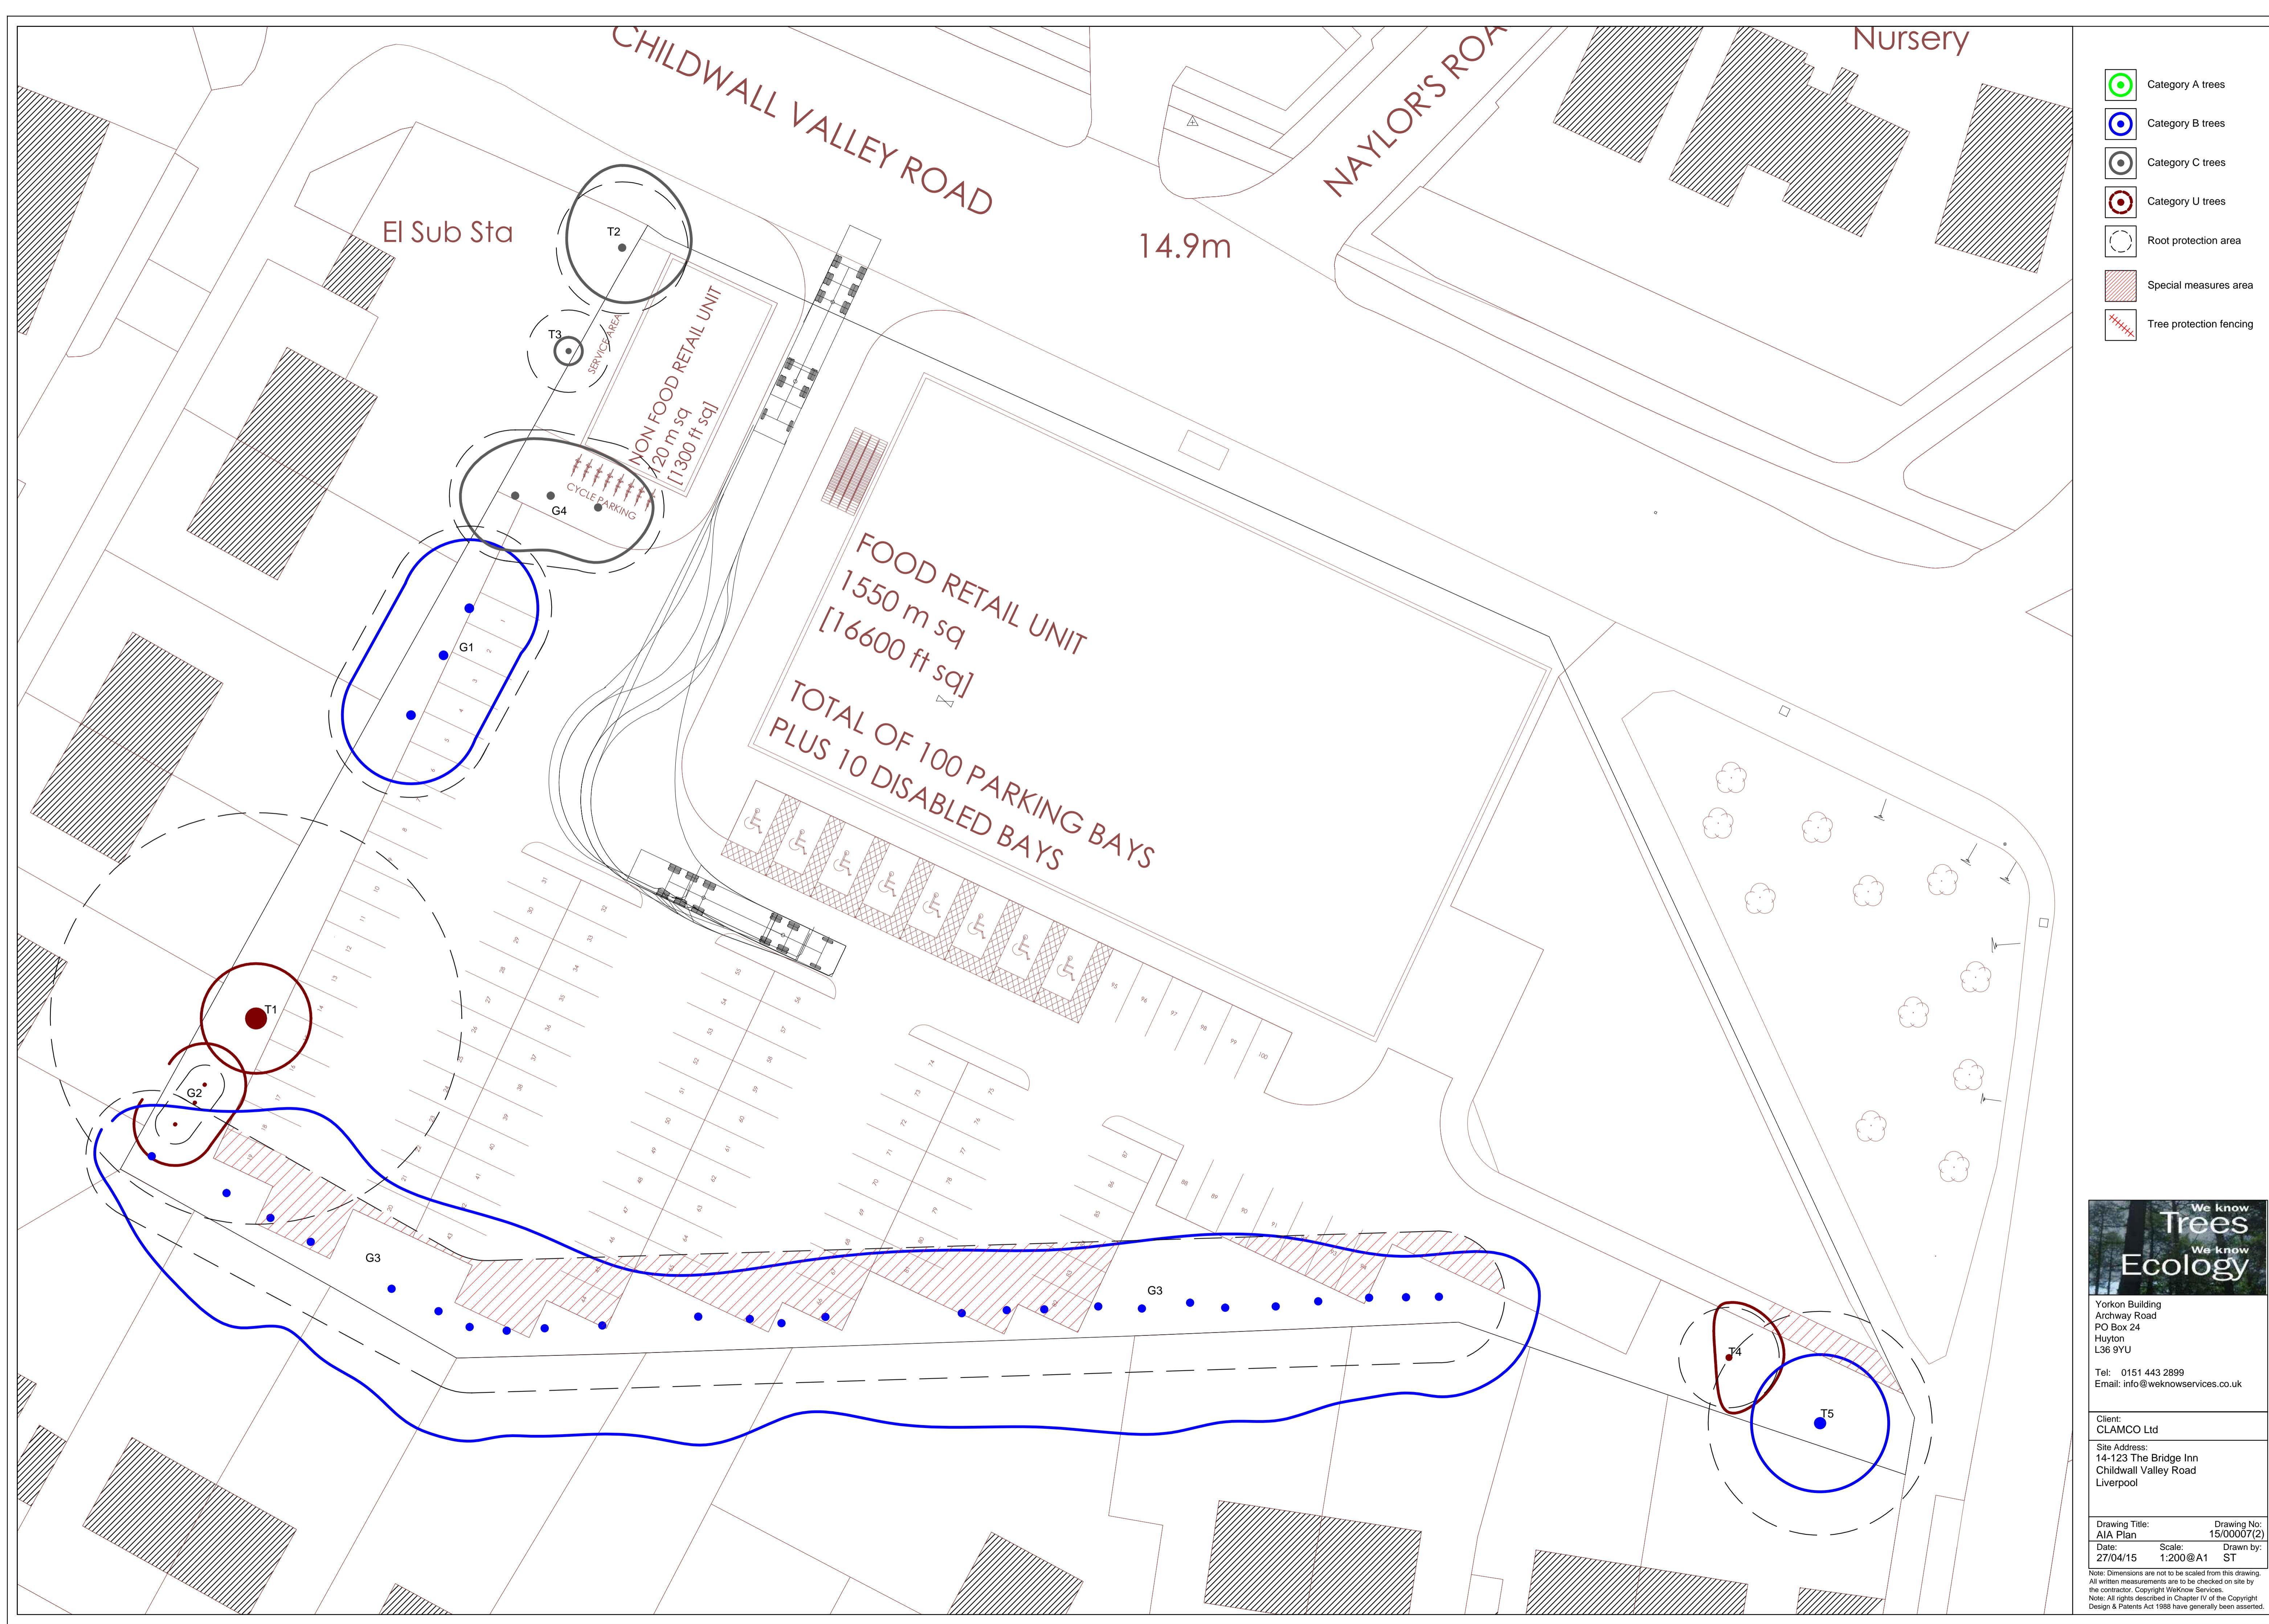
Plans

- 3.1 Due to the proposed development and its associated infrastructure there are a number of locations where the proposals are in close proximity to the trees surveyed. The site layout plan within appendix three identifies the trees in relation to the proposed development.
- 3.2 In order to fully assess the impact of the proposals an Impact Table has been created detailing each tree, which shows the proximity of the associated works to the tree.
- 3.3 This can then be assessed in accordance with BS 5837:2012 to determine whether the development will have a detrimental impact on the health of each tree. Once this has been determined remedial measures can be detailed to reduce the impact the proposals will have on the treescape.

- 1.5 The following documents have been made available by the client:
 - Drawing- Existing Site Plan
 - Drawing- Proposed Site Layout
- 1.6 The supplied drawing included tree positions plotted, however it did not include all tree positions, they have therefore been added to the drawing indicatively. Any dimensions regarding tree positions and protective fencing must be checked on site.

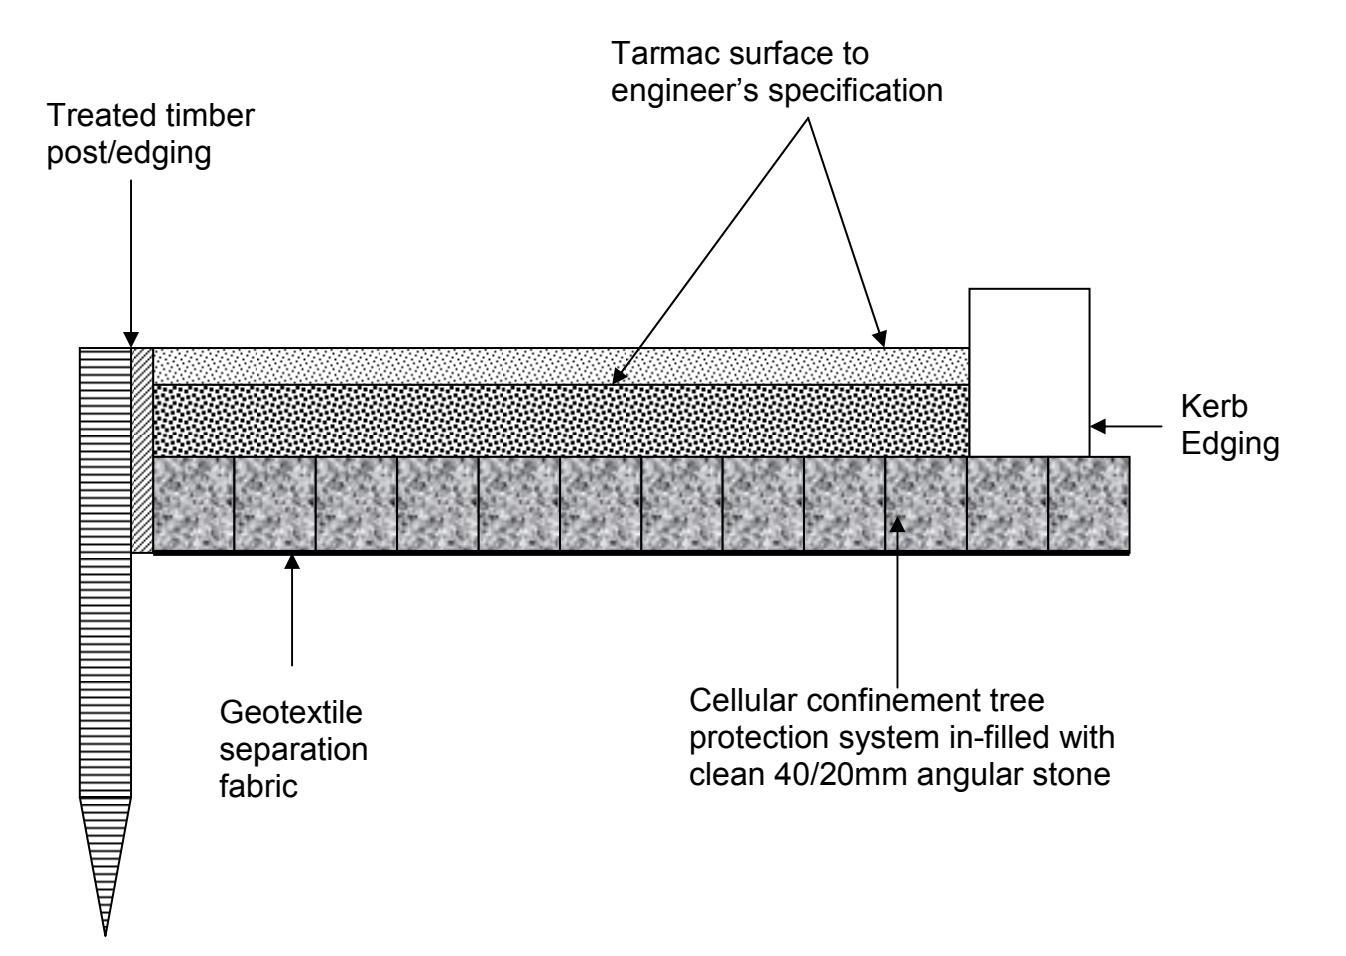
Tarmac Surface

Geoweb Based Construction – (Indicative Only)

Depth of confinement system variable according to use- refer to manufacturer

- 5.2.5 A proposed methodology and cross-sectional diagram for the construction of the access way can be found in appendix four of this report. Should this be used for the car parking, in the area effecting T5 & G3 then the proposals should not have a detrimental effect on the trees.

The following methodology supports the drawing indicating the construction of the proposed car parking. The methodology is prepared on the basis of the sequence of operations necessary to complete the construction of the driveway with the minimum damage to the trees proposed for retention.

- Surface layer to be scraped off. This can be done either by hand or by very small machinery.
- Erect protective fencing to the edge of the construction area.
- Spread a sub grade material over the length of the driveway to fill any small ruts.
- Construct edging using treated timber if required.
- Lay geotextile mat over smoothed area.
- Extend the Geoweb perforated tree root protection system over the area of the driveway with sufficient overlap such that kerbs can be constructed on top of the Geoweb.
- Fill the voids within the Geoweb with reduced fines Type 1 material working into the site over the top of the Geoweb.
- Lay kerbs and surface over the Geoweb such that the construction binds itself together.
- Construct finished surface as required in line with guidance illustrations below.
